MAI-2005-05

REPORT OF INVESTIGATION

Fatal Machinery Accident

**South State, Inc.
South State, Inc., Dredge & Plant
Mine I.D. No. 28-00639**

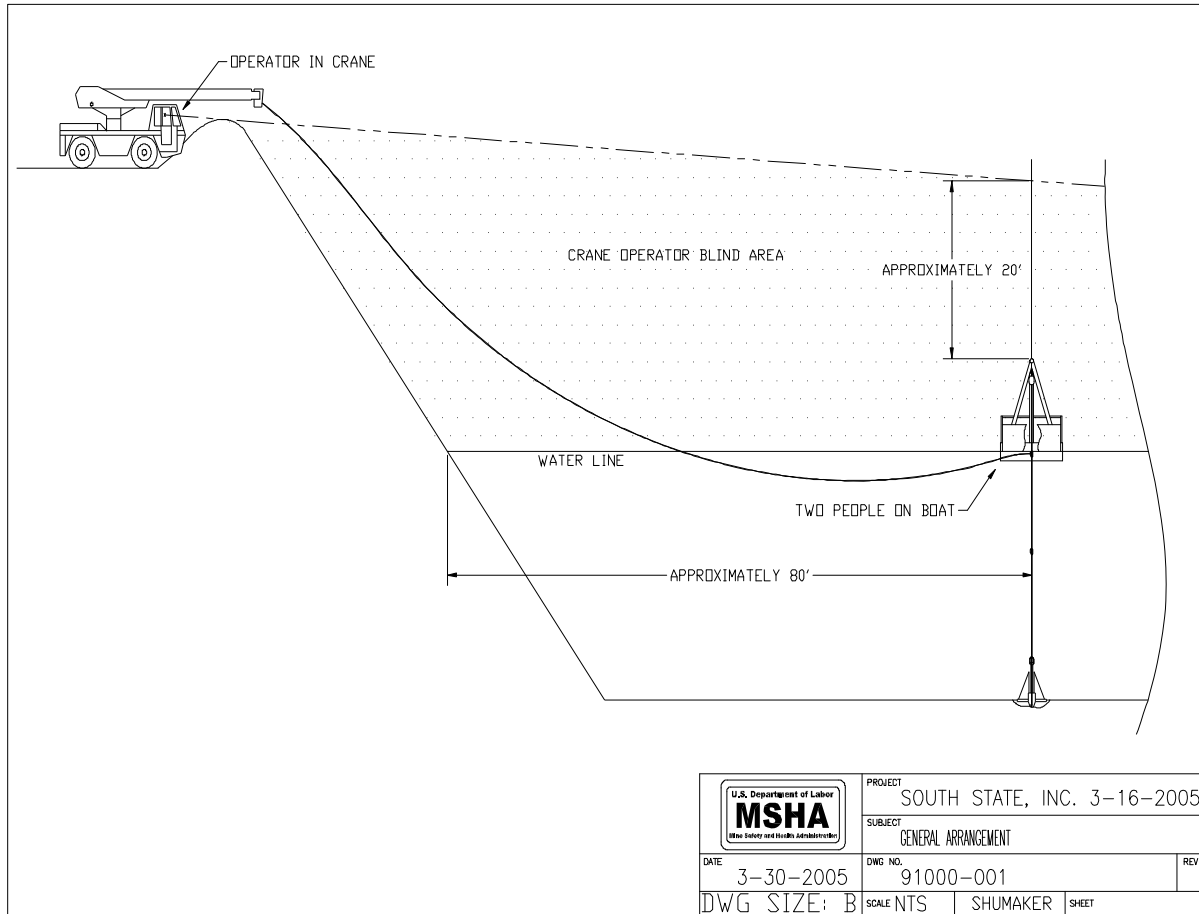
APPENDIX B

There were no communication devices to allow employees in the workboat to communicate with the crane operator. The crane operator could not see or talk with the employees from the operator's cab. The position of the right front corner of the crane cab was approximately 14 feet from the top edge of the bank. The berm in front of the crane's operator cab was 5 feet high. The water level was 32 feet below the elevation of the access road and the anchor pontoon was approximately 80 feet from the bank. An estimated line of sight of the crane operator was 20 feet above the boat's A-frame apex. The closest point on the surface of the water that would have been visible to the crane operator would have been at least 570 feet from the bank (see Appendix B).

Corrective Action: Ensure that communications are in place when tasks are performed that require two separate crews. Use a spotter if visual contact cannot be maintained at all times between the crane operator and the workboat crew.
