REPORT OF INVESTIGATION

Fatal Powered Haulage Accident  
February 14, 2022

Cortez District-Underground  
Nevada Gold Mines, LLC  
Crescent Valley, Lander County, Nevada  
ID No. 26-02573

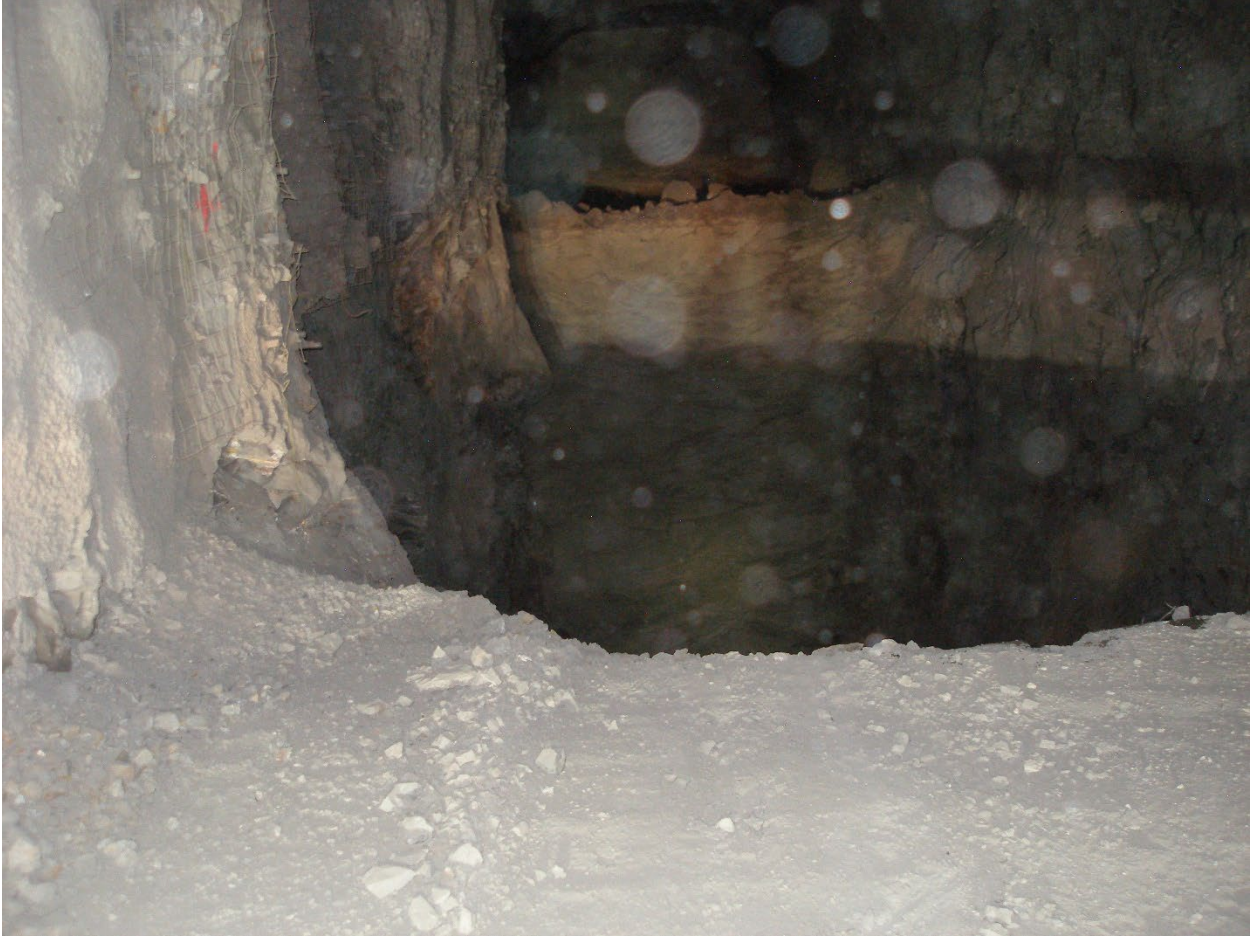
APPENDIX B – Photograph of the 430 Stope from the LA4070 Level

The accident occurred at the LA4070 level in the 430 stope of the mine when the lube truck over-traveled the edge of the stope (see Appendix B). The vehicle fell approximately 60 vertical feet and came to rest upside down on the LA4010 level (see Appendices C and D).

The drift off the LA4070 level to the 430 stope measured 31 feet wide by 19.5 feet high and is 16 feet to the 430 stope's vertical edge. The 430 stope was about 65 feet across to the other side towards the North, and approximately 31 feet wide. Miners last worked this area on January 5, 2022, and it was ready for backfill. Miners drill and blast gold bearing ore in stopes and transport the ore to the surface with haul trucks and belt conveyors. Once production in the stope is complete, it is scheduled for backfill. The mine has two batch plants, one on the surface and one underground, where cemented rock fill (CRF) is processed. The CRF mixture is hauled by

Based on interview statements and a review of records, the investigator determined that the LA4070 level was commonly traveled by mine management and miners and was not being adequately examined. The lack of a berm blocking access to the 430 stope was a hazardous condition that existed for approximately one and a half months and was not reported, despite mine management's daily travel through the area, looking for mining hazards, and by mine management's own admission. Mine management did not notify miners of the hazardous condition or promptly initiate appropriate action to correct it. The investigator determined that inadequate workplace examinations, including no record of the adverse condition, contributed to the accident.

1. Root Cause: The mine operator did not place a berm in front of the open 430 stope.

Corrective Action: The mine operator installed berms and new signage at all open stopes. The mine operator provided additional training on the procedures for placement of berms and signage at the open stopes.

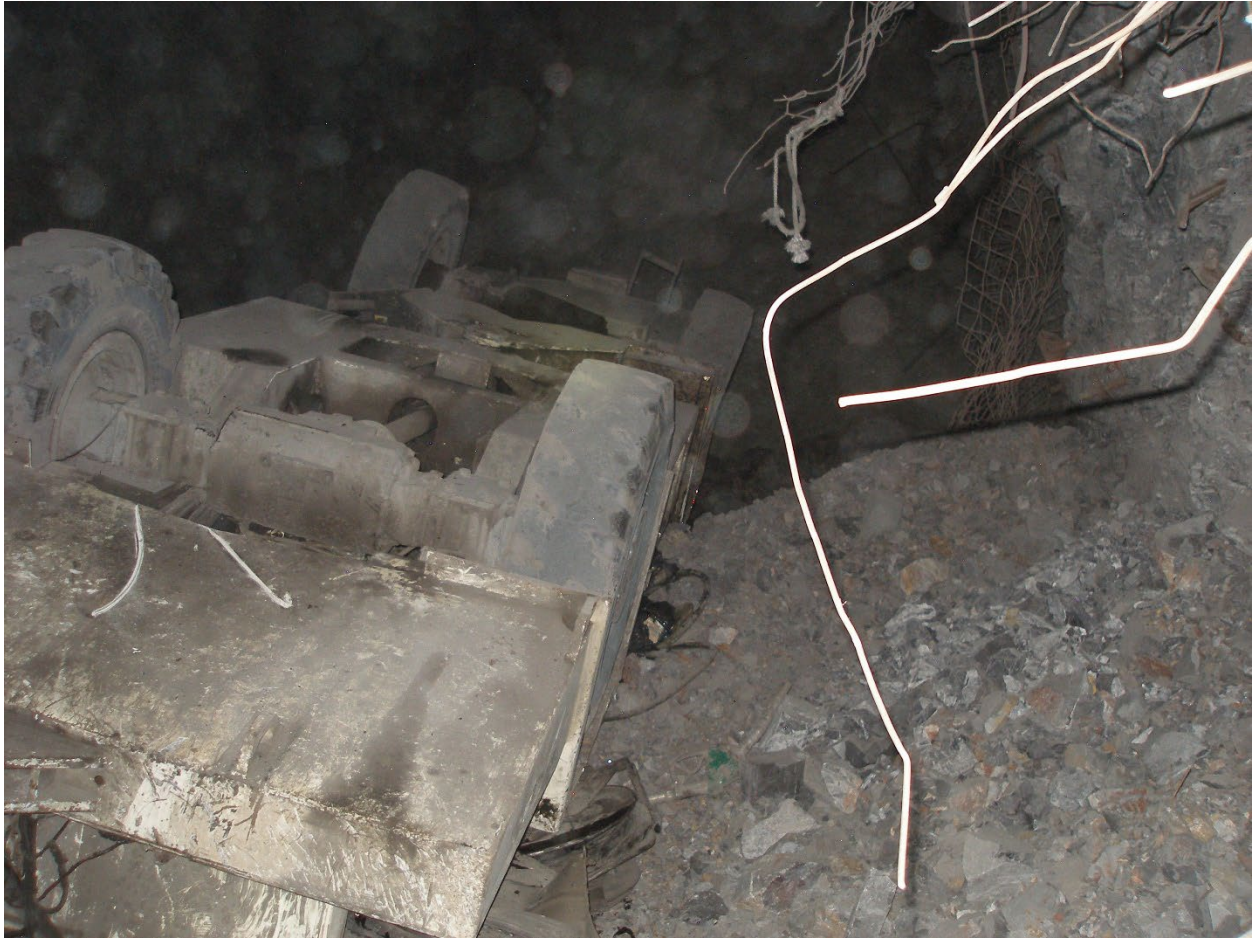
APPENDIX C – Photograph of the Equipment Involved

The Getman A64 Lube/Fuel truck, company number TRL0003, was a diesel-powered articulated haulage truck used daily to deliver fuels and lubricants to mining equipment throughout the mine. The lube truck had hydraulic articulated steering and hydraulic wet disc brakes. The lube truck also had a restricted view to the rear and therefore was equipped with a backup camera. Due to the severe damage caused by the accident, the investigator was unable to determine if the lube truck had any safety defects prior to the accident. The investigator determined the seat belt was functional but not used at the time of the accident.

The investigator reviewed the maintenance and inspection records for the lube truck for several months prior to the accident. The only safety defect reported during this time was a crack in the right cab window. The investigator does not believe the cracked window contributed to the accident. During interviews, the investigator learned that the backup camera on the lube truck was not functional and had not worked for several years. The camera was difficult to maintain in a functional condition due to vibration that would dislodge the wiring, and wet, muddy conditions around the mine. Therefore, according to interviews, the miners had stopped reporting the defect for over two years. The company maintains a digital record of reported defects, and this was not listed. As the defective items are corrected, they are removed from the list. The investigator determined the defective back-up camera contributed to the accident.

3. Root Cause: The mine operator did not maintain the backup camera on the Getman A64 Lube/Fuel truck, company number TRL0003.

Corrective Action: The mine operator installed functional backup cameras on the two remaining lube trucks at the mine and trained miners in conducting proper and thorough examinations of mobile equipment.
