Report on the Explosion in

Frontier No. 1 Mine

Frontier, Wyoming

August 14, 1923

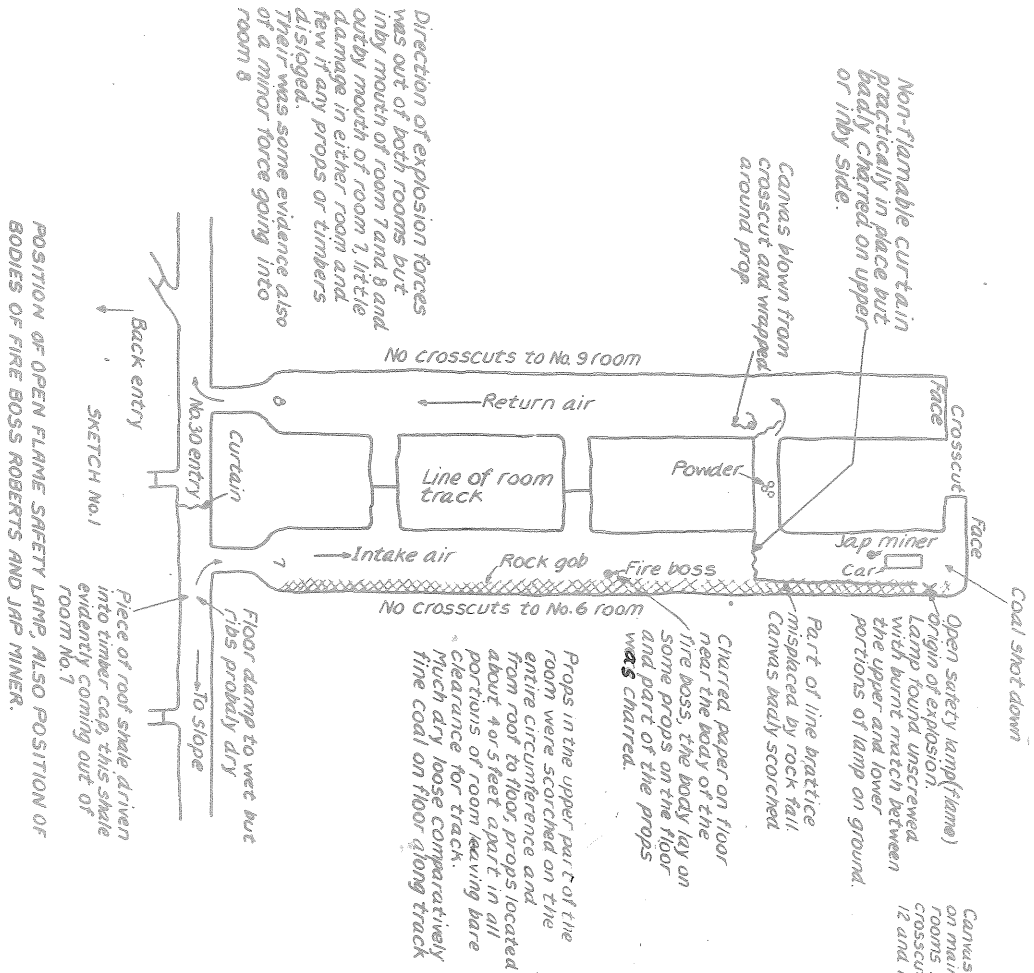
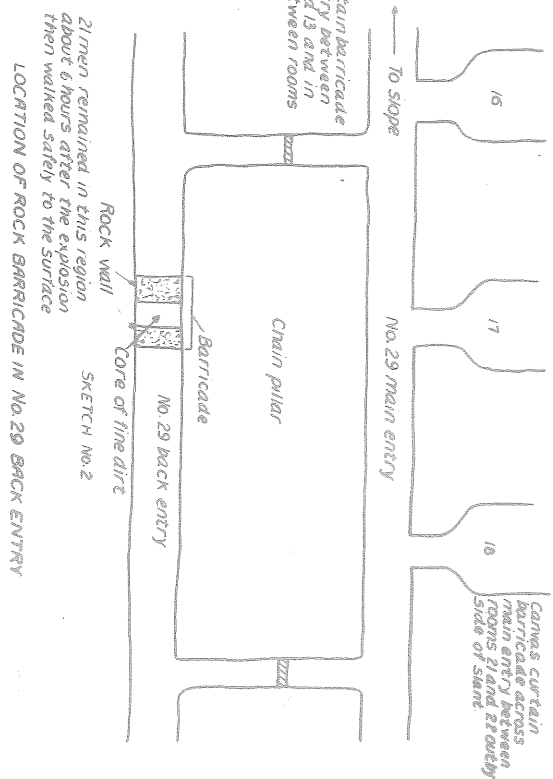
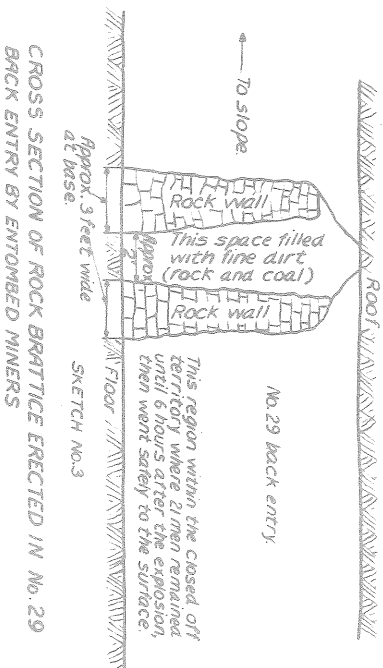
accumulated at the face through the fact that the line brattice was partly thrown down by a rock fall. With the ignition of the gas, Roberts apparently ran down the room to the point about 50 or 60 feet distant where his body was later found. The flame undoubtedly caught the Jap miner near the room face and in standing position, hence the heat was concentrated and his death caused by burns was nearly instantaneous. Roberts, probably kneeling or sitting on the floor relighting his lamp encountered less flame immediately than did the Jap hence was able to go about 60 feet before dying. Roberts had evidently been called by the Jap digger into No. 7 to repair the line brattice which had apparently been knocked down by a fall of roof sometime between the hour of the Fire Boss' examination and the time the Jap entered his place.

A brattice curtain which had been strung across the room to within four feet of the right rib from a point below the last crosscut to No. 8, and through which mules, cars and men could travel, was badly burned on the upper side, and not so much on the lower side. There was very little violence in the upper part of Room 7, only a part of the brattice being dislodged. Retreating to the 3rd cross cut, and through same to No. 8 Room, evidences of considerable heat coming from 7 Room and proceeding down No. 8 were noted. In addition, evidences of force coming up No. 8 room from the entry were noted. Room 8 was very little disturbed. Opposite the last cross cut from Room 7, a piece of brattice was found wrapped around a prop in such a way as to indicate that it came from Room 7. Further investigation on the 30 main entry showed that pit cars at necks of rooms 11 and 13 were forced in by toward the face of the entry. This was true also of entry curtains, which in all cases on the inside of No. 7 Room were blown toward the entry face. These observations indicated strongly that the origin of the explosion must have been in or near No. 7 Room.
