FINAL REPORT OF MINE EXPLOSIONS
SAYRETON NO. 2 MINE, REPUBLIC STEEL CORPORATION
SAYRETON, JEFFERSON COUNTY, ALABAMA
AUGUST 28-29, 1943

R. W. Stahl
Senior Coal Mine Inspector

Jas. B. Benson
Senior Mining Engineer

UNITED STATES
DEPARTMENT OF THE INTERIOR
BUREAU OF MINES

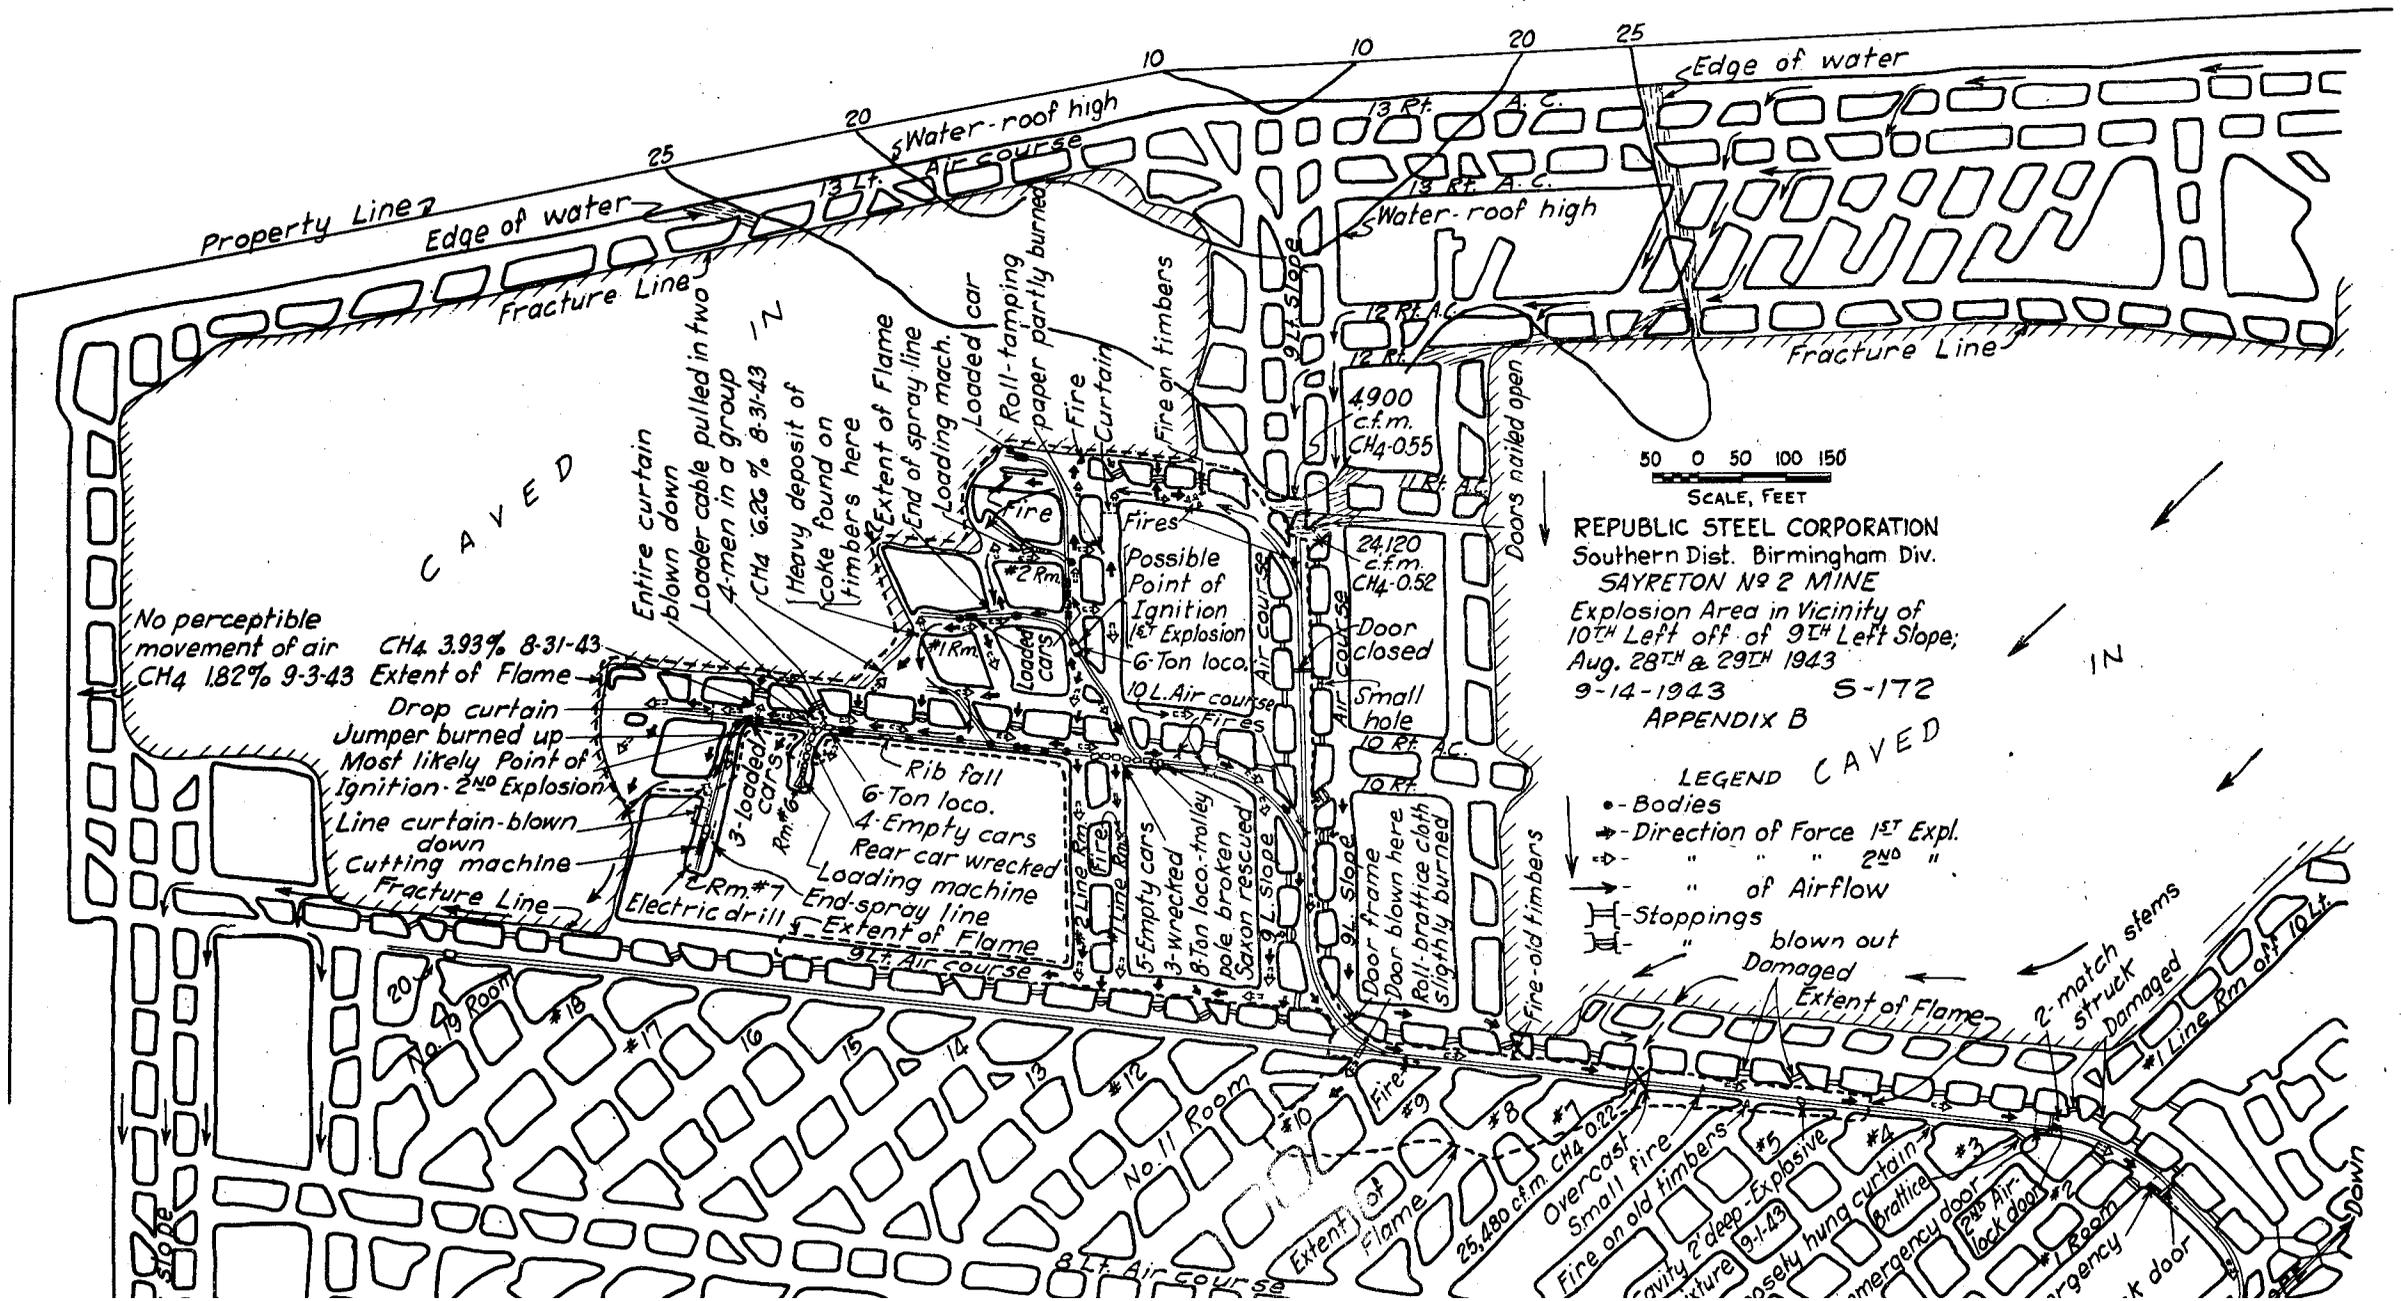
REPUBLIC STEEL CORPORATION
Southern Dist. Birmingham Div.
SAYRETON No 2 MINE
Explosion Area in Vicinity of
10TH Left off of 9TH Left Slope;
Aug. 28TH & 29TH 1943
9-14-1943 S-172
APPENDIX B

along 9 left entry about 200 feet outby from the overcast into the necks of rooms contiguous to 9 left entry, and into 9 left air course adjacent to the explosion area. The flame was apparently cooled at the boundaries, or limited by the presence of rock dust and water, and further propagation was prevented by these fire-retarding agents. Had not the territory immediately surrounding the explosion area been rock-dusted, plus the presence of water inby 11 left entry, a widespread explosion might have resulted. The persons in the explosion area were burned severely, timbers were charred, and coke particles were present on timbers, ribs, and roof, all of which represent the presence of intense heat. The extent of flame is shown on the map in appendix "B".

The large scale map of the explosion area, appendix "B", shows the location of equipment, the bodies of workmen as found after the explosions, clothing, tools, and other articles found in the explosion area. This print also shows the extent of flame, the direction of forces; areas adjoining the explosion area; the area of impounded water, which obstructed air-circulation through the bleeder entries surrounding the caved area contiguous to the explosion area; and points at which methane readings were taken to verify the contention that the caved area immediately adjacent to the affected area was evidently filled with methane.
