Belle Isle Mine
Cargill, Inc
Franklin, St. Mary Parish, Louisiana
June 8, 1979

FINAL REPORT OF MINE EXPLOSION DISASTER
BELLE ISLE MINE
CARGILL, INC.
FRANKLIN, ST. MARY PARISH, LOUISIANA

June 8, 1979

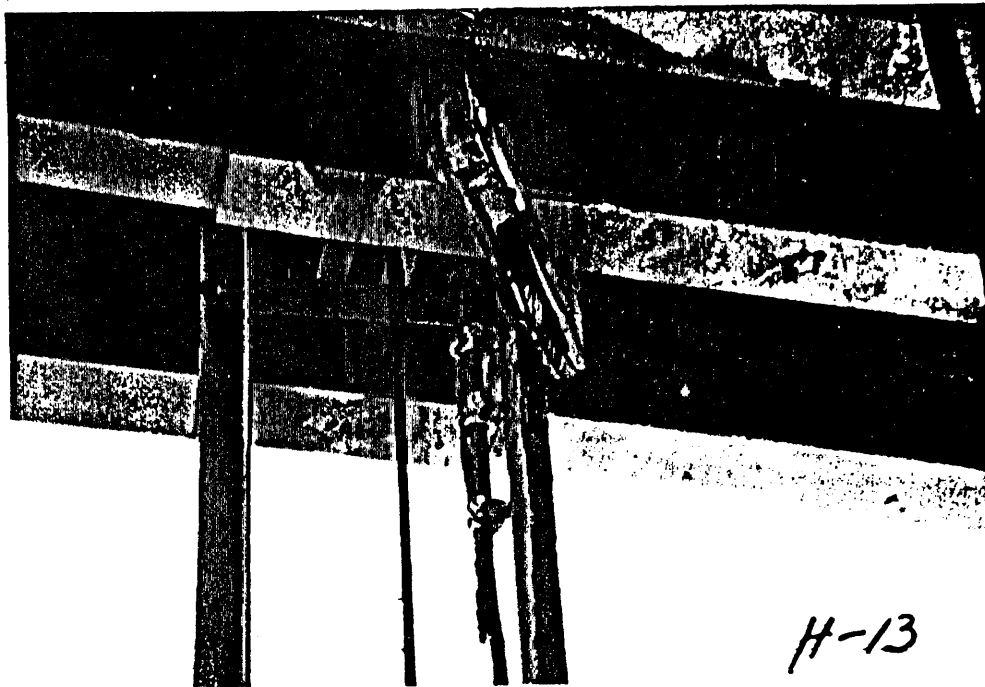
H-13

View of rope damaged when cage was blown to the top of No. 2 shaft headframe.

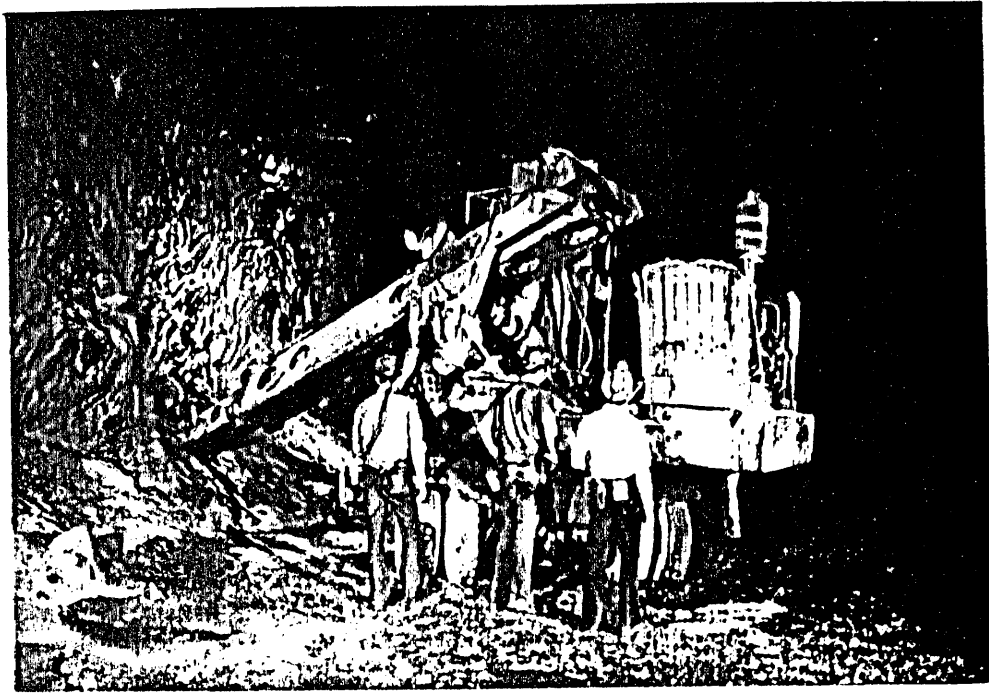
Viewing east or inby side of the Gradall scaler along south rib at 8 Main Entry East at Room 11. Paint does not show heat deterioration.

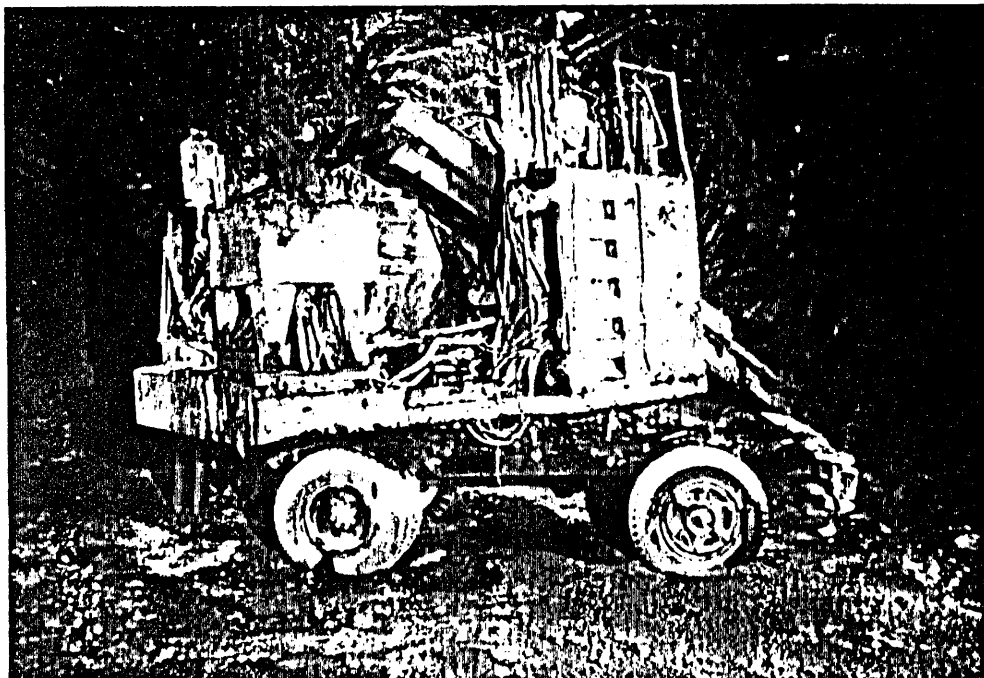
Viewing the west or outby side of the Gradall. Paint shows heat deterioration and a heavy salt encrustation from a high, hot wind moving east is evident.

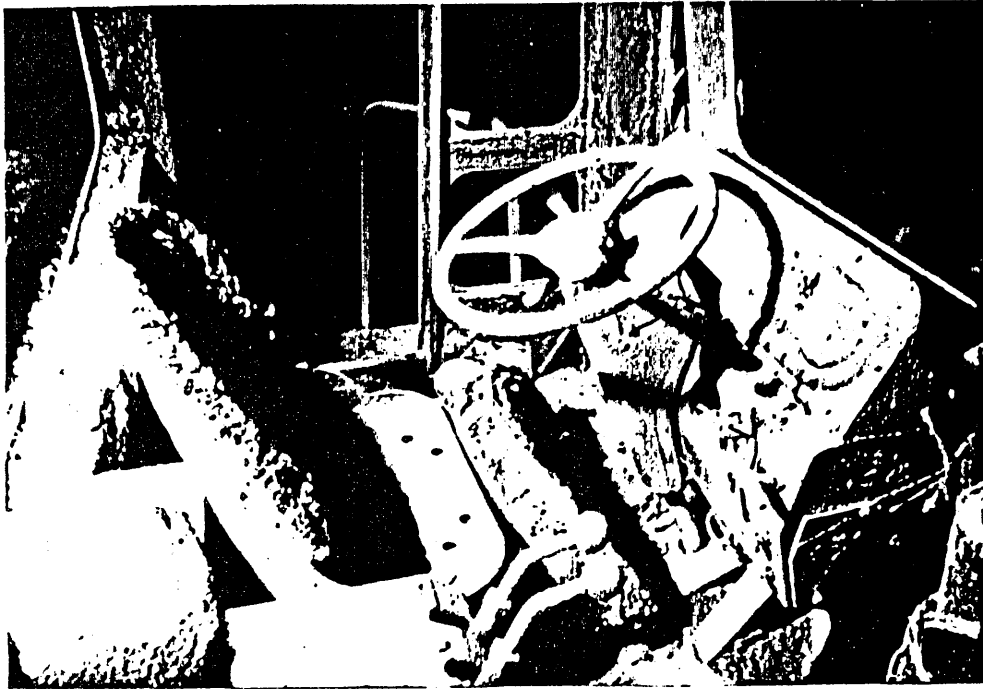
Heat damage in cab of the Terex loader at 7X Entry East and Room 10 lower level.
Vinyl seat covering burned off, leaving edge -..scorched foam.

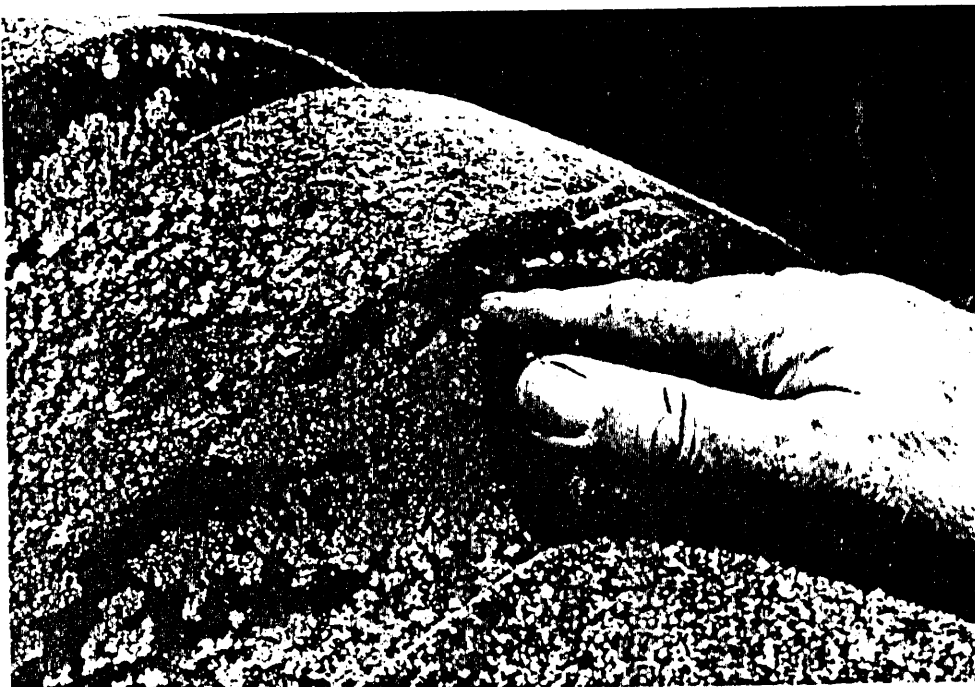
Rear recapped tires showing chars and salt on Terex loader at 7X Entry East
and Room 10 lower level.

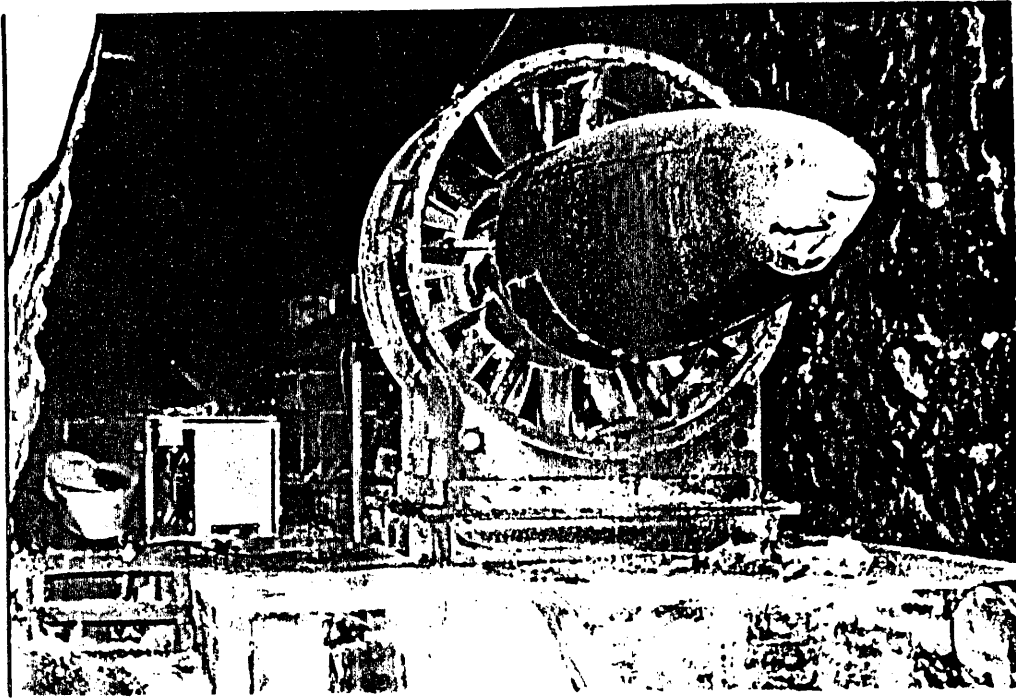
Main fan in airway tunnel south of No. 2 shaft. Portion of the metal fan bulkhead found in No. 2 shaft sump.

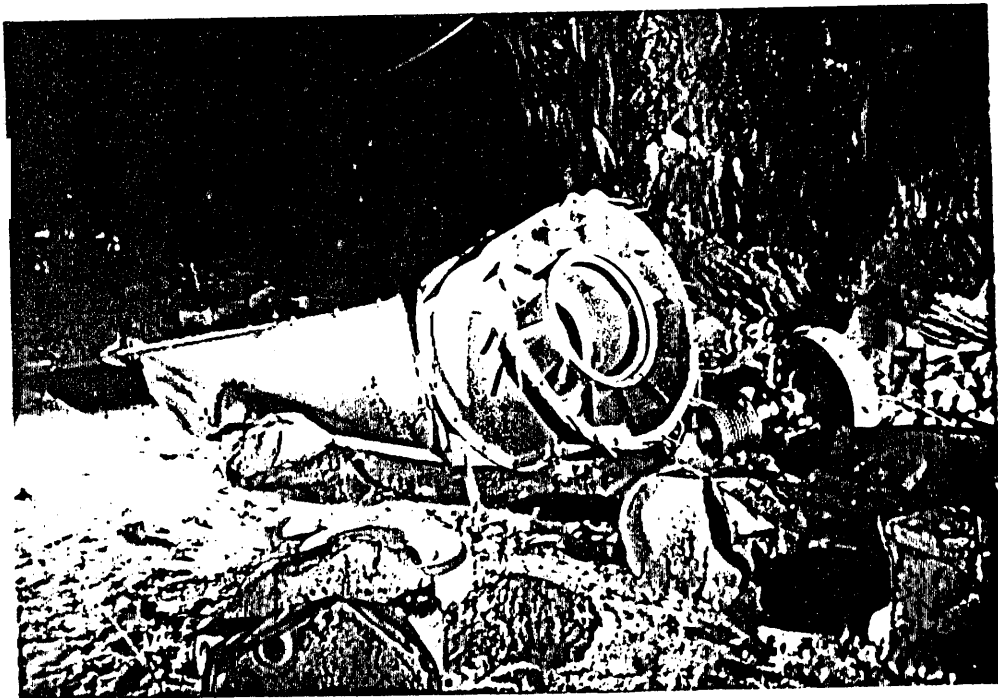
Remnants of free-standing fan originally in No. 2 Main Entry South, south of 7 Main Entry East, blown north to between 4 and 5 Main Entry East in 2 Main Entry South.

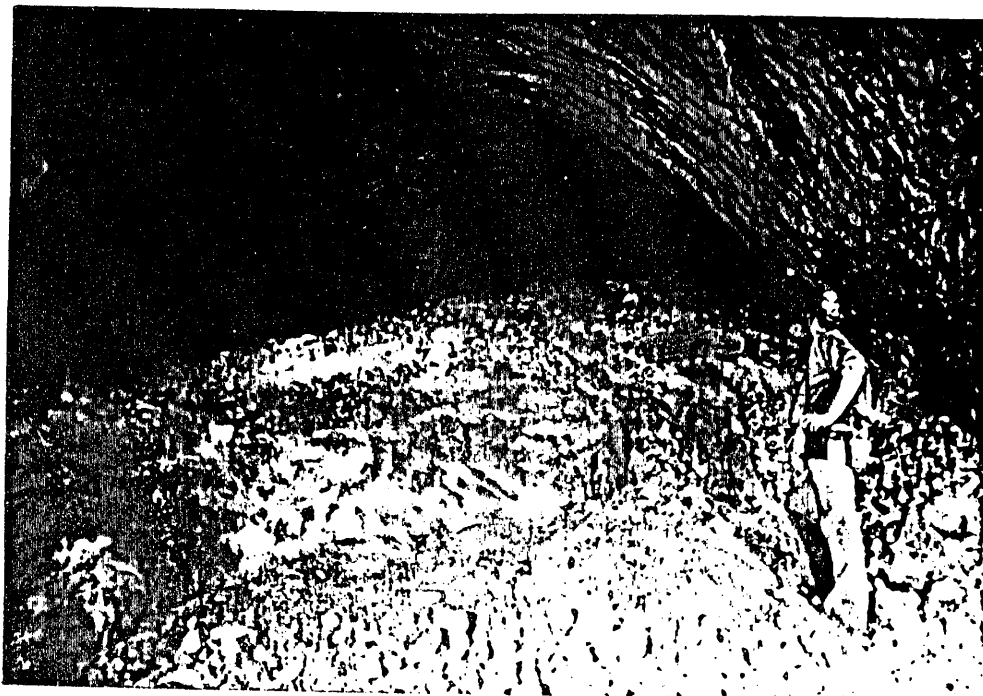
1975 blowout in 7 Main Entry West Room 4.

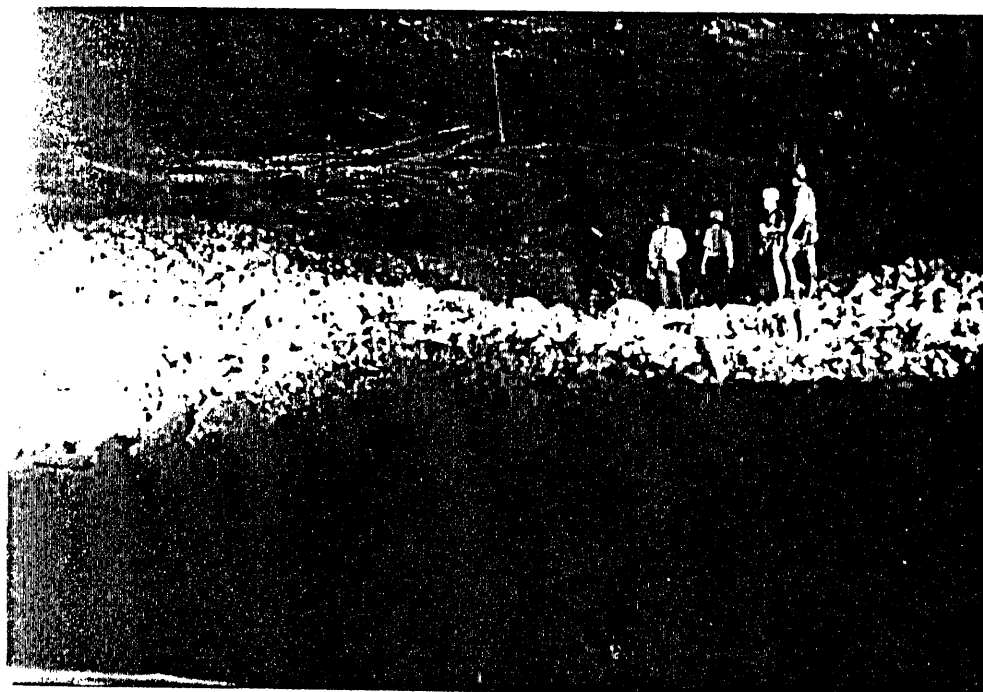
Viewing south from 7X Entry East at outburst salt piled in Room 13.

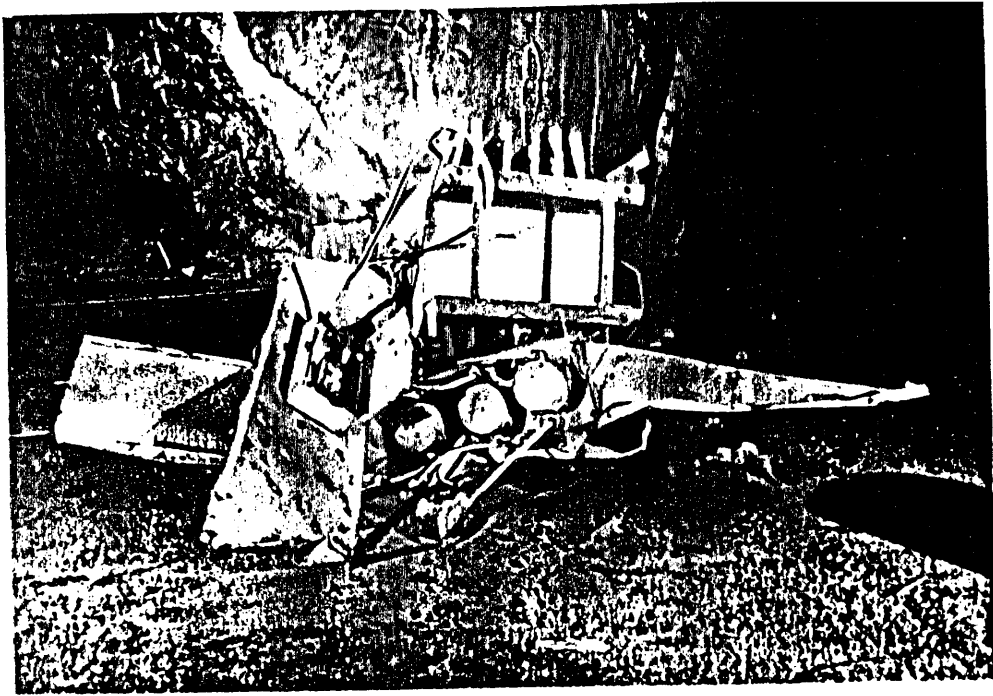
Transformer blown west from 1X crosscut east of 2 Main Entry South into middle of 2 Main Entry South.

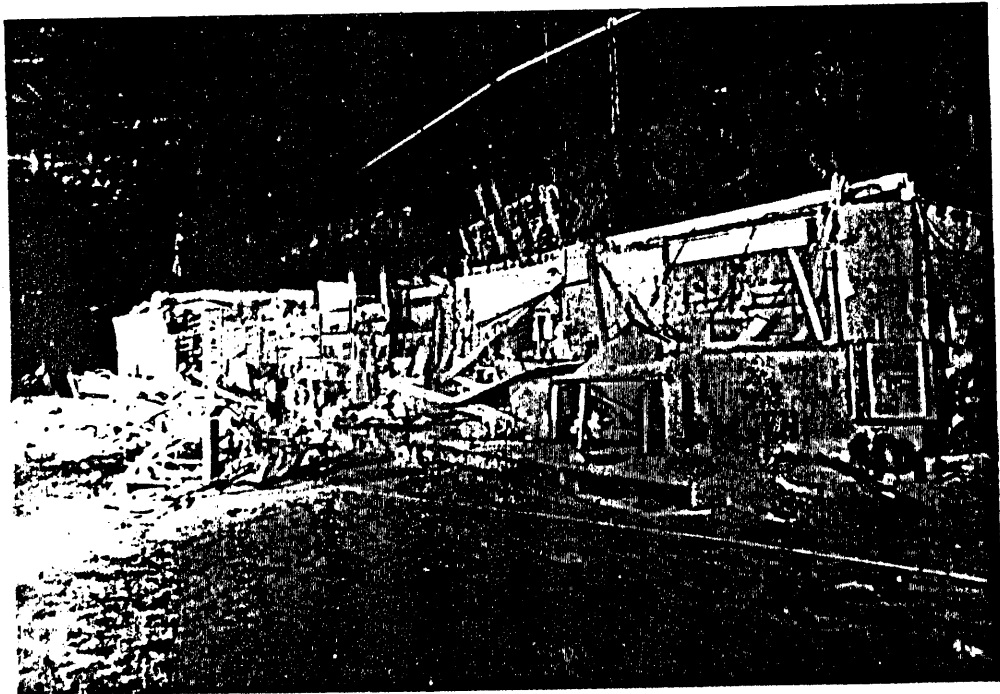
Viewing north at damaged maintenance office and parts room in 2 Main Entry South, north of 1X crosscut.

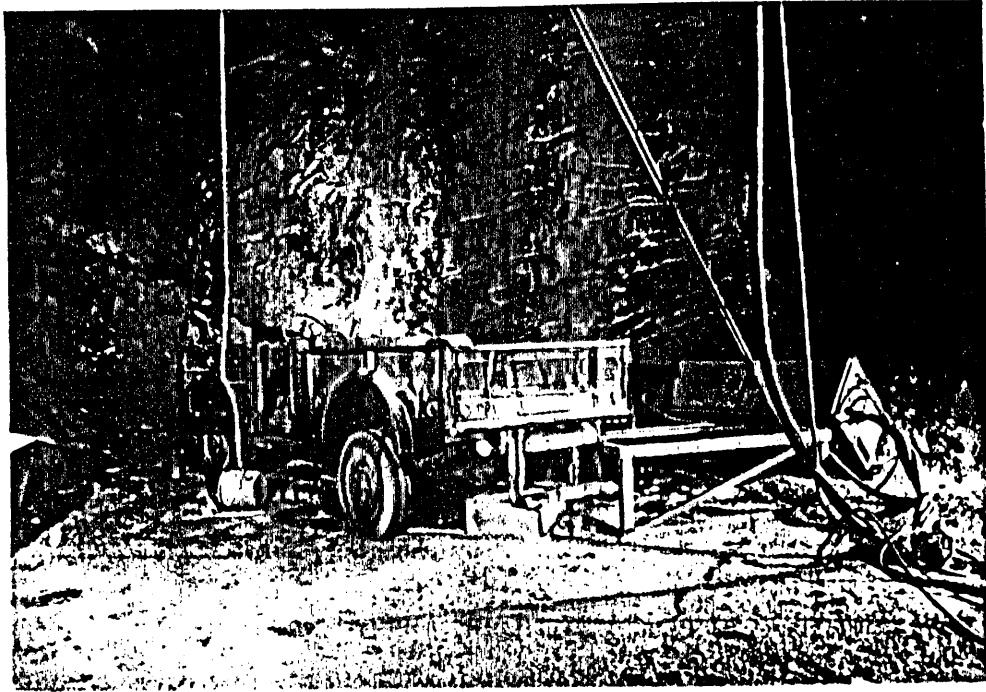
Truck at 2 Main Tunnel West of 1 Main Tunnel South in which the 11 men were sitting and one standing for the safety meeting.

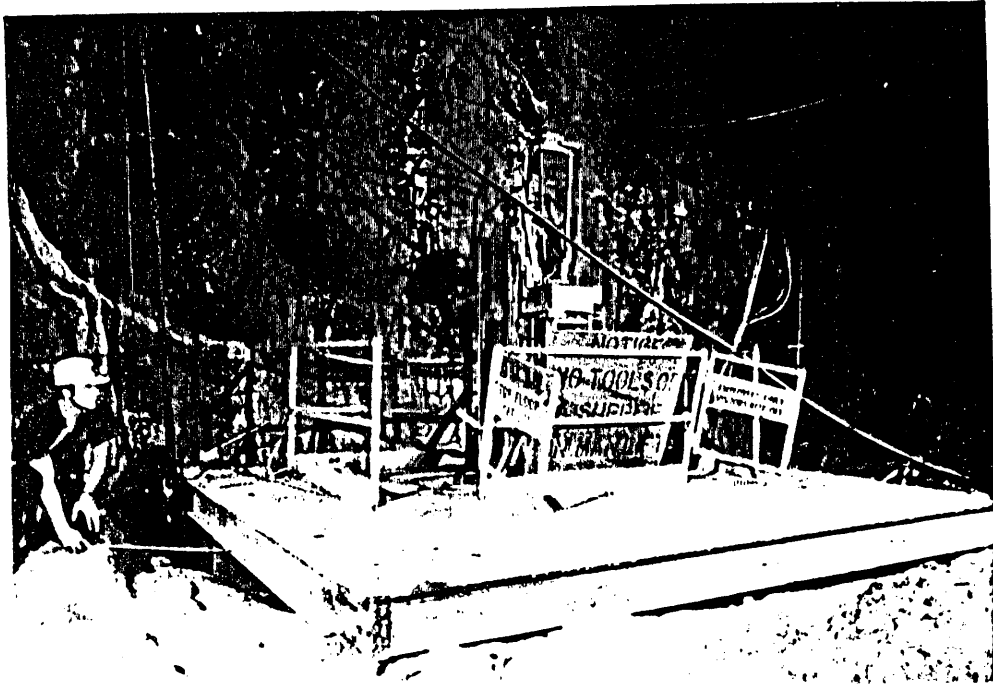
Top of manlift at 2 Main Entry East just west of 1 Main Entry South. Entire frame moved to the west 2 feet.

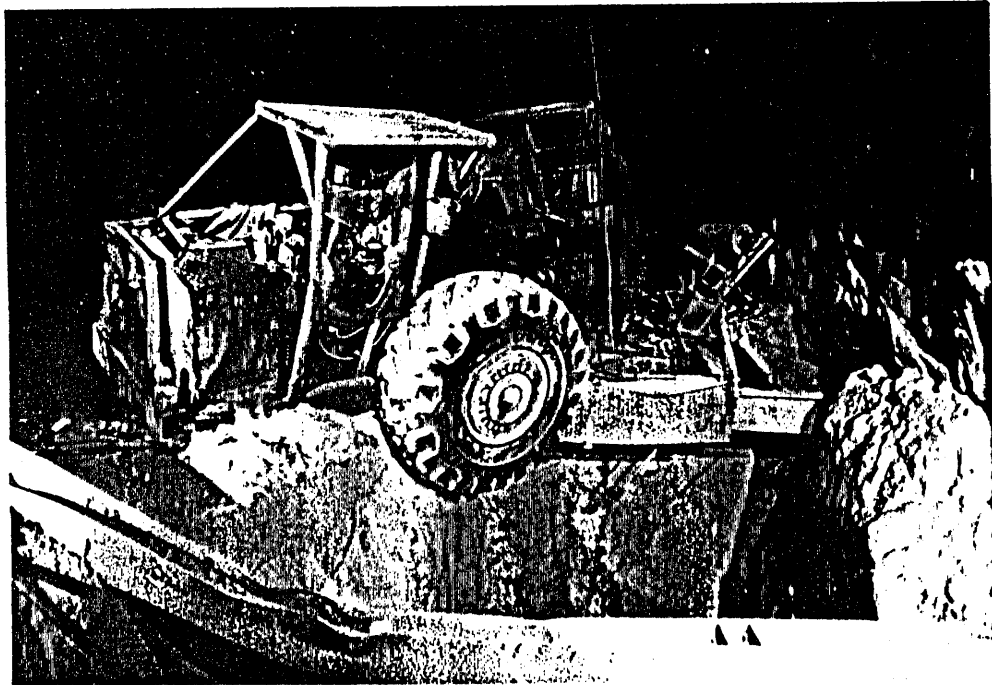
Terex truck in 1 Main Entry South moved north by the explosion into the reclaim bin located just north of 2 Main Entry East.

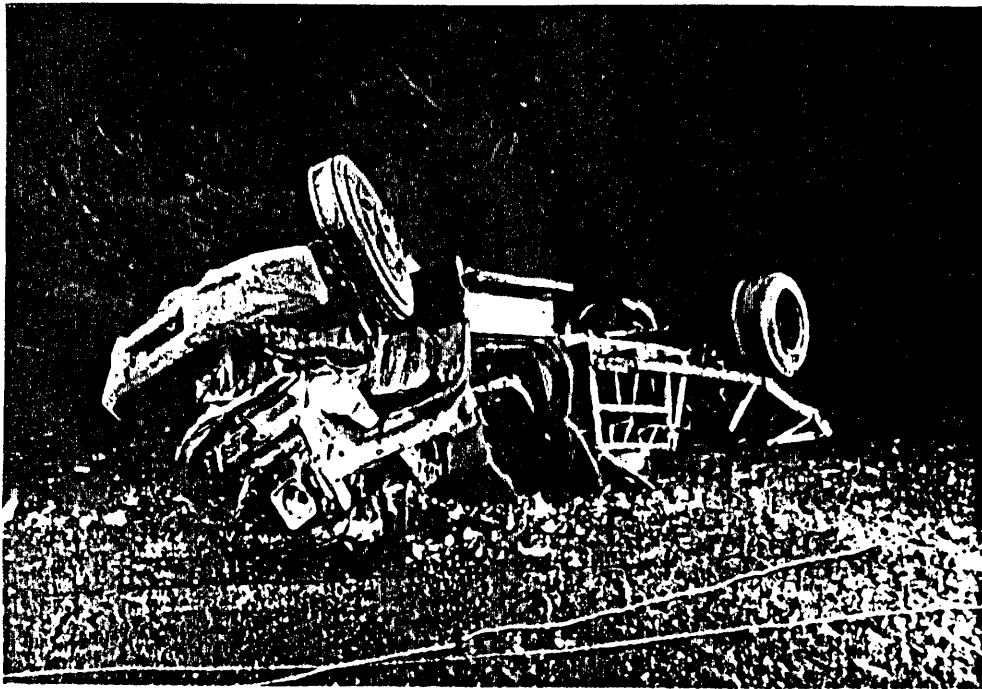
Turned over red shop truck. Picture taken viewing the truck from the south. Truck was located in 7 Main East Entry just west of Room 13.

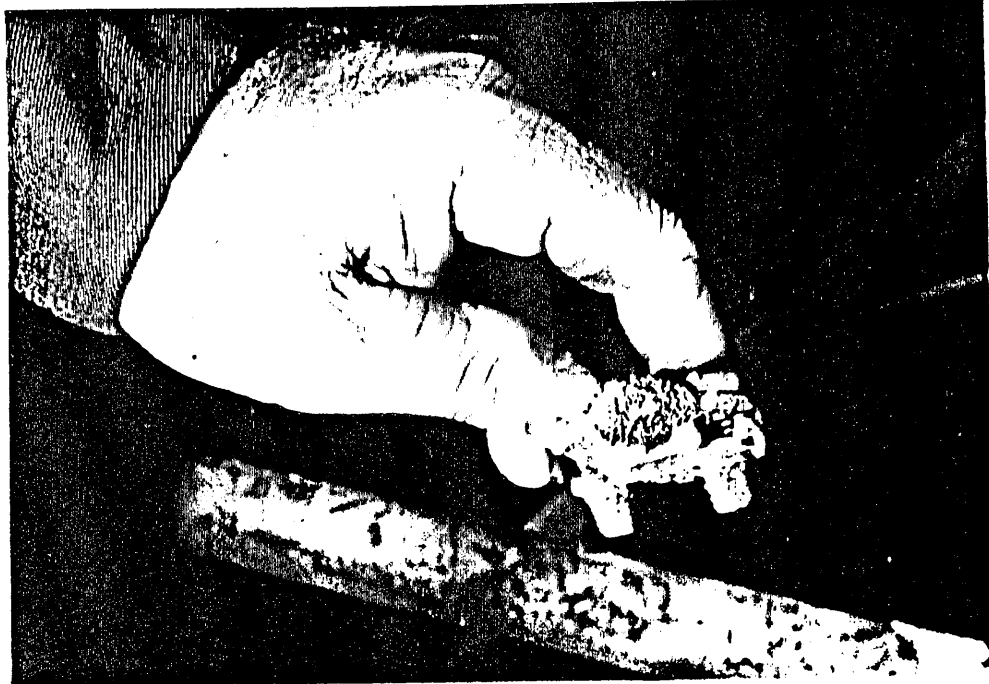
Negative terminal on overturned maintenance shop truck in 7 Main Entry East and west of Room 13. The terminal exhibited that lead had melted.

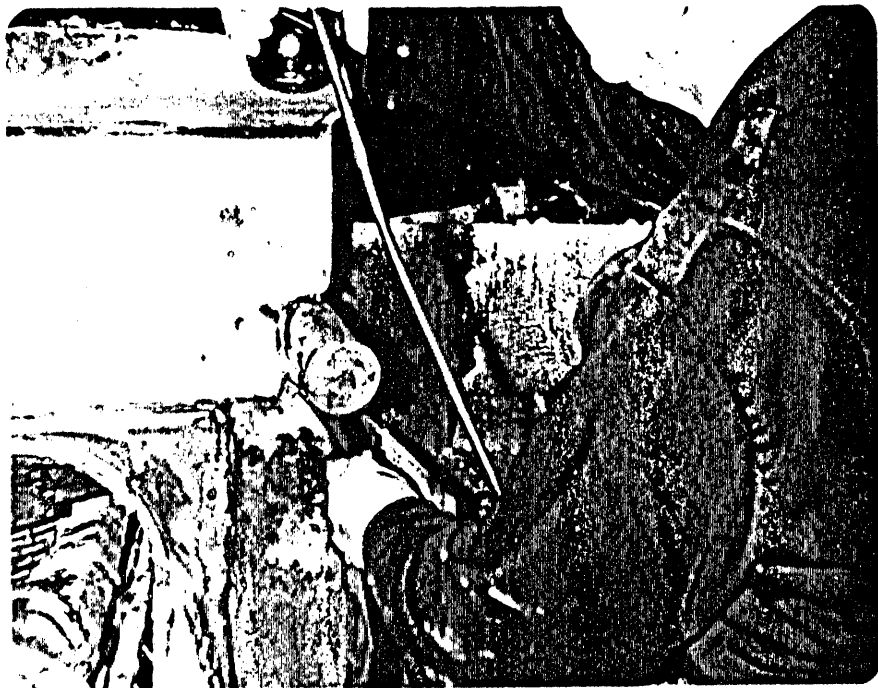
Pinched positive conductor on overturned truck. Bare copper wire exposed.

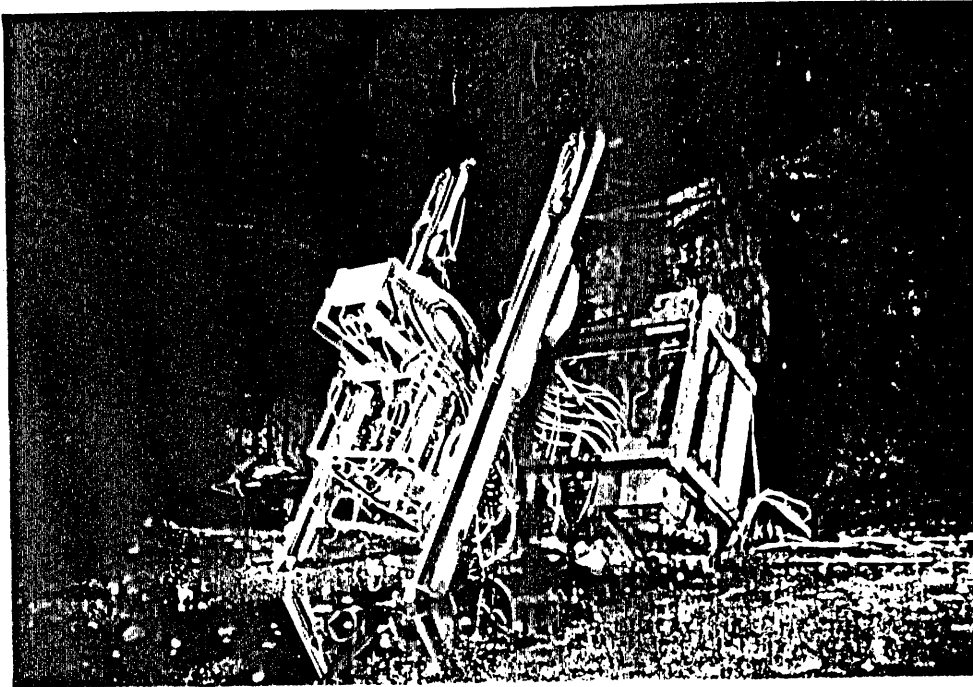
Viewing to the southwest at the face drill located at the southeast corner of 7X Entry East and Room 13. Drill was blown 50 feet to the southeast.

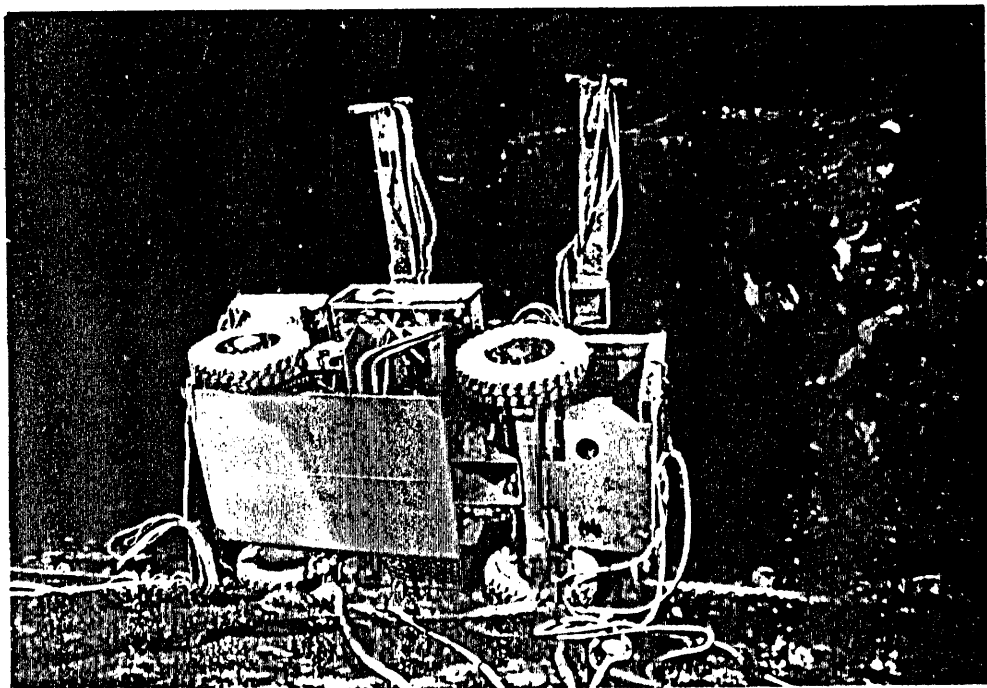
Viewing southeast at the bottom side of the face drill above.

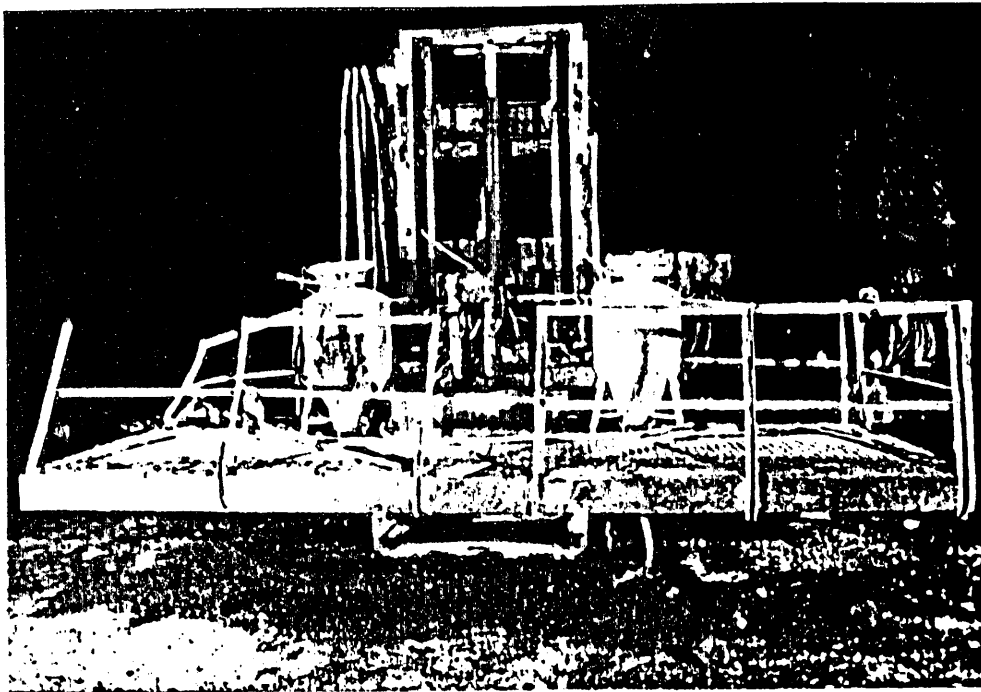
Explosives loading Jumbo facing south. Located just north of 8 Main Entry East along the east rib at Room 12.

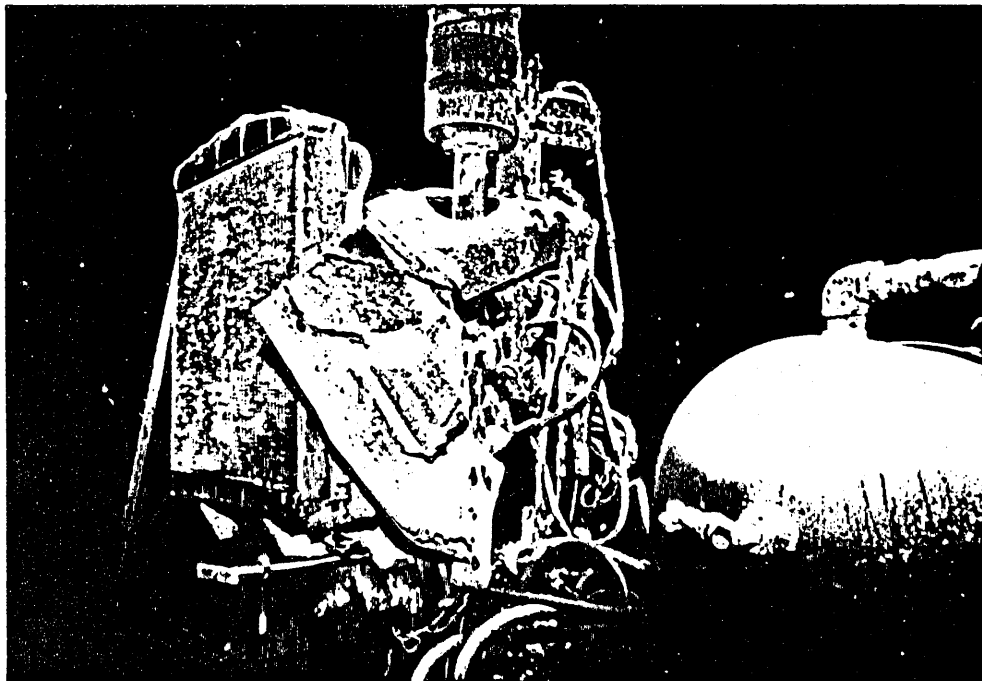
Portable blasting board impaled on south side of engine of loading Jumbo. Board was located between Rooms 11 and 12 in 8 Main Entry East before the blast and distributed power to the 8 Main East face shot and bench shot at Room 11X.

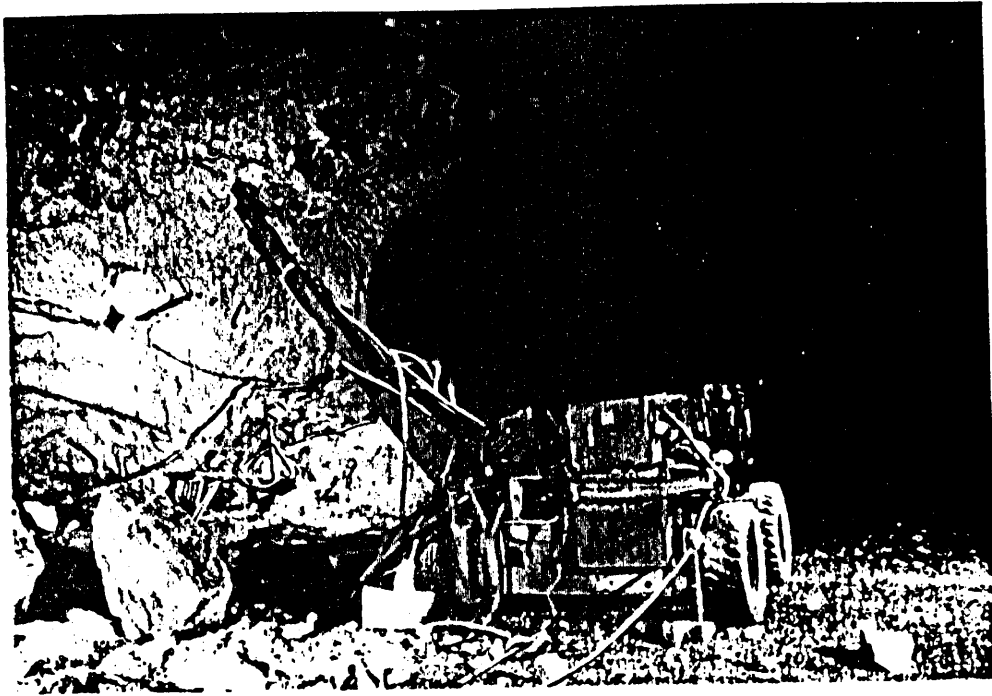
Viewing floor drill at northeast corner of 7 Main Entry East and Room 14. Boom bent away from normal vertical position. Hydraulic unit on left side badly damaged and pushed to the east. Electric cable on right side pulled apart.

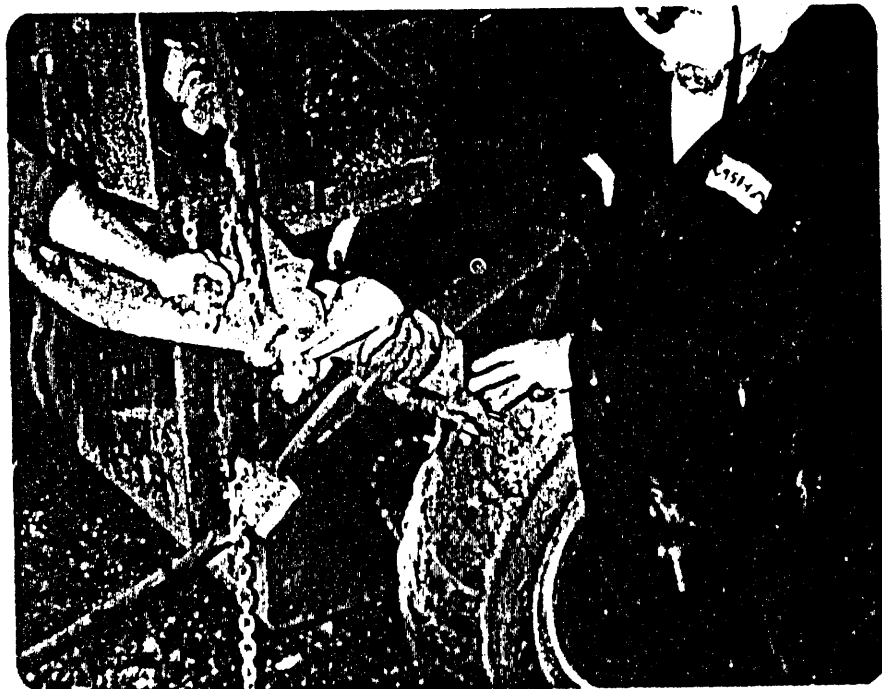
Close-up view of parted cable.

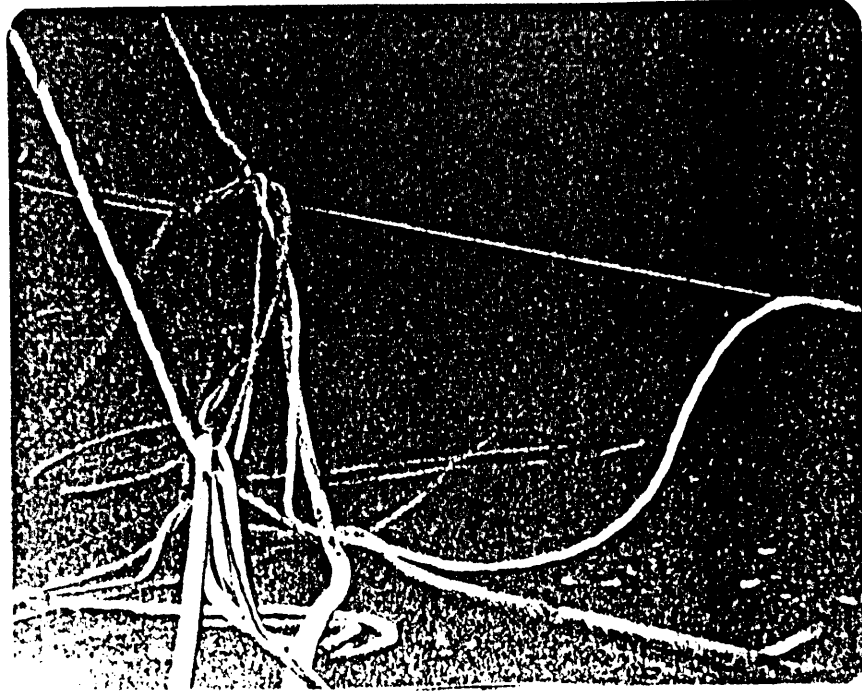
Entangled electric cables blown from the roof at 7 Main Entry East Room 13.

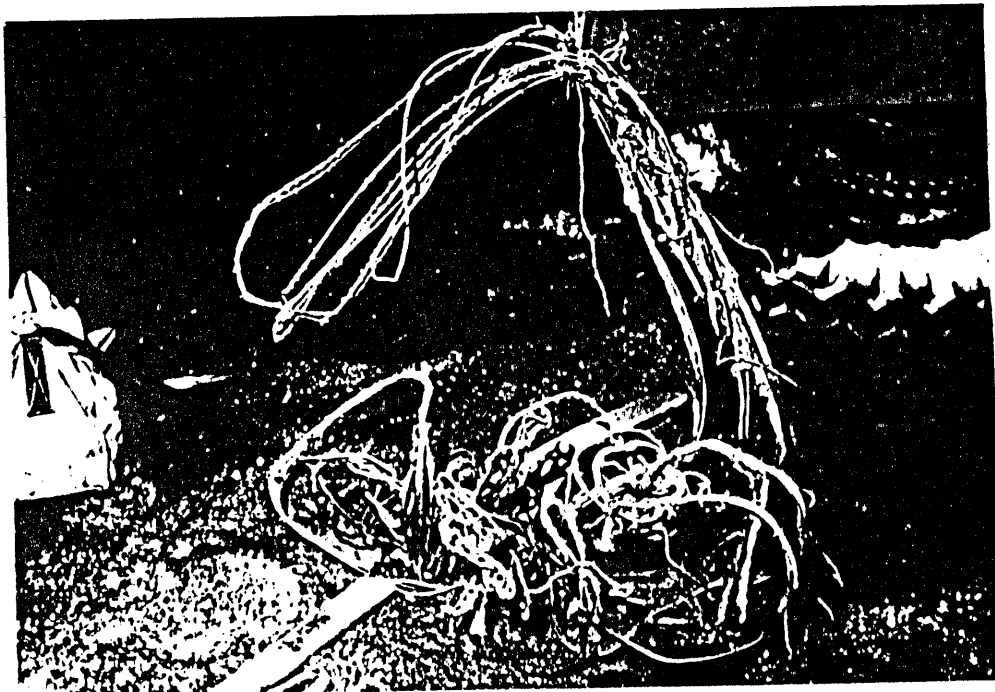
Burned wires at base of turned over face drill at 7X Entry and Room 13.

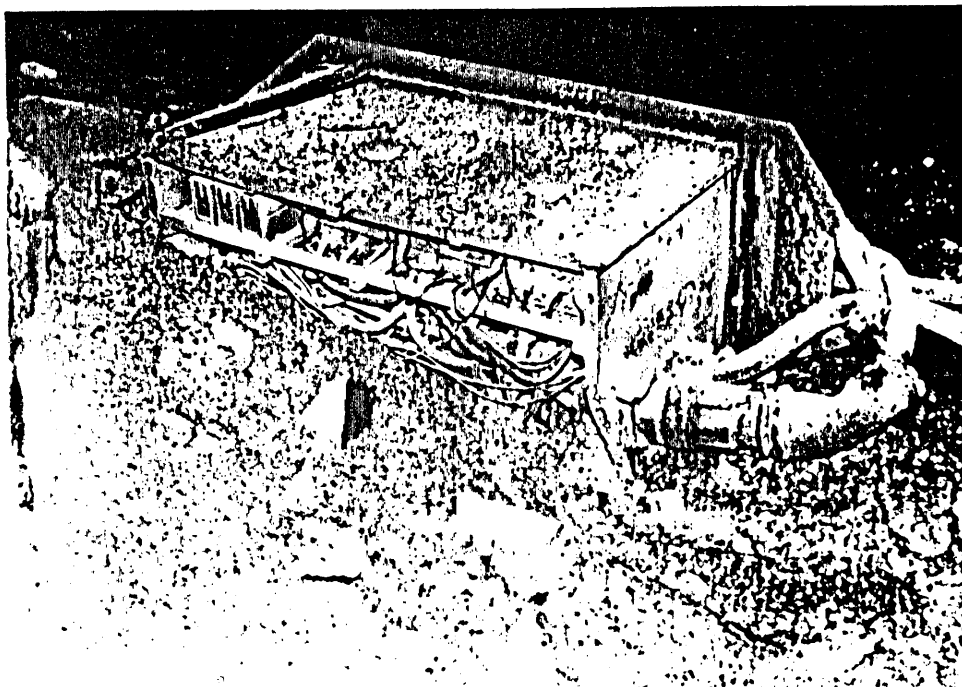
Damaged distribution box at 7X Entry and Room 12.

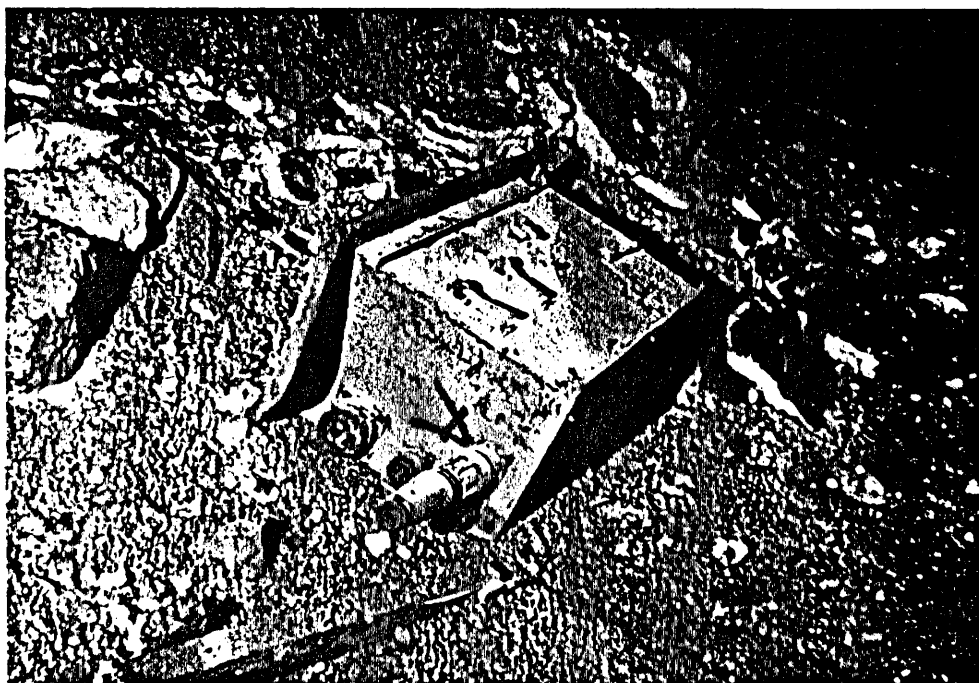
Damaged distribution box at northeast corner of 7 Main Entry East and Room 14.⁹

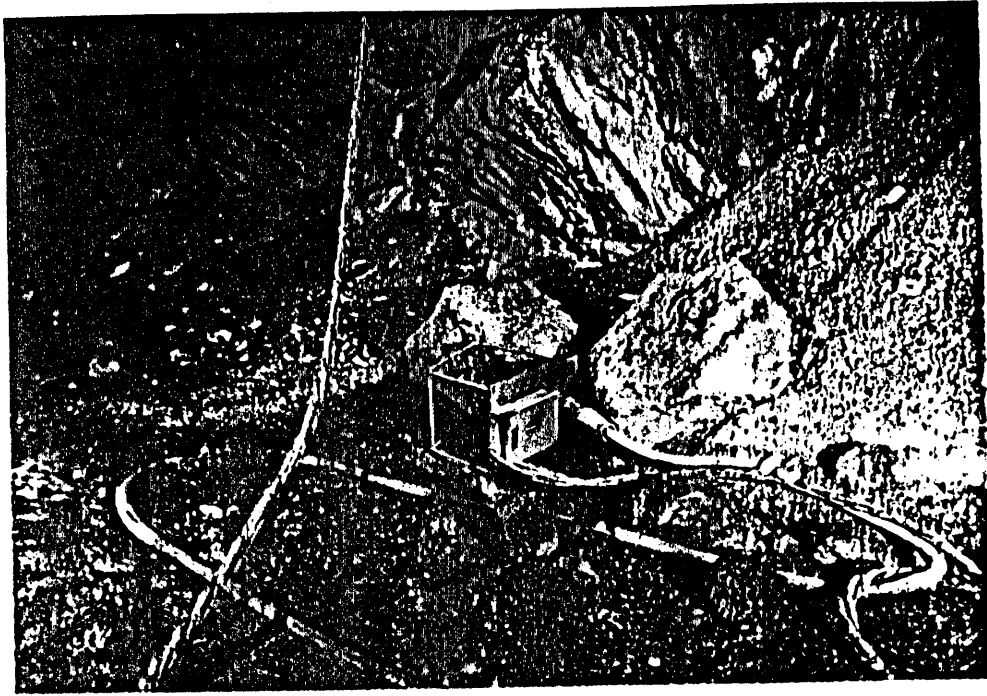
Junction box at North rib line of 8 Main Entry East near Room 11. Ty S.E. cable from roof had badly burned insulation.
