REPORT OF INVESTIGATION
UNDERGROUND COAL MINE INUNDATION (BLACKDAMP)
Moss No. 3 Portal A Mine (I. D. 44-01642)
Clinchfield Coal Company
Duty, Dickenson County, Virginia

April 4, 1978

Abstract

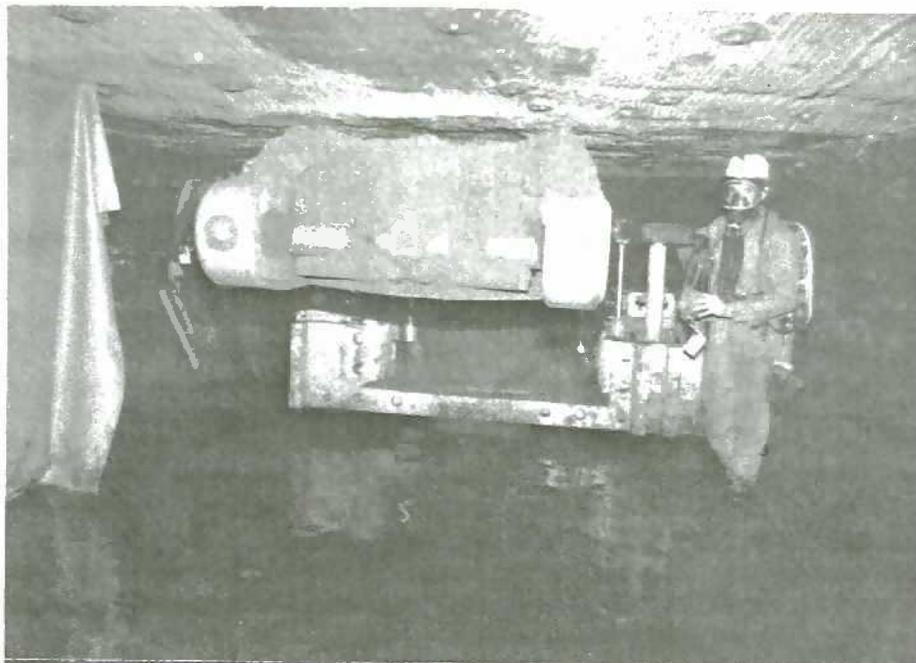
No. 1 End of line curtain with continuous mining machine at face

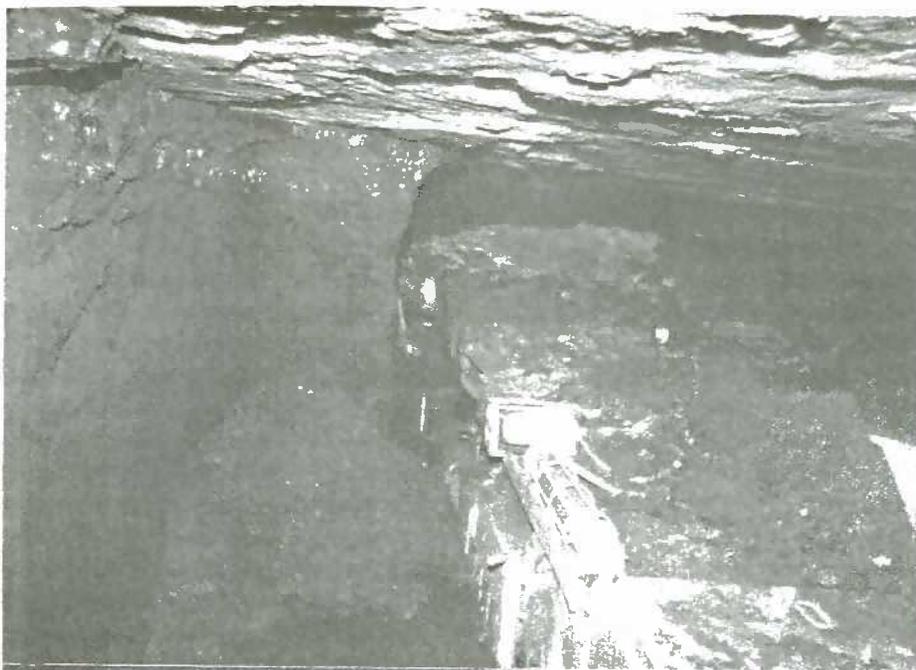
No. 2 Offset left side showing extent of last continuous mining machine advance in Drainway entry

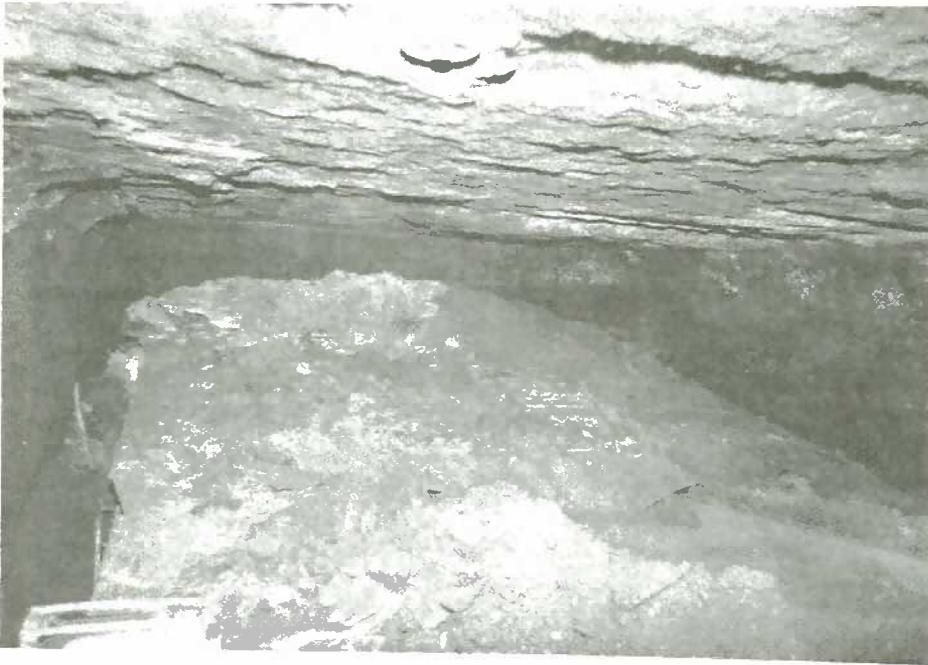
A permissible-type Marietta continuous mining machine, serial number 7486 was in the face area. The cutting head of the machine was down near the mine floor and against the face of the coal and was partially obscured by loose coal and thin layers of draw rock which had fallen from the mine roof. See Appendix F, , Photo No. 3. The opening that had

No. 3 Position of continuous mining machine at time of cut through into abandoned area

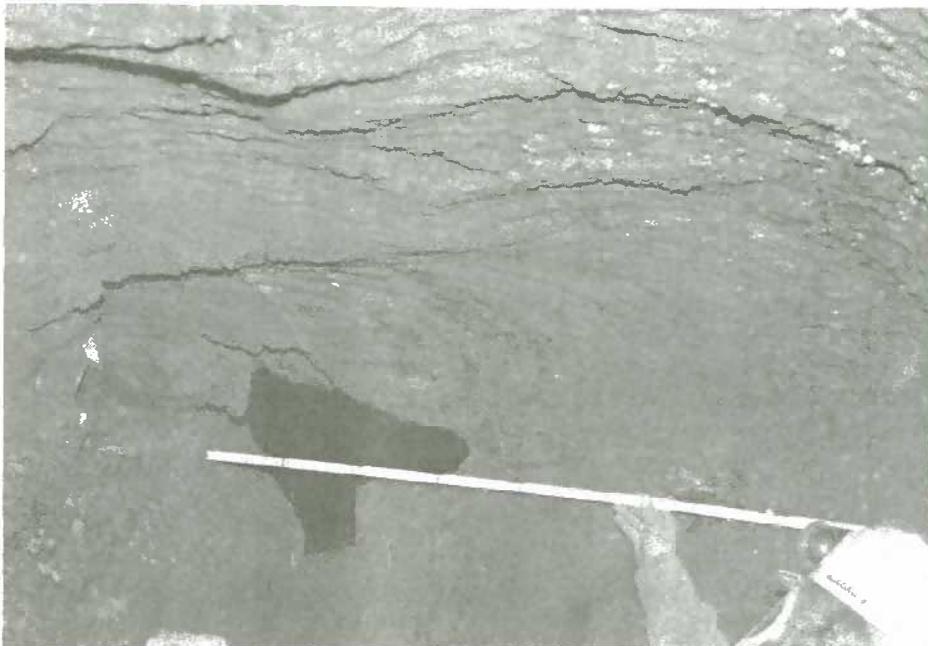
After temporary roof supports (posts and jacks) were installed in by the permanent roof supports (roof bolts), an examination of the face area by the investigators revealed an irregularly shaped opening into the abandoned area approximately 14 x 20 inches on the left side of the place approximately 2 feet from the bottom which had been made by the continuous mining machine. See Appendix F, Photo No. 4. Also a test borehole was observed in about the center of the place approximately 18 inches from the roof. This test hole had also penetrated the abandoned area and was approximately 5 feet 3 inches in depth.

The quality of the air in the abandoned area was determined by putting detection equipment through the 14 x 20 inch opening. These gas tests showed the air in the abandoned area contained 12 percent oxygen, 2 percent carbon dioxide and no methane. The flame safety lamp that was found underground by the investigators on April 6, was taken into custody and removed to the surface by James Bowman of MSHA.

No. 4 Opening made by continuous mining machine at time of inundation

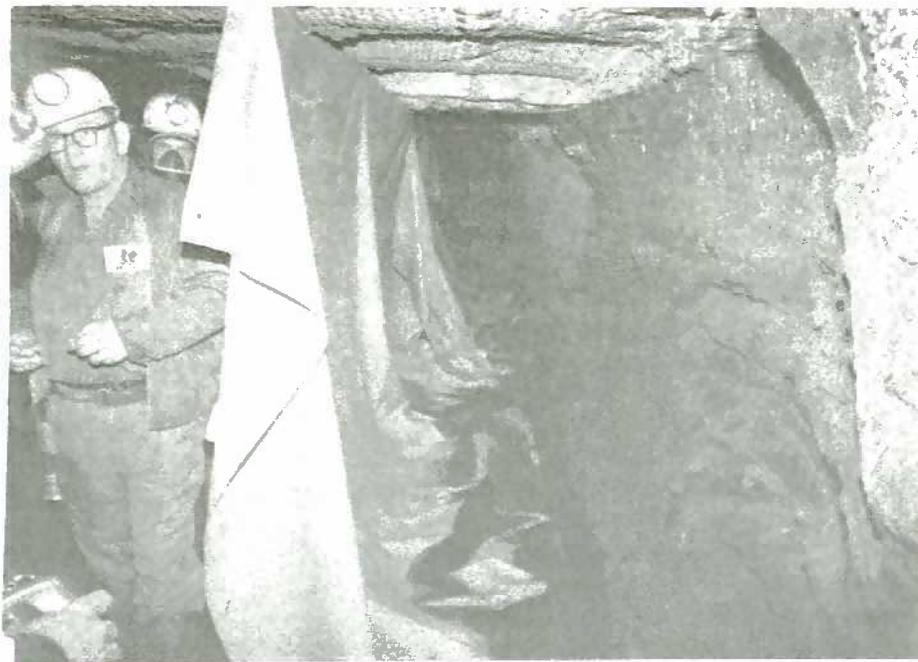
No. 6 View from face area looking toward outside showing return air side of line curtain

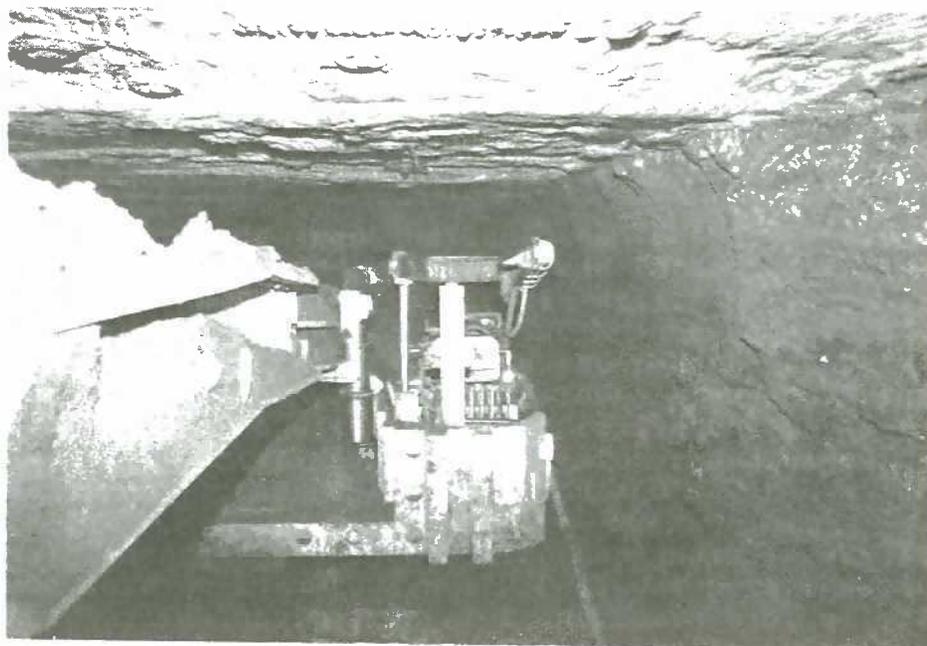
No. 7 Right side of continuous mining machine after last advance

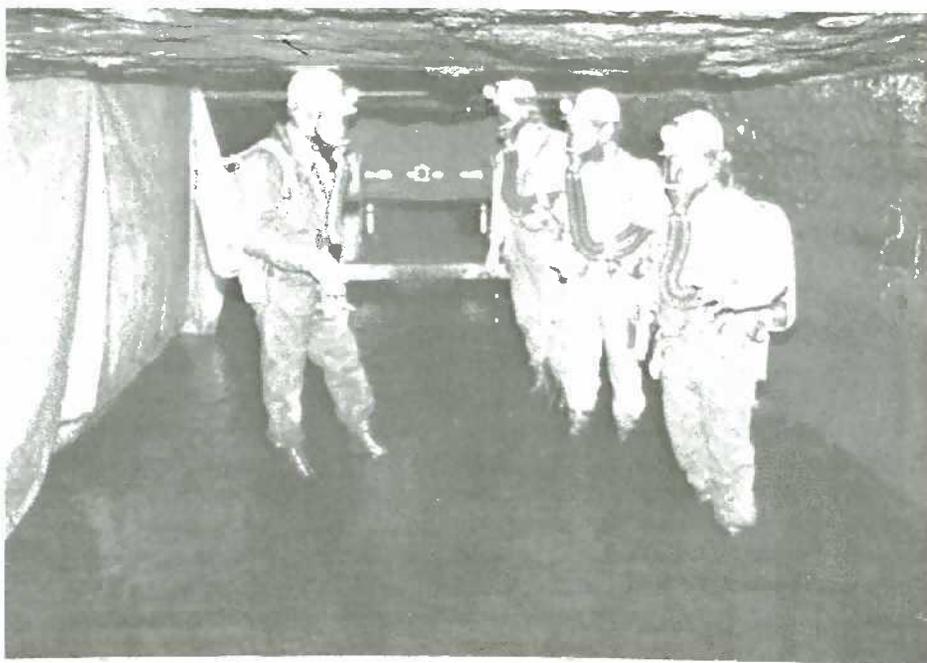
No. 8 Mine rescue team members near face area of Drainway entry during investigation
