INTERIM REPORT OF INVESTIGATION
UNDERGROUND COAL MINE EXPLOSION

Ferrell No. 17 Mine – ID No. 46-02493
Westmoreland and Coal Company
Uneeda, Boone County, West Virginia

November 07, 1980

Originating Office – Mine Safety and Health Administration
4015 Wilson Boulevard, Arlington, Virginia 22203
Joseph A. Lamonica, Administrator for Coal Mine Safety and Health

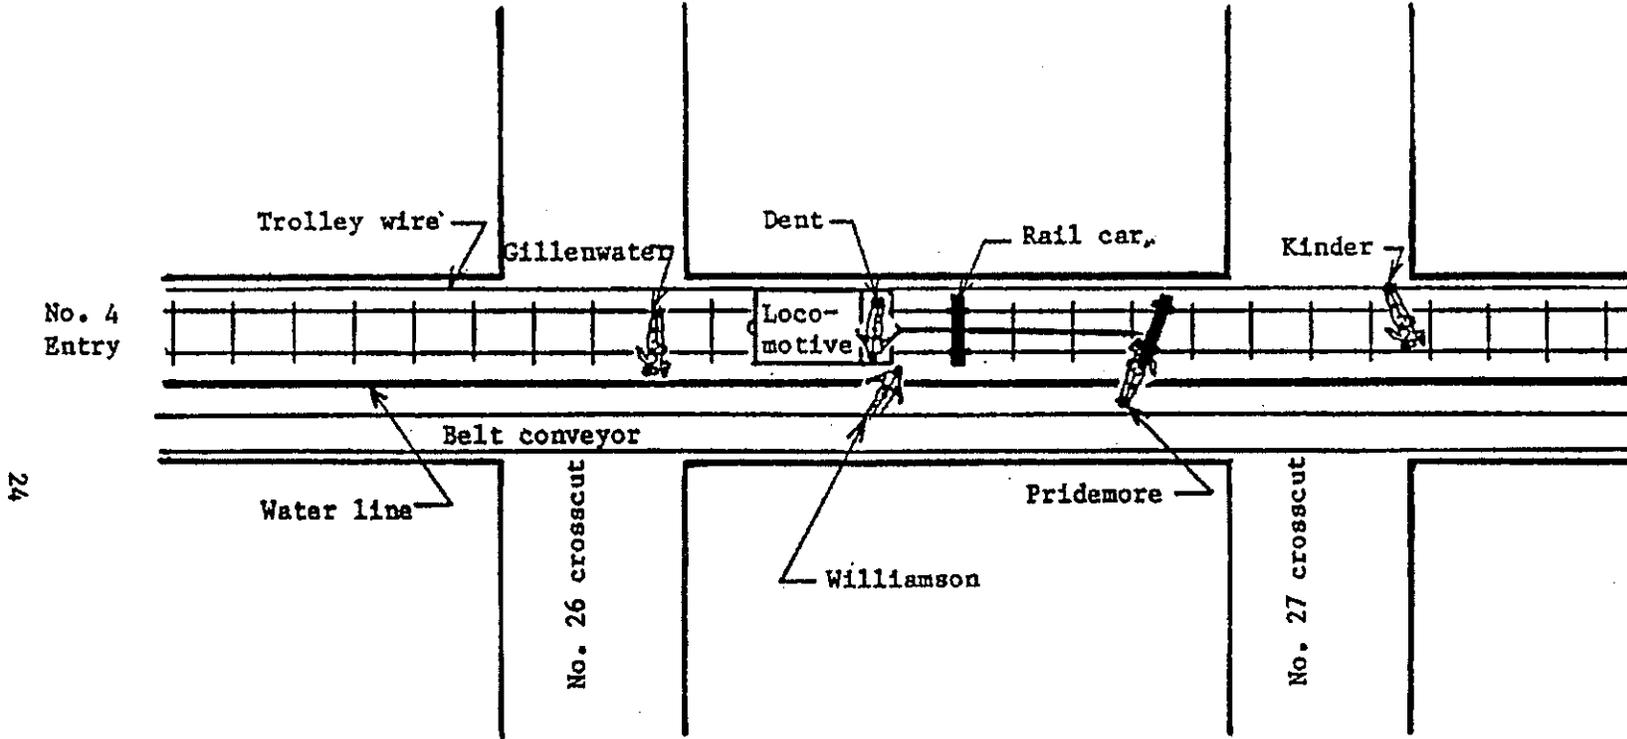
APPENDIX D

On November 8, at approximately 12:30 a.m., the Stonega Division No. 2 mine rescue team, Westmoreland Coal Company, traveled in by the second fresh-air base and began exploring in by the No. 24 crosscut. At approximately 1:15 a.m., they found the bodies of two miners in the vicinity of No. 26 crosscut in No. 4 entry. The team returned to the fresh-air base to report their findings. At approximately 2:20 a.m., the bodies of three more miners were located by the Stonega Division No. 1 mine rescue team in the No. 4 entry. Two bodies were between Nos. 26 and 27 crosscuts, and one body was at the No. 27 crosscut. All five bodies were in the vicinity of the locomotive and rail car (Appendix D). The team returned to the fresh-air base and reported their findings.

Preliminary Sketch of Accident Scene
