**Jamison #9 Mine**

UNITED STATES  
DEPARTMENT OF THE INTERIOR  
BUREAU OF MINES

FINAL REPORT ON MAJOR EXPLOSION AND FIRE DISASTER  
NO. 9 MINE  
JAMISON COAL AND COKE COMPANY  
FARMINGTON, MARION COUNTY, WEST VIRGINIA

November 13, 1954

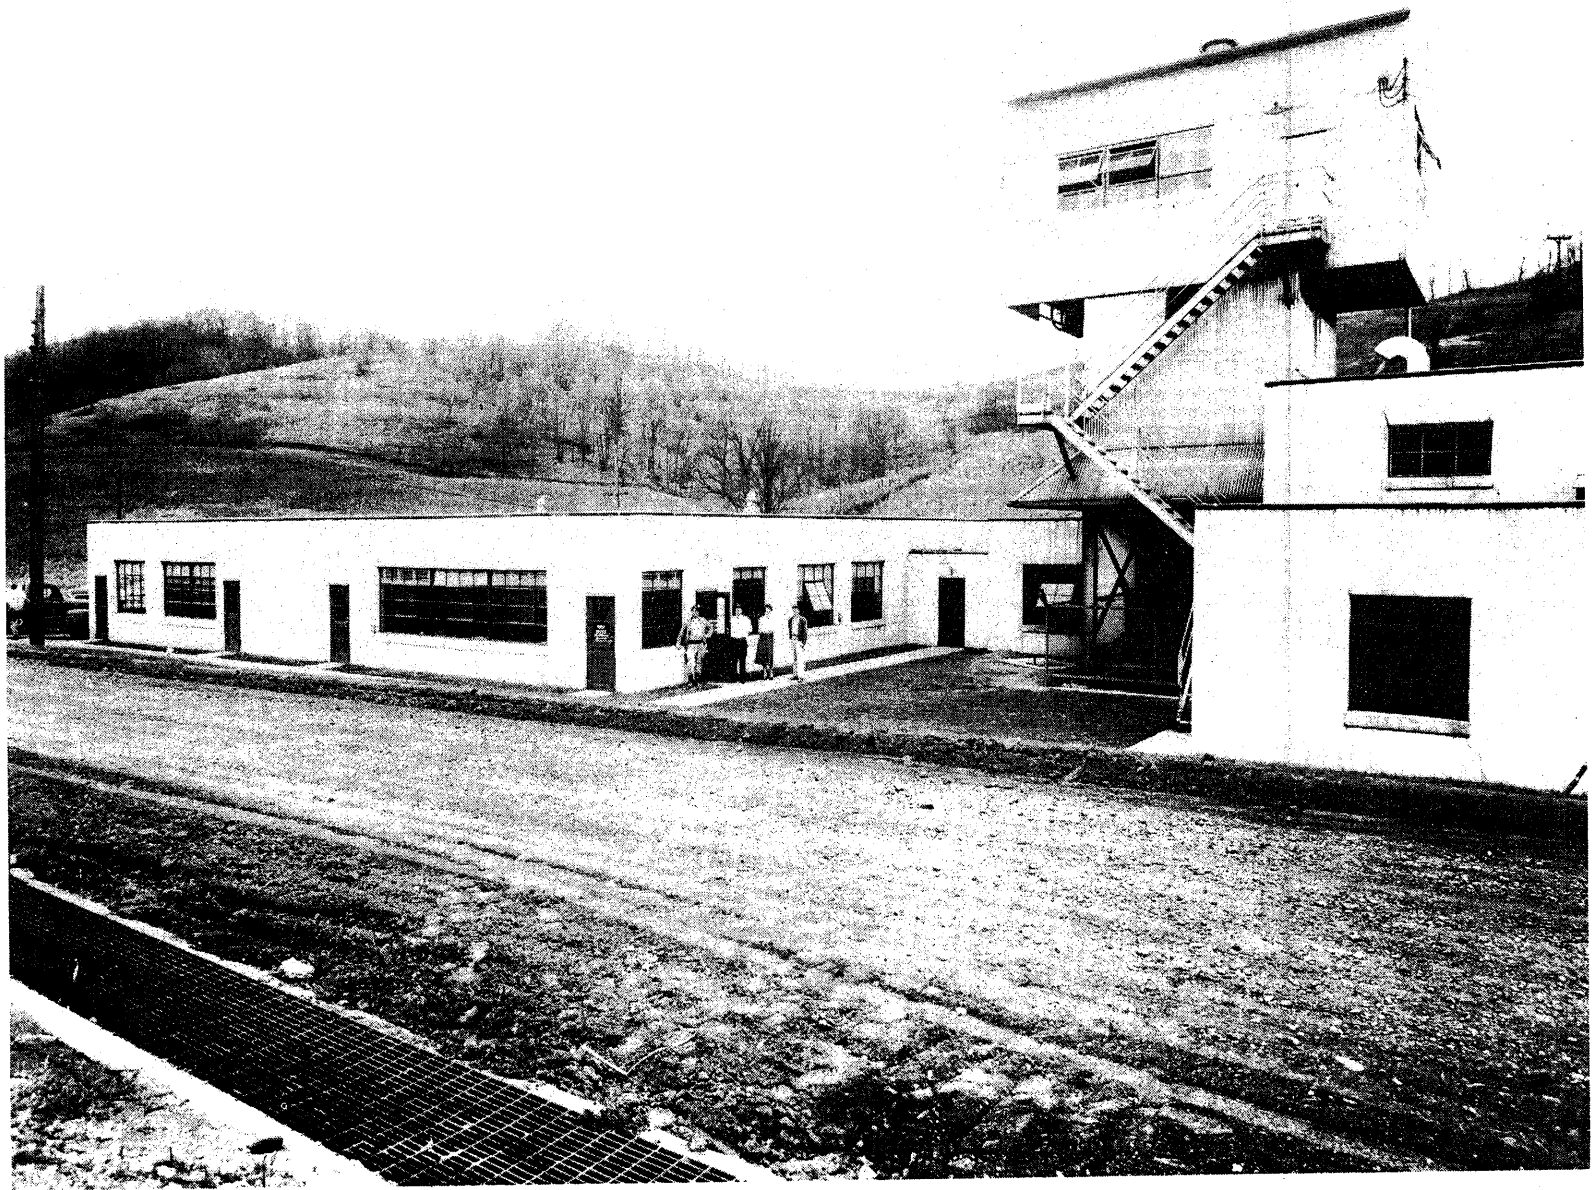
Figure 1. - Surface buildings at man shaft before explosion.
