Jamison #9 Mine

UNITED STATES
DEPARTMENT OF THE INTERIOR
BUREAU OF MINES

FINAL REPORT ON MAJOR EXPLOSION AND FIRE DISASTER
NO. 9 MINE
JAMISON COAL AND COKE COMPANY
FARMINGTON, MARION COUNTY, WEST VIRGINIA

November 13, 1954

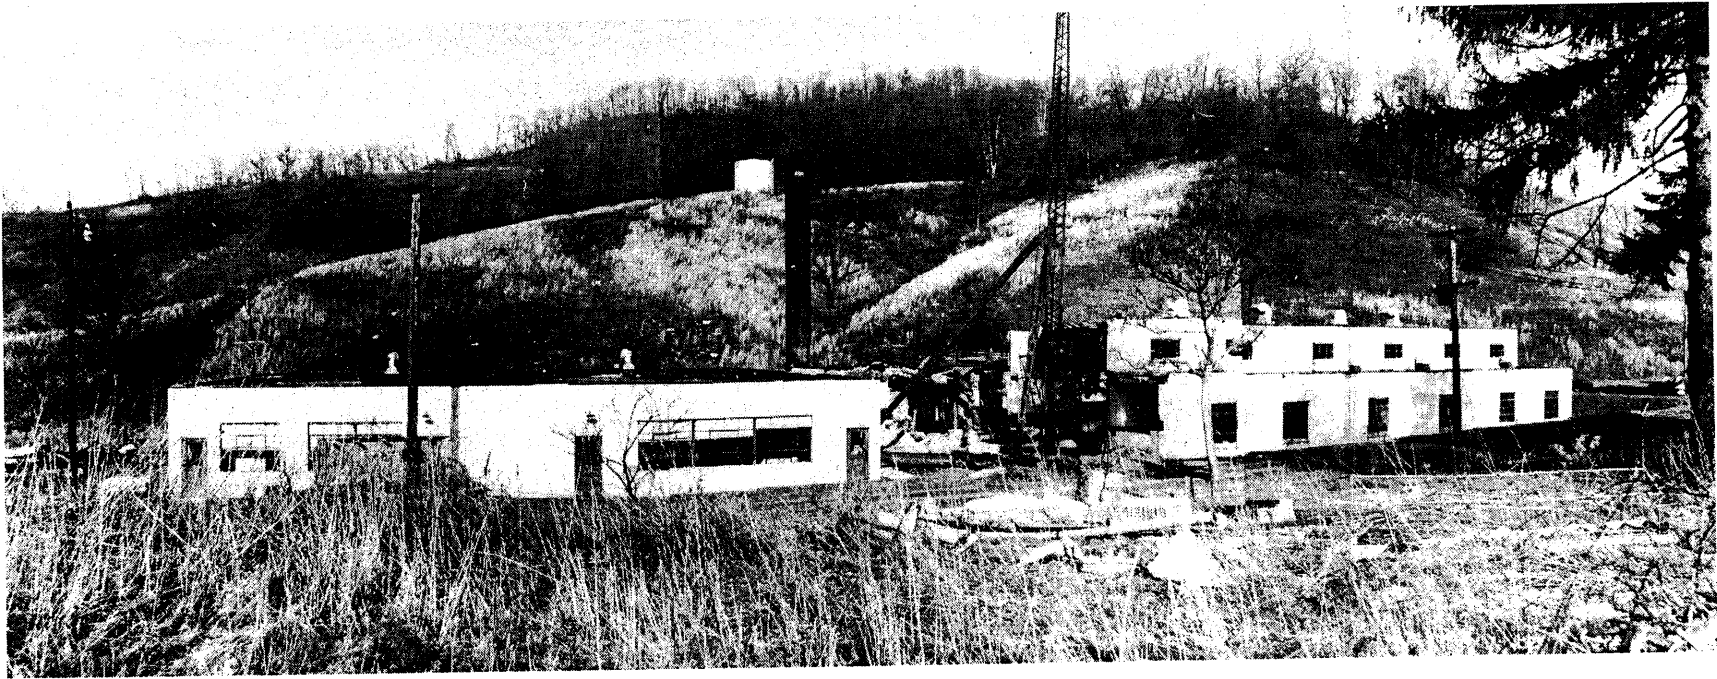
Figure 2. - Surface buildings at man shaft after explosion.

Hoisting equipment in and above the man shaft and one of the two main fans (No. 2 fan) were destroyed by the first explosion, and thereafter dense smoke continued to pour from this fan shaft. Following the second explosion, dense smoke poured from either or both of these shafts and was being drawn from the mine by the No. 1 fan, and smoke and fumes containing carbon monoxide began to flow from the slope portal, the only means of ingress. In a conference of responsible officials of the company, the United Mine Workers of America, the West Virginia Department of Mines, and the Bureau of Mines, convened at 12:30 a.m., November 14, it was decided to seal the mine at the surface openings.

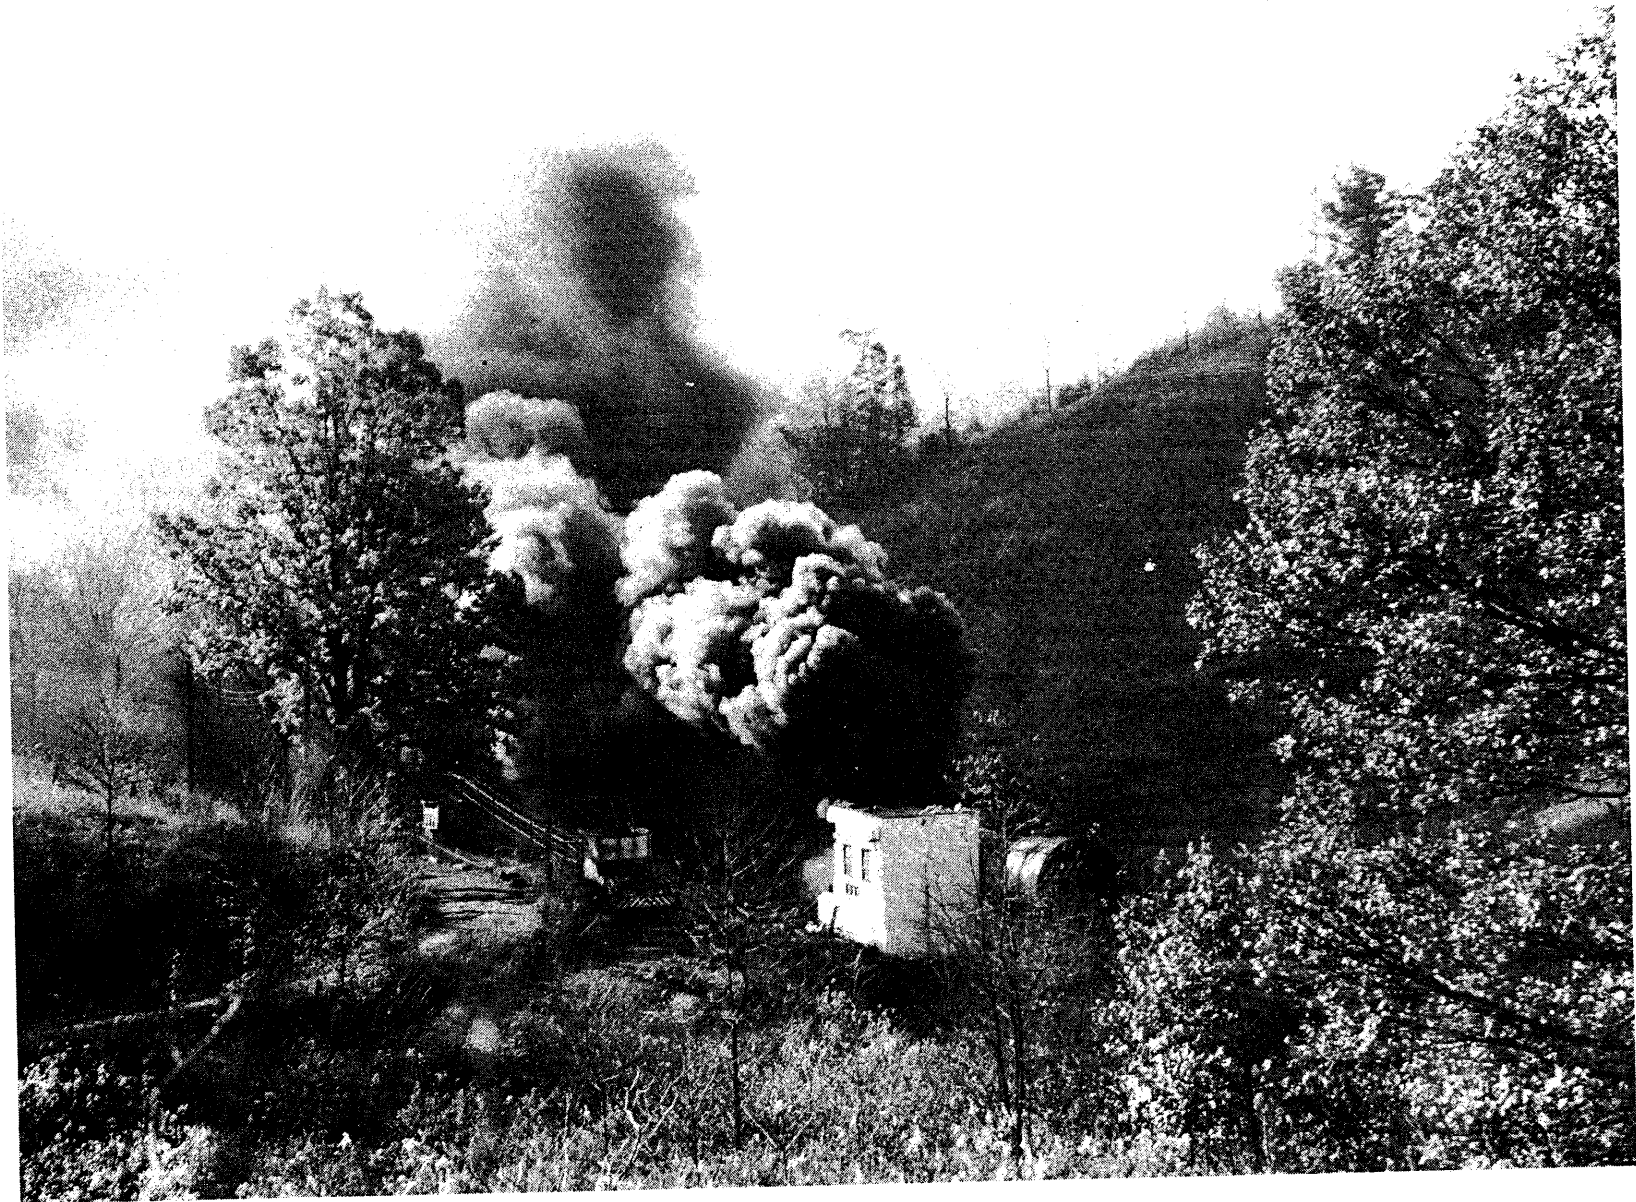
Figure 3. - No. 2 fan after explosion.

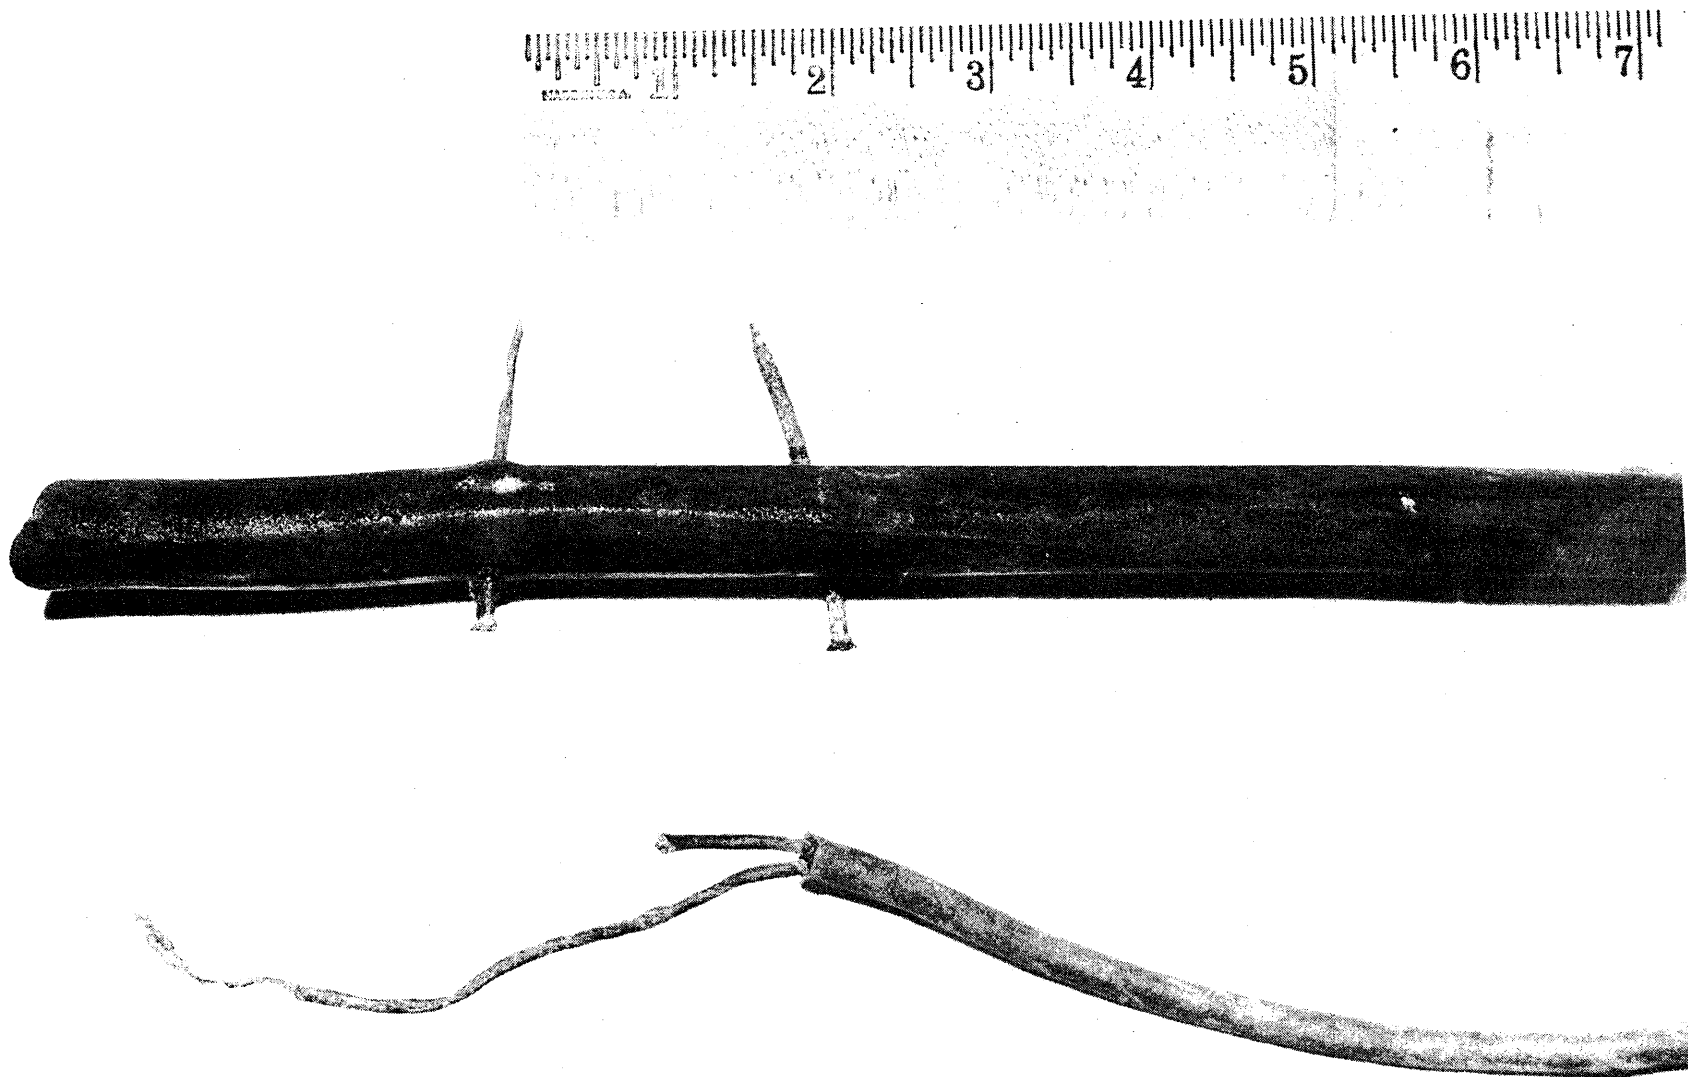
Although company safety rules required that only one shot be fired at a time, and multiple-blasting units were not provided, it was learned during the investigation that: (1) Shots in pillar stumps were usually fired two at a time; nonpermissibly, with a single-shot blasting unit; (2) 3 or 4 shot-firing cables, each attached to 1 or 2 of the 6 to 8 charges in a series of stumps, were employed in such blasting; (3) frequently tests for gas were not or could not be made, or could not be made safely close to the point of blasting, immediately before shots other than those fired first were blasted; (4) at times charges in stumps were not fired and were lost because roof falls resulting from firing previous shots "rode out" these stumps; and (5) it was not an altogether uncommon practice to connect all the shots in a series of stumps and fire them simultaneously by means of electric power obtained from the 275-volt mine electric circuit, either through an opening in face electrical equipment, nails driven into the trailing cable on such equipment, or the power line in the working section. The last-mentioned information was partly confirmed on September 9, 1955, when a three-conductor trailing cable on a shuttle car, with two 8-penny nails driven through the positive and negative conductors of the cable, was uncovered in cleaning up the large roof fall in No. 8 entry of 4 left off 2 north (See figure 4). The untwisted ends of the blasting cable were within 2 feet of the nails in the trailing cable, and a spool of cotton-insulated copper wire for connecting shots had been found nearby. Examination of trailing cables on the face electrical equipment indicated that shots had been fired similarly in 2 left off 1 south section, as nail holes and a part of a nail were found in the loading-machine cable.

Figure 4. - Battery end of blasting cable and part of shuttle-car trailing cable, showing nails through cable, used for firing shots in No. 7 pillar place.

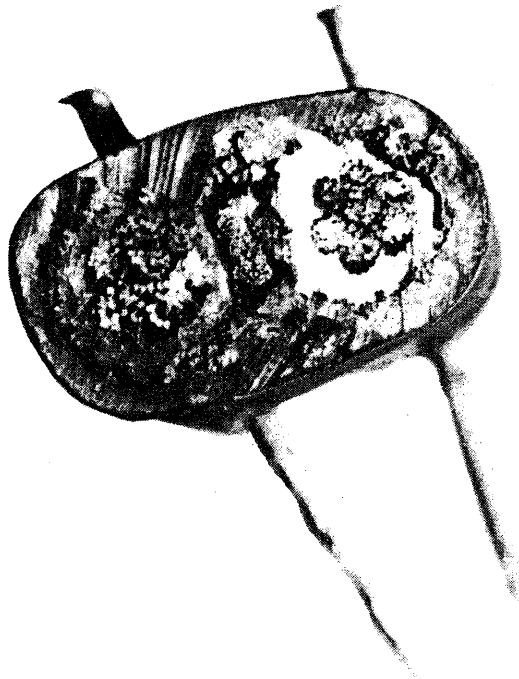
Figure 5. - End view of trailing cable with nails through positive and negative conductors.
