Jamison #9 Mine

UNITED STATES
DEPARTMENT OF THE INTERIOR
BUREAU OF MINES

FINAL REPORT ON MAJOR EXPLOSION AND FIRE DISASTER
NO. 9 MINE
JAMISON COAL AND COKE COMPANY
FARMINGTON, MARION COUNTY, WEST VIRGINIA

November 13, 1954

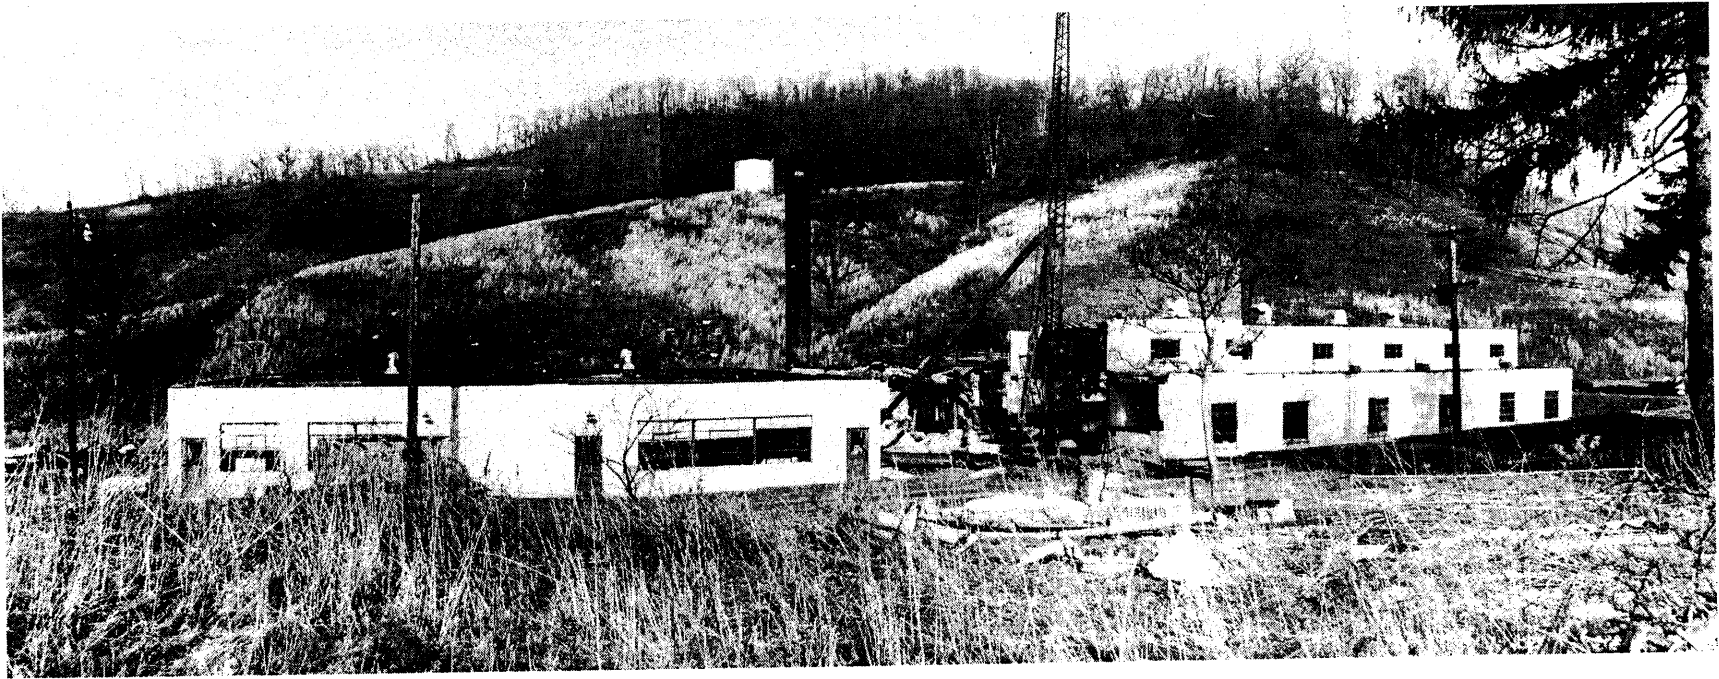
Figure 2. - Surface buildings at man shaft after explosion.

The explosions caused extensive damage underground and on the surface. The concrete linings of the man shaft and No. 2 fan shaft spalled and were chipped and cracked at many places. The No. 2 fan air duct and an end of the fan house were destroyed; the elevator, guides, and the hoisting equipment and housing at the man shaft were destroyed or damaged to the extent that all except the hoist motors had to be replaced. A combination building adjoining the man shaft, housing a bath house, lamp room, waiting room, foremen's offices, boiler room, supply room, clerical offices, engineer's quarters, first-aid room, mine-rescue equipment room, and superintendent's and general manager's offices, was damaged extensively. The first explosion could have caused considerable loss of life on the surface had it occurred on a regular work day when large groups of men preparing to enter the mine for the second shift congregated in the bath house and on benches near the man shaft while waiting for the elevator.

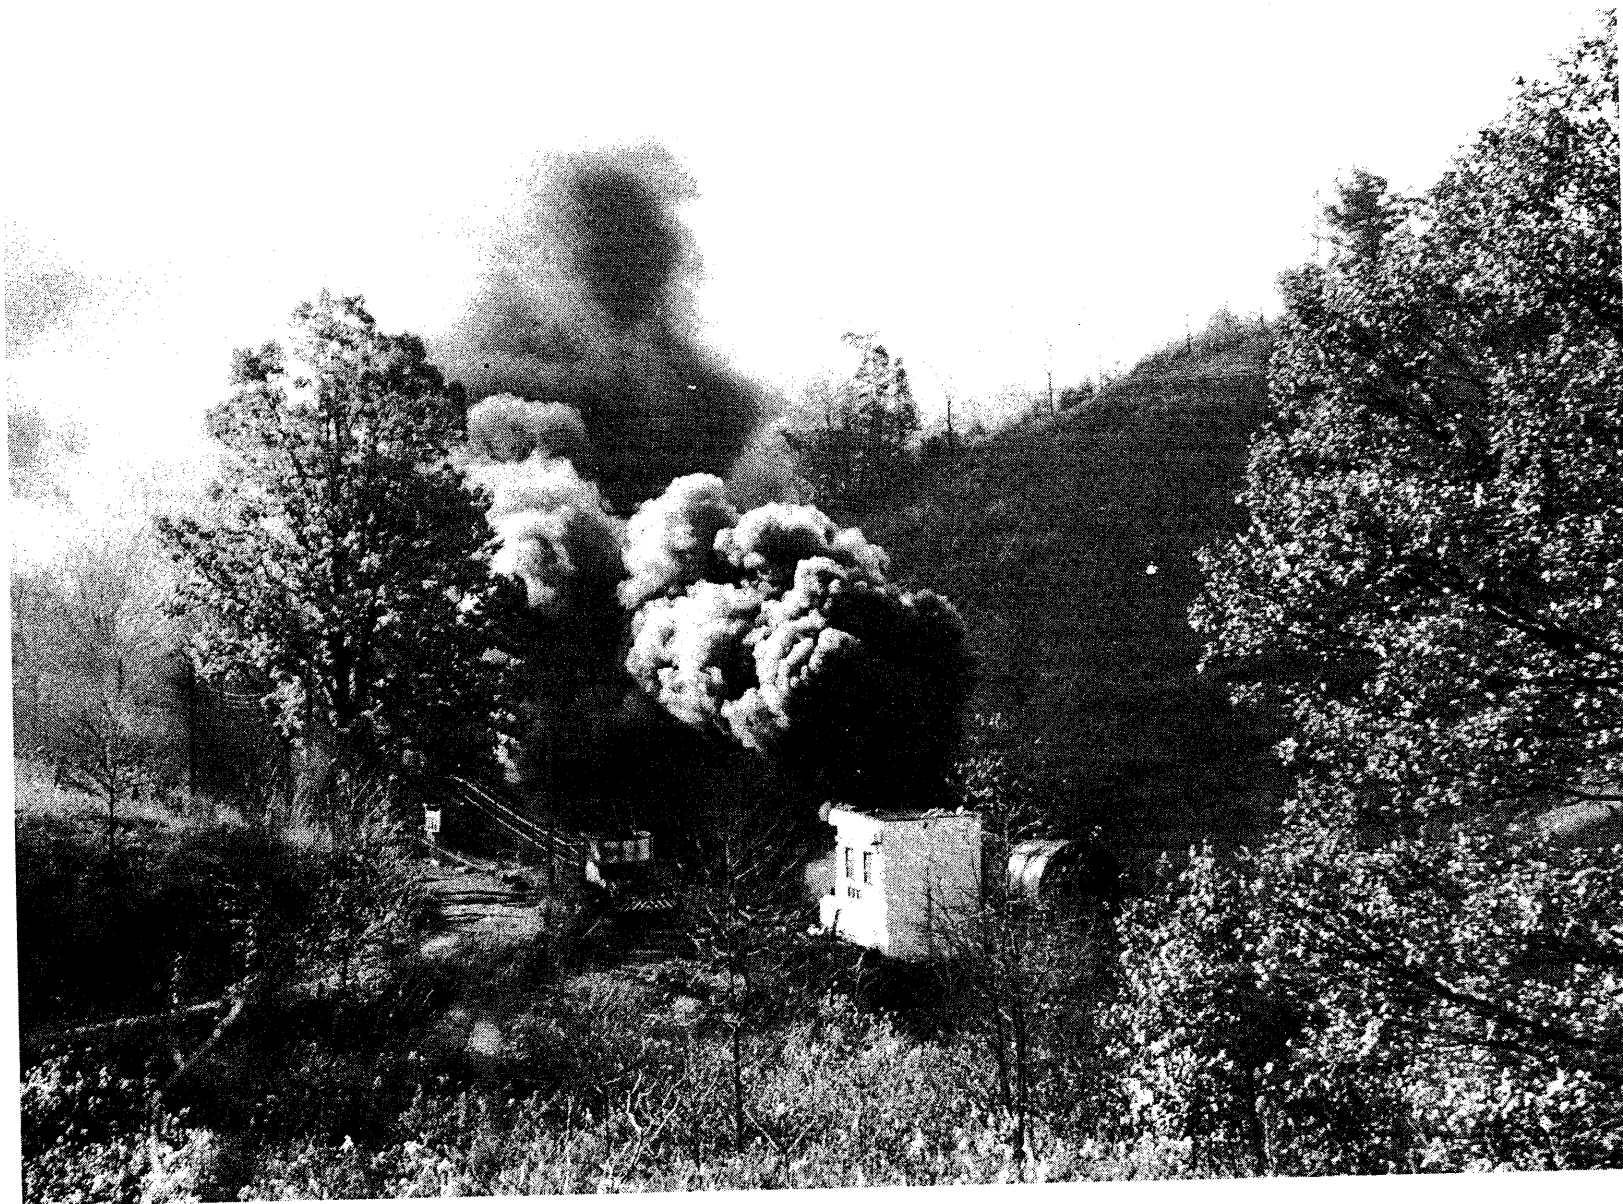
Figure 3. - No. 2 fan after explosion.

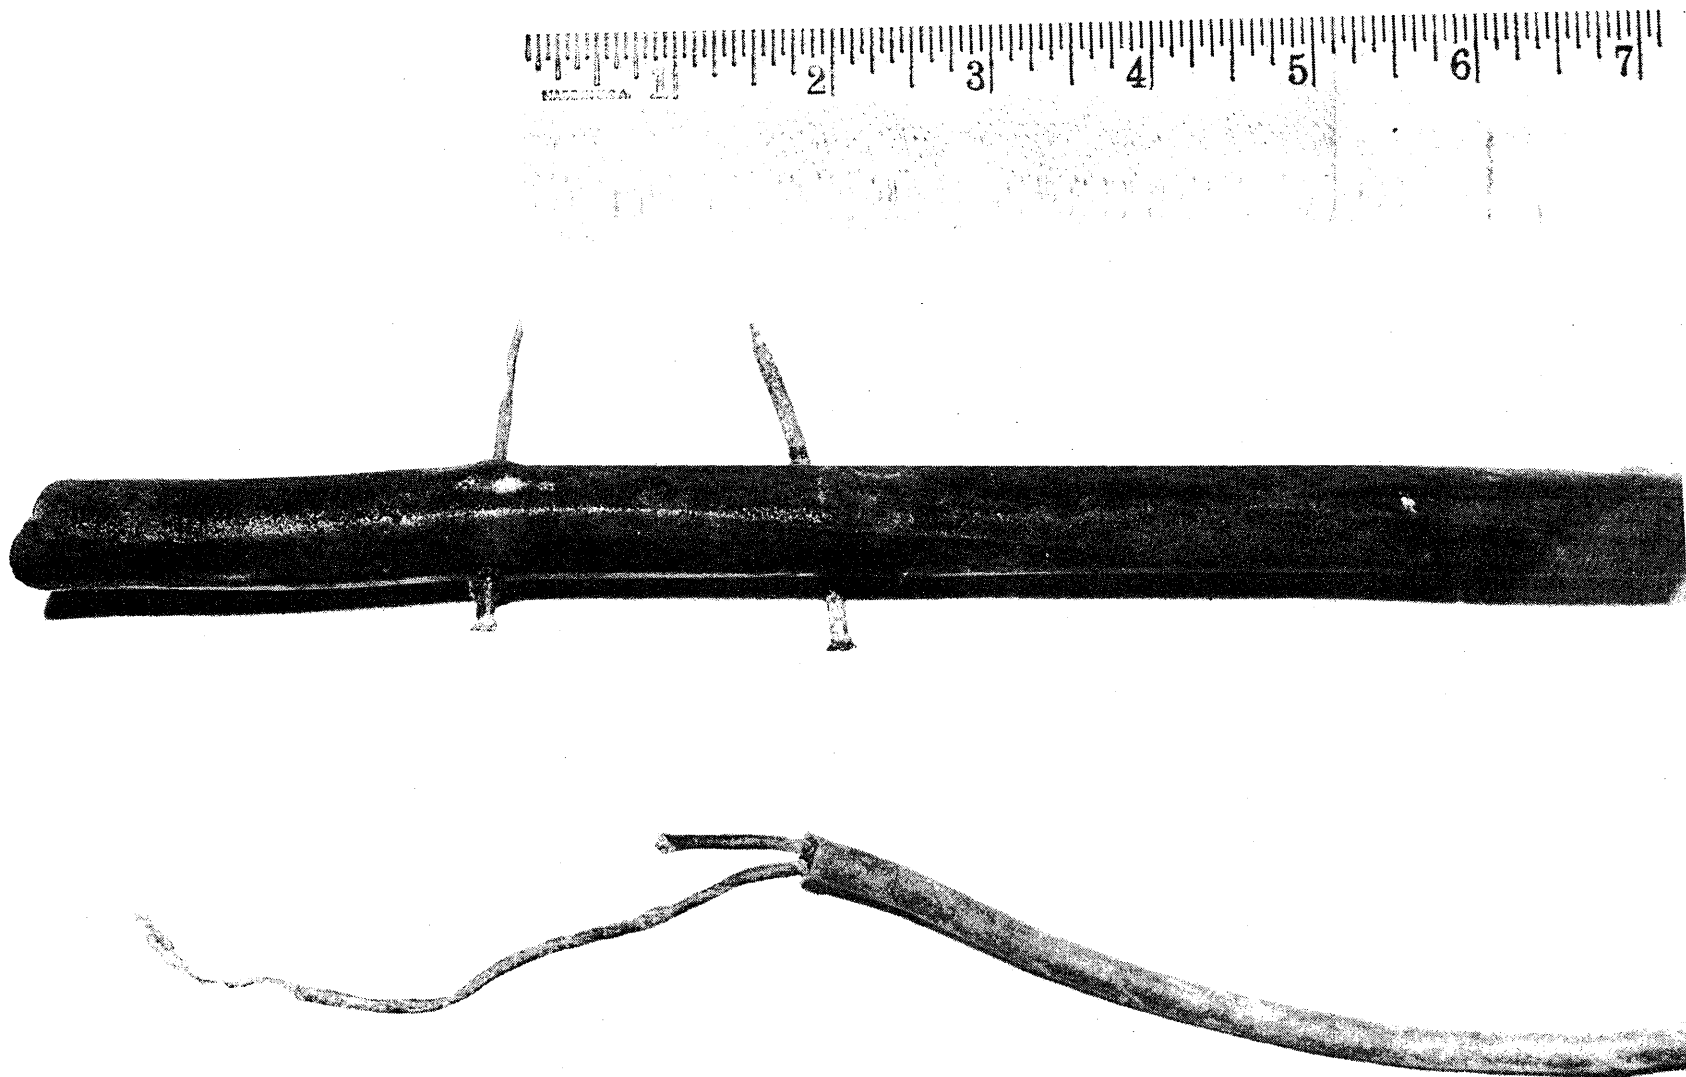
Although company safety rules required that only one shot be fired at a time, and multiple-blasting units were not provided, it was learned during the investigation that: (1) Shots in pillar stumps were usually fired two at a time; nonpermissibly, with a single-shot blasting unit; (2) 3 or 4 shot-firing cables, each attached to 1 or 2 of the 6 to 8 charges in a series of stumps, were employed in such blasting; (3) frequently tests for gas were not or could not be made, or could not be made safely close to the point of blasting, immediately before shots other than those fired first were blasted; (4) at times charges in stumps were not fired and were lost because roof falls resulting from firing previous shots "rode out" these stumps; and (5) it was not an altogether uncommon practice to connect all the shots in a series of stumps and fire them simultaneously by means of electric power obtained from the 275-volt mine electric circuit, either through an opening in face electrical equipment, nails driven into the trailing cable on such equipment, or the power line in the working section. The last-mentioned information was partly confirmed on September 9, 1955, when a three-conductor trailing cable on a shuttle car, with two 8-penny nails driven through the positive and negative conductors of the cable, was uncovered in cleaning up the large roof fall in No. 8 entry of 4 left off 2 north (See figure 4). The untwisted ends of the blasting cable were within 2 feet of the nails in the trailing cable, and a spool of cotton-insulated copper wire for connecting shots had been found nearby. Examination of trailing cables on the face electrical equipment indicated that shots had been fired similarly in 2 left off 1 south section, as nail holes and a part of a nail were found in the loading-machine cable.

Figure 4. - Battery end of blasting cable and part of shuttle-car trailing cable, showing nails through cable, used for firing shots in No. 7 pillar place.

explosion occurred (See Appendix J). On September 9, a section of the three-conductor trailing cable to a shuttle car was uncovered; two nails had been driven into the cable and the untwisted battery ends of the blasting cable were found within 2 feet of the nails in the cable. The nails and the blasting cable were about 4 feet inby the place where the last of the five bodies had been recovered. The shuttle car was recovered on September 27 and brought to the surface September 29. The car was not damaged badly except for water in the motors, and the inby end of the trailing cable was in good condition. Work of loading out the roof fall was discontinued October 21, when it was discovered that the first stump between the "skinny" and No. 8 entry was crushed out. Nothing further of importance was found in the area, except that the blasting cable continued under the fall toward the face of No. 7 pillar place.

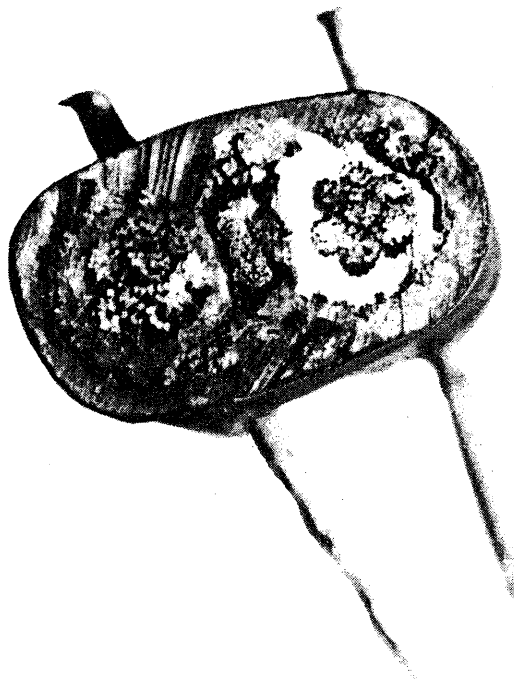
Figure 5. - End view of trailing cable
with nails through positive
and negative conductors.

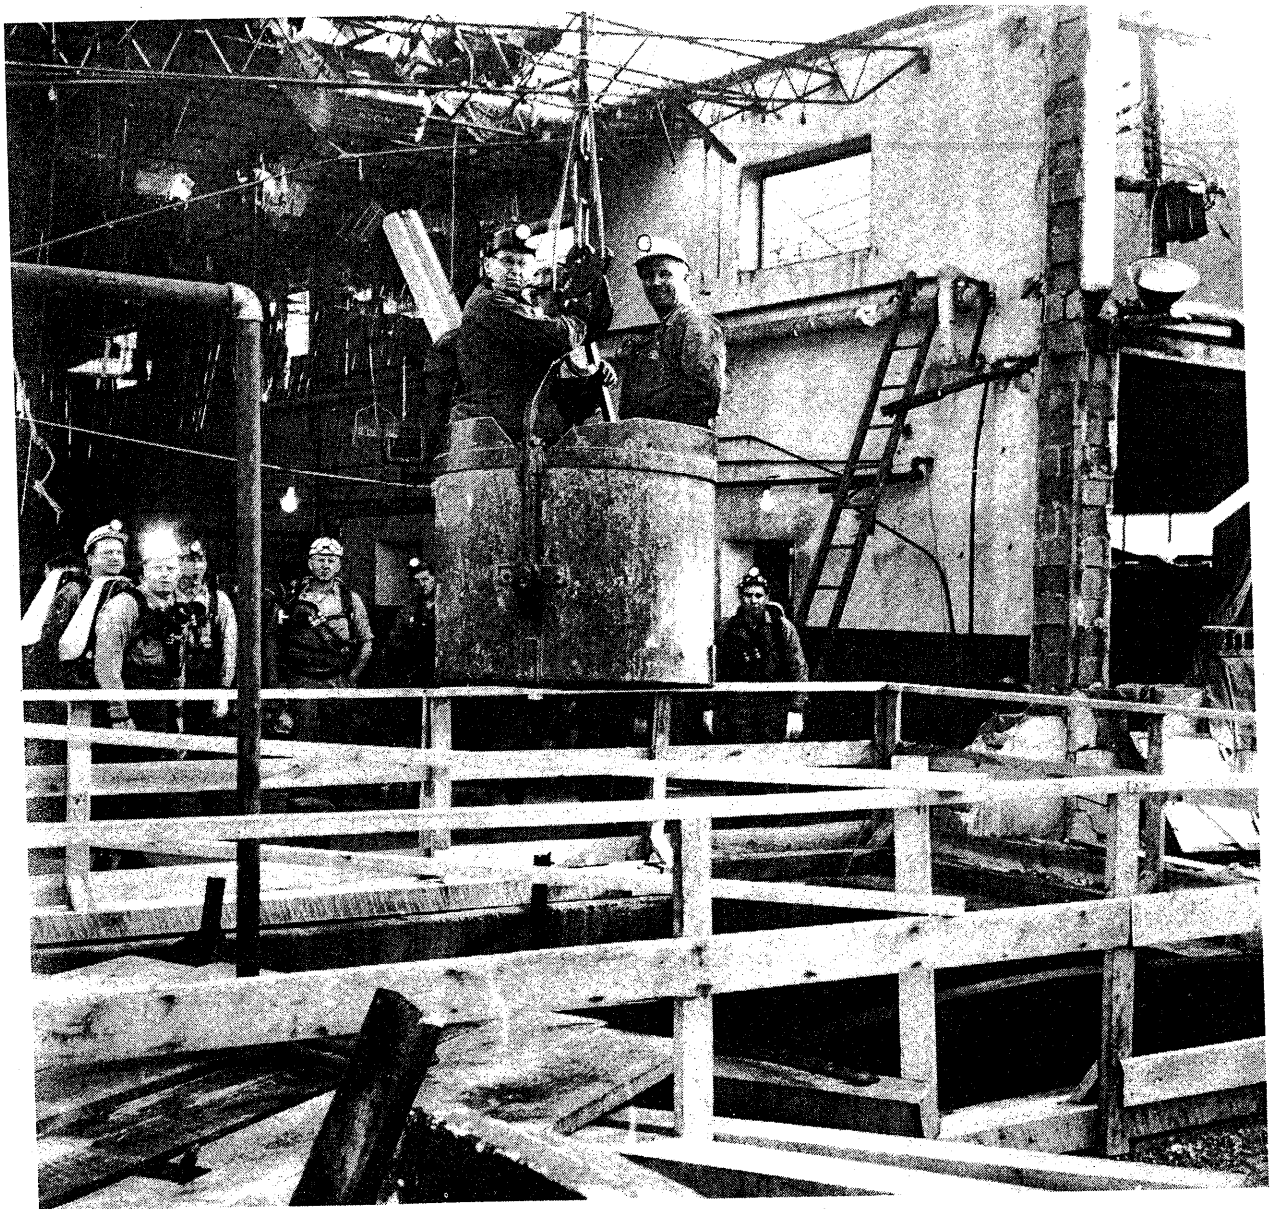
Figure 7. - Top of man shaft and bucket used for handling men during recovery operations.

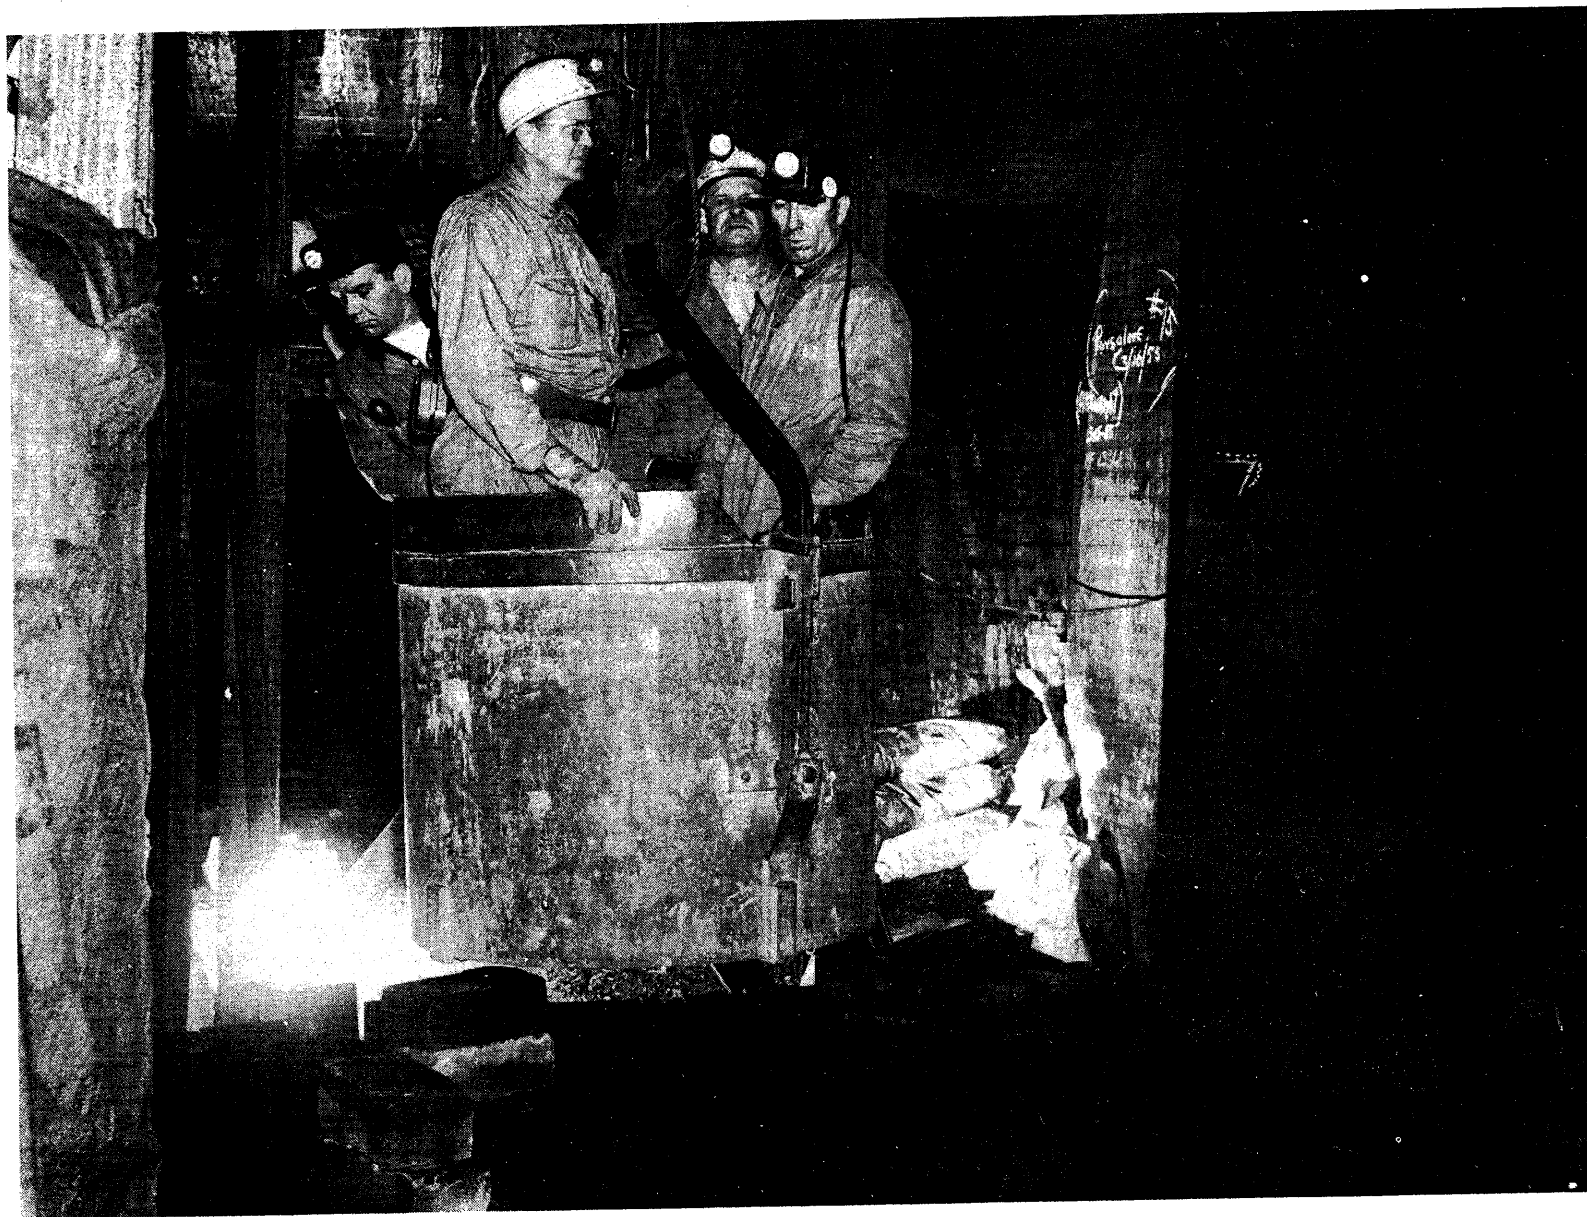
Figure 9. - Bottom of man shaft during recovery operations.

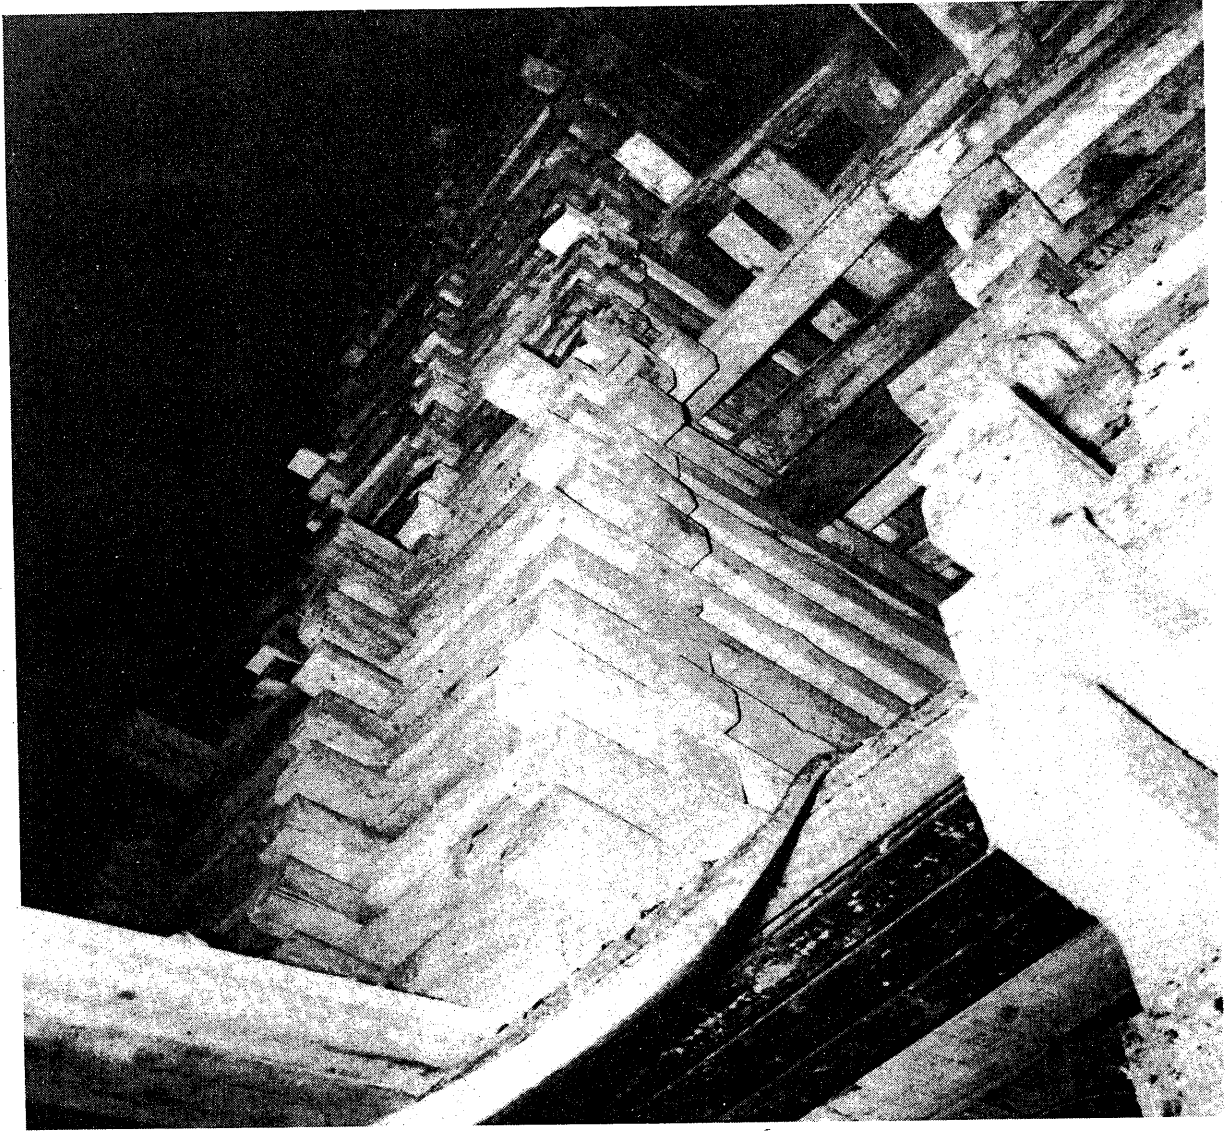
Figure 10. - Timbering in fire area.

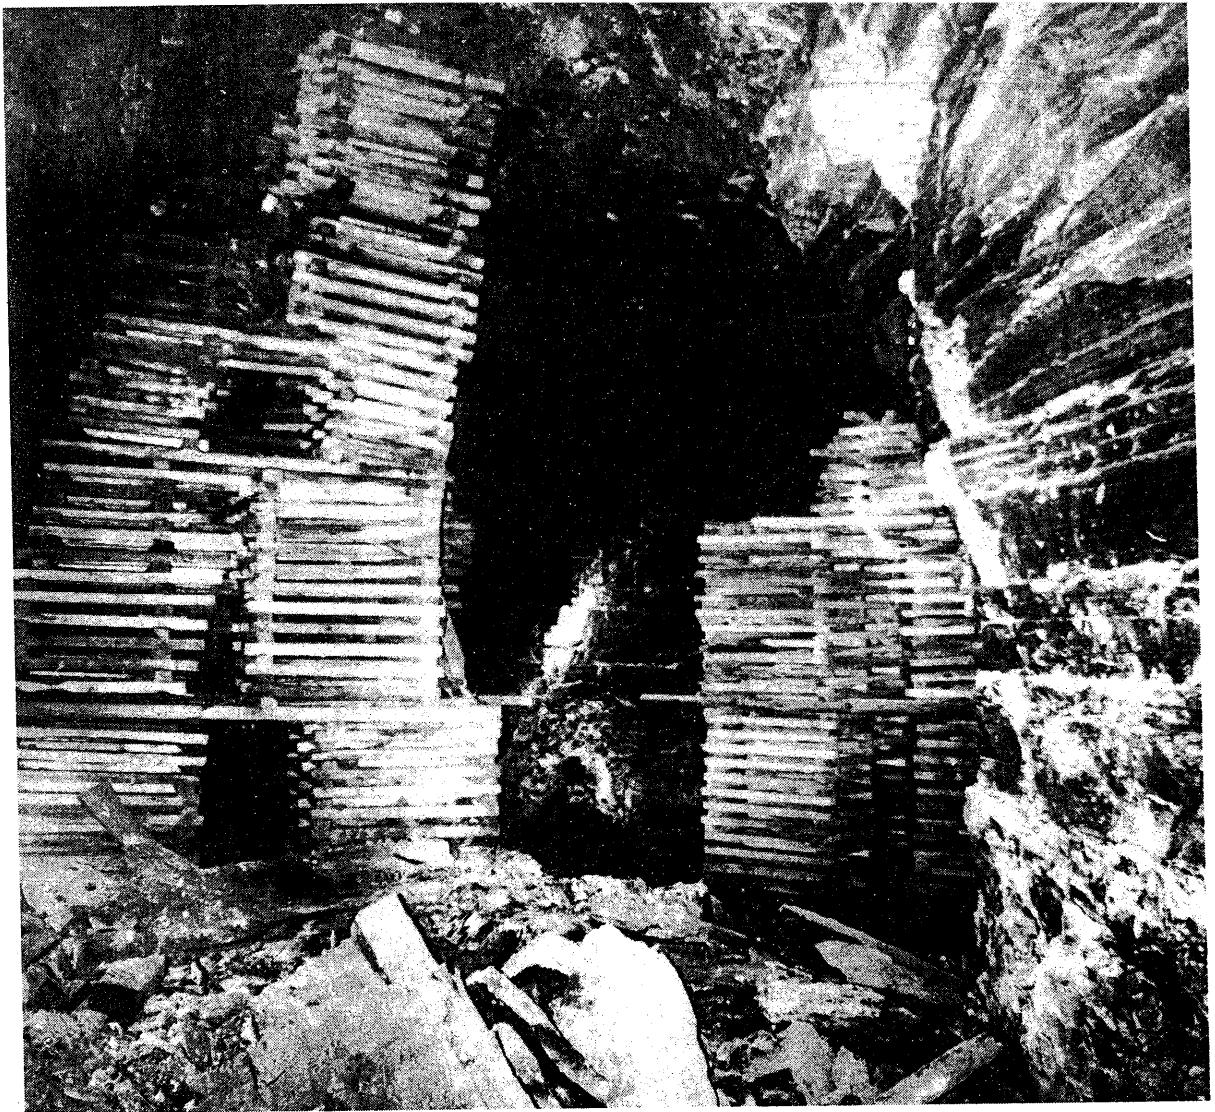
Figure 11. - Timbering in fire area.
