Report of Investigation Underground Coal Mine Fatal Fall of a Coal Pillar

U.S. Department of Labor
Mine Safety and Health Administration
1996

**No. 4 Slope Mine
I.D. No. 36-08014
L.V. Coal Company
Keffers,
Schuylkill County,
Pennsylvania**

July 25, 1995

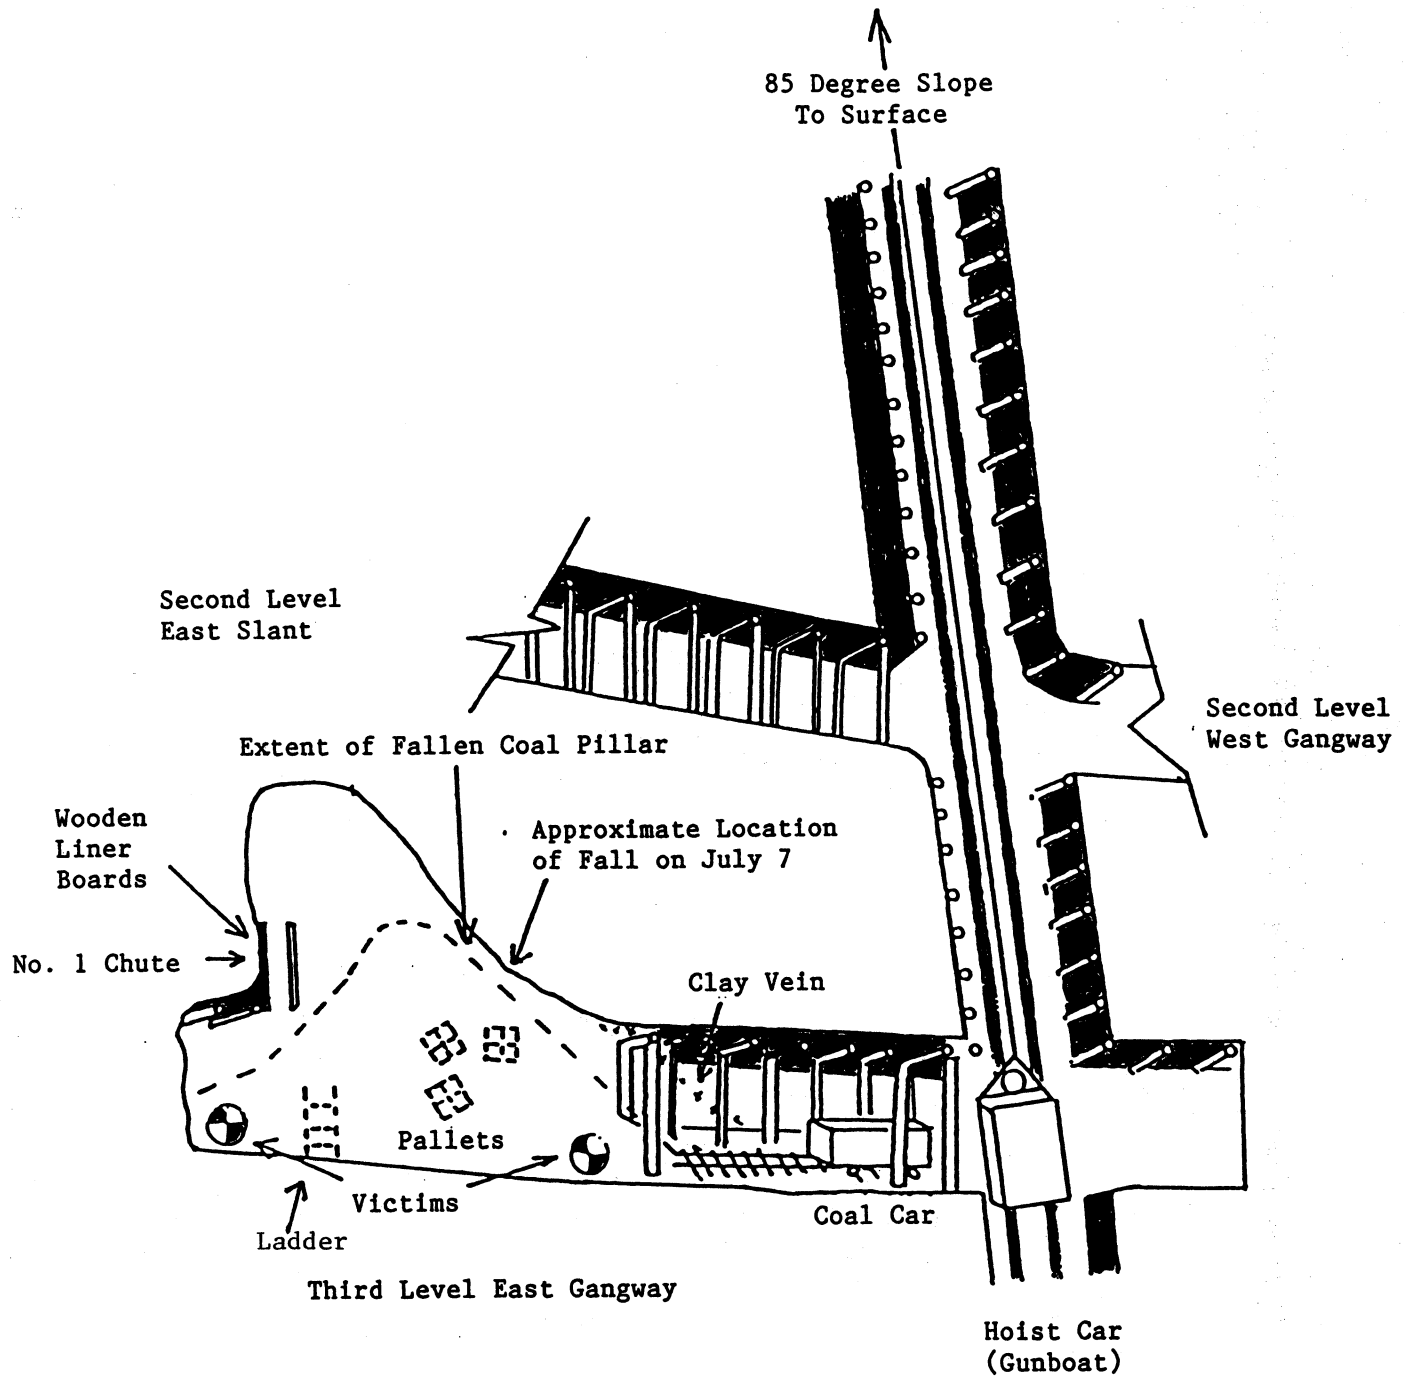
SKETCH 1

Sketch of Fatal Fall of Pillar
 L.V. Coal Co.
 No. 4 Slope Mine
 MSHA I.D. No. 36-08014
 Keffers, Schuylkill County, Pennsylvania
 July 25, 1995

15. Rescue operations began at 11:45 a.m. with MSHA, State and local mine rescue personnel participating. First rescuers on the scene found that a fall of a coal pillar had occurred approximately 45 feet from the slope in the third level East gangway. Efforts to resupport the roof and remove coal that was blocking the gangway were started immediately. See Sketch 1.

19. In the third level East gangway, approximately 37 feet in by the slope rib, a clay vein was observed. The projected angle of the clay vein extended upward into the cavity of the fall.

23. Evidence suggests that due to the presence of the clay vein, the high side pillar at the accident site was unstable. The friable nature of the coal coupled with a zone of weakness provided by the existence of the clay vein resulted in a small fall of the coal pillar on or about July 7, 1995. When the No.1 chute was turned upward off the gangway, the integrity of the coal pillar was further weakened to the point where a sudden failure occurred along the clay vein. The inrush of coal caused a roof prop, set in an area of an incompetent roof, to dislodge. This resulted in a domino effect dislodging two other props. These supports failed with little or no warning resulting in both men being buried

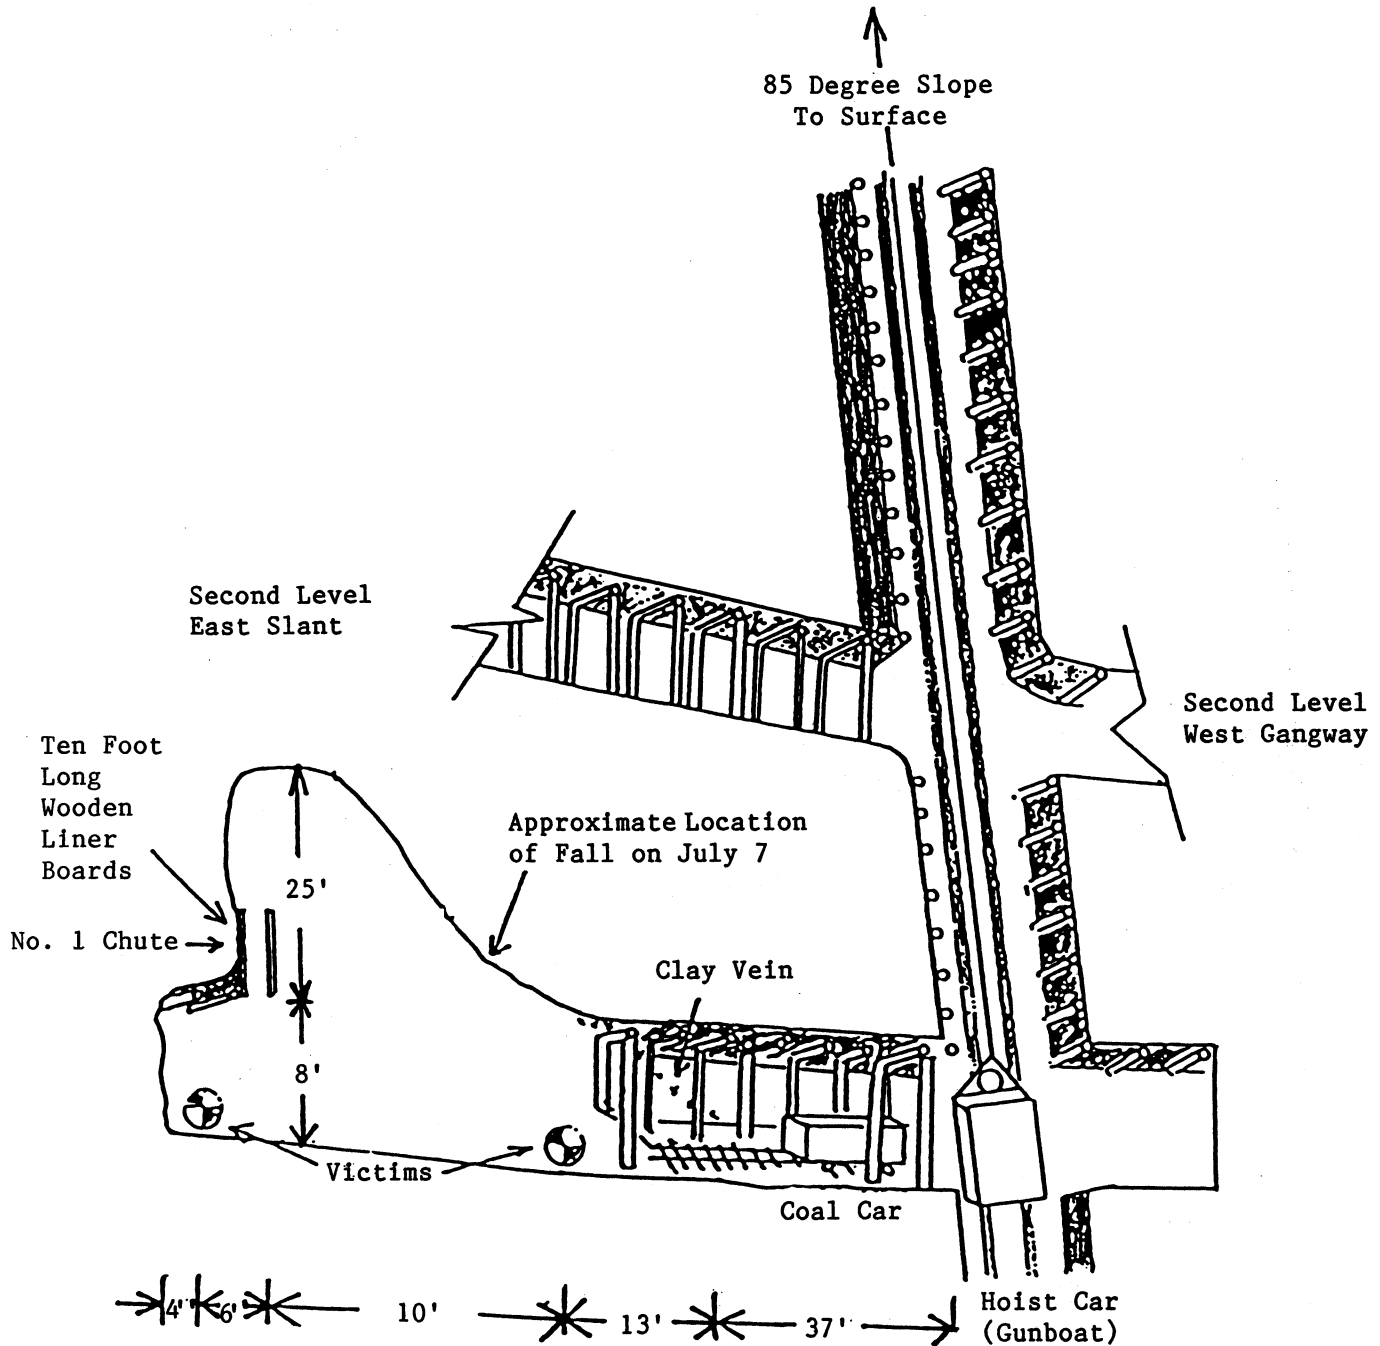
SKETCH 2

Sketch of Fatal Fall of Pillar
L.V. Coal Co.
No. 4 Slope Mine
MSHA I.D. No. 36-08014
Keffers, Schuylkill County, Pennsylvania
July 25, 1995
