FINAL REPORT ON EXPLOSION
KENILWORTH MINE, INDEPENDENT COAL & COKE COMPANY
KENILWORTH, CARBON COUNTY, UTAH
MARCH 14, 1945

By
W. B. Odendahl
Coal-Mine Inspector.

UNITED STATES
DEPARTMENT OF THE INTERIOR
BUREAU OF MINES

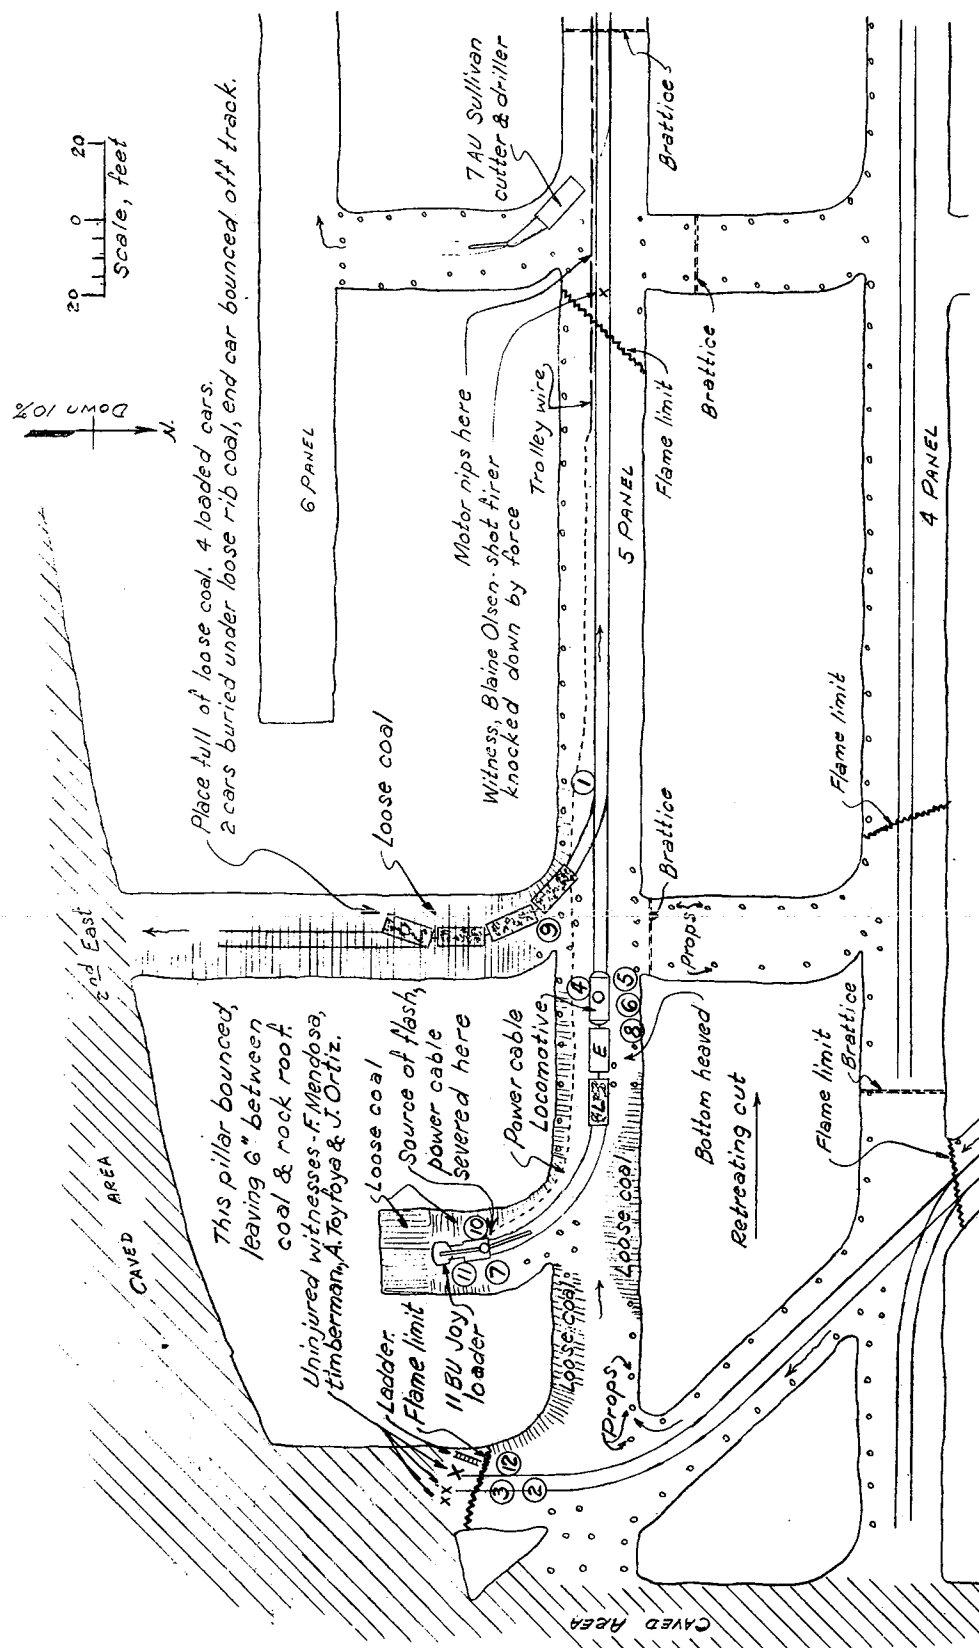
SCENE OF FATAL ACCIDENT
REILLY CO. COKE COMPANY

Appendix 3 is a sketch of the explosion area, and the forces, as shown in the sketch, originated apparently at the loading machine in the last split of the pillar at the inby end of 5 panel, 3 east, 2 slope. From indications that were apparent after the explosion, the flame extended about 170 feet from the loading machine inby and down No. 10 room to 4 panel and about 260 feet outby the loading machine in 5 panel, as well as through the crosscut to 4 panel.

ACCIDENT OCCURRED AT 1:15 P.M., ON WEDNESDAY, MARCH 14, 1945, AT THE INSIDE END OF NO. 5 PANEL ON THE THIRD EAST SHIFT OFF NO. 2 SLOPE. IT WAS CAUSED BY A BOUNCE ORIGINATING IN THE PILLAR DESIGNATED ABOVE, WHICH THREW COAL DUST INTO SUSPENSION AND AT THE SAME TIME SEVERED THE POWER TRAILING CABLE ON THE 11 BU JOY LOADER, CAUSING AN ELECTRIC ARC WHICH IGNITED THE SUSPENDED COAL DUST. 12 MEN OF THE 16 MAN CREW, RECEIVED SEVERE BURNS FROM THE FLASH. ALL WERE ADMINISTERED FIRST AID AND THEN REMOVED FROM THE MINE TO THE HOSPITAL. LATER 7 MEN WERE TRANSFERRED TO THE PRICES HOSPITAL WHERE 5 PASSED AWAY WITHIN 48 HOURS. NUMBERS ENCIRCLED OF THE ABOVE SKETCH SHOW THE LOCATION OF THE INJURED AT THE TIME THE ACCIDENT OCCURRED. THEIR NAMES, AGES, MARITAL STATUS AND OCCUPATIONS ARE TYPED IN THE LOWER LEFT CORNER.
