# COAL FATAL

REPORT OF GAS EXPLOSION  
LLEWELLYN SHAFT  
R. G. JOHNSON COMPANY (CONTRACTOR)  
FARMINGTON, MARION COUNTY, WEST VIRGINIA

April 30, 1965

Matthew I. Duncan and W. D. Baldwin  
Federal Coal Mine Inspectors

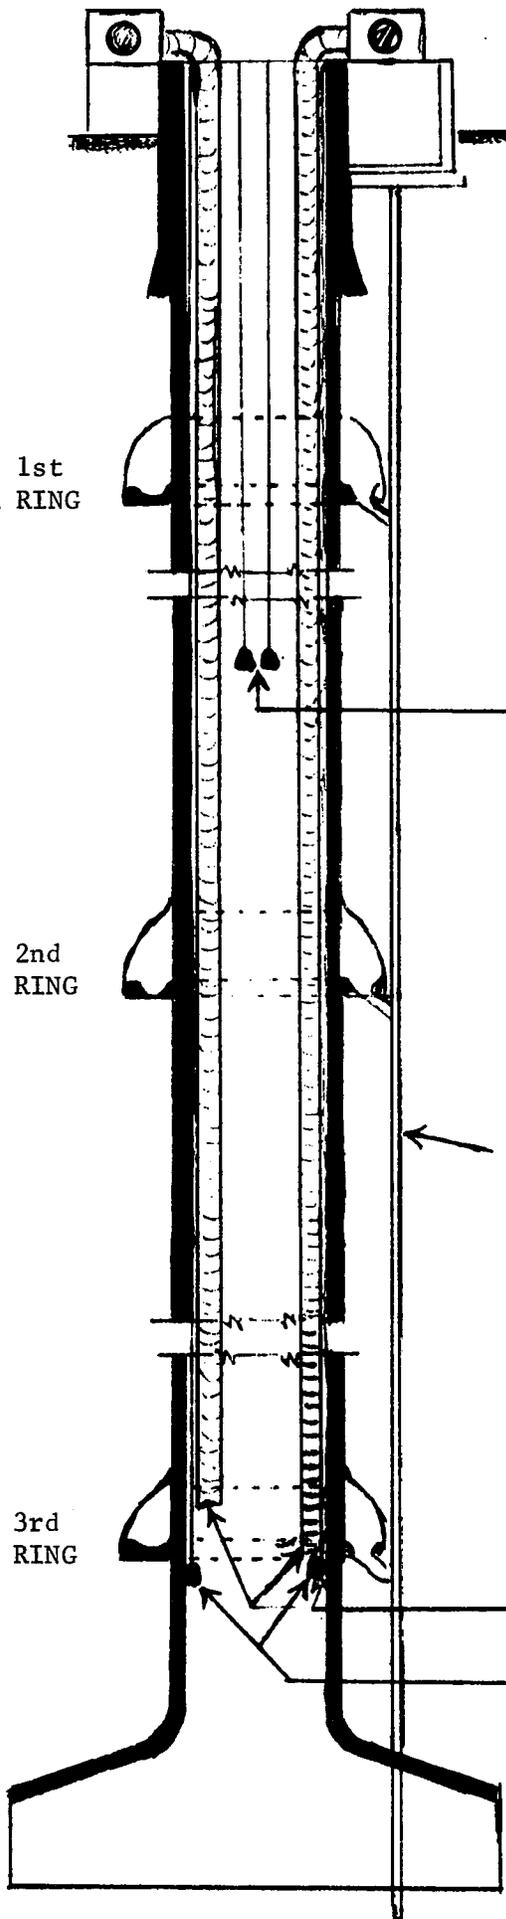
APPENDIX D

10. The damaged vaportight light used for supplemental illumination was suspended in the shaft to within 27 feet of the bottom and was exposed to damage from falling material.

11. The damaged condulet of the light indicated that it had been hit by some falling object.
12. Fused ends of several broken wire strands of the connecting wires in the light cable indicated that a short circuit had occurred.

Cause of Explosion: Methane, being liberated freely from the coal faces in the approaches accumulated and gravitated to or was moved in an enriched state toward the source of ignition which was suspended in the shaft approximately 27 feet from the bottom.

END OF FAN  
TUBING

VAPORTIGHT  
LIGHTS

1. The discharge ends of the fan tubings should be extended to a point in the shaft where the air will be directed to the locations where methane is being liberated, maintained in good condition, and the fans and air conductors should be of a size and capacity to provide air of sufficient volume and velocity to dilute and carry away flammable or harmful gases.

4. Frequent examinations for methane should be made during each working shift.
5. Only permissible-type portable flood lights should be used when necessary to supplement personal permissible lighting.
