**ACCIDENT INVESTIGATION REPORT
SURFACE NONMETAL MINE
FATAL FALL OF HIGHWALL ACCIDENT**

**Portable Crusher #2, ID No. 45-03226
Lloyd Logging, Inc.
Wenatchee, Chelan County, Washington**

May 19, 1995

INVESTIGATION OF MASSIVE SLOPE FAILURE
PORTABLE CRUSHER NO. 2 (ID NO. 45-03226)

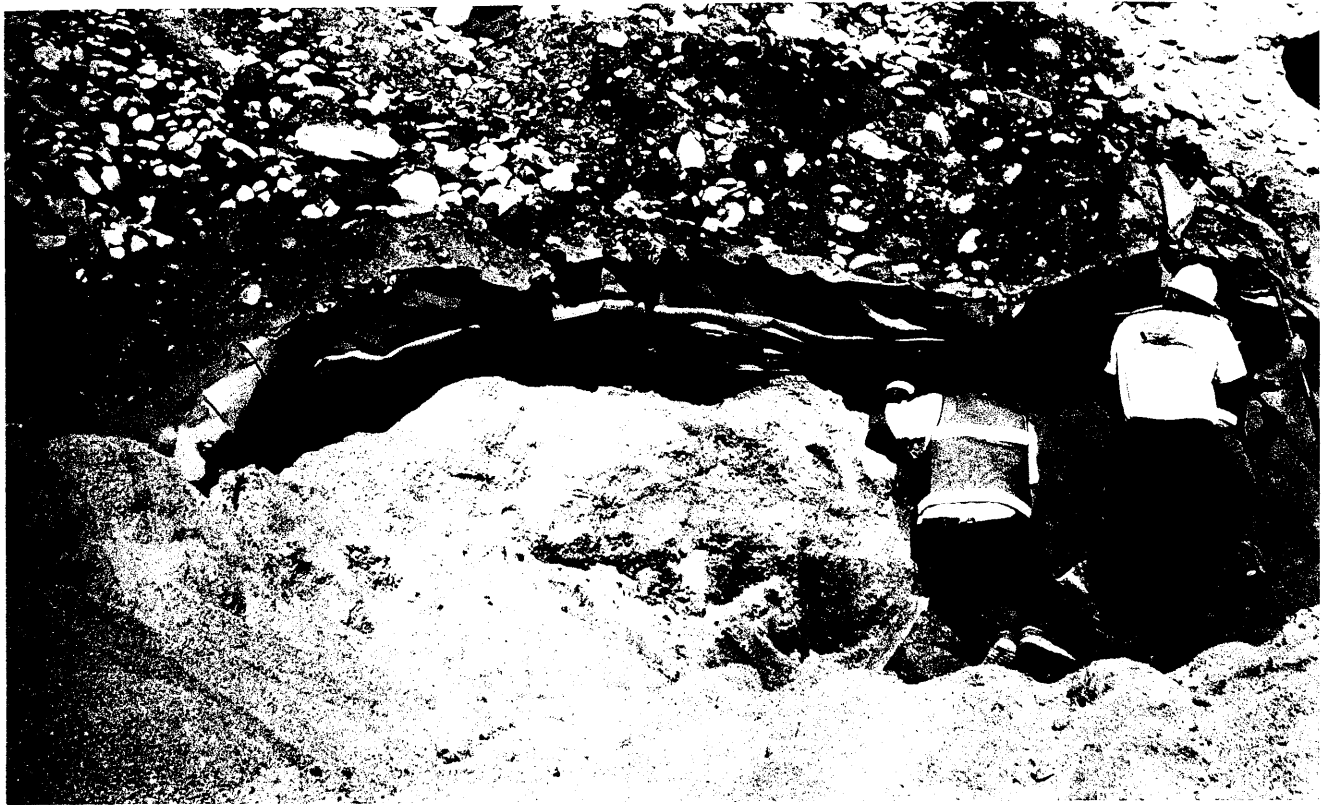
RECOVERY PHOTO 1. - Recovery of Victim No. 1. Victim was found inside of crushed bus, May 20, 1995.

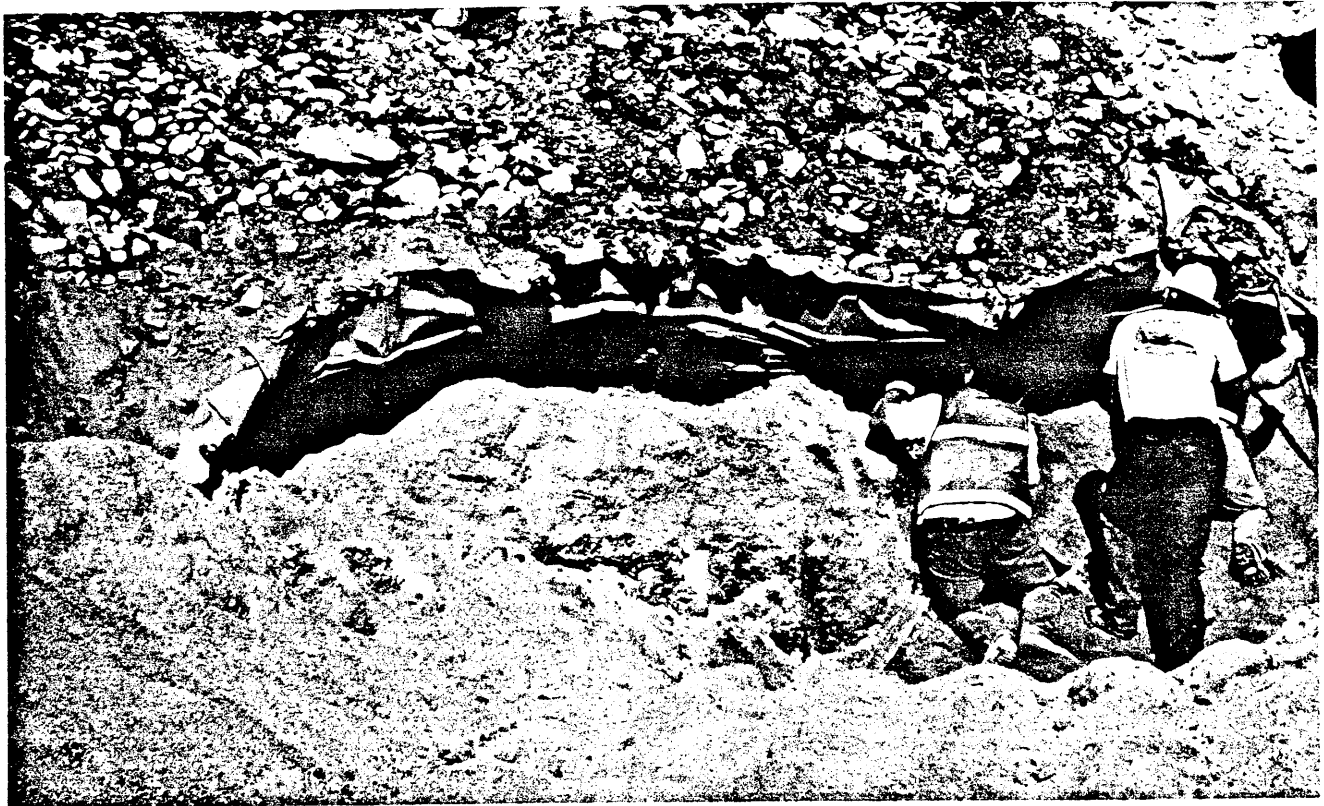
RECOVERY PHOTO 1. - Recovery of Victim No. 1. Victim was found inside of crushed bus, May 20, 1995.

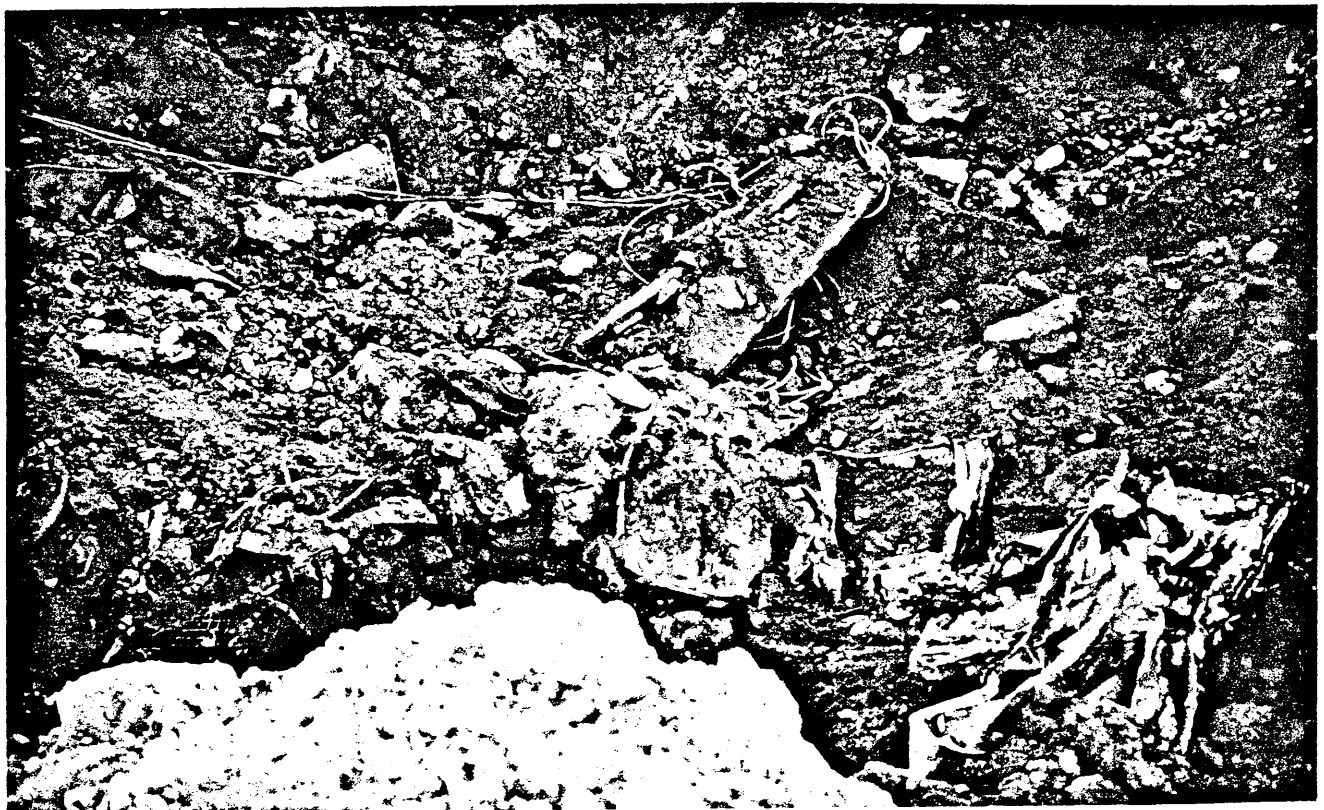
RECOVERY PHOTO 2. - Wreckage of crusher cab recovered at Victim No. 2 location, May 21, 1995.

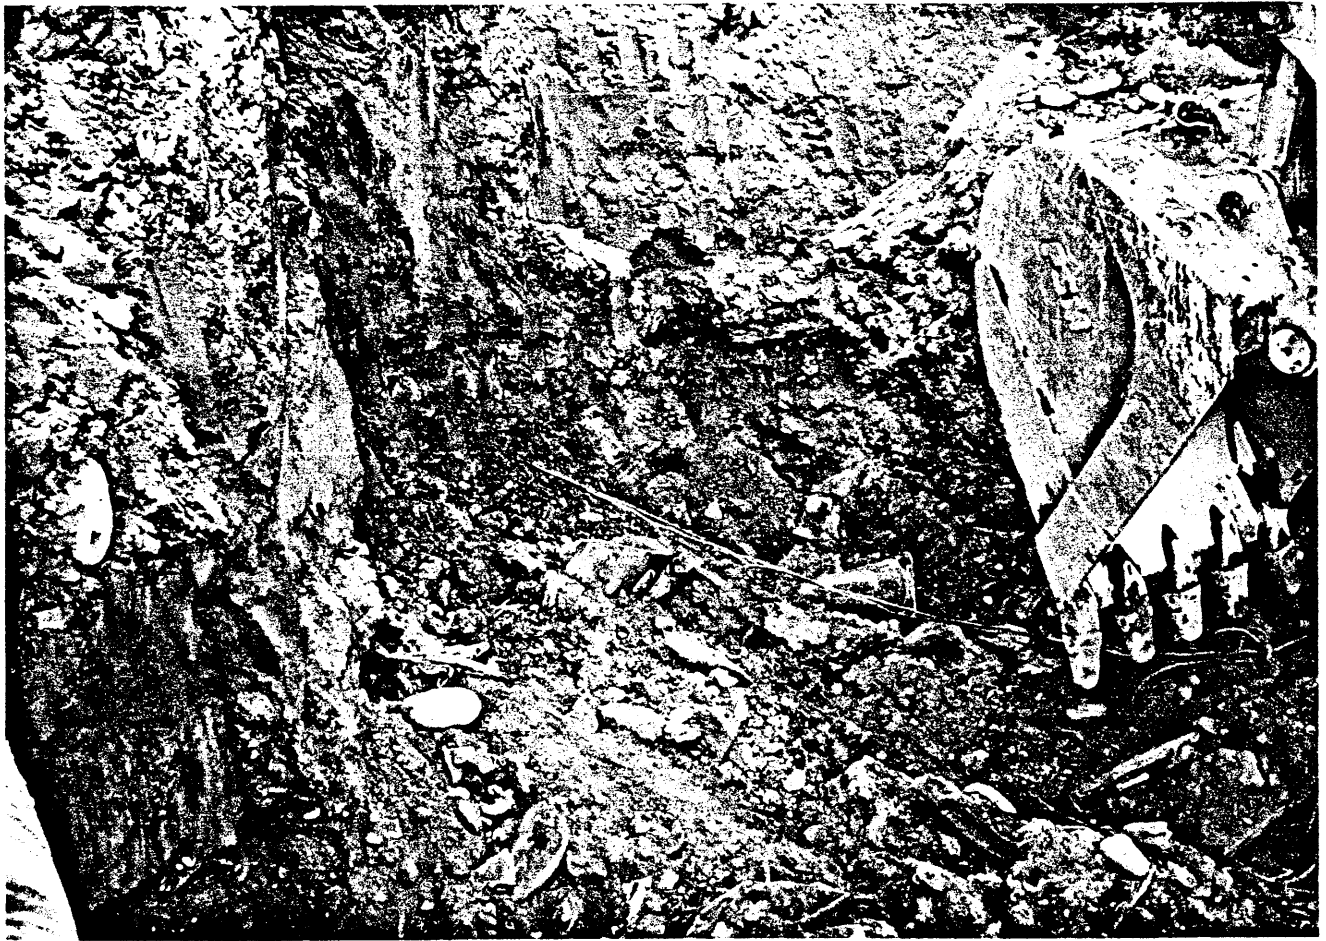
RECOVERY PHOTO NO. 3. - Recovery site of Victim No. 2, Crusher operator. Note clay-like material (upper material) interface with silty-sand (lower material). Crusher cab debris was recovered at clay/sand interface, slightly buried in the sand, May 21, 1995

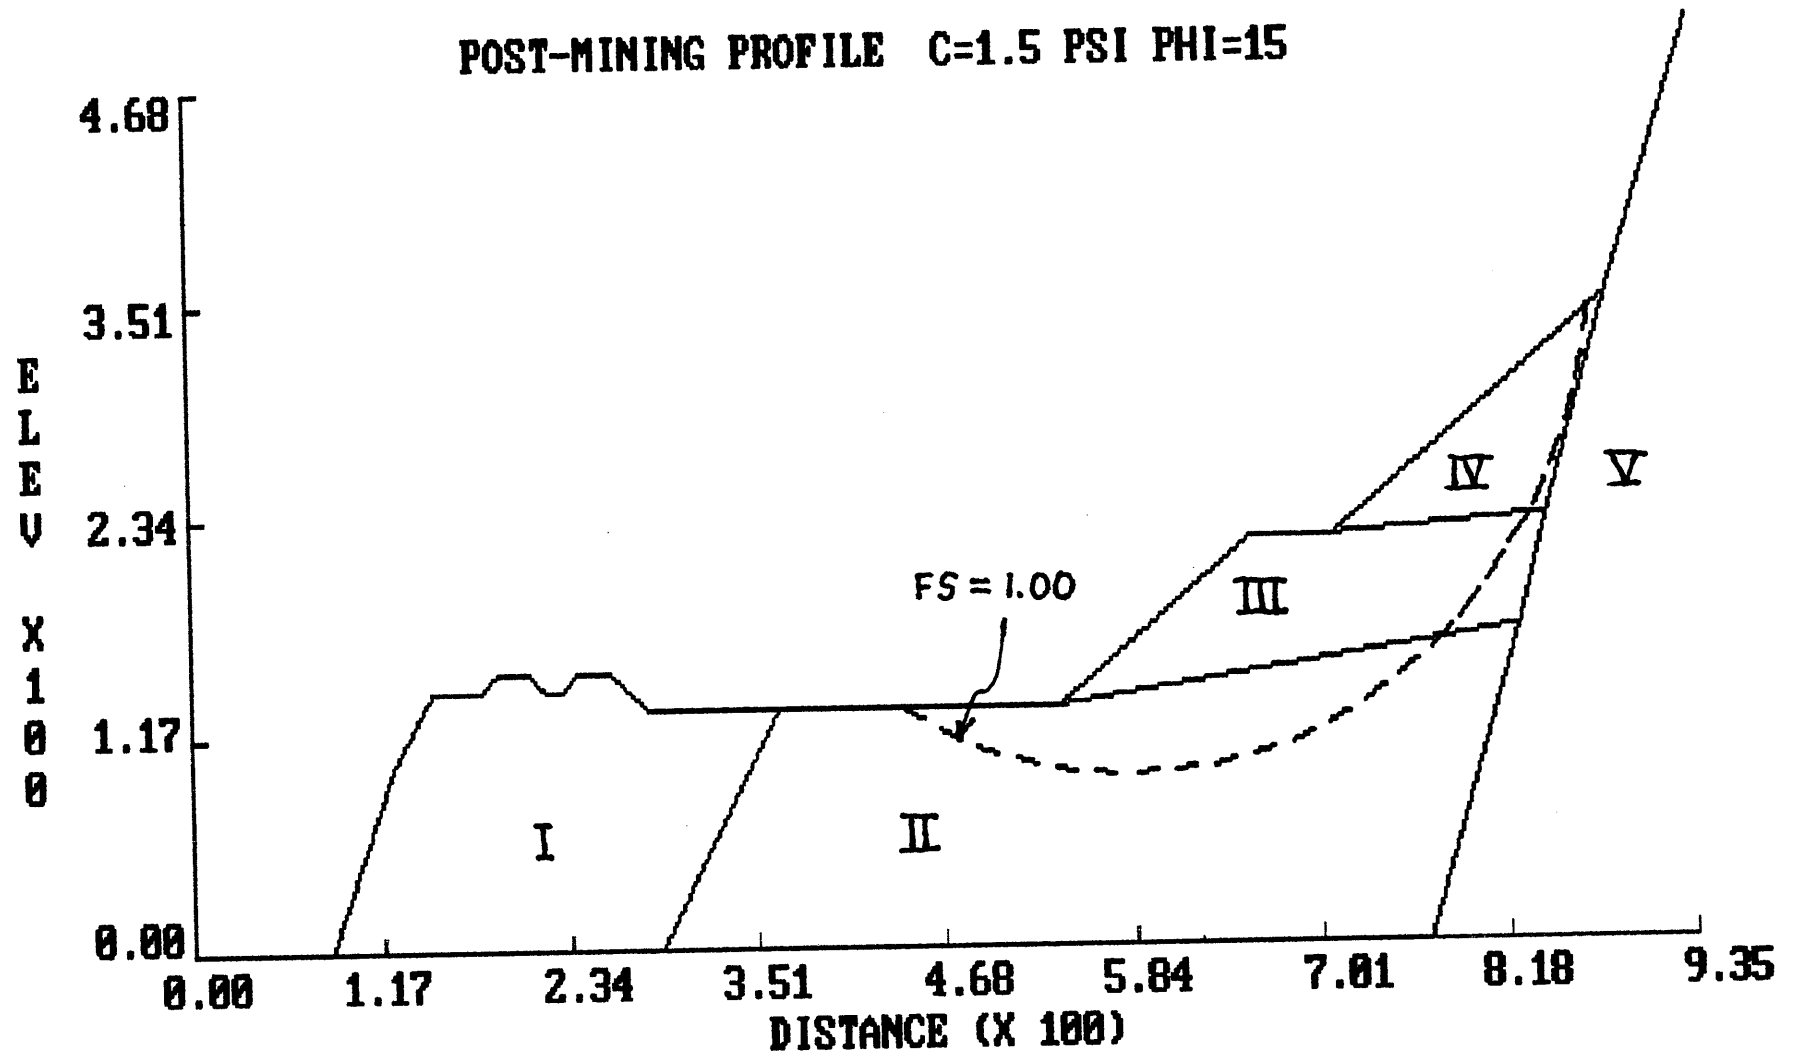
FIGURE 8.

POST-MINING PROFILE C=1.5 PSI PHI=15

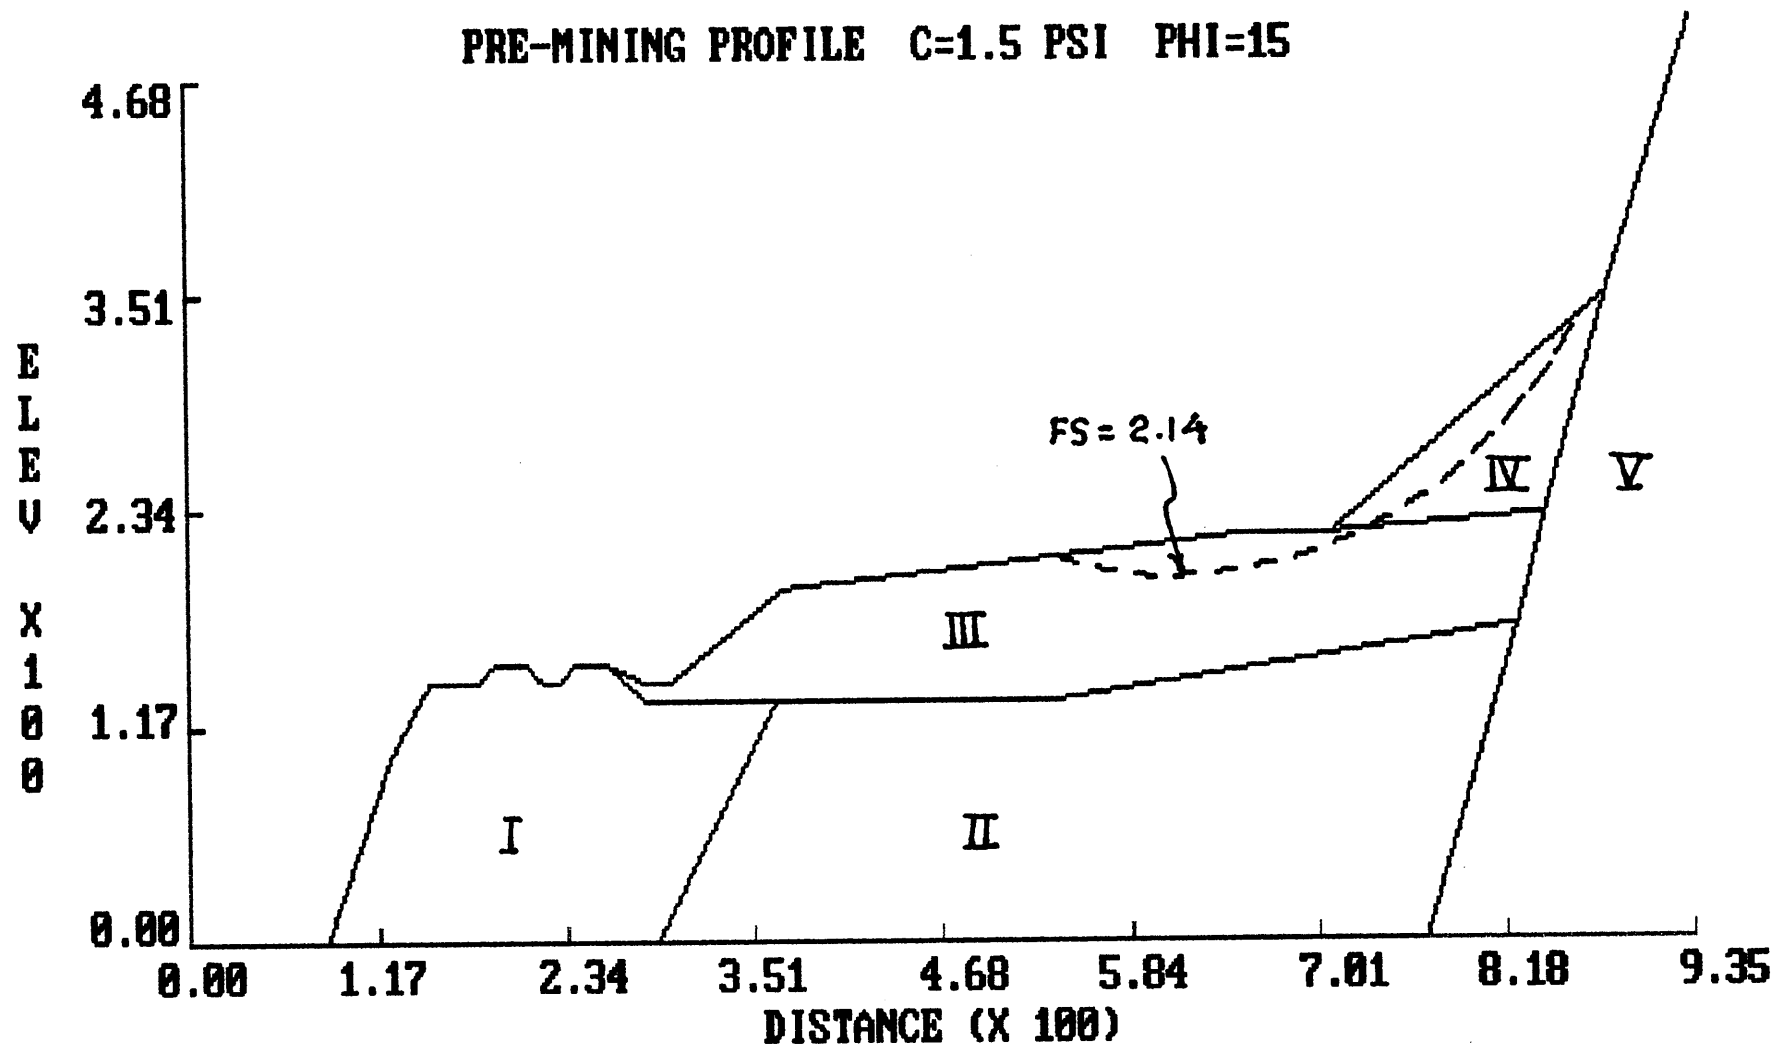
FIGURE 9.

PRE-MINING PROFILE C=1.5 PSI PHI=15

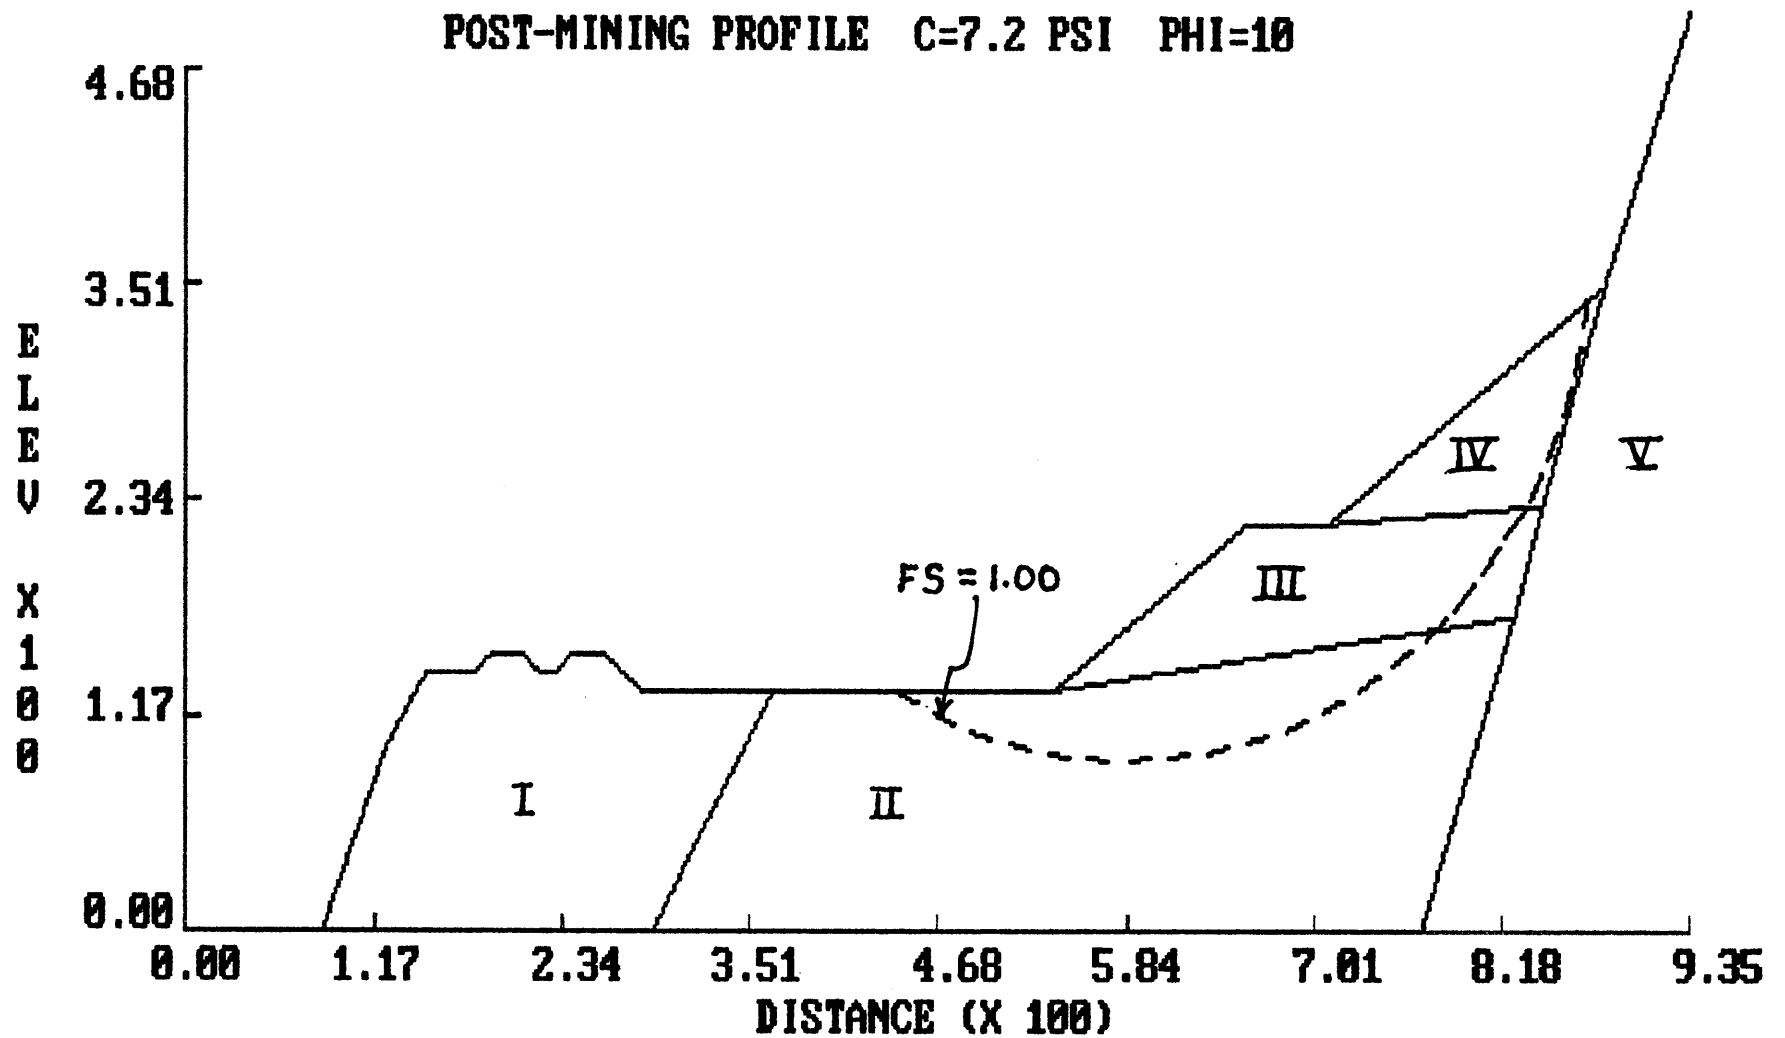
FIGURE 10.

Computer analysis using a Simplified Bishop failure program (PCSTABL5M) was performed to determine a probable failure surface. Parameters for alluvium and colluvium materials were varied slightly during the search routines. Soil index testing results dictated shear strength inputs of 15° or less, zero cohesion and a wet density of 145 lbs/ft³ for foundation materials. Zero contact friction was assumed between the Entait mountain metamorphics and the talus/alluvium materials. These parameters are in close agreement with soil parameters determined from other landslide failures in glacial deposits within the Columbia River valley. From these calculations, a deep-seated rotational failure was projected.

POST-MINING PROFILE $C=7.2$ PSI $\Phi=10$

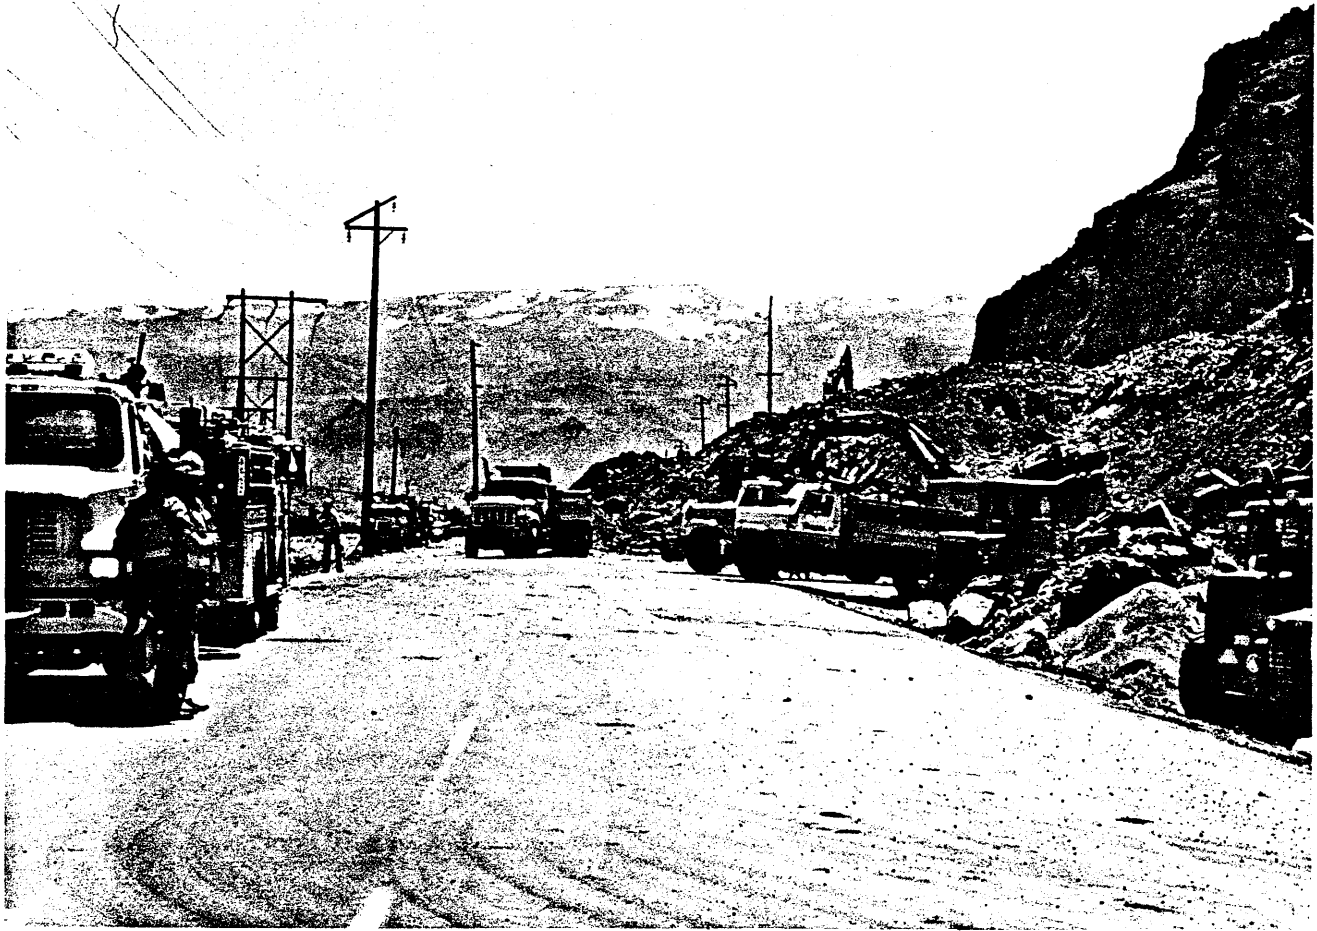
PHOTO 1. - Taken a few hours after the failure. Looking south on State Highway 97A. Slide material has run out about halfway across the highway to a depth of about 20' (Washington State Department of Natural Resources).

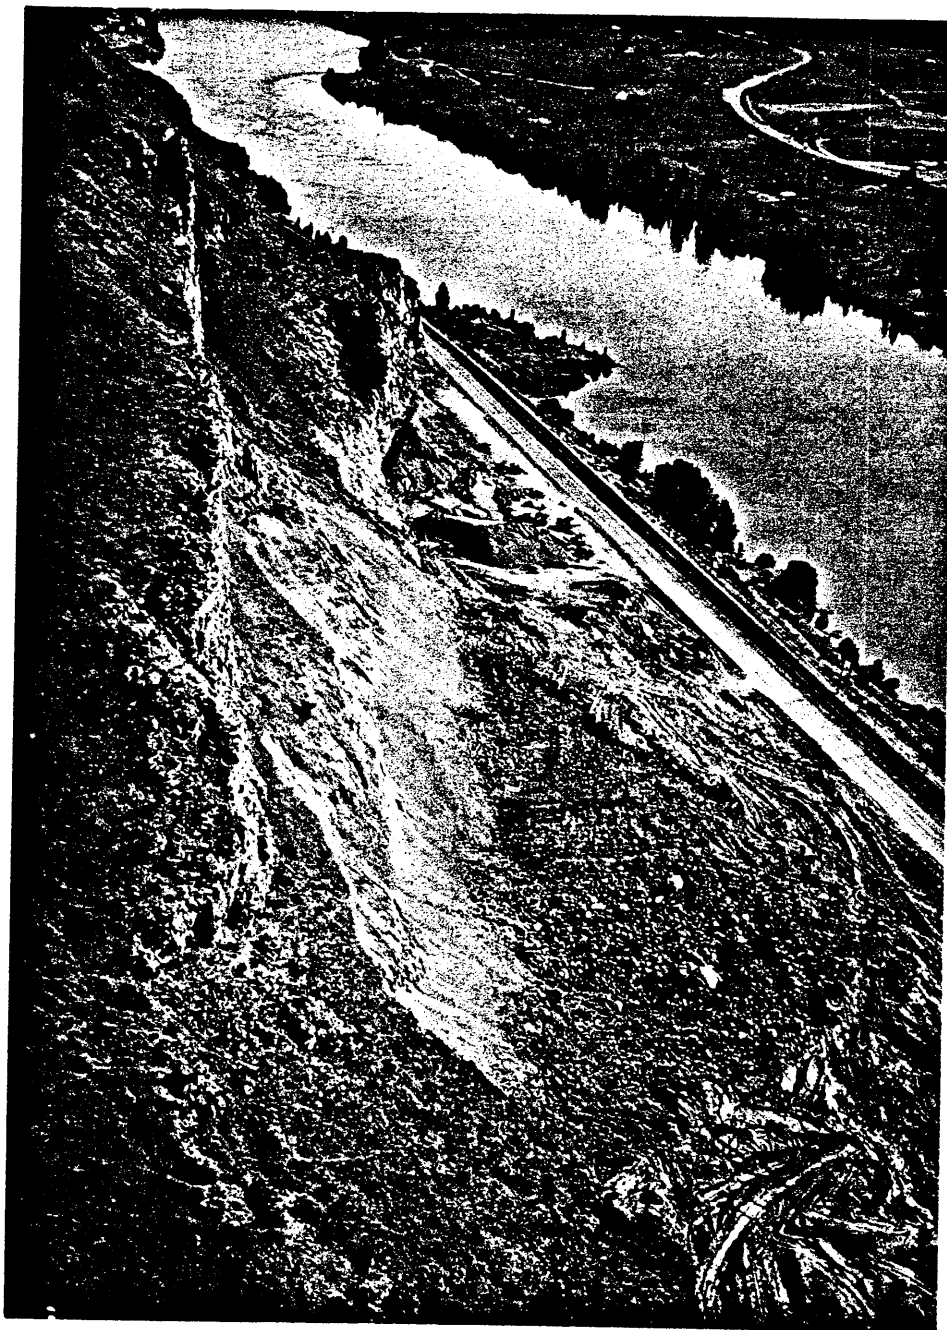
Much of the top area of the slide is covered with a mantle of talus and shrub growth that has been loosened but not tumbled. Much of this material appears to have ridden down like a carpet on top of the slide (photos 2, 3, and 4). There are cracks and evidence that rocks have moved in this carpet of material. Walking on it was difficult, as it felt compressible or airy under foot. Rocks were loose and sometimes quite unstable. The condition of this material is consistent with a foundation failure where the upper surface of the talus moved in mass as the lower section of the slide rotated up and out of position. Thus, much of the talus was loosened, but was not tumbled and mixed together.

PHOTO 2. - Aerial view of slope failure looking down the vertical scarp above the slide area. The rock face against which the talus rested before the slide is partially obscured by post slide slough. Note the carpet-like appearance of the vegetated top surface of the slide area (below center-right).

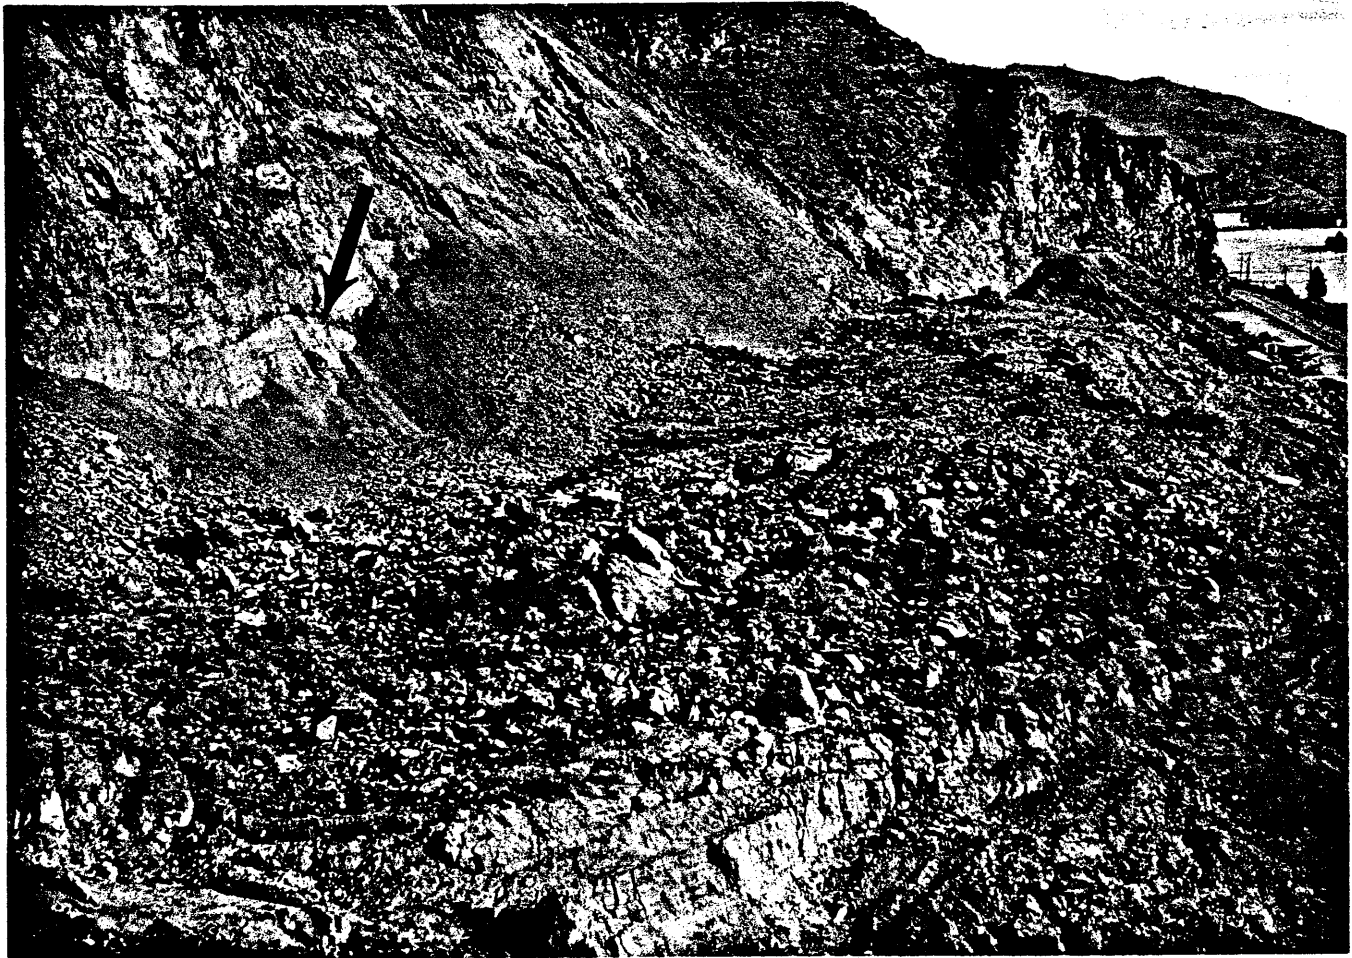
PHOTO 3. - Looking to the north at the landform created by the slope failure. Much of the surface of the talus came down as a "carpet." The area near the gneiss rock surface (center left) is lower and has formed a pocket or shallow depression relative to the higher part of the debris to the right in the photo. Post failure slough has covered the talus near the rock surface. Varved clay remnant is shown at arrow.

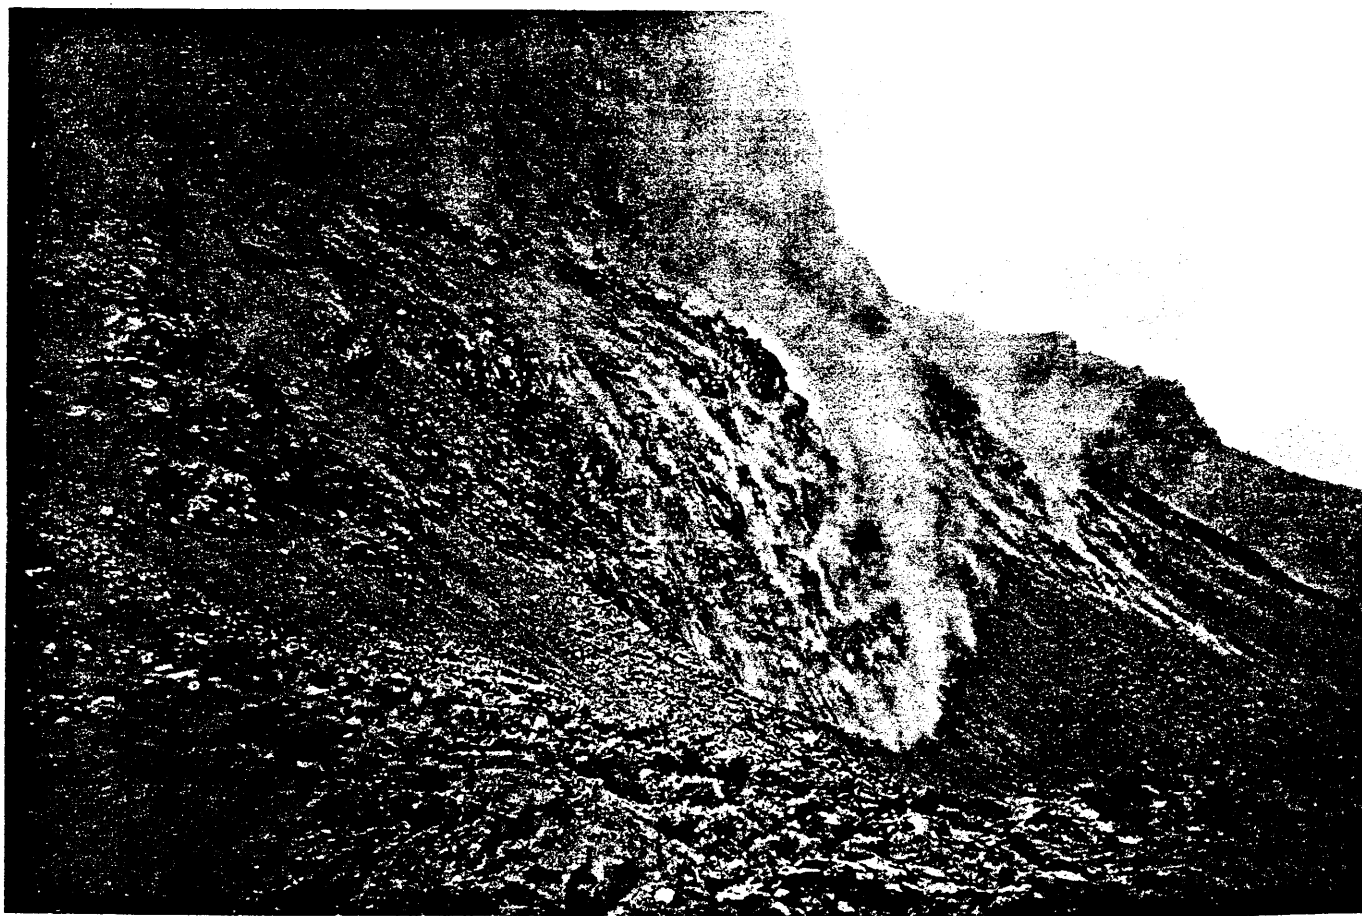
PHOTO 4. - Post accident drying, sloughing and adjustment of slope to new slope configuration.

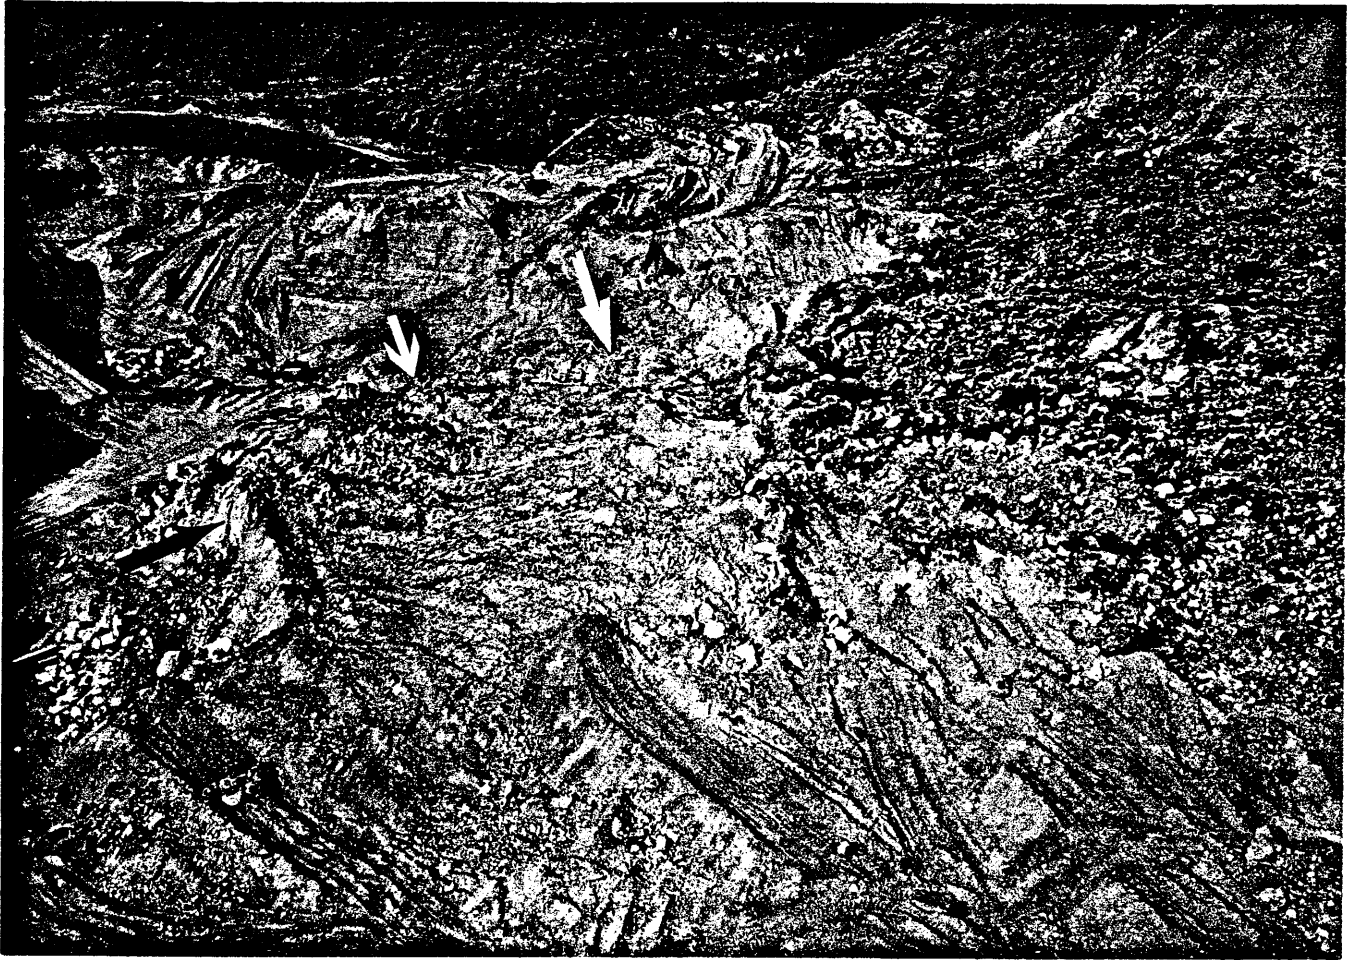
Eyewitness accounts stated that the failure started at the south pit (deepest area excavated) and ran northward. The existing south pit has been mostly filled with slide material except for the very most southern part. Evidence (photos 5 and 6) shows where equipment tracks made on the pit floor and a boulder estimated at 120 tons that was also setting on the pit floor have been raised 30 to 40 feet and carried about 150 feet laterally from their original location. This material was near the front and western limit of the slide. Also varved clays were observed at the top of the slide material that filled the south pit (photos 5, 7, 8 and 9). About 20 feet below this surface expression of varved clays, massive clay material was observed in the south face of the slide material, in this south pit. The south end of the slide also shows a "stepped" surface, especially through the finer sedimentary material (photo 5). The tan colored material in photo 5 is wind blown soil (loess). The slide has spread this material horizontally approximately 200 hundred feet from its original position.

PHOTO 5. - Aerial photo of the south pit area after the failure. Highway 97A is just off the left edge of the photo. White arrows point to location of varved silts/clays observable in the slide material. Black arrow (on left) points to material that was originally in the pit floor about 150 feet to the right in the photo and 30 to 40 feet lower (as shown in photo 6). Just above the arrow is a 120 ton boulder that was displaced at the same time.

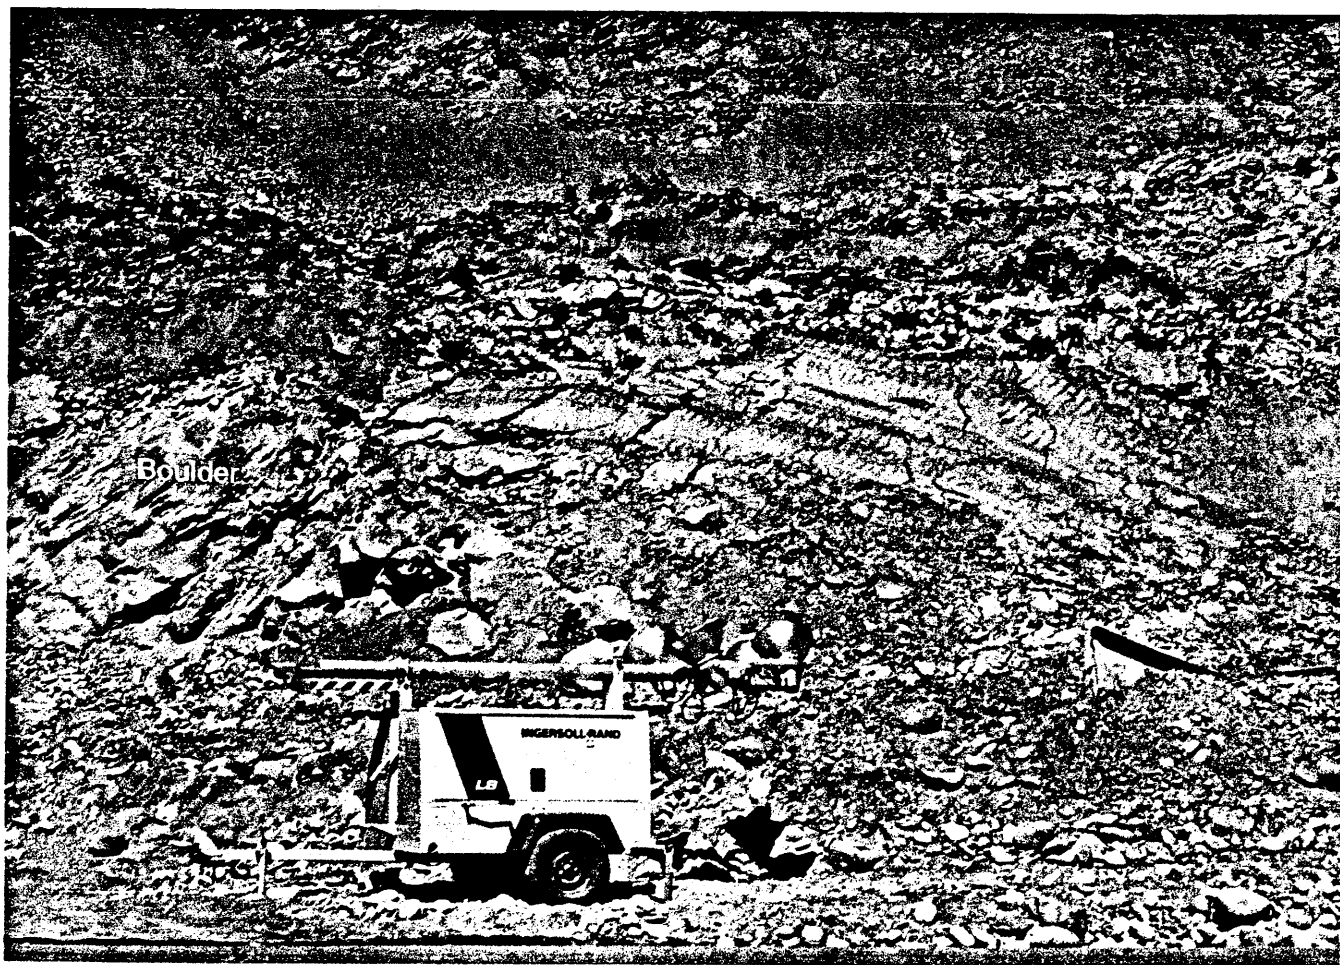
3. The post-failure exposure of varved clays on the surface approximately 40 feet higher than the pre-failure pit floor.
4. The movement and uplifting of one large boulder (approximately 15-ft x 15-ft by 10-ft-thick and weighing 120 tons) approximately 150 feet horizontally and 40 feet in elevation.

PHOTO 6. - Large boulder (on left) and upheaved pit floor with tire tracks. Both boulder and tire tracks were raised up 35 to 40 feet and moved approximately 150 ft. east.

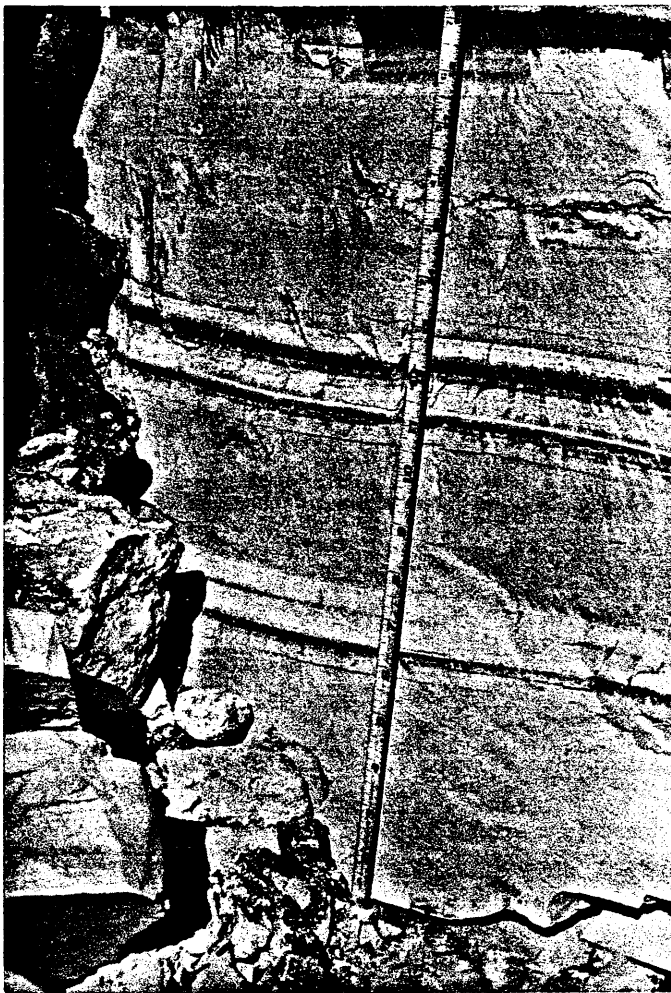
PHOTO 7. - Varved silt and clay with thin sand layers between varves. Located on upper surface of slide in south end of slope failure (See Photo 5).

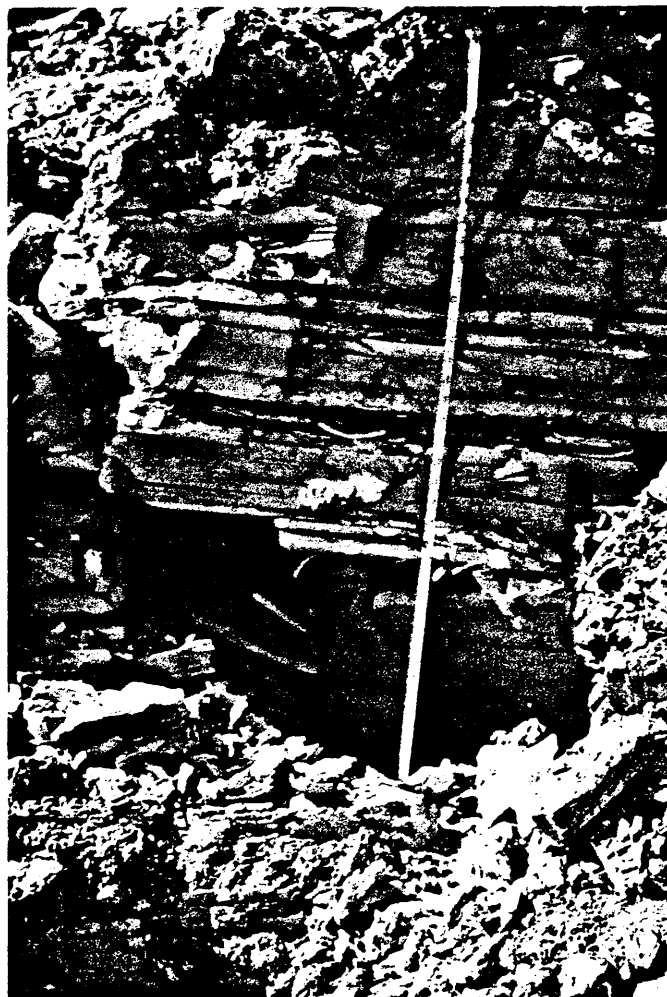
PHOTO 8. - Another view of the varved clay and silt at the same location as photo 7. Note the very laminar structure of this material.

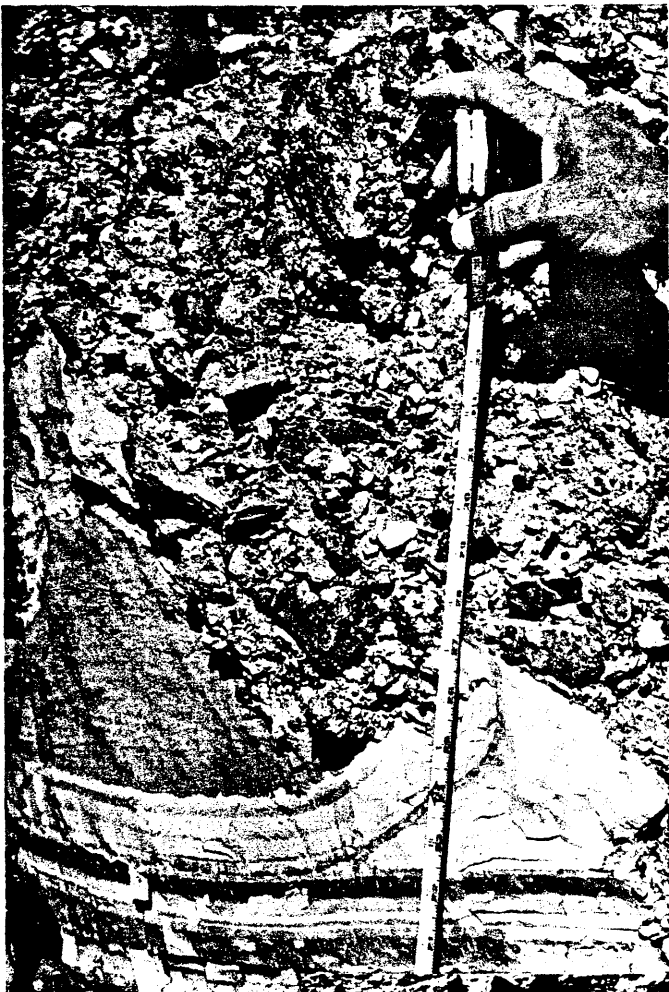
PHOTO 9. - Varved clay showing a historic slump-type failure feature where one bed has slid over another. Note gneiss coluvium (talus) on top of clay. This demonstrates that the clay material can fail under its own weight indicating a very low shear strength.

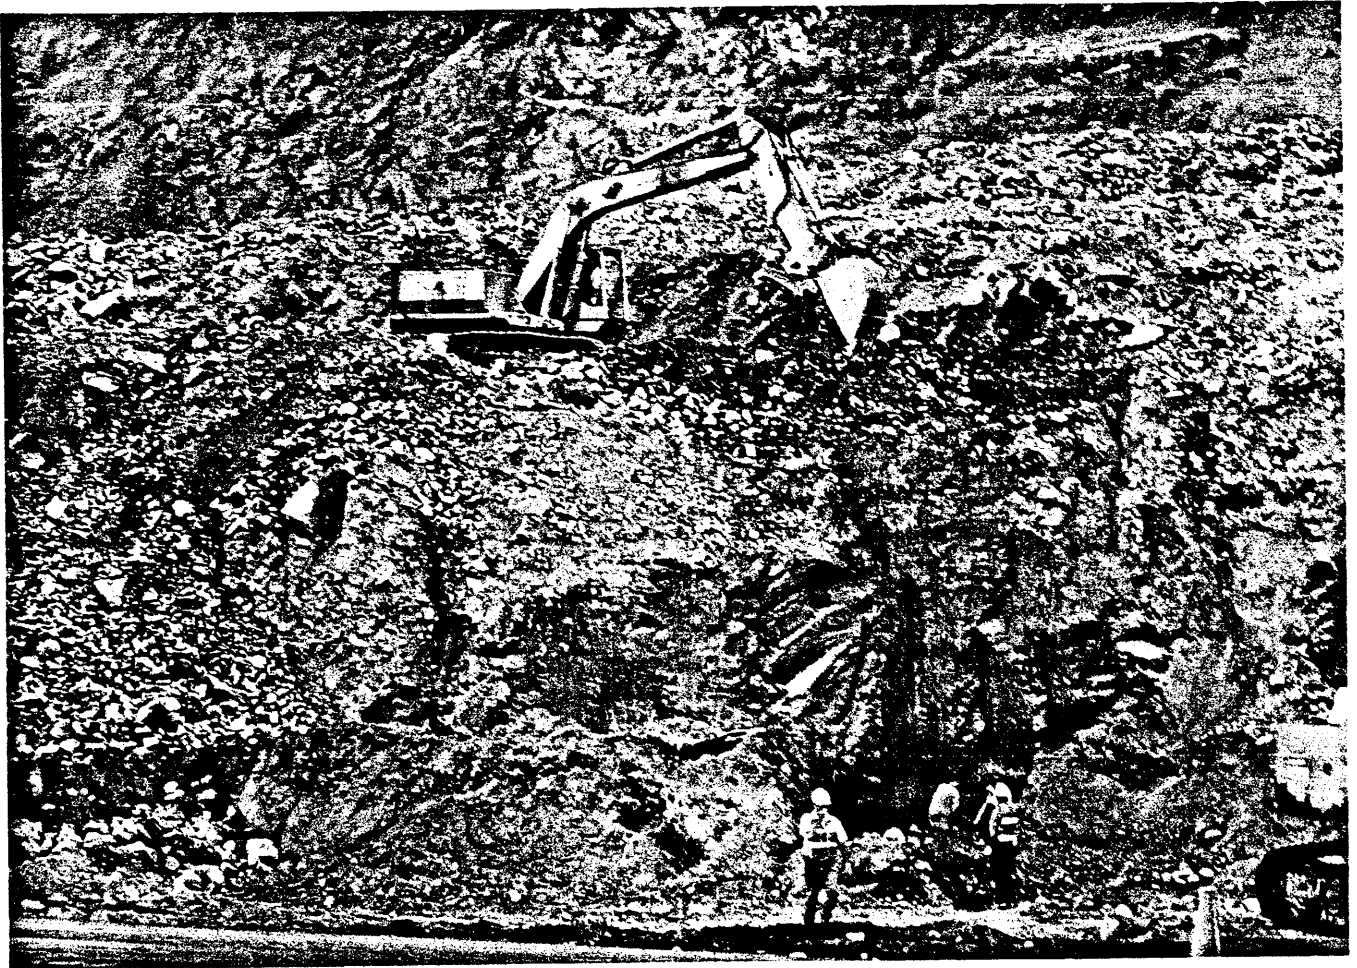
PHOTO 11. - Face of slide at the location where second victim was recovered in the north part of the pit. Tooth marks from backhoe denotes silt/clay layer 25 to 30 feet thick above pit floor.
