**ACCIDENT INVESTIGATION REPORT
SURFACE NONMETAL MINE
FATAL FALL OF HIGHWALL ACCIDENT**

**Portable Crusher #2, ID No. 45-03226
Lloyd Logging, Inc.
Wenatchee, Chelan County, Washington**

May 19, 1995

INVESTIGATION OF MASSIVE SLOPE FAILURE
PORTABLE CRUSHER NO. 2 (ID NO. 45-03226)

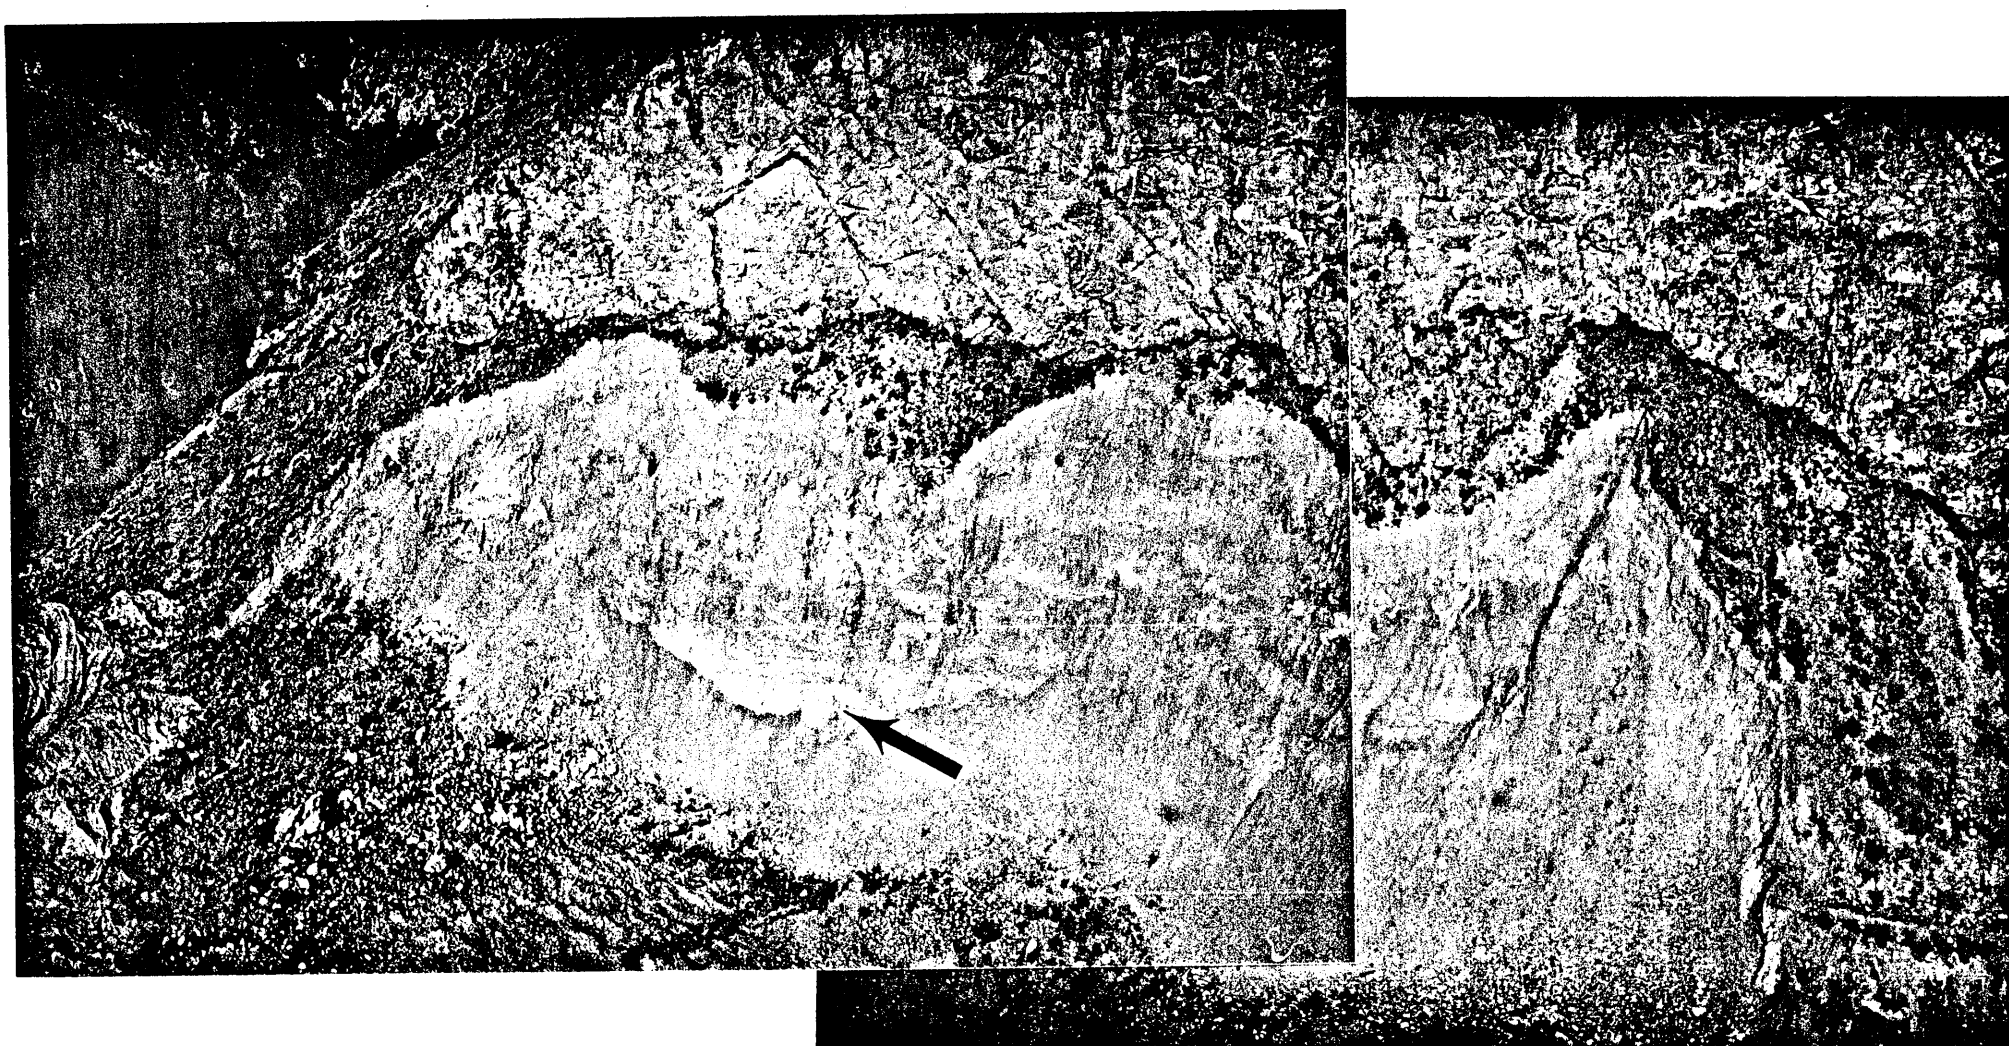
The slope failure uncovered a large face of the Swakane gneiss against which the talus had been resting (photo 12). This rock face was estimated at 175 to 200 feet high and about 1100 feet across. The face is very uneven but slopes about 70 degrees downward toward the east. The rock scarp above the original slope is nearly vertical. Below and somewhat to the left of center in this face, a remnant of varved clay/silt was observed clinging to the rock surface. This is indicated by the arrow in photo 12 and is shown in detail in photo 13. This is significant as it is estimated to be about one third of the height of the original talus slope.

PHOTO 12. - Aerial view of the rock surface of the Swakane gneiss exposed by the slide. Arrow points to the location of remnant area of varved silt/clay on the rock surface. Closeup of this is shown in photo 13.

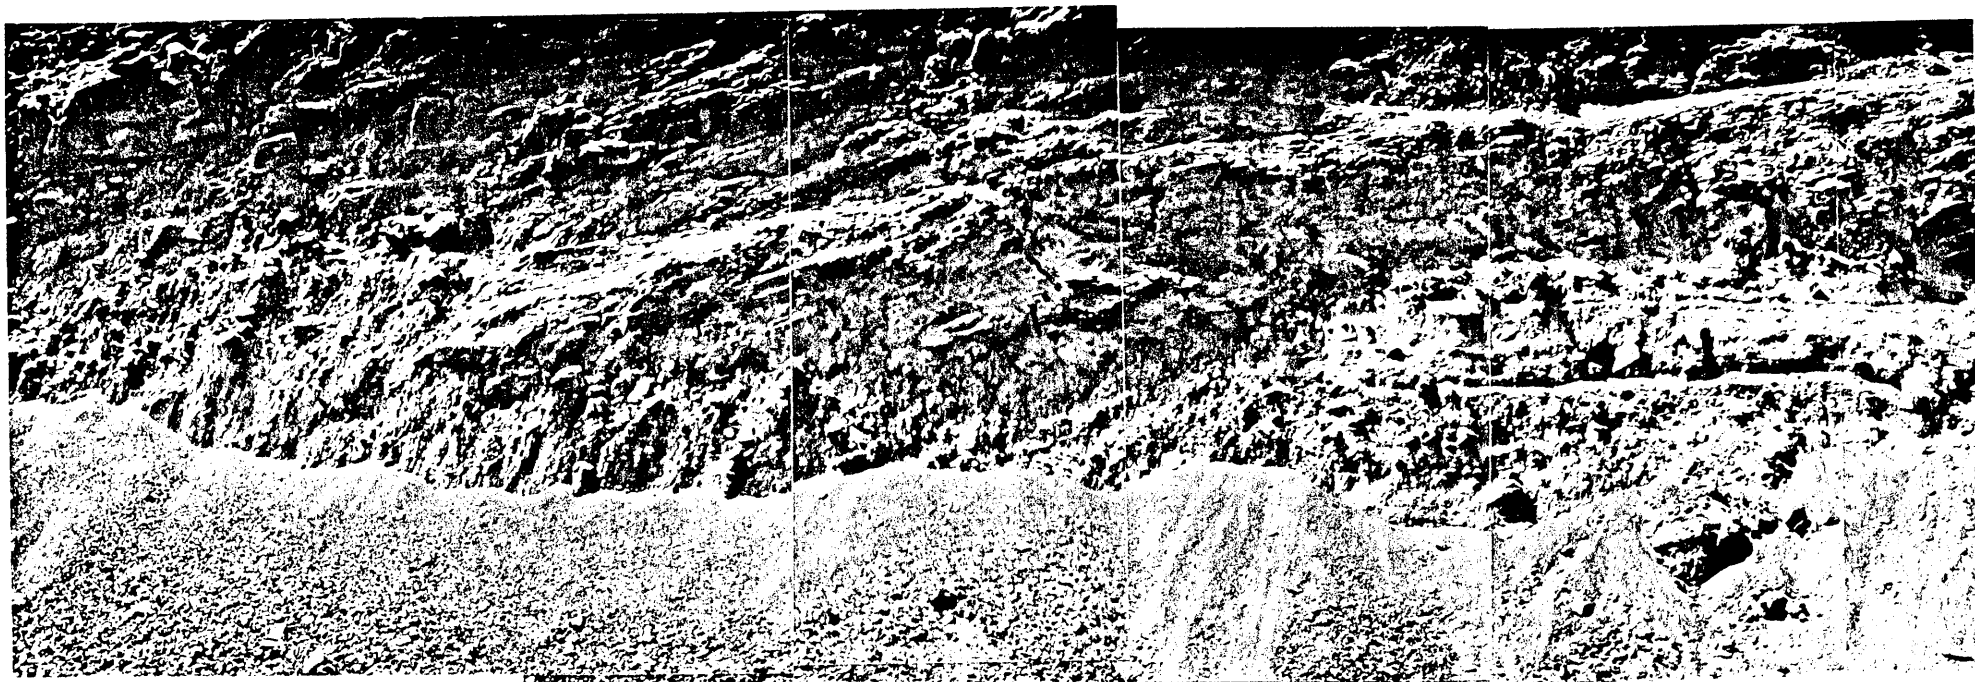
PHOTO 13. - Remnant of varved silt/clay beds on the gneiss rock surface exposed by the failure of the talus slope. Pieces of the gneiss talus are embedded in the silt/clays. This remnant is estimated to be about 100 feet above the pre-failure pit floor. Post failure slough covers the lower part of these silt/clay beds in the photo.

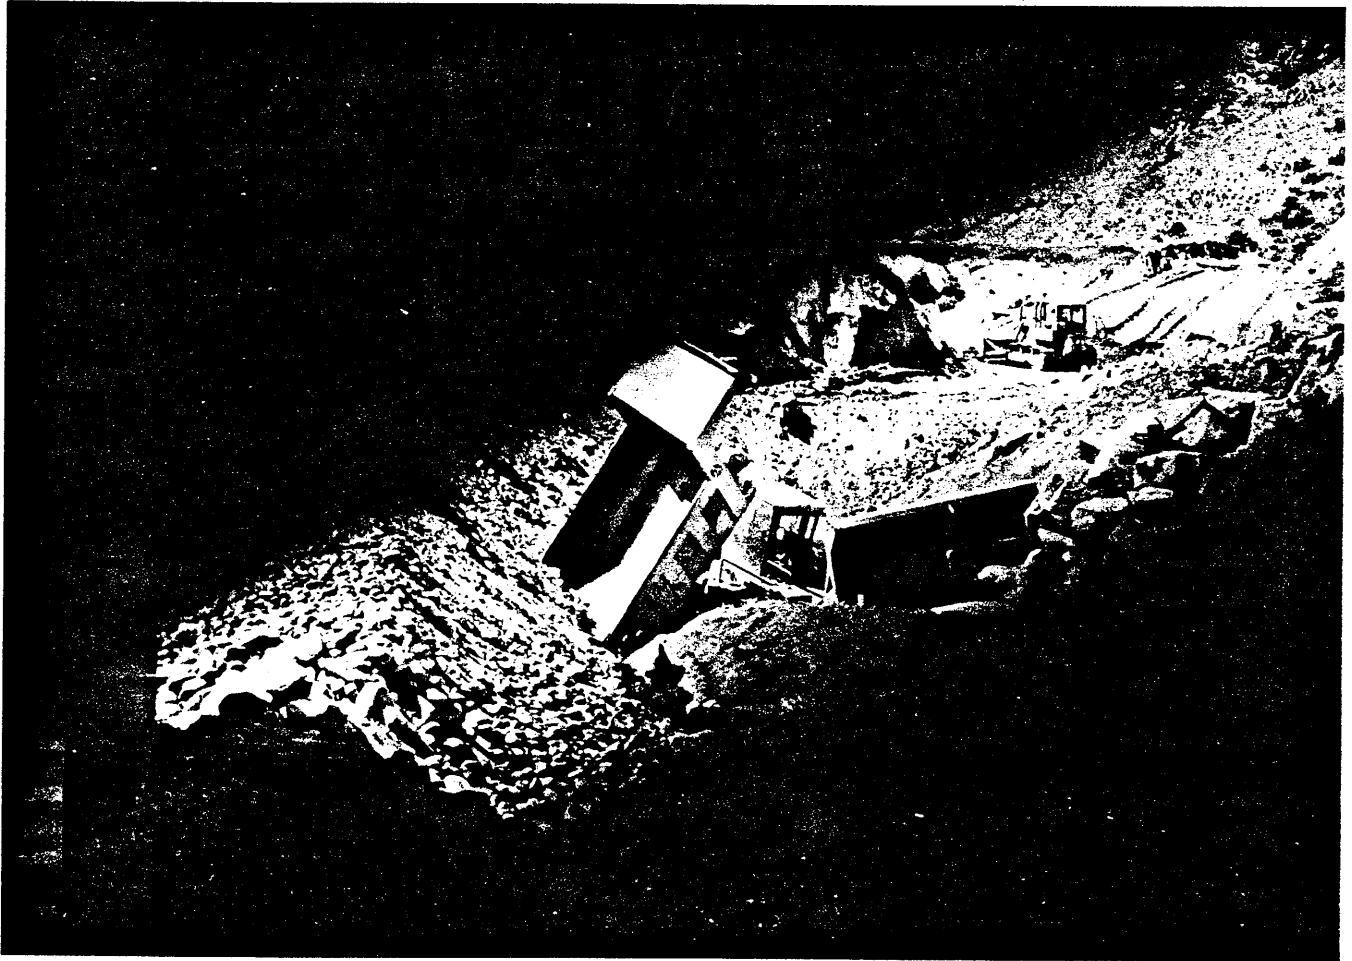
PHOTO 16. - Two Euclid dump trucks located at west end of accident site. Trucks were on pit floor near screen-all at time of accident. After accident, trucks were surrounded by gravel debris.
