Identification No. 23-00134
Report Issued March 28, 1986

Karen Laverne Welker, general truckdriver, age 40, SSN 3520, was fatally injured at approximately 7:30 a.m. on February 12, 1986. Her head and the upper part of her body were crushed by a metal Dempster Dumpster trash container (Figure 1). She apparently was behind the open dumpster, preparing to clean out the suspended open container with a scraper, when the top portion of the container fell and crushed her. She was killed instantly. Welker had 7 years 8 months total mining experience with 2 years 5 months experience as a general truckdriver, all at this operation.

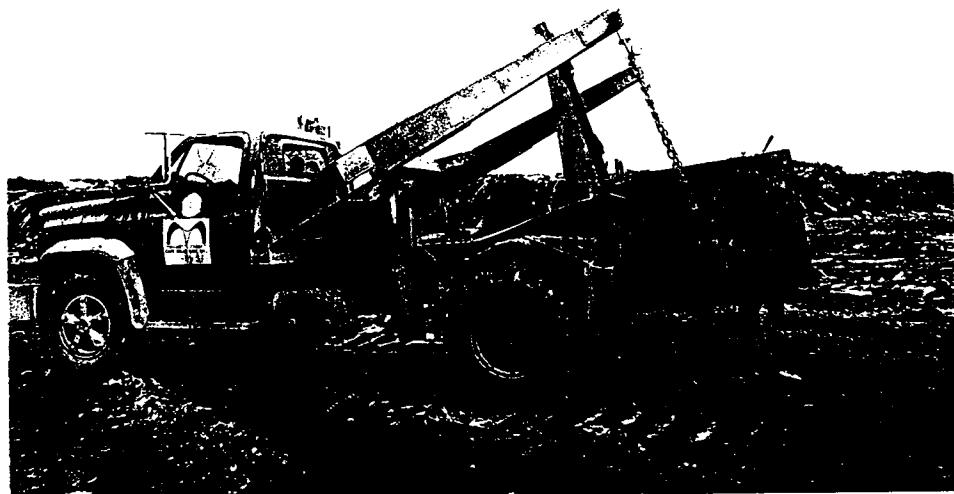
The dumpster assembly and mechanisms, which were mounted on the rear of the truck and were constructed so that they could lift a metal refuse container, place the container on a carrying stand at the far rear of the dumpster for transport, and then dump the container at a disposal site. The dumpster assembly basically consisted of two side arm lifts with chains for raising containers from two lifting pins, one on each side of the hinged bottom of the container, and a hydraulic cylinder operated center ram with a tilted vertical member carriage on the end, for controlling the fore and aft position of a container (Figures 2 and 3).

Figure 2. Center ram extended with the vertical member carriage in position for picking up the container.

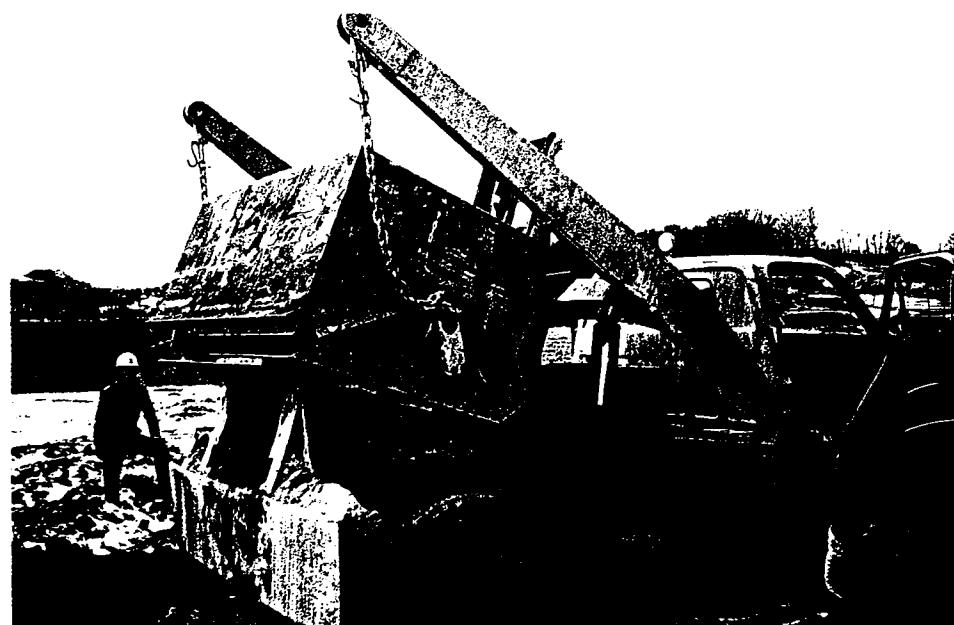
Figure 3. Center ram retracted with the vertical member carriage against the container which is resting on the transporting stand.

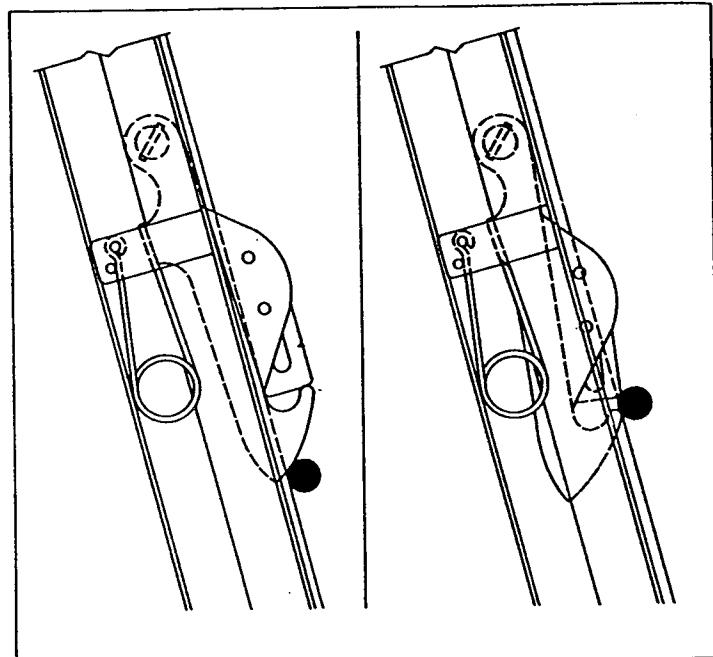
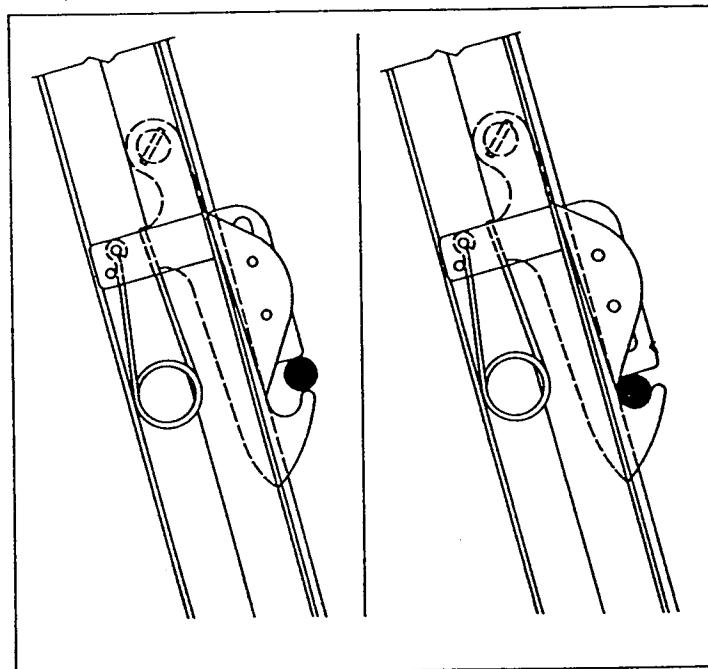
Figure 7. Dumping hook mechanism.

Lower the boom arms and attached container until the container bail is below the top dumping hook. Return the boom control to neutral for a moment, then reverse the control and slowly raise the boom. As the container slides up the face of the carriage, the container bail contacts the bottom of the dumping hook, pushing the hook back into the carriage.

As the bail rises, the dumping hook is further depressed, and the bail catches on the corner of the shuttle moving it upward. As the bail clears the end of the dumping hook, the counterbalancing springs snap the hook back in place engaging the bail. The shuttle drops back on the bail and the container is locked to the dumping hook on the carriage. Return the boom control to neutral.

4. The dumping hook mechanism of the Dempster Dumpster should be lubricated as recommended by the manufacturer. A light film of oil may be applied to the hook-pivot-wrist pin. No grease or oil should come in contact with the shuttle of the hook. Grease or heavy oil inside the shuttle guide walls will hamper rather than help operation of the mechanism.
