FINAL REPORT OF MAJOR ROOF-FALL DISASTER

LUNDALE MINE
AMHERST COAL COMPANY
LUNDALE, LOGAN COUNTY, WEST VIRGINIA

February 12, 1958

James T. Whalen
Federal Coal-Mine Inspector

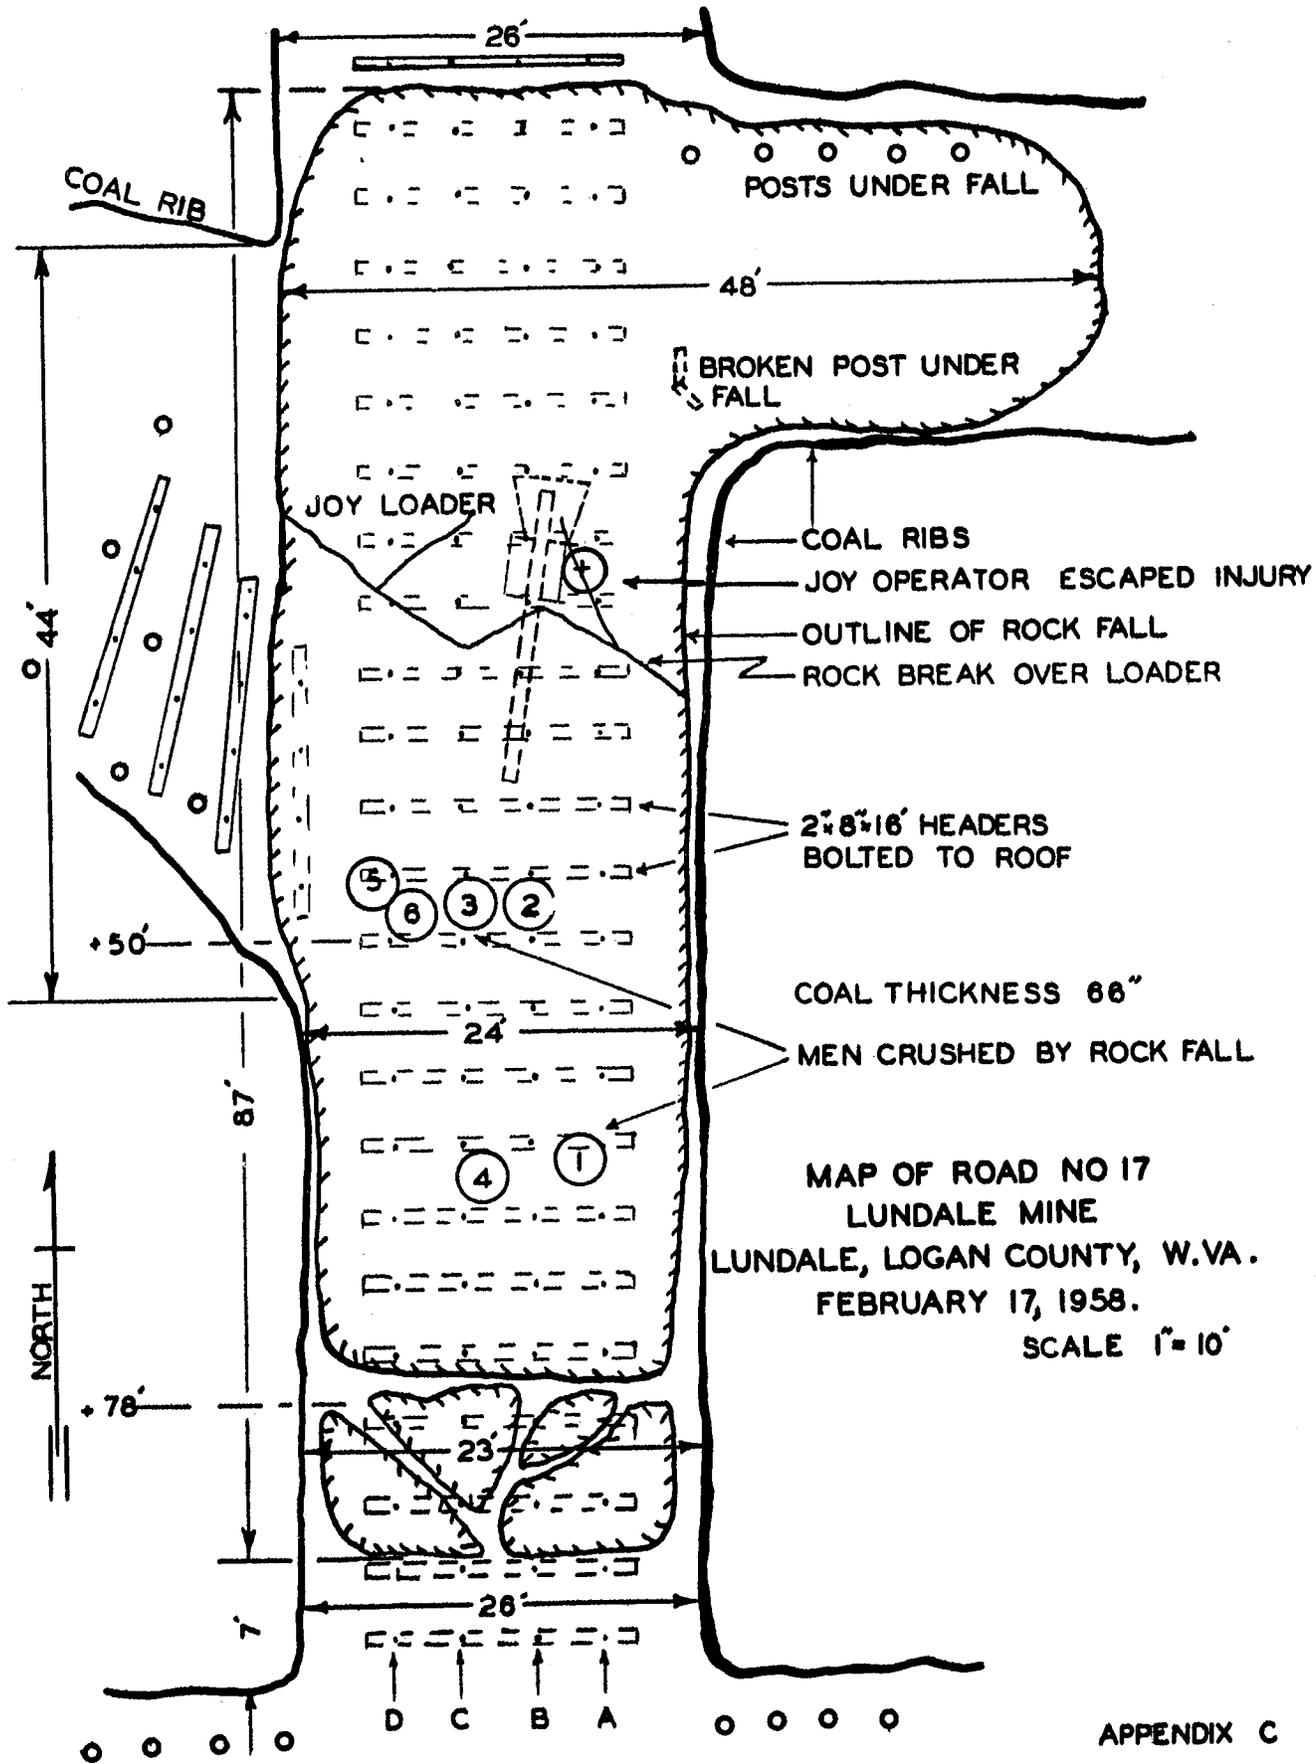
MAP OF ROAD NO 17
 LUNDALE MINE
 LUNDALE, LOGAN COUNTY, W.VA.
 FEBRUARY 17, 1958.
 SCALE 1" = 10'

The rock that fell intact measured 87 feet in length, averaged 25 feet in width, and varied from 60 inches in thickness at the inby end to 12 inches at the outby end of the fall (see Appendix C).

in No. 18 road beginning midway between Nos. 9 and 10 rooms and extending inby and diagonally over the coal pillar left of the crosscut where the loading machine was last operated.

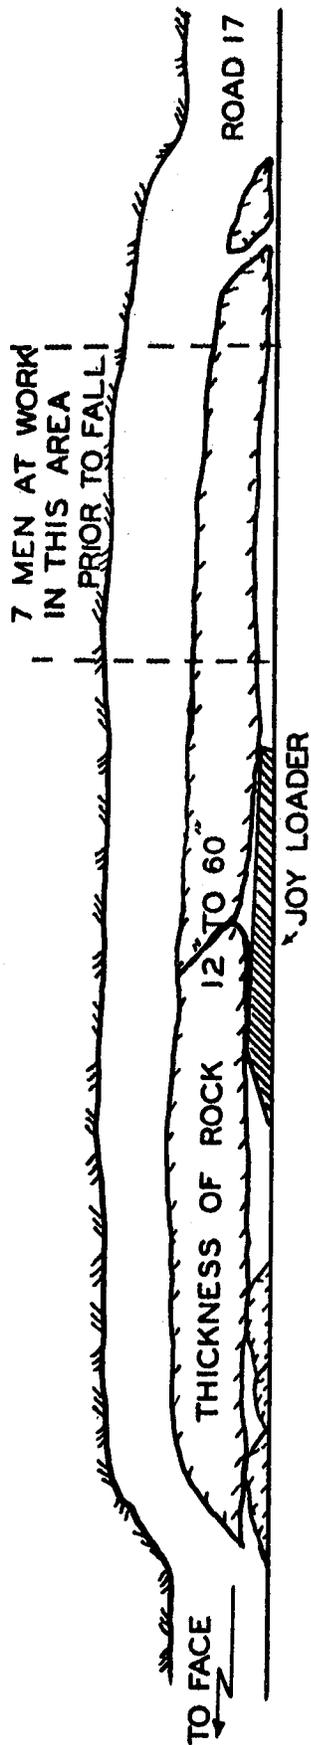
SIDE VIEW OF FALL LOOKING TOWARD ROCK FALL FROM SLANT
SCALE 1" = 10'

The roof material fell from rib to rib and extended lengthwise for 87 feet in No. 17 road; it ranged from 12 to 60 inches in thickness and extended into the right crosscut off No. 17 road about 24 feet. The fallen material broke over the loading machine and into several pieces on the outby end.

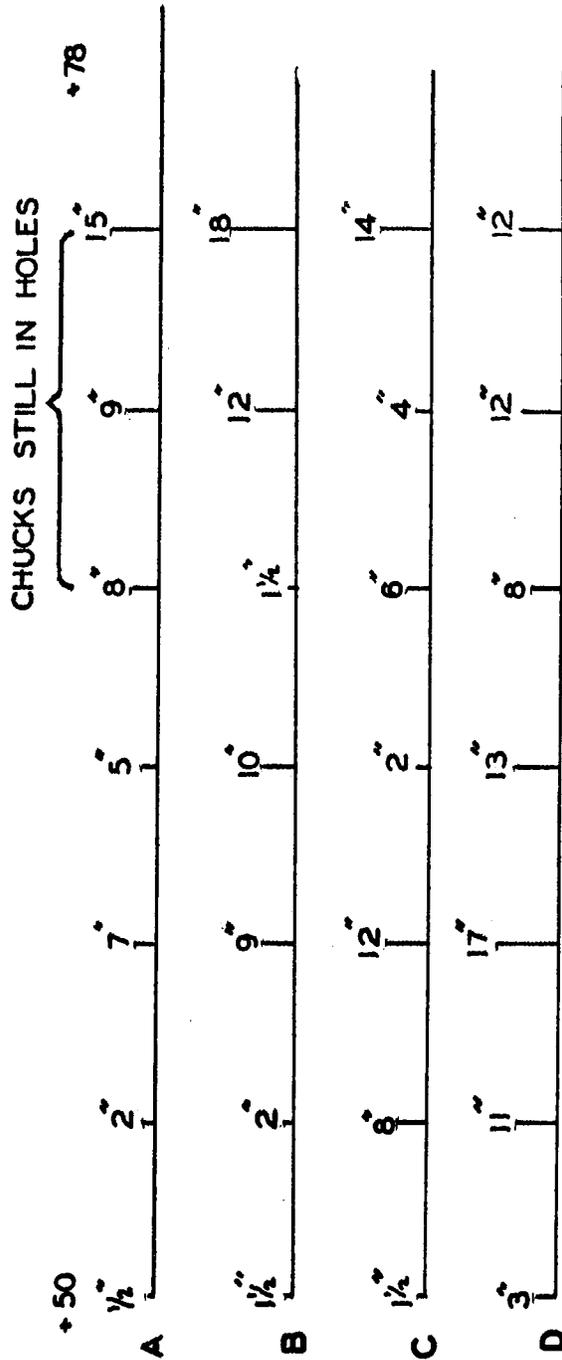
SIDE VIEW LOOKING OUT SHOWING DEPTH
OF BOLT HOLES LEFT IN ROOF AFTER FALL
SCALE 1/4" = 1'-0"

14. There was no evidence to indicate that the roof fall occurred because of roof-bolt failures; the greater part of the fallen material separated and failed 1 to 2 feet above the bolt anchorage.
