UNITED STATES  
DEPARTMENT OF LABOR  
MINE SAFETY AND HEALTH ADMINISTRATION  
COAL MINE SAFETY AND HEALTH

REPORT OF INVESTIGATION  
Fatal Shaft Sinking Explosion  
January 22, 2003

McElroy Mine  
McElroy Coal Company  
(Subsidiary of CONSOL Energy Incorporated)  
Cameron, Marshall County, West Virginia  
ID No. 46-01437

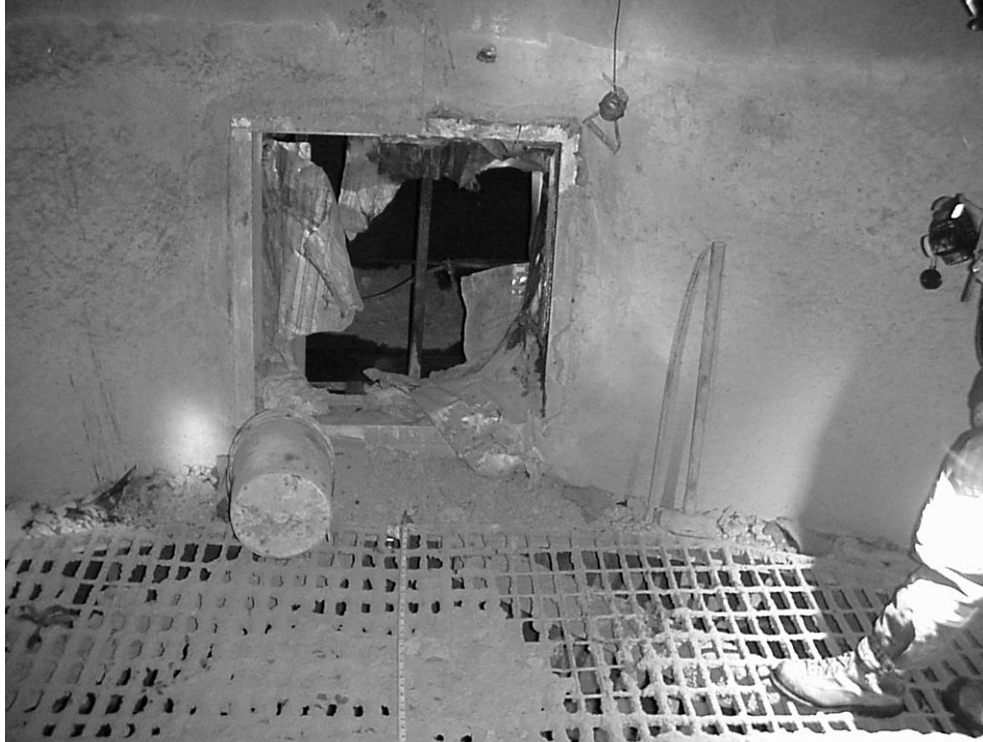
View into water ring through mandoor frame from work deck.

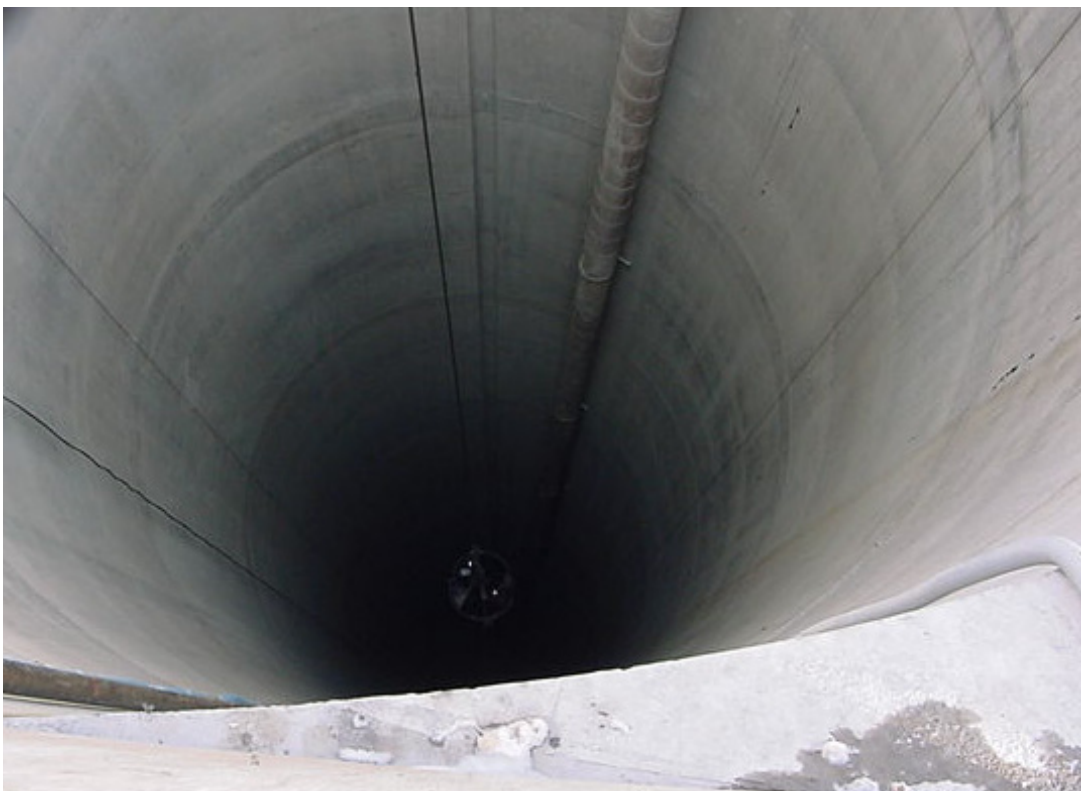
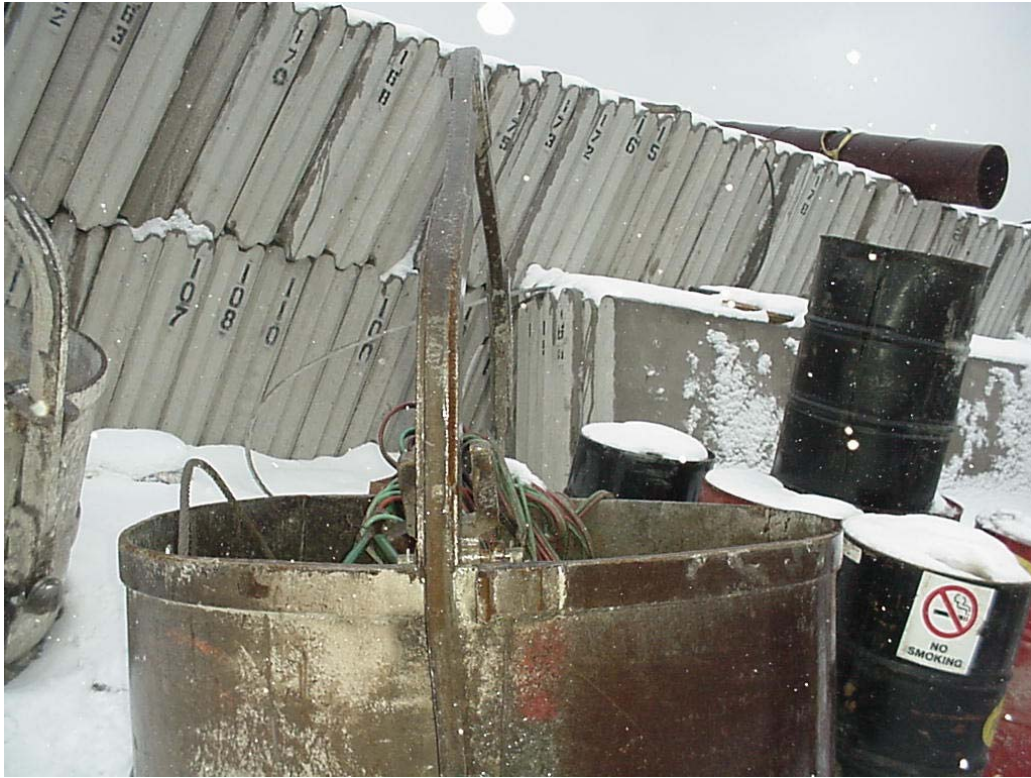
Just prior to the accident, the mechanic checked the torch before taking it into the shaft. The investigation revealed that the torch cutting assembly, including the valves on both the oxygen and the acetylene tanks, were damaged as a result of the explosion. Portions of the torch were tested by MSHA Approval and Certification Center (A&CC) and the results are contained in Appendix Q.

Views of bucket containing oxygen-acetylene tanks and hoses which were in shaft at time of explosion

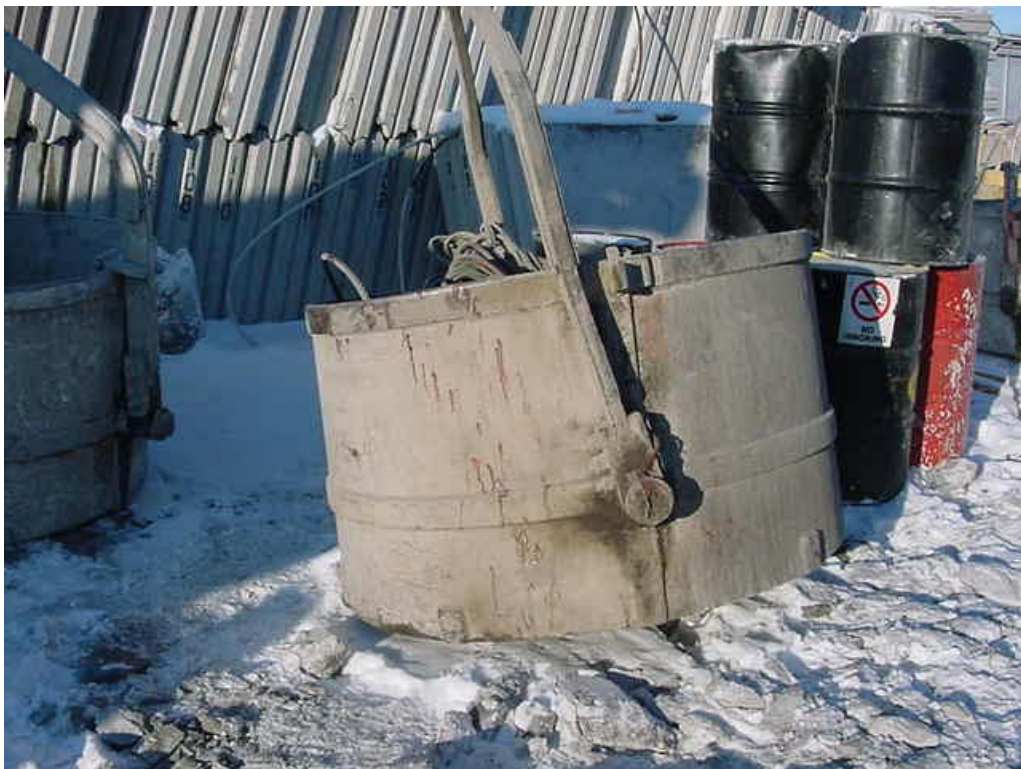
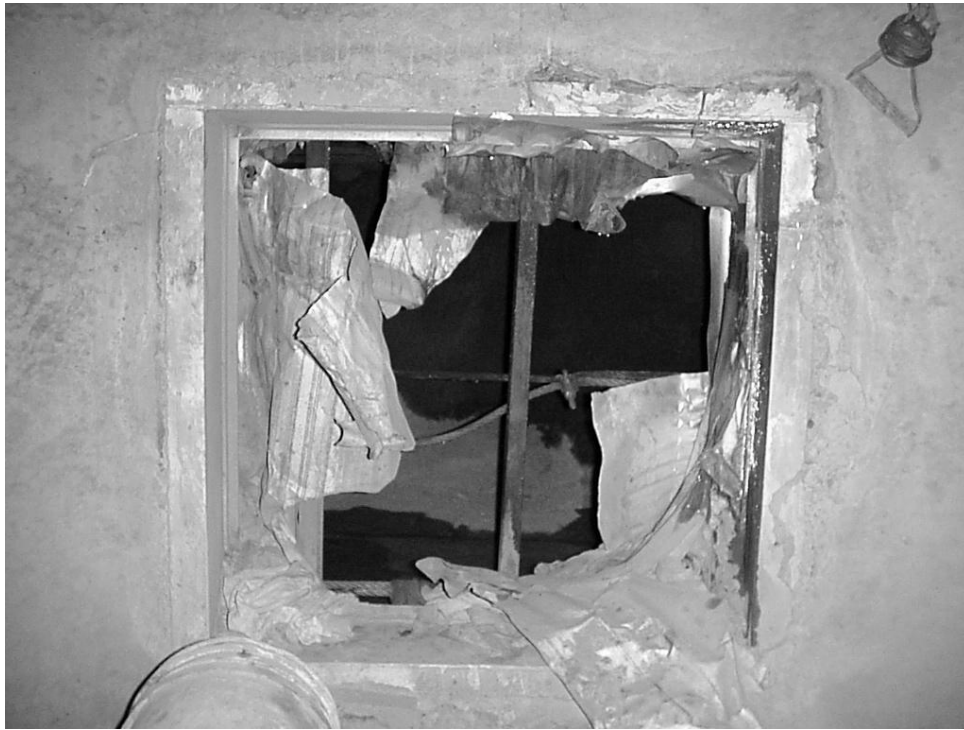
The explosion force exited the water ring through the mandoor frame. Flames shot across the shaft to the opposite wall and continued left and right around the shaft. Meyer, who was positioned to the right side and away from the mandoor, covered his face and dropped to the work deck. When Meyer no longer felt heat, he took his hands away from his face and looked around. He had very limited visibility because of the dust in suspension. Meyer walked toward the center of the shaft and found Brumley who was trying to sit up. Meyer helped Brumley move toward the bucket, however, Brumley was not able to board the bucket due to his injuries.

As methane from the surrounding strata entered and mixed with air trapped within the unventilated water ring, the methane-air mixture eventually entered its explosive range between 5% and 15%. Based on the observed damage caused by the explosion, methane within its explosive range most likely was present in portions of the water ring, including the vicinity of the mandoor frame.

View into water ring through mandoor frame from work deck

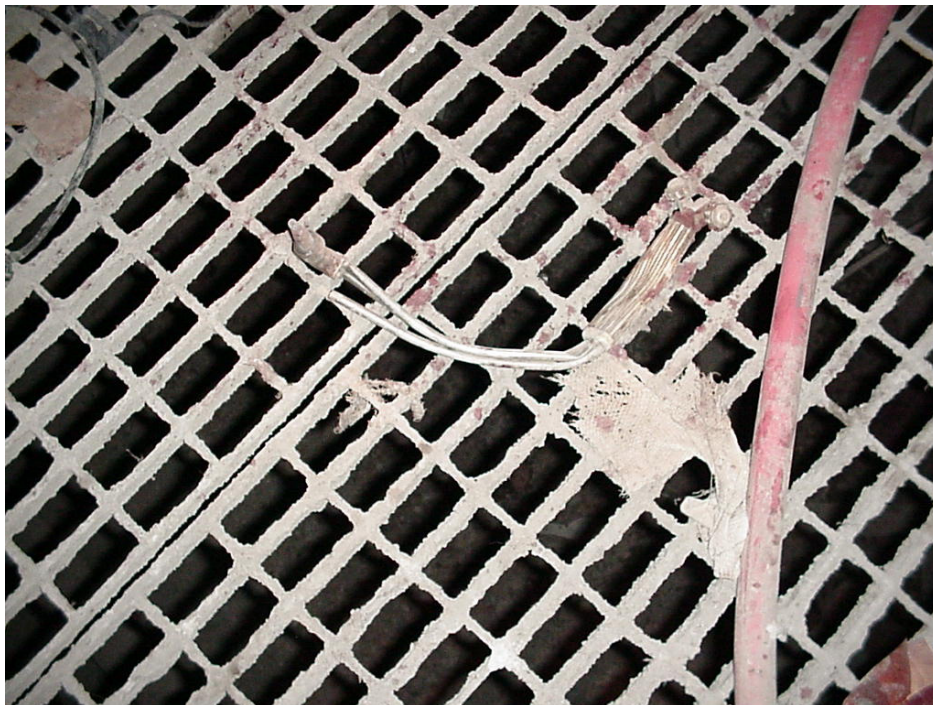
View of damaged oxygen-acetylene torch head shown laying on work deck

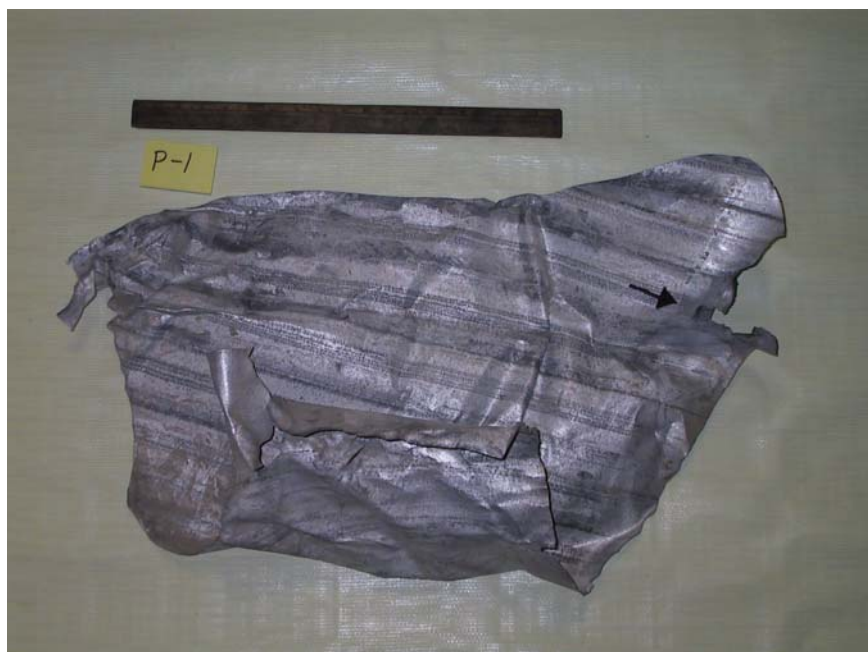
**Figure 1** Item P-1, the area of the burn cut is on the right and is designated by the black arrow. The 18-inch rule indicates the size of the item.

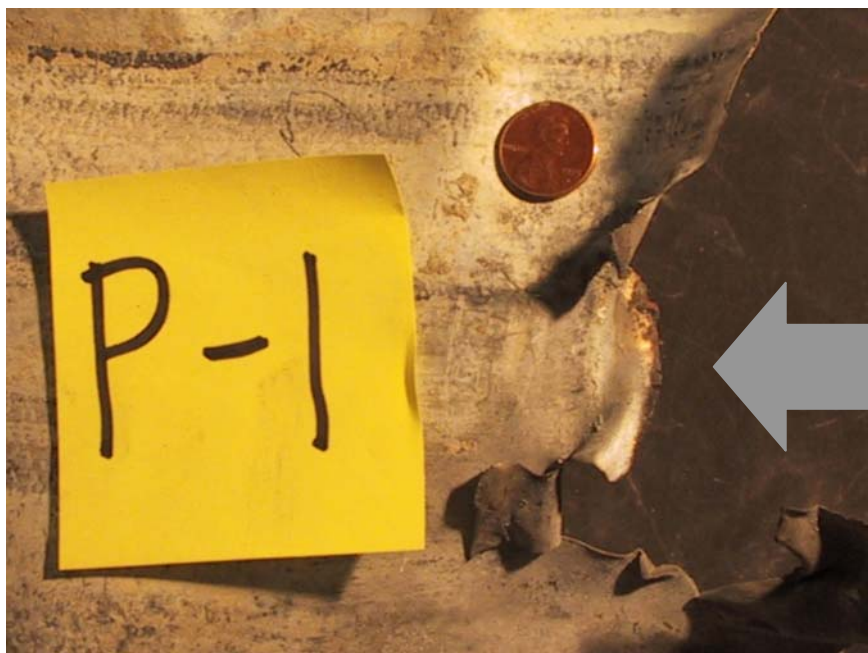
**Figure 2** Item P-1, the area of burn cut is indicated by the gray arrow. Part of the burned edge has been torn. The penny is for scale.

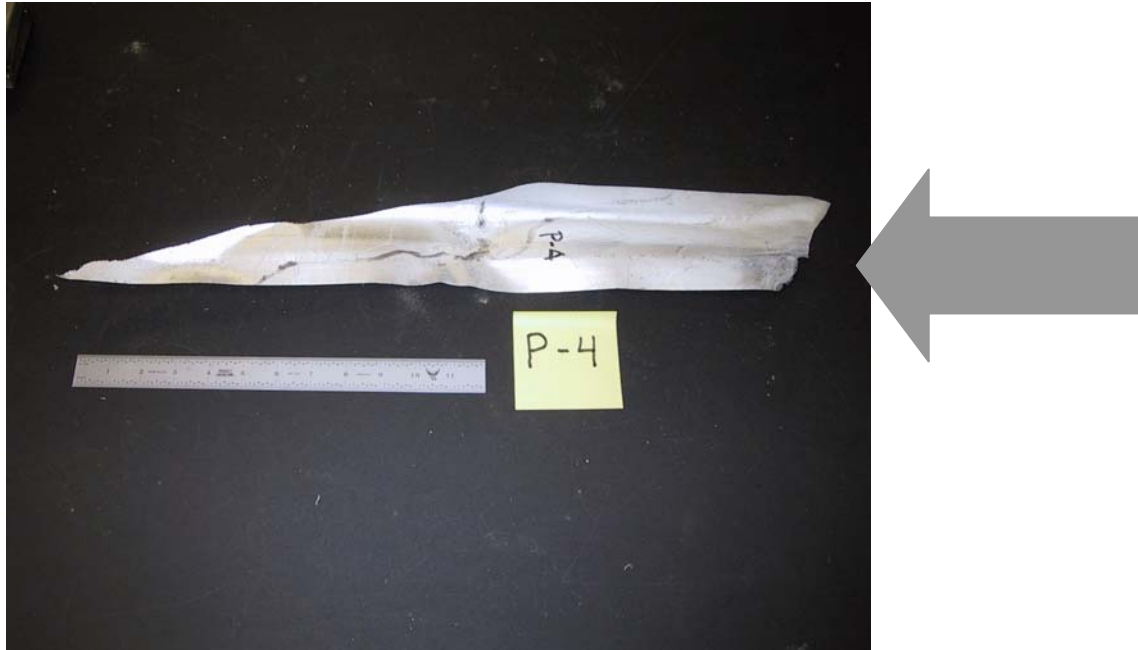
**Figure 3** Item P-4, the area of burning is on the bottom right corner and is indicated by the gray arrow. The 12-inch rule indicates the size of the item.

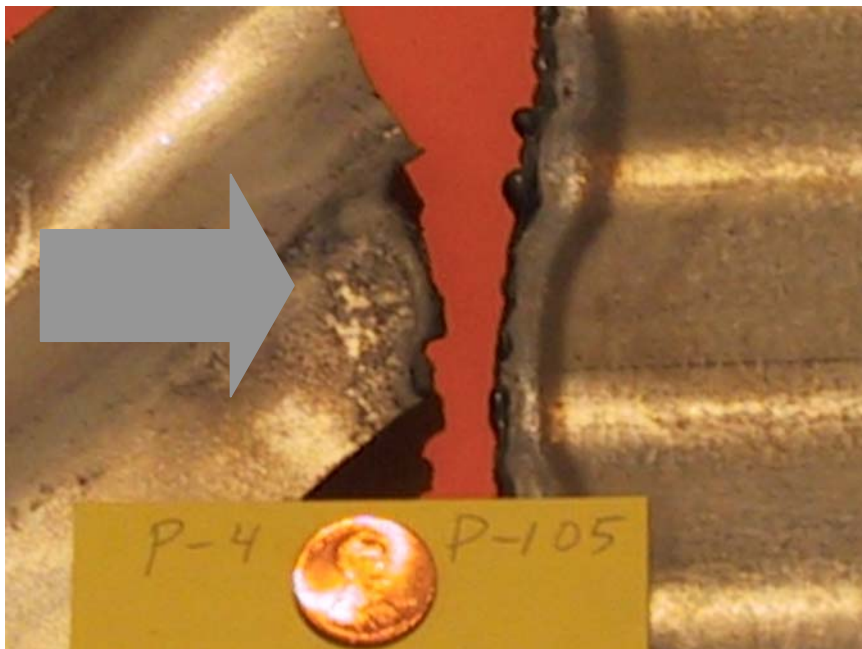
**Figure 4** The burned section of item P-4 is on the left. The burn cut edge of item P-105 is on the right. Item P-105 is a reference sample which had been cut with an oxygen/acetylene torch. Banding caused by heat is visible on the surface of both items. The burned edge of item P-4 is indicated by the gray arrow. The penny is for scale.

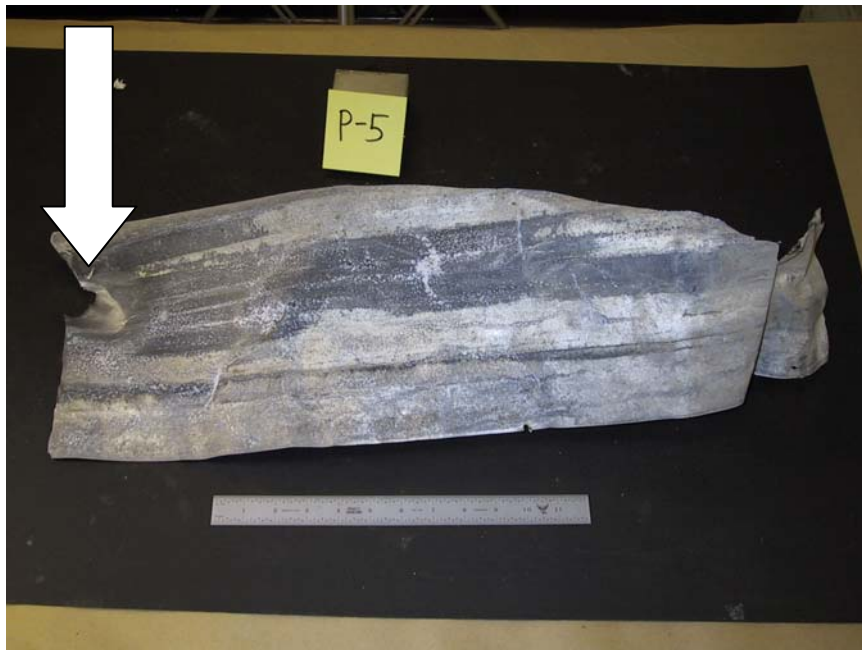
**Figure 5** Item P-5, the burnt area is on the left as indicated by the white arrow. The 12-inch ruler is for scale.

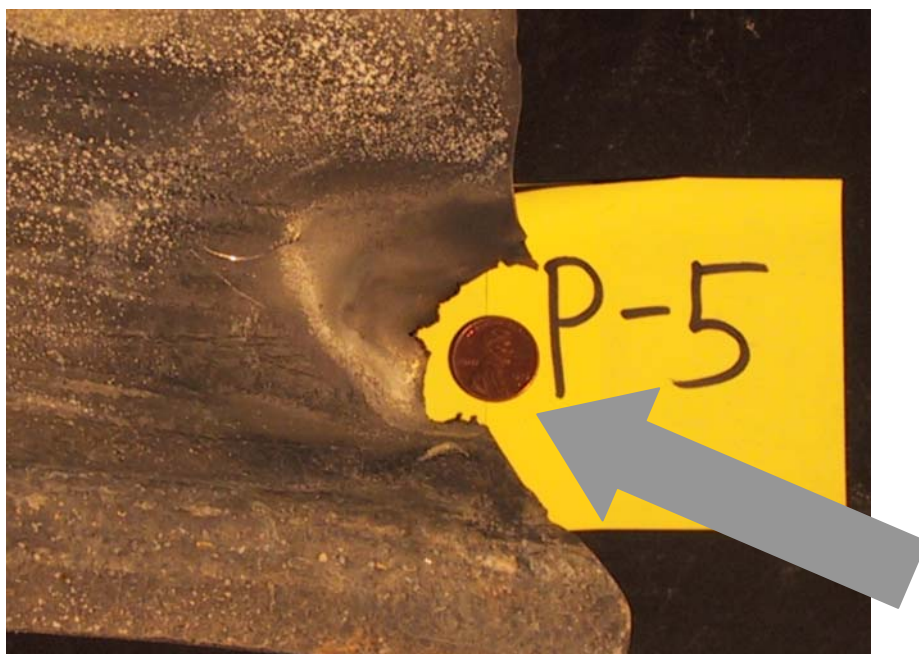
**Figure 6** Item P-5, areas where the zinc coating has been melted or ablated are visible. The gray arrow points to the burned edge. The penny is for scale.

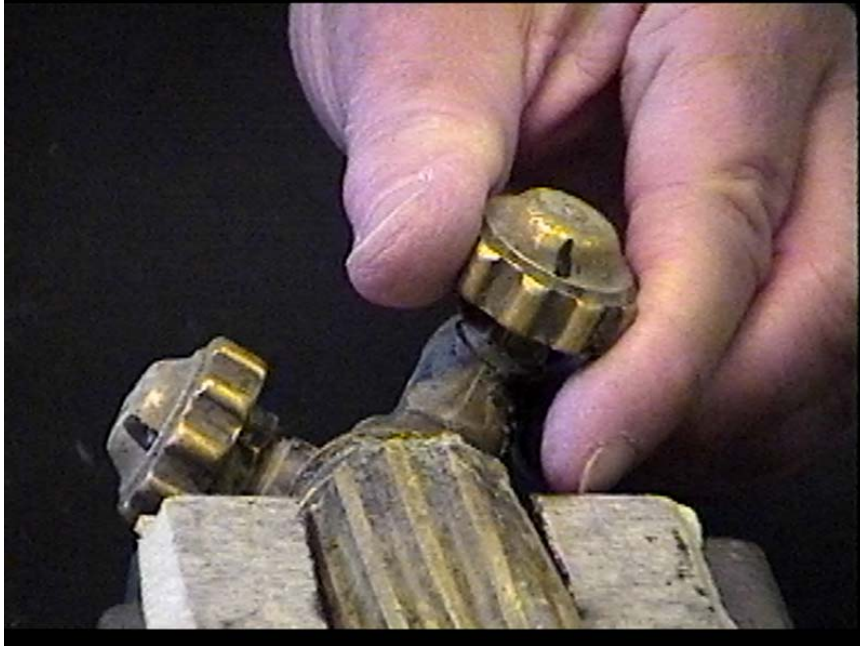
**Figure 7** The acetylene valve on the oxygen-acetylene torch (item P-32) is in the position at which it was received and is about to be turned for the first time. The black mark on the front of the knob has been placed there to keep track of valve rotation.

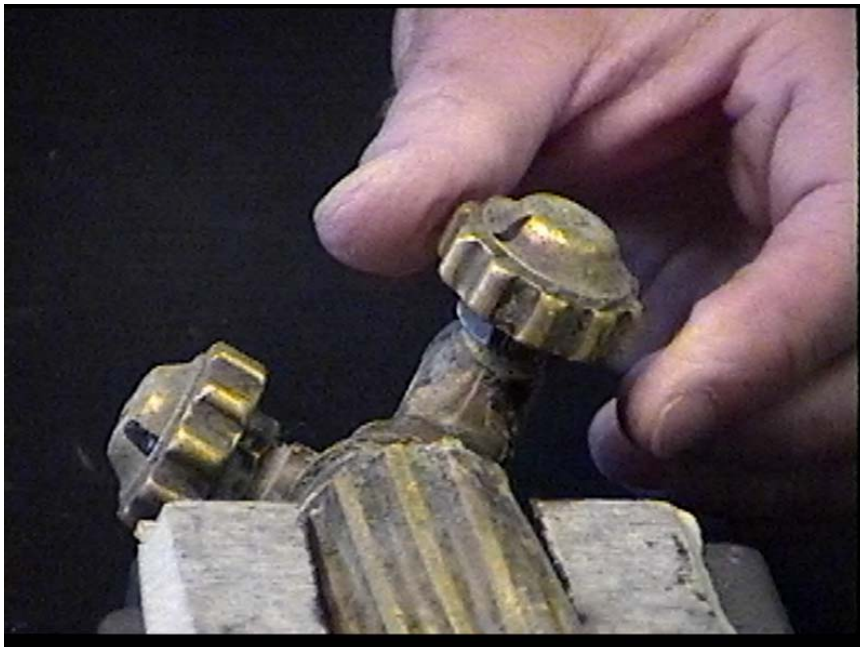
**Figure 8** In this image, the acetylene valve on the oxygen-acetylene torch (item P-32) has been turned for the first time. The black mark placed to keep track rotation of the valve knob has moved about one-quarter turn clock-wise, which is the limit of its rotation in that direction. The valve was completely closed after a one quarter turn clock-wise. The acetylene valve was open a quarter turn when received for examination.

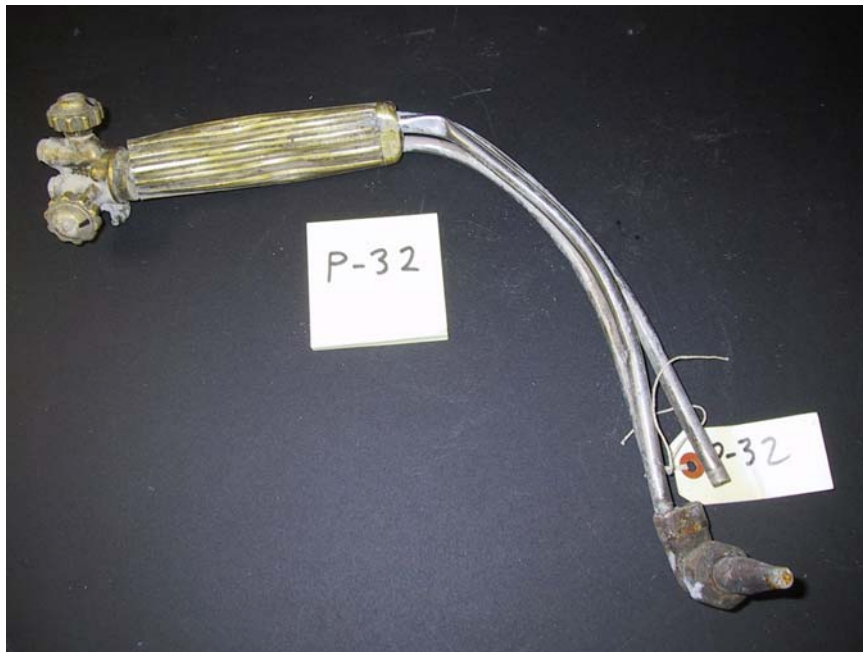
**Figure 9** Item P-32 is the oxygen-acetylene torch recovered from the accident site.

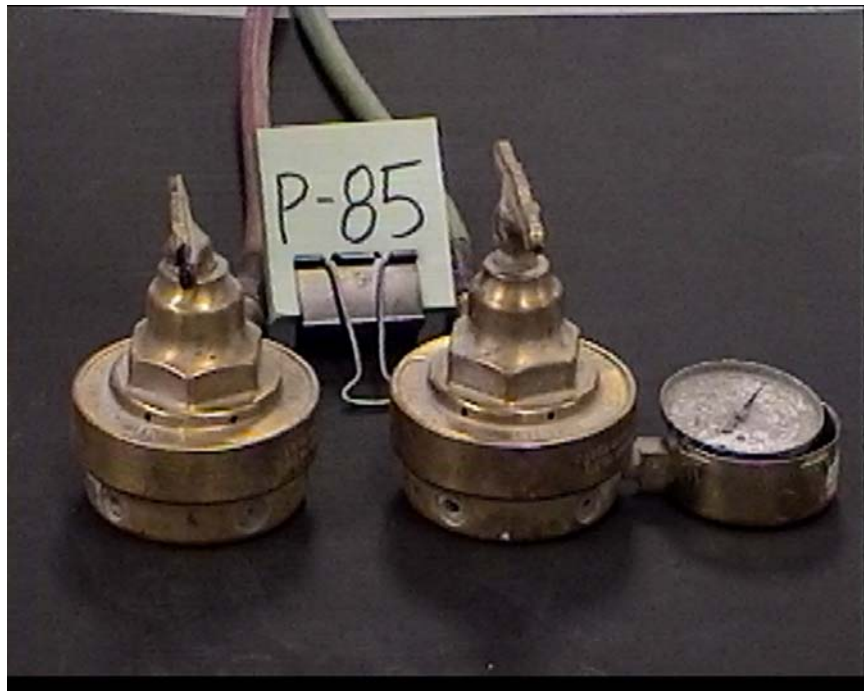
**Figure 10** The severely damaged acetylene regulator is on the left. The oxygen regulator is on the right. A black mark on the front of the pressure adjusting handle on the acetylene regulator has been placed there to track rotation of the adjusting screw. The adjustments are in the positions at which they were received for examination.

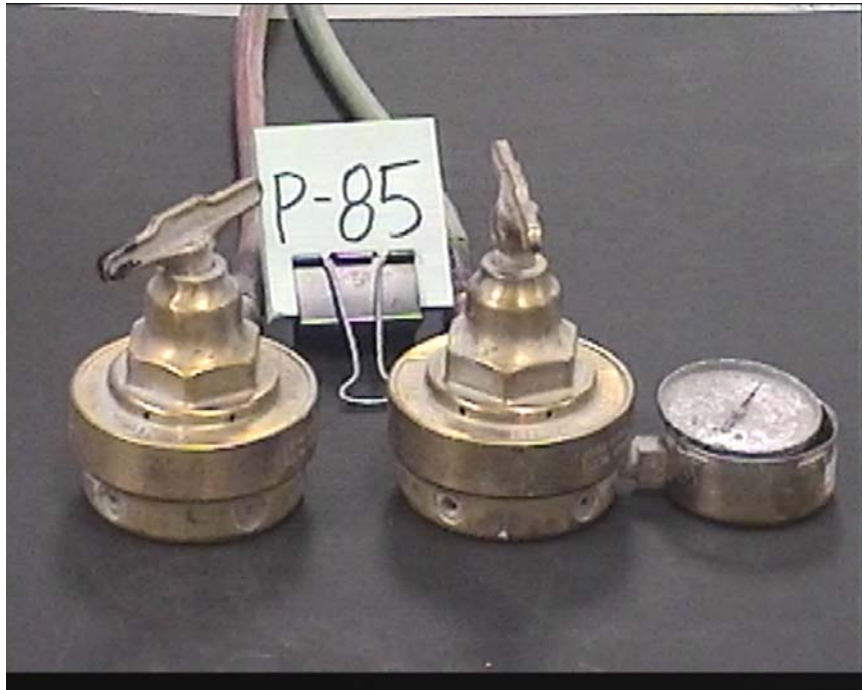
**Figure 11** In this image, the pressure adjusting handle on the acetylene regulator has been turned for the first time. The black mark placed to keep track rotation of the screw has moved only one-quarter turn clock-wise (downward), which is the limit of its rotation. This indicates that the acetylene control valve was almost completely open, which would permit the flow of acetylene.
