# Accident Investigation Report

U.S. Department of Labor  
Mine Safety and Health Administration

REPORT OF FATAL FALLING EQUIPMENT ACCIDENT  
MINNTAC MINE  
UNITED STATES STEEL CORPORATION  
MOUNTAIN IRON, ST. LOUIS COUNTY, MINNESOTA

FEBRUARY 28, 1980

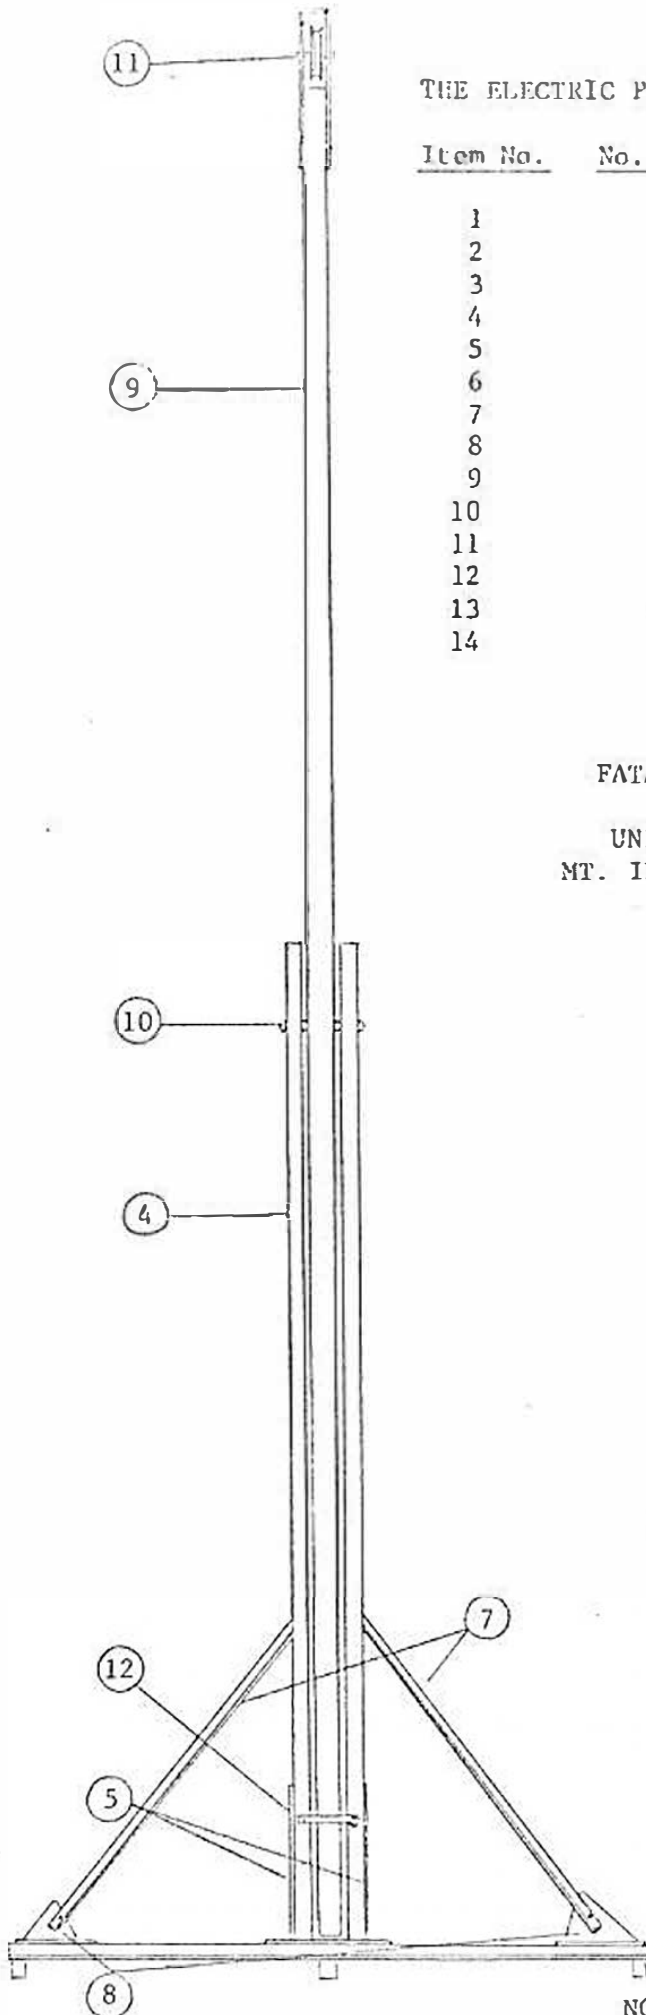
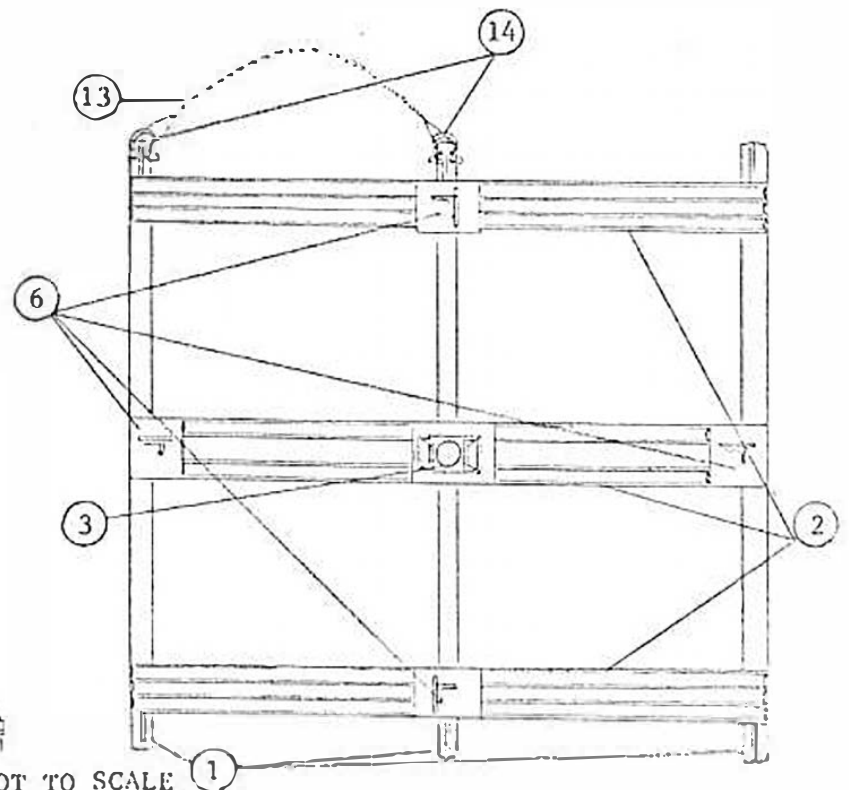
# THE ELECTRIC POWER CABLE SUPPORT STAND

<u>Item No.</u>	<u>No. Pieces</u>	<u>Description</u>
1	3	Skid Rail
2	8	Base Top
3	1	Mast Base Plate
4	2	Mast Support
5	2	Mast Support Reinforcing
6	4	Anchor Pads and Gussets
7	4	Mast Support Braces
8	8	Connecting Bolts
9	1	Mast Pole
10	1	Pivot Pin
11	1	Sheave
12	1	Hinged Lock Plate
13	1	Tow Cable
14	2	Clevis w/pins

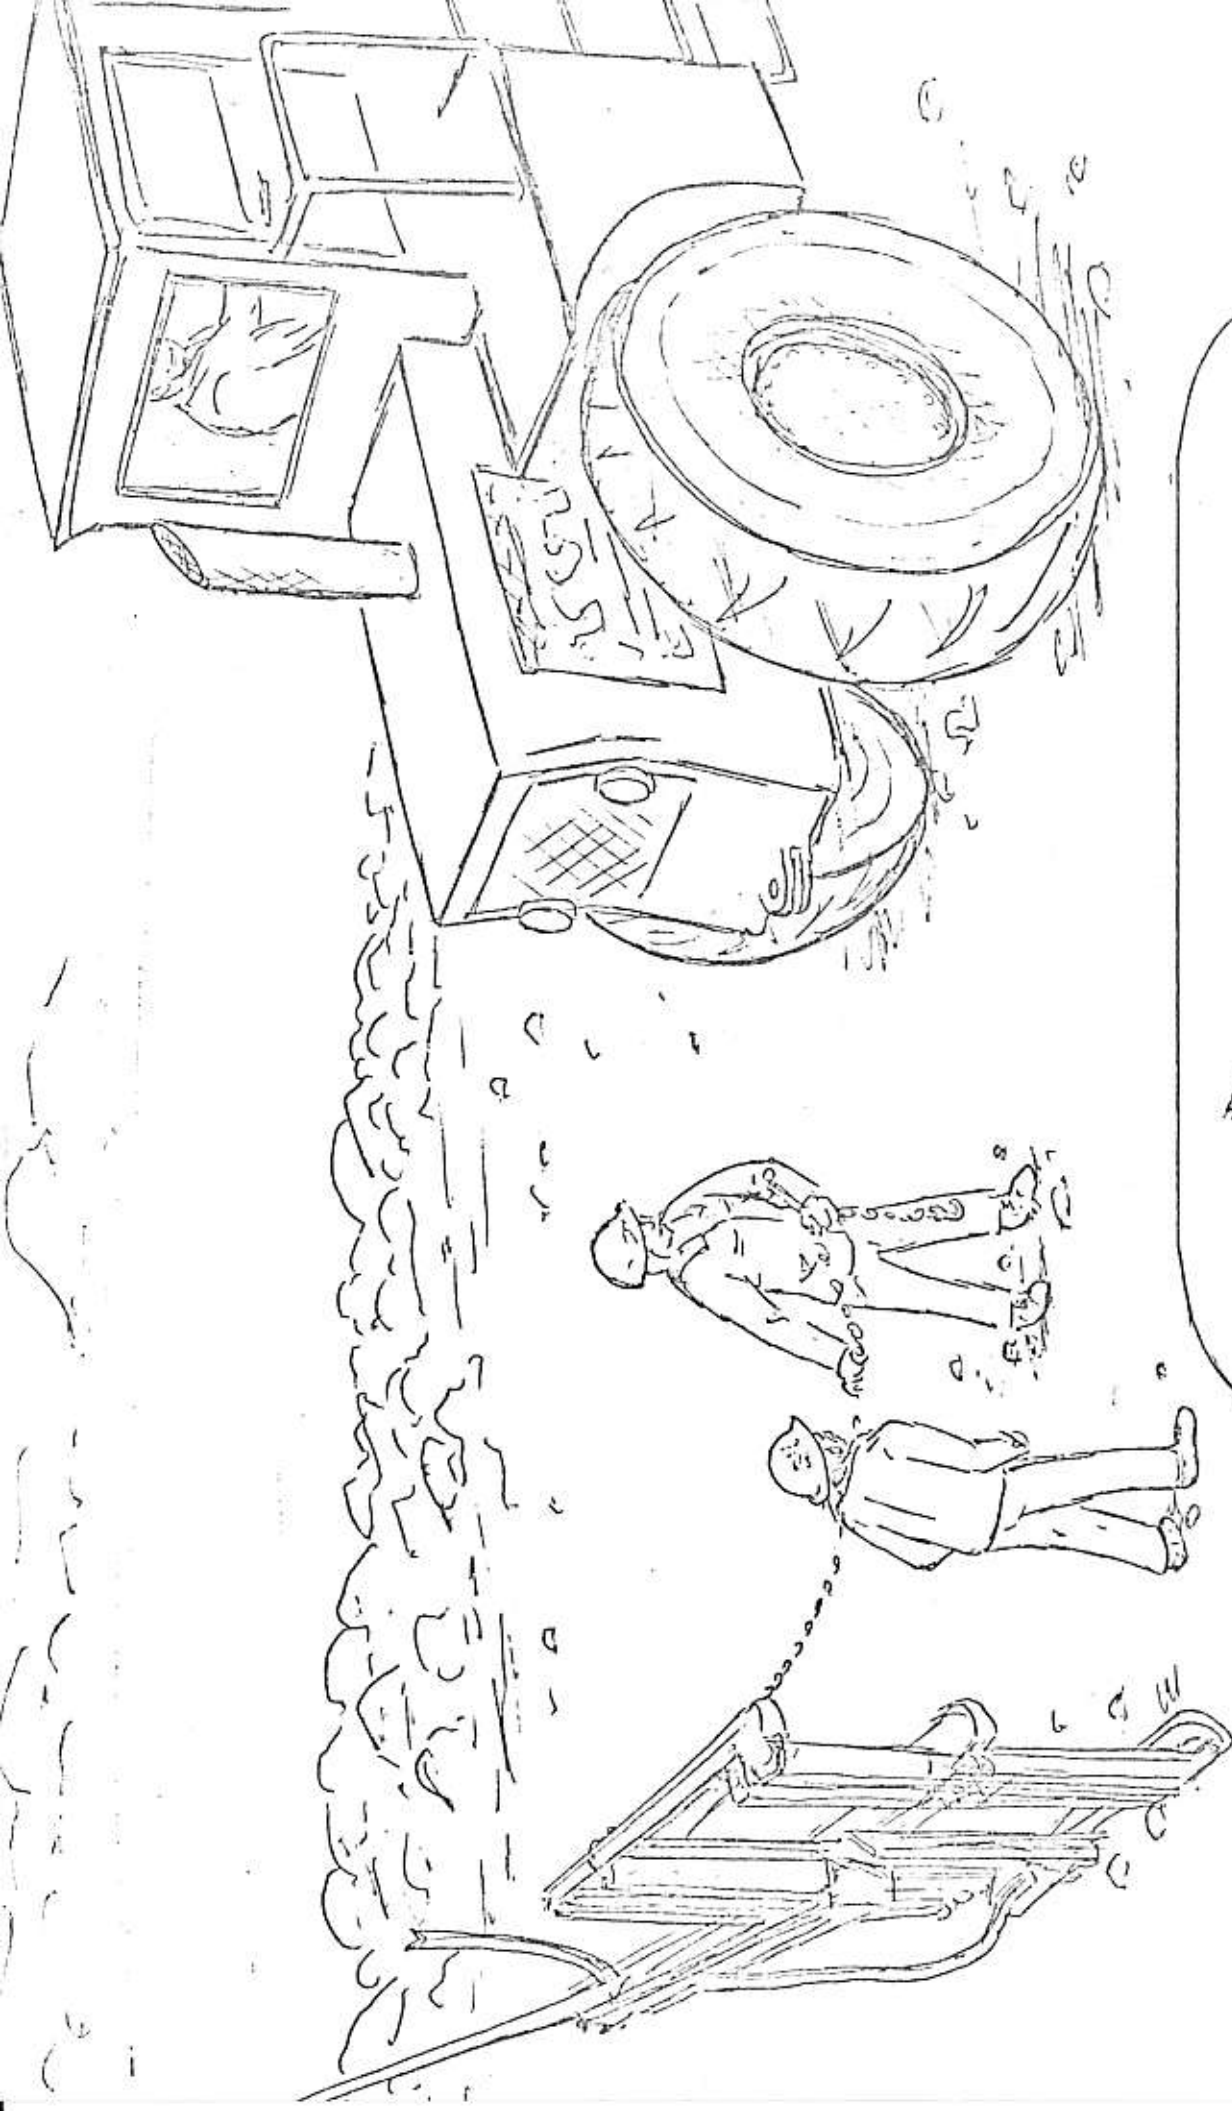
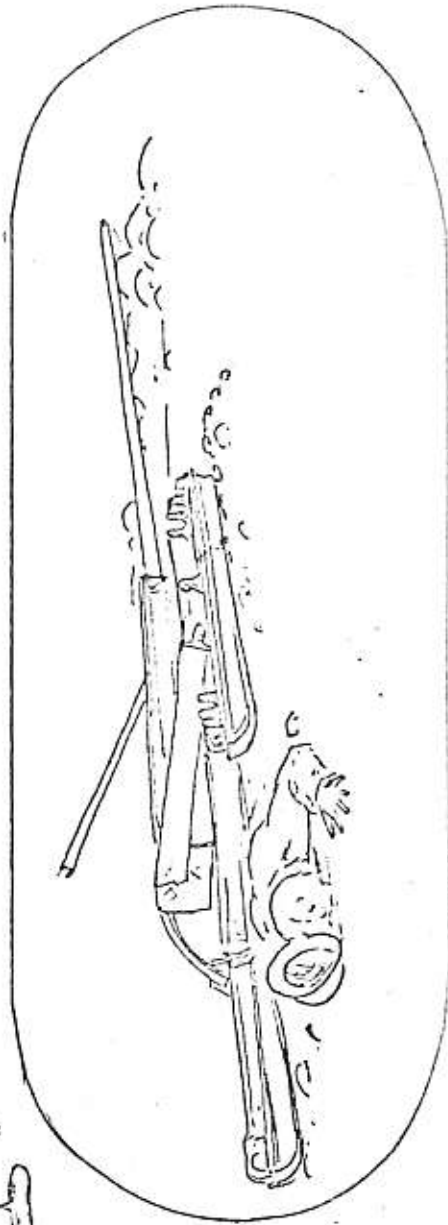
The cable stand base had numerous old cracks or breaks in the rails that indicated the stand had been damaged previous to the date of the accident. This evidence was supported by the heavy oxidation and discoloration observed on the crack surfaces.

All cable stands at the mine should be inspected and any defects should be corrected or the defective cable stands should be discarded if necessary.
