REPORT OF INVESTIGATION  
(UNDERGROUND COAL MINE)

FATAL POWERED HAULAGE ACCIDENT

No. 4 Mine (ID No. 46-03082)  
P. M. Charles Coal Company  
Rawl, Mingo County, West Virginia

March 11, 1980

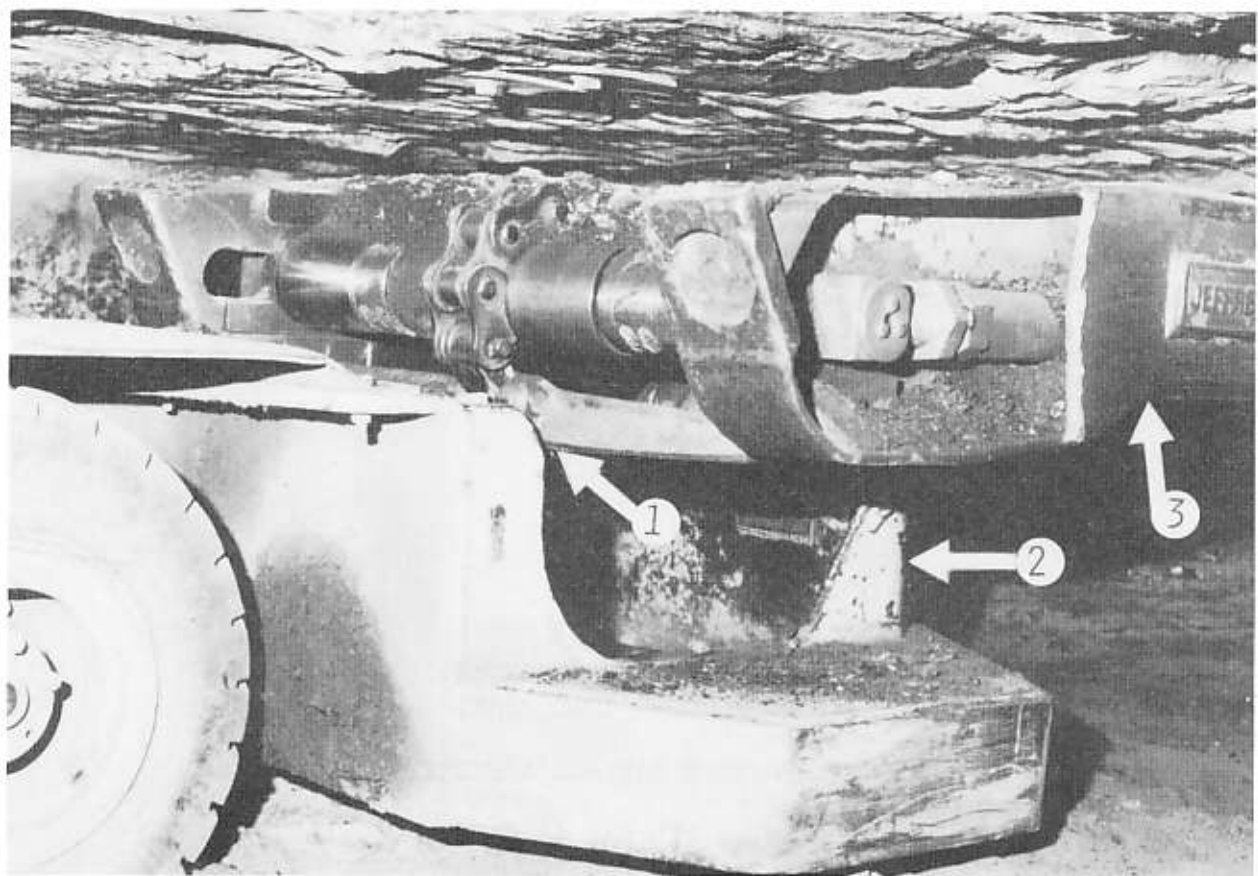
1. Bowen (victim) was found here following the accident.
2. Battery tractor which victim was operating.
3. Conveyor boom of continuous-mining machine.

7. Observations at the accident scene revealed that the victim trammed the tractor through the curtain that was installed immediately outby the connecting cross-cut in the No. 5 entry (See Sketch). The victim trammed the tractor straight for a short distance and then gradually cut the wheels in the direction of the left coal rib and based on the impressions of the tire tracks on the mine floor, the victim stopped the tractor approximately 5 feet outby the end of the conveyor boom. The forward (inby) tires were slightly cut toward the left coal rib and for some undetermined reason, she trammed the tractor into the discharge end of the conveyor boom of the continuous-mining machine.

14. The width of the No. 5 entry (accident scene) was about 19 feet and the width of the tractor was about 7 feet 4 inches. The vertical clearance over the tractor at the scene of the accident was about 12½ inches. The overall height of the S. and S. tractor, Model No. 100, was about 24½ inches. The roadway in the No. 5 entry was relatively smooth and the ventilation check curtain installed across the No. 5 entry immediately outby the scene of the accident was properly installed. (See Sketch.)
