REPORT OF INVESTIGATION  
(UNDERGROUND COAL MINE)

MULTIPLE FATAL EXPLOSIVES ACCIDENT  
(CARBON MONOXIDE POISONING)

No. 3 Mine (I.D. No. 15-13127)  
R and R Coal Company  
Woodbine, Whitley County, Kentucky

August 15, 1985

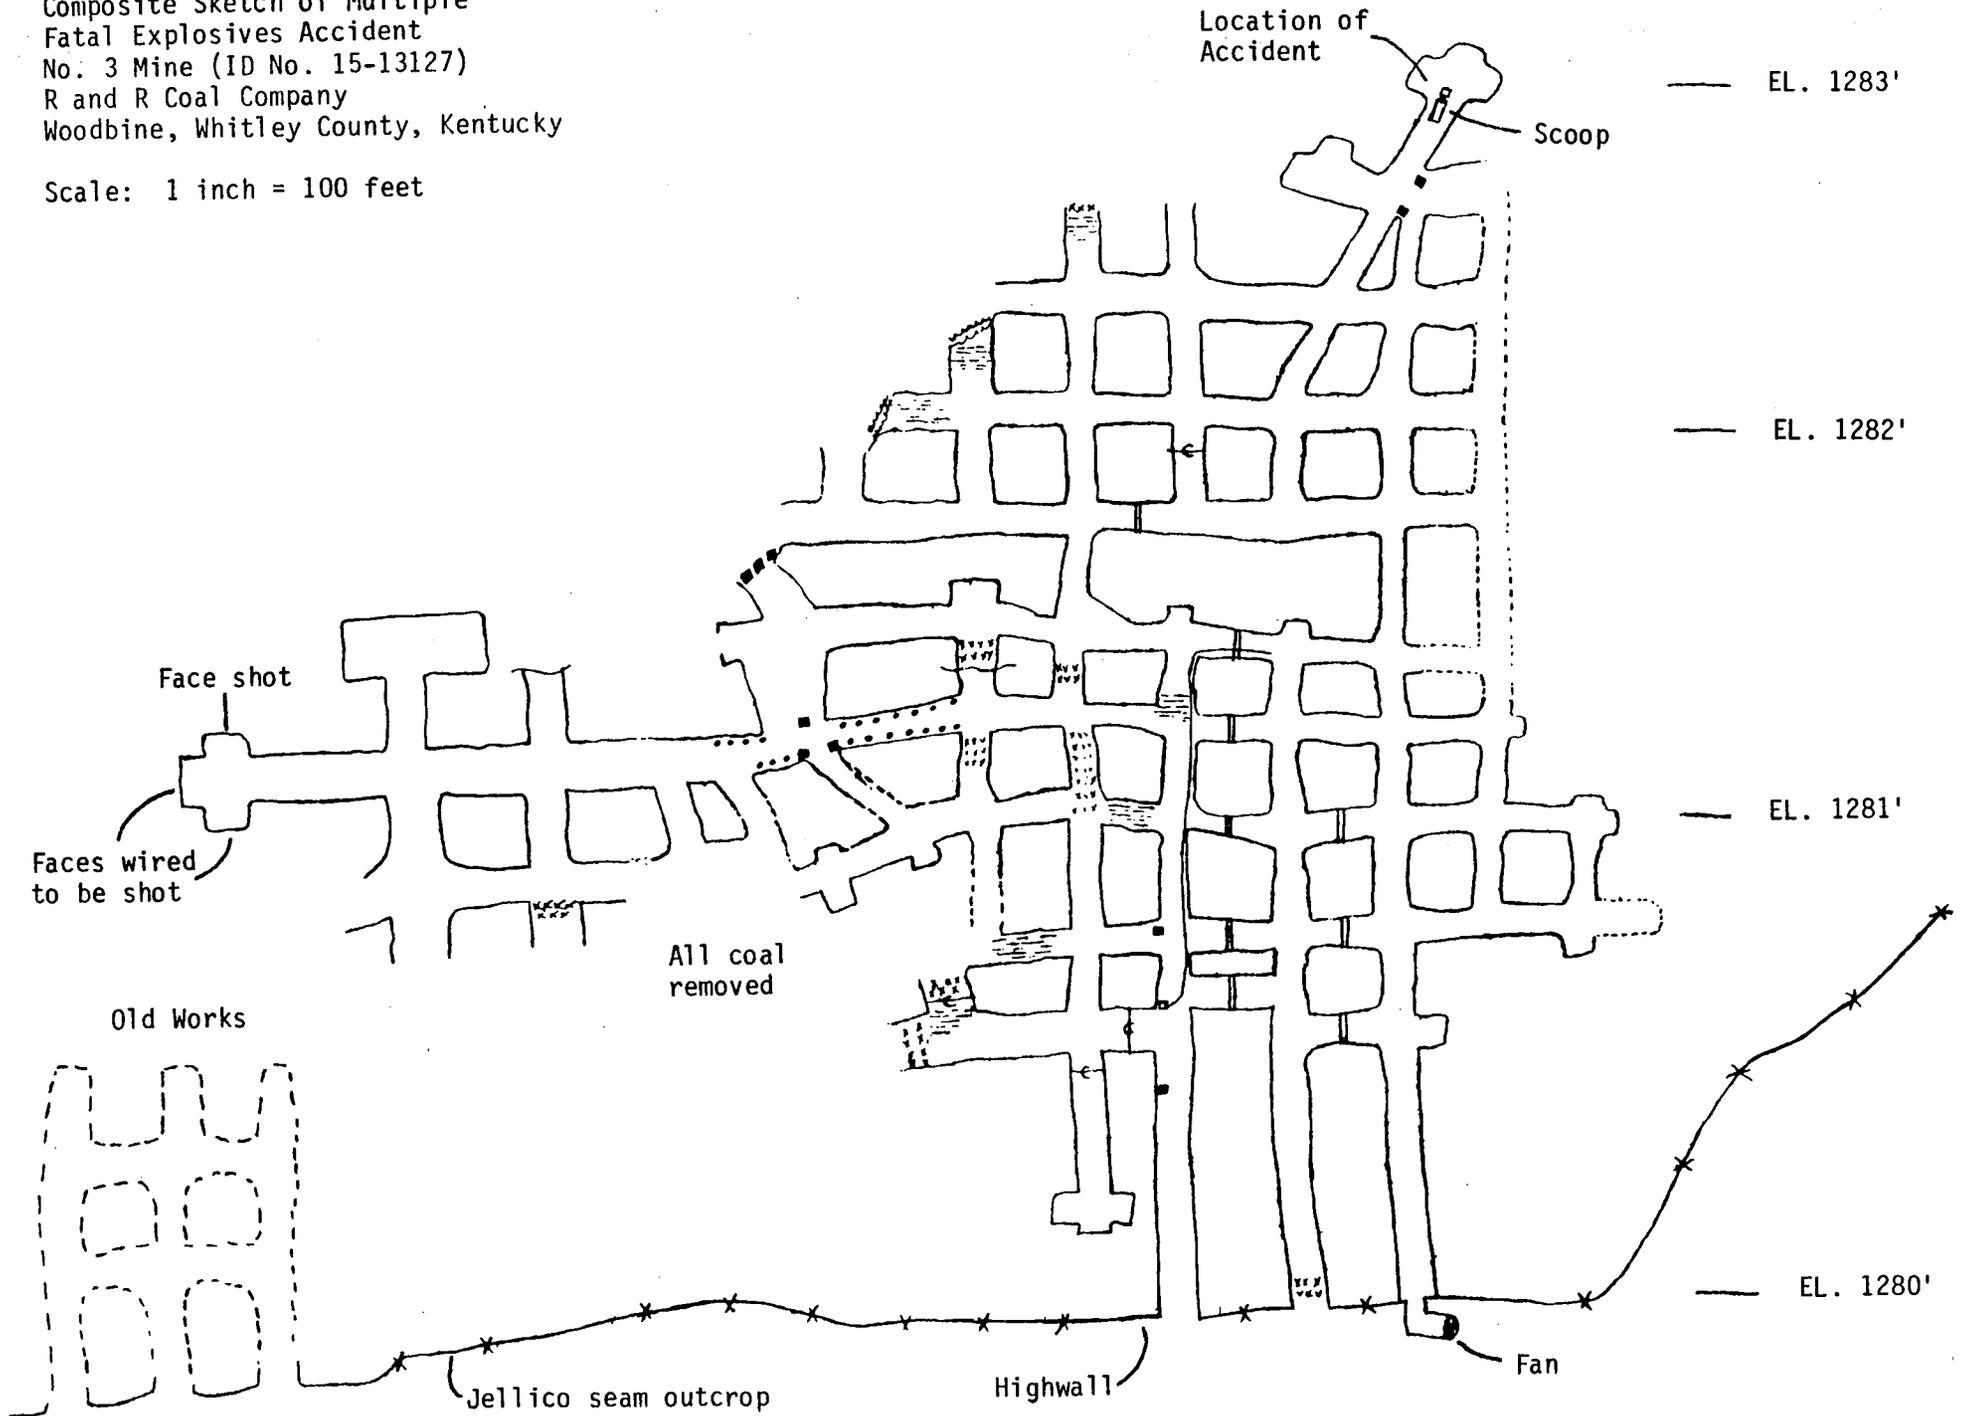
Composite Sketch of Multiple  
Fatal Explosives Accident  
No. 3 Mine (ID No. 15-13127)  
R and R Coal Company  
Woodbine, Whitley County, Kentucky

On Thursday, August 15, 1985, at approximately 4:00 p.m., a multiple fatal explosives accident (carbon monoxide poisoning) occurred in the face area of the No. 4 entry of the R and R Coal Company, No. 3 Mine. The accident resulted in the death of Reed R. McKiddy, assistant mine foreman, Robert L. Bauer, drilling machine helper, and Randy W. Powers, miner. A fourth miner, Rick Bauer, scoop operator, was hospitalized and later released. McKiddy had 3 years of mining experience, while Robert Bauer and Powers had 2 months of mining experience each. Rick Bauer had 3 years of mining experience. The Jellico coalbed was being developed by blasting the coal from the solid without an approved roof control or ventilation plan. The accident occurred when members of the mining crew reentered the mine in scoops and were overcome by carbon monoxide that was allowed to accumulate in the face areas of the No. 4 entry following blasting. The accident occurred due to mine management's failure to adequately ventilate the face areas of an active working section.
