REPORT OF FATAL COAL MINE RIB-FALL ACCIDENT
BANNING NO. 4 MINE
REPUBLIC STEEL CORPORATION
NORTHERN COAL MINES DISTRICT
WEST NEWTON, WESTMORELAND COUNTY, PENNSYLVANIA

September 12, 1967

Everett Turner
Federal Coal Mine Inspection Supervisor

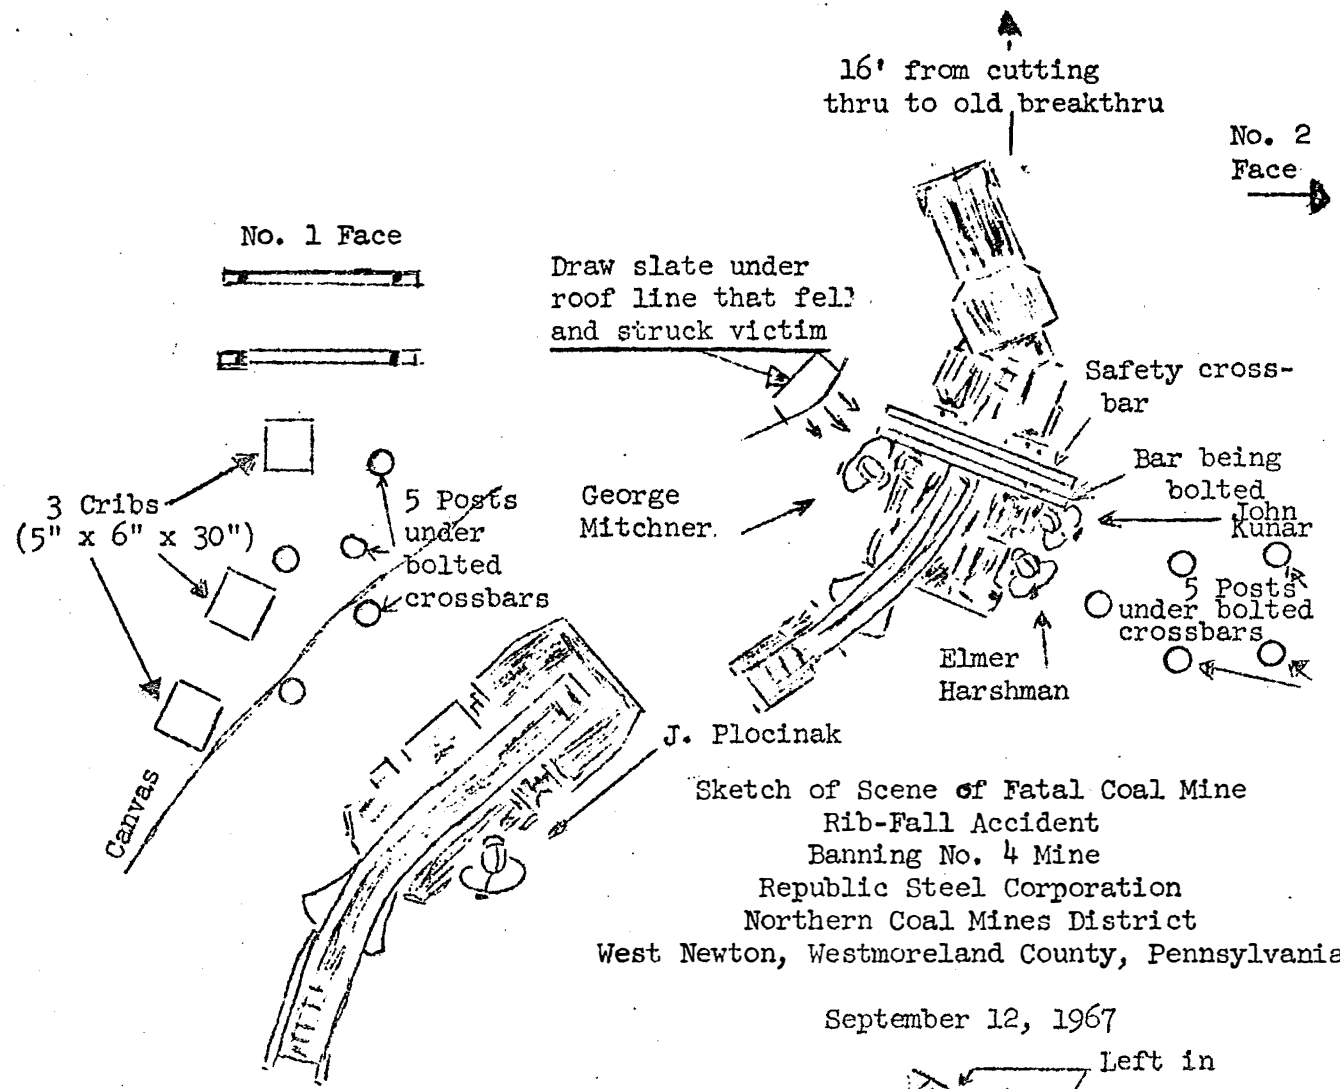
Sketch "A"

Mining operations progressed in a normal manner until the time of the accident. The pillar split, 16 feet wide, was mined through to a fall or gob in No. 2 entry, a distance of approximately 60 feet. The equipment was pulled back in preparation for starting a pocket to the left off the pillar split. Five posts were installed under crossbars just inby where the pocket was to be started (see sketch A). The mining of the pocket was started. About 10:35 p.m. Julius examined the working place, which included testing the roof and ribs in the area where Mitchner was working. He told Mitchner to be careful and left the place.

About 5 minutes after Julius left the place, Harshman and Kuhar observed Mitchner testing the roof and ribs. Mitchner then started drilling a hole through a crossbar and into the roof. He had drilled the hole to a depth of 55-1/2 inches and was in the act of changing the drill steel when the rib toppled over and caught him against the machine. He had changed the drill steel but had not inserted the cotter key.

Typical bolting and roof support pattern throughout this area

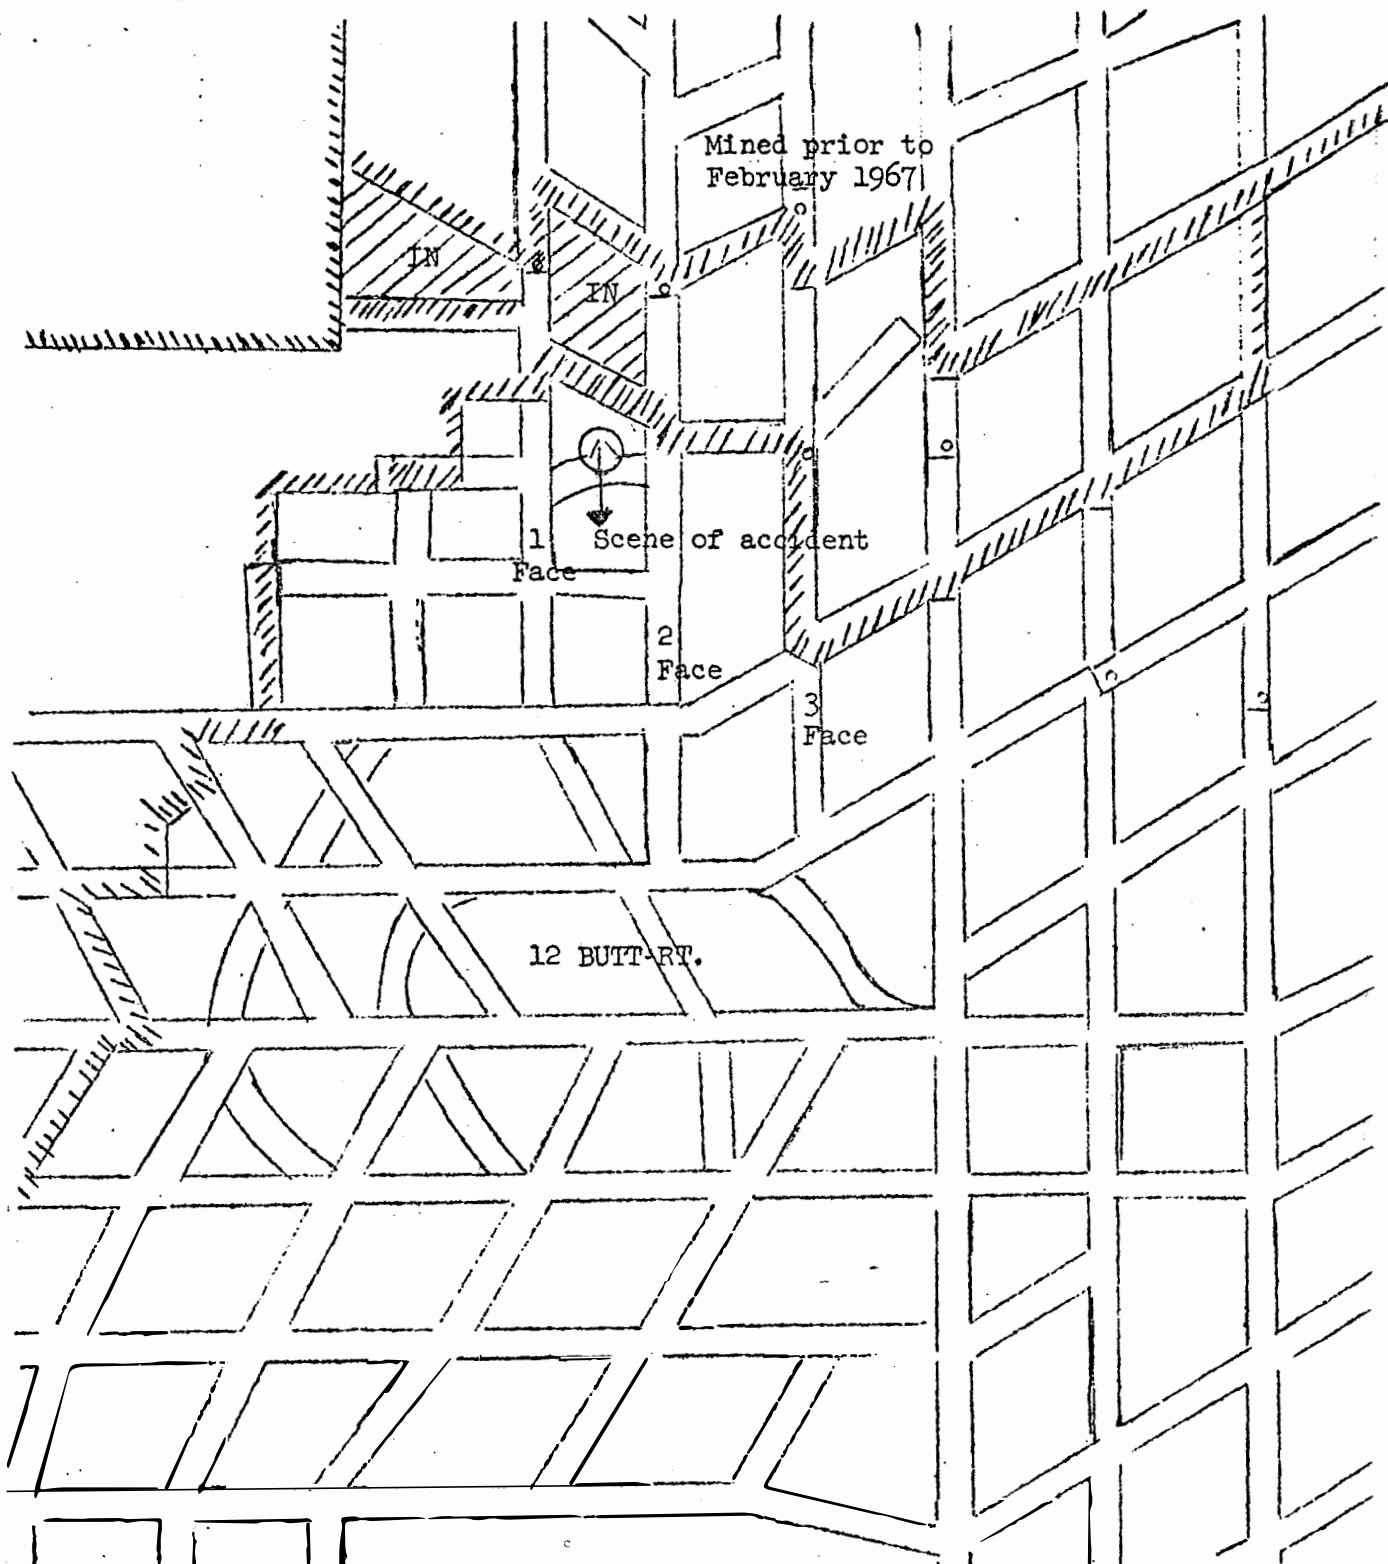
Sketch B

During the investigation, about 3 hours after the accident, it was evident that extraordinary stresses were present on the ribs of the accident area and surrounding area. Considerable crushing and spalling of the ribs were observed. The abandoned gob areas were in proximity to the block being mined (see sketch B); It was also evident that abnormal height existed in the accident area due partially to the unusual thickness of the draw slate.

extraordinary stresses on the ribs crushing the coal and causing the slate to topple over. Contributing factors could have been improper or inadequate examination and tests and failure to detect and evaluate properly a dangerous condition. Another contributing factor could have been a condition created by two inaccessible pillars (see sketches) that had been left during previous mining.

1. A more thorough examination of areas where abnormal conditions exist should be made by officials and employees so that a better evaluation of hazardous conditions can be made and necessary safety precautions taken. If an unsafe condition is detected and cannot be corrected, the place should be vacated.
2. When unusual or abnormal conditions are encountered, such as excessive pressure causing spalling of the ribs and where the thickness of the coalbed including the draw slate is abnormal adding height to the ribs as in the accident area, special safety precautions should be taken to protect employees from falls of such ribs.
