REPORT OF INVESTIGATION (PREPARATION PLANT)

FATAL FALL OF PERSON ACCIDENT

Russellton Mine (ID No. 36 00808)

BCNR Mining Corporation
Russellton, Allegheny County, Pennsylvania

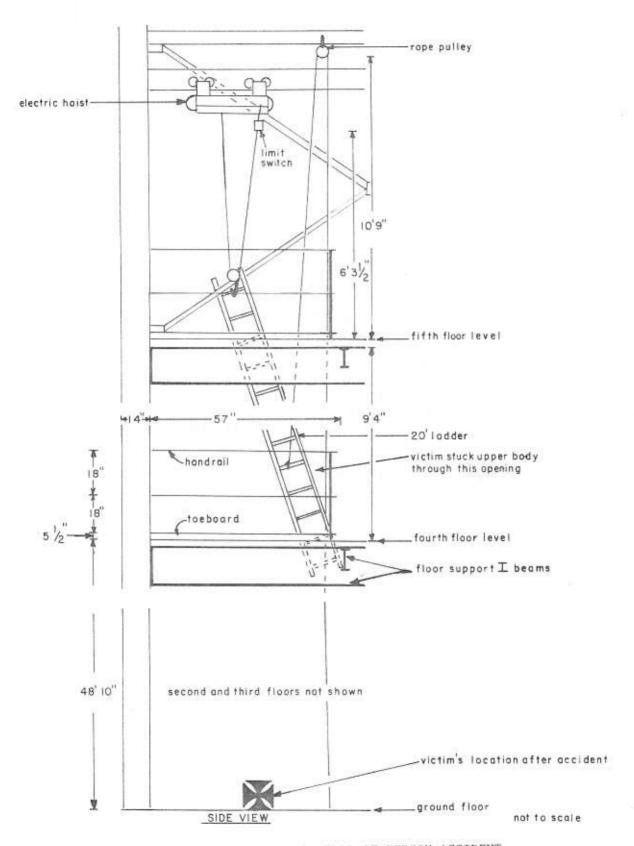
SKETCH OF FATAL FALL OF PERSON ACCIDENT
Russellton Mine (ID No. 36 00808)
BCNR Mining Corporation
Russellton, Allegheny County, Pennsylvania

- 3. Materials were raised through the floor openings with a rope and pulley or a Shepard Niles, 3-ton capacity, 440-volt alternating current electric hoist with a 3/8-inch wire rope. The rope pulley was attached to a beam 10 feet 9 inches above the fifth floor and the electric hoist was attached to another beam 9 feet 8 inches above the fifth floor. The height from the fifth floor to the hoist rope electric limit switch was 6 feet 3-1/2 inches. (See sketch).

- 4. According to Kerleski, this was the first time he had hoisted a 20-foot long ladder to the fourth floor. He used the electric hoist because he felt the ladder was too heavy to hoist with the hemp rope and pulley. The ladder was raised vertically until the electric hoist limit switch stopped the hoist; however, there was 3 to 4 feet of the ladder below the fourth floor level. After Kerleski attached the hemp rope near the bottom of the ladder, he and Wilhelm tried to maneuver the ladder so that it could be unloaded at the fourth floor level. This maneuvering continued until the ladder became wedged. After several unsuccessful attempts to free the wedged ladder, Wilhelm leaned out between the top and middle rails around the fourth floor opening and began pushing on the ladder with one hand while holding onto a toeboard with the other hand. As the ladder became free, Wilhelm fell 48 feet 10 inches to the concrete ground floor.

The victim was not wearing a safety belt and line when he placed his body between the top and middle rails around an opening in the fourth floor of the preparation plant. The victim was attempting to free a ladder wedged between beams inside the opening and when the ladder became free, he lost his balance and fell to the concrete ground floor. A violation of Section 77.1710(g).
