REPORT OF INVESTIGATION
(UNDERGROUND COAL MINE)

FATAL ELECTRICAL ACCIDENT

Clyde (ID No. 36 00967)
BCNR Mining Corporation
Fredericktown, Washington County, Pennsylvania

June 30, 1986

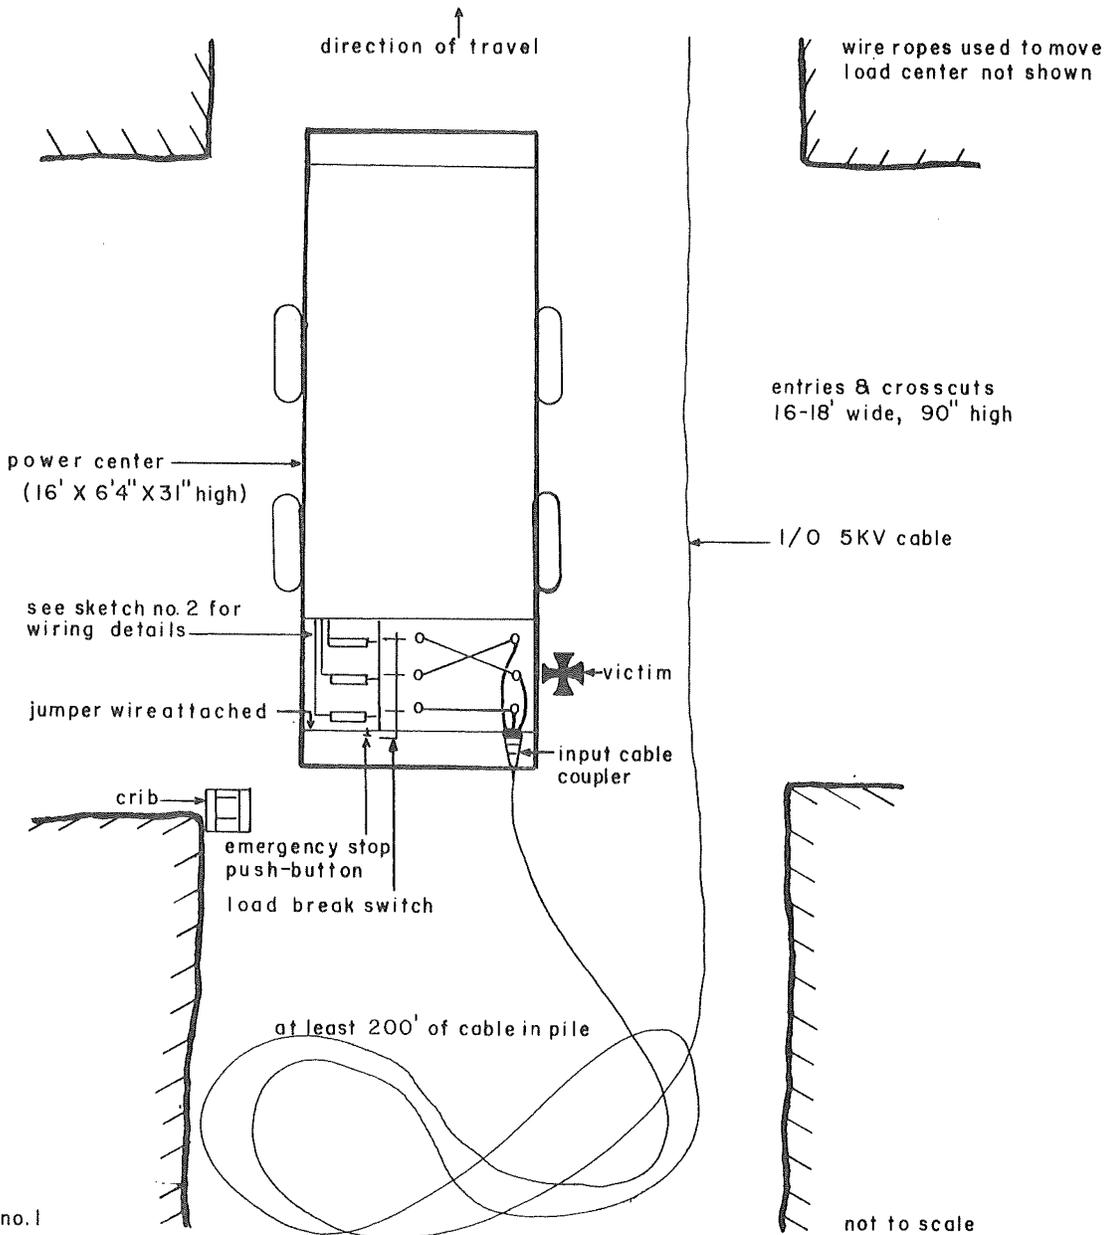
Sketch of
FATAL ELECTRICAL ACCIDENT

On Monday, June 30, 1986, at about 8:00 p.m., an electrical accident occurred in the 8 Left (022) section of BCNR Mining Corporation's Clyde mine, resulting in Charles Wilson being fatally injured. Wilson, a qualified electrician, was 40 years of age and had a total of 15-1/2 years mining experience, with 12 years 7 months as a mechanic first class. Wilson was in the process of disconnecting energized high voltage lead wires, which were inside a section power center, when he contacted one of the leads and was electrocuted (see sketch No. 1).

The accident and resultant fatality occurred because management and the victim failed to deenergize, disconnect, lock out, tag and ground the affected portion of the underground high voltage circuit while working in and around the section power center.

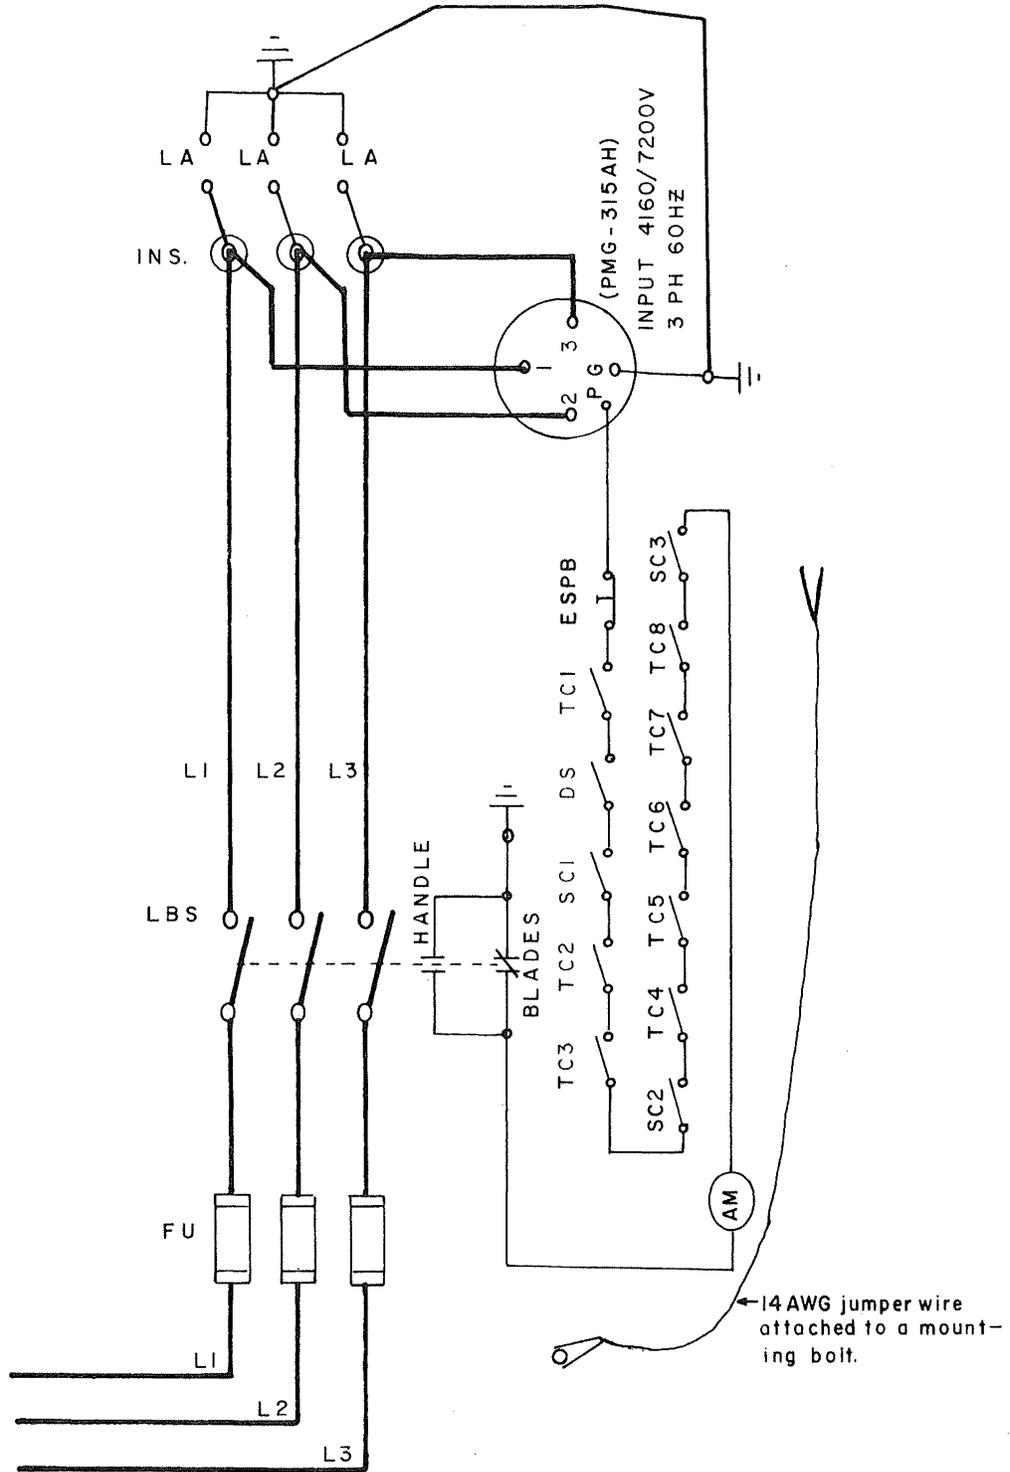
Sketch no.2

8. An examination of the section power center revealed that the emergency stop push button was depressed. The load break switch lever was in the open position and the input cable coupler had numerous hammer type marks on the outside of it. These marks indicated that while attempting to remove the screw on/off coupler, it had been turned in both directions. One of the top covers had been removed, thus exposing the interior of the high voltage end of the power center. On the fuse side of this compartment, a No. 14 Awg insulated jumper wire with alligator clips was observed. One end of the wire was attached to an inside mounting bolt and the other end was on the floor of the compartment. An examination of the wire terminals of the emergency stop push button switch revealed scratches that would occur while attaching and removing the alligator type clips at the terminals. Two of the top cover switches (TC1 and TC3) were jumpered out. The interlock switches mounted to operate with the load break switch were out of adjustment due to bent linkage. These interlock switches would not open the ground continuity pilot check circuit when the load break switch was activated.

9. Tests were conducted with the jumper attached to the emergency stop push button switch on July 11, 1986. This resulted in all the top and side cover switches, load break interlock and emergency stop switches to be inoperative in the circuit. It could not be established that the jumper was attached to the emergency stop switch terminal prior to the accident. According to Dave Hamilton, the jumper wire found inside the section power center was possibly left there for testing purposes. The mine examination record book indicated that the last examination of all electrical equipment was made on June 21, 1986.

B. The jumper wire found inside the section power center was attached to the line side of the emergency stop push button switch.

Partial wiring diagram of section power center

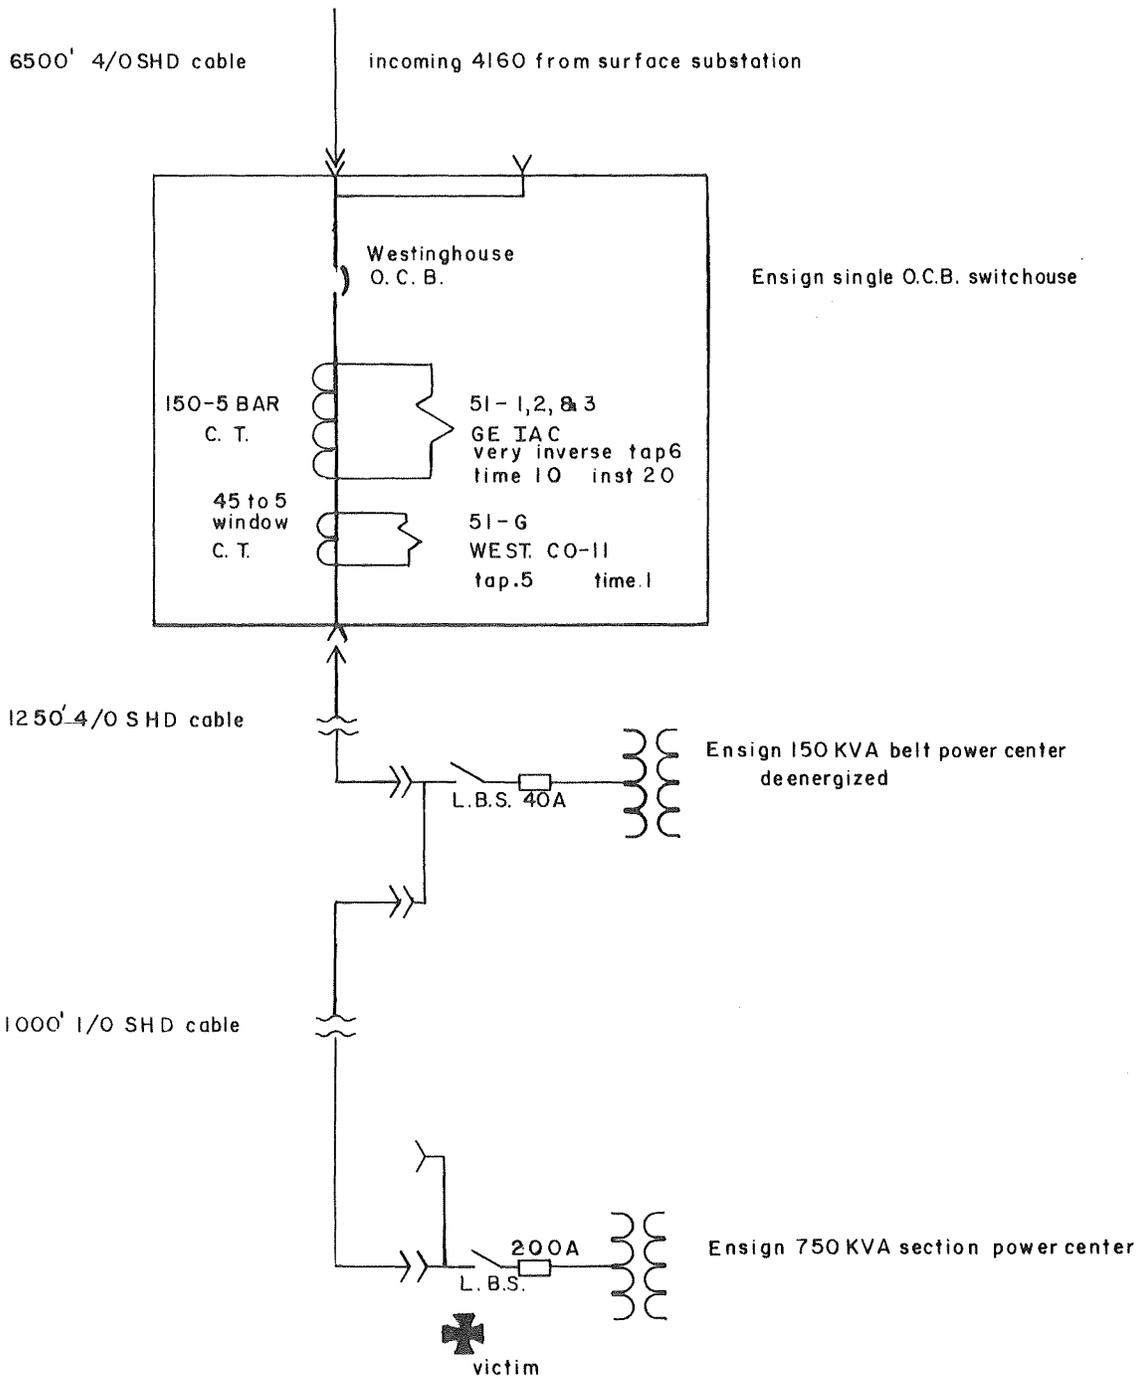
Sketch no. 3

2. Power for Clyde mine was purchased at 25 KV and transformed to 4.1 KV at a surface substation for underground distribution. The electrical configuration at the surface was delta/wye. Power entered the mine at No. 3 portal through No. 4/0 Awg, three conductor, type SHD-GC, 5 KV cable and was protected against short circuit, overcurrent, ground phase, and under-voltage conditions by an oil circuit breaker. Fault current in the grounding circuit was limited to 25 ampere at the source by a 96 ohm current limiting resistor. The Westinghouse CO relay was set on a 2 amp tap and connected to the grounding circuit by a ground fault current transformer with a ratio of 45:5. Approximately 6,500 feet of No. 4/0, 5 KV mine power feeder cable was installed between the surface and the 8 Left section single oil circuit breaker switchhouse, Serial No. 492, that protected the 8 left belt conveyor and section power centers (see sketch No. 3).

11. Further investigation of the belt conveyor power center revealed a jumper wire across the pilot check terminal block (TBI). This rendered the top and side cover switches, load break interlock, and emergency stop switches inoperable. The pilot circuit was also short circuited as the result of water that was found inside the three interlock switches. These switches are operated by the load break switch linkage (see sketch No. 3). It could not be determined if the water entered the interlock switches before or after the accident.

A. The pilot circuit was short circuited as the result of water that was found inside the three interlock switches or,

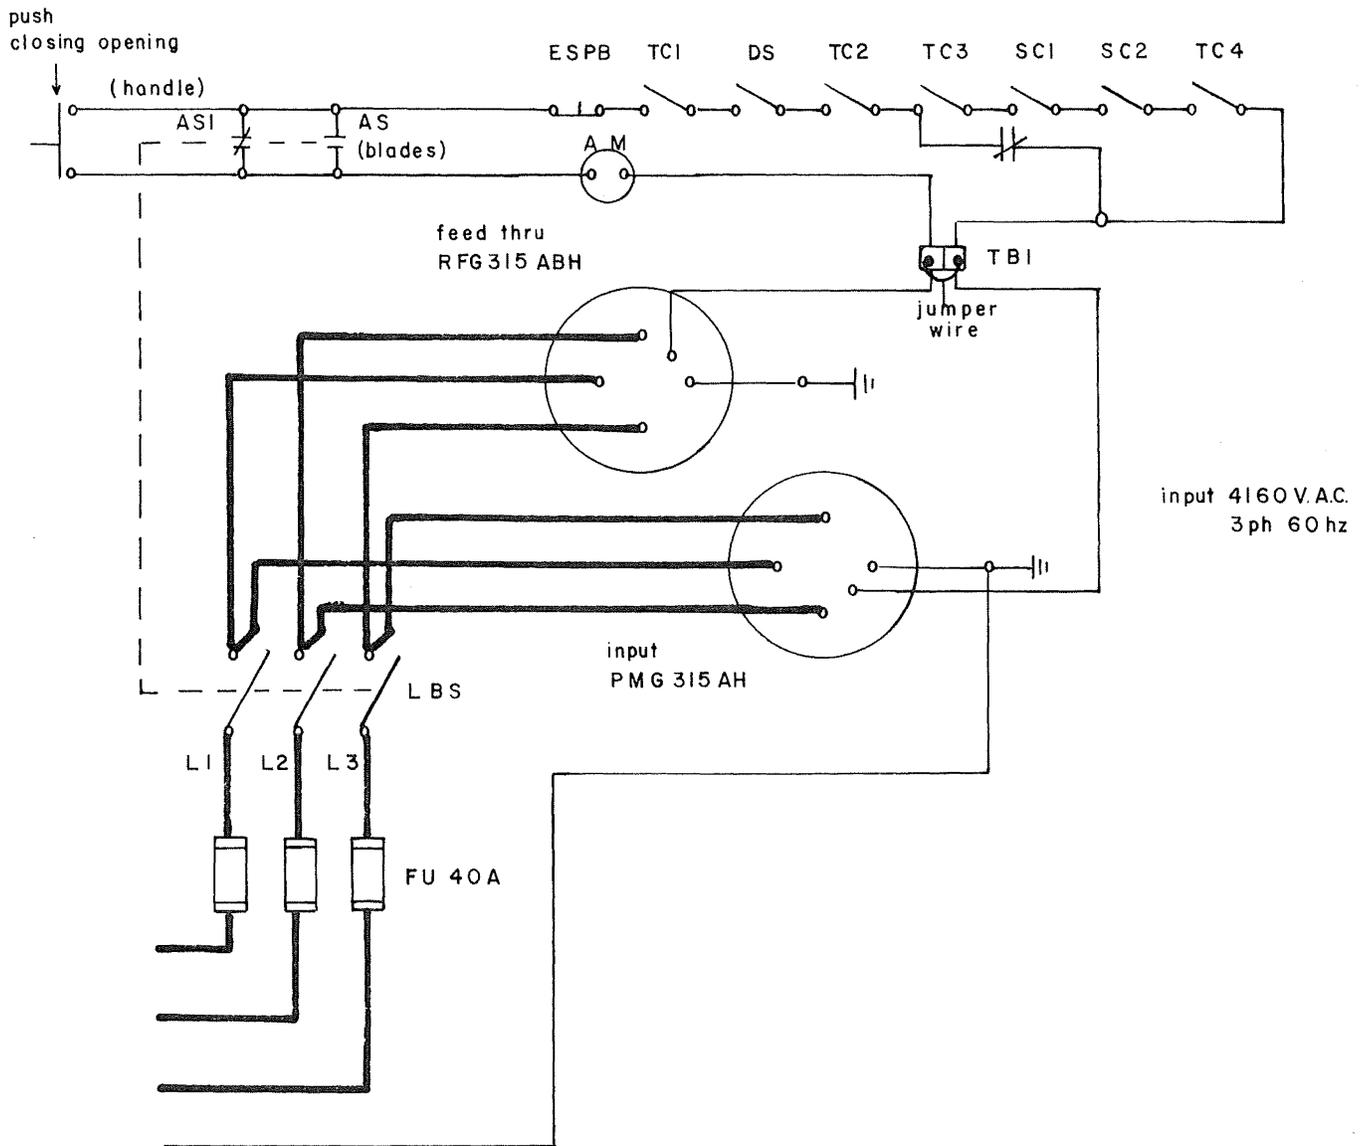
Sketch no.4

General Electric IAC very inverse relays, set on 6 amp tap, time dial 10 and instantaneous trip setting of 20 amps, were connected to the circuit by 150:5 current transformer in all three phases. Westinghouse CO-11 relay was set on .5 amp tap and time dial 1 and connected to the grounding circuit by a 45:5 window current transformer. The mine power feeder cable went from the oil circuit breaker switchhouse through the Ensign 150 KVA belt conveyor power center to the section load center (see sketches Nos. 3 and 4).

Partial wiring diagram of belt power center
