REPORT OF INVESTIGATION

Underground Metal Mine
(Silver Ore)

Fatal Explosives and Blasting Agents Accident
November 17, 2013

Star Mine Operations LLC
Revenue Mine
Ouray, Ouray County, Colorado
Mine ID No. 05-03528

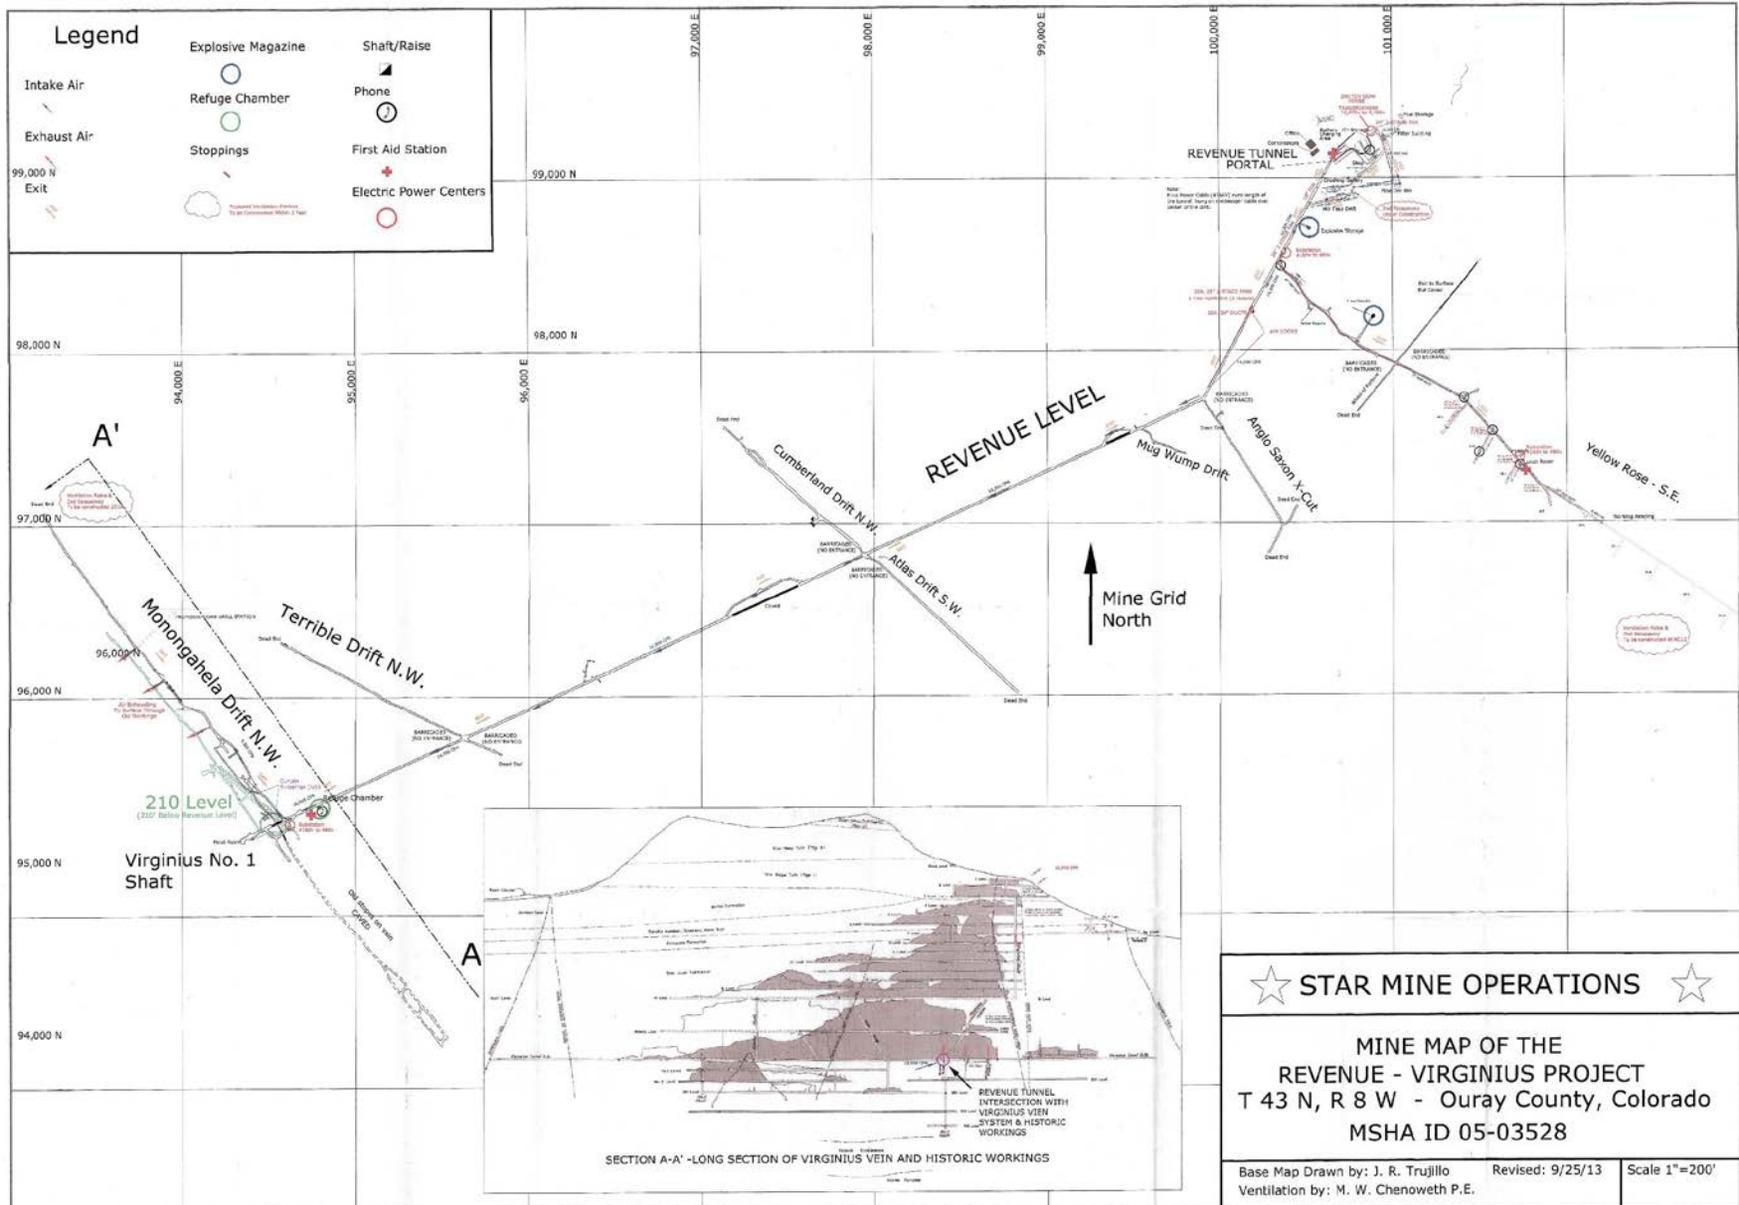
Figure 4 –Ventilation Plan Map for the Revenue Mine, September 25, 2013

Ventilation in the mine is supplied by two 28-inch diameter, double 30 horsepower Spendrup fans in the Revenue tunnel. These main fans are located approximately 950 feet in by the portal and are connected in a blowing arrangement to two, 24-inch ducts. The two ducts extend through a pair of airlock doors allowing the fans to operate as if installed in a bulkhead. This creates positive ventilating pressure in by the doors. The doors are approximately 500 feet apart. A copy of the ventilation plan in effect at the time of the accident is shown in Figure 4.

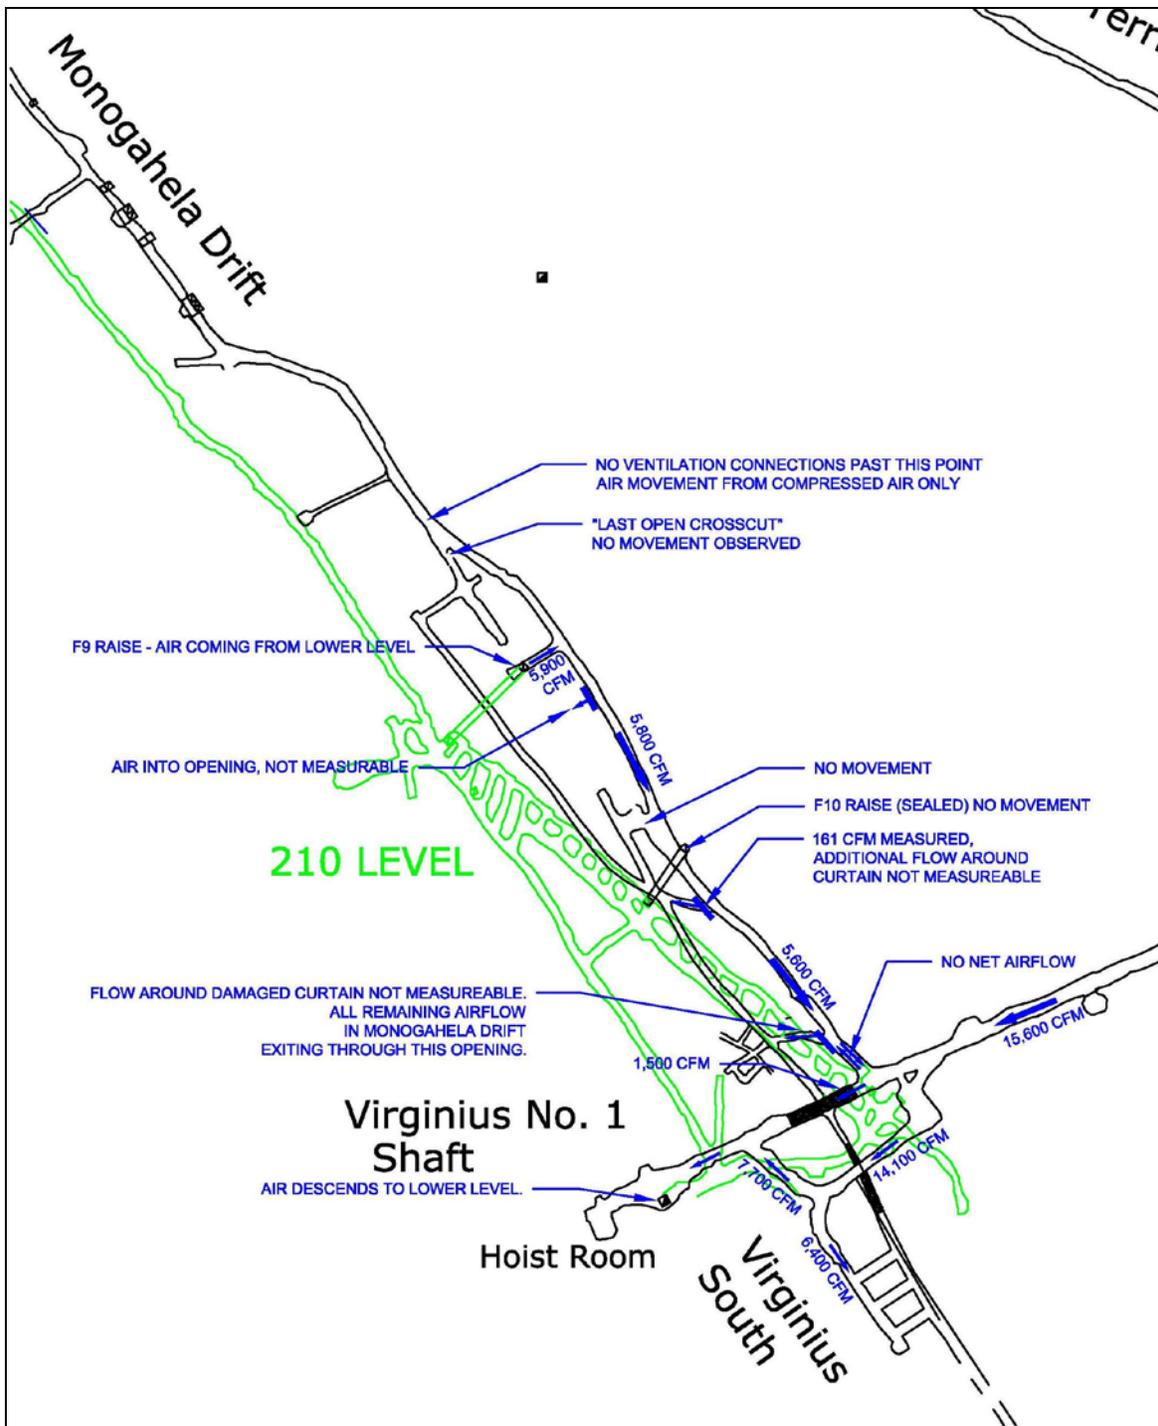
Figure 5 – Post-Accident Ventilation

Minimal air flowed from the mouth of the Monogahela drift to the first crosscut; i.e., airflow was observed moving slightly inby near the back and slightly outby near the floor. Approximately 5,800 cfm was measured coming from the F9 raise and traveling outby in the Monogahela drift to the first crosscut. One crosscut, inby the F9 raise, was referred to as the "last open crosscut" because management and the miners believed airflow entered this crosscut. Chemical smoke tests showed no airflow entered or exited this opening.

The accident investigation team used chemical smoke to check every opening off the Monogahela drift, in by the last open crosscut, and no airflow was detected entering or exiting the drift. In by the F9 raise, compressed air lines, opened during the recovery, provided the only airflow toward the face of the drift. Measurements showed this quantity ranged from 1,300 cfm to 3,100 cfm. With the compressed airline closed, there would be no ventilation beyond the F9 raise. The F9 raise was located approximately 450 feet into the Monogahela drift. The drift was 2,300 feet long. The site of the explosive detonation was 50 feet from the face of the drift (2,250 feet into the drift), 1,650 feet beyond the last open crosscut and approximately 1,800 feet in by the F9 raise. A flexible ventilation duct had been installed in a portion of the drift; however, no fan was installed to provide forced airflow.

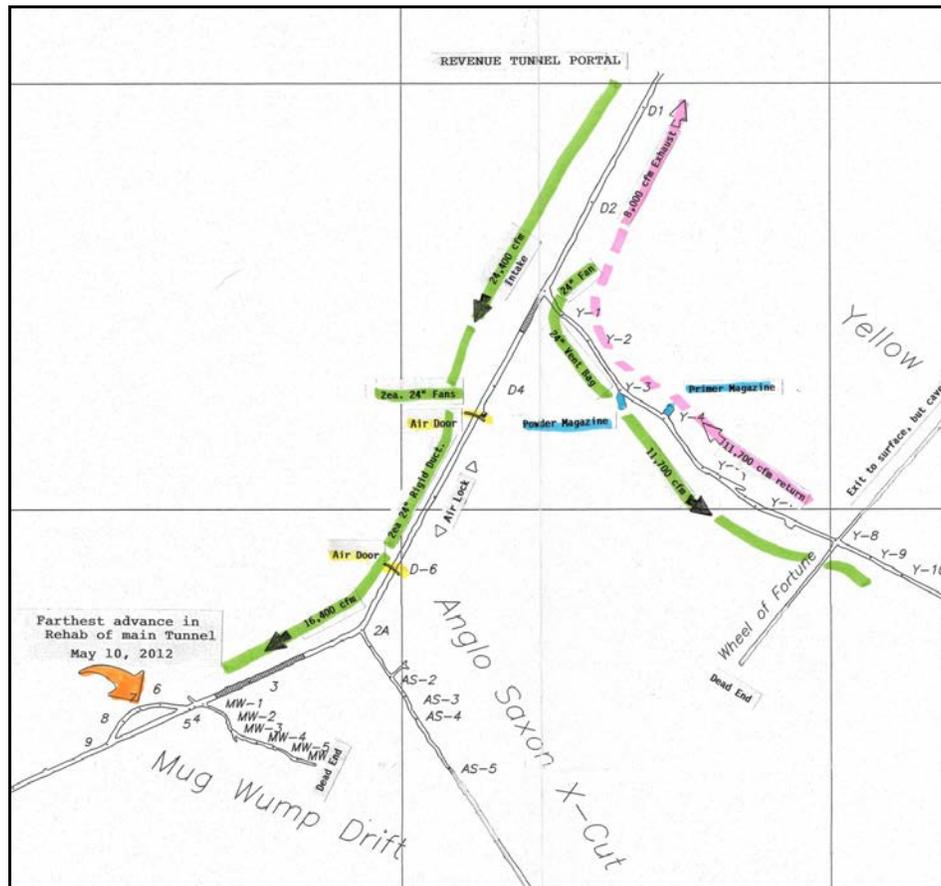
Figure 6 – Portion of the May 9, 2012 Ventilation Plan Map

The revised plan map depicted that the single-entry Revenue tunnel had been rehabilitated a short distance beyond the Mug Wump drift, approximately 2,000 feet from the portal (see Figure 6). No ventilation arrows or controls were shown on the map in by the furthest point of rehabilitation. The plan indicated that two 24-inch diameter fans had been installed in the Revenue tunnel and indicated that the fans delivered 16,400 cfm to the tunnel. The map also indicated that the operator installed a separate 24-inch fan and approximately 1,000 feet of flexible ventilation tubing (vent bag) in the Yellow Rose drift. The map indicated that the fan in the Yellow Rose drift produced 11,700 cfm of airflow in the drift.

The air quantities shown on the map in the Revenue tunnel and in the Yellow Rose drift were consistent with those measured during the accident investigation; however, the revised plan map also depicted that 24,400 cfm was flowing from the portal to the fans in the Revenue tunnel and 8,000 cfm was exhausting from the Yellow Rose drift toward the portal in the same single-entry drift. Although the resultant airflow (16,400 cfm) was shown traveling past the fans, airflow could not travel in two directions as depicted without a physical separation between the two air currents.

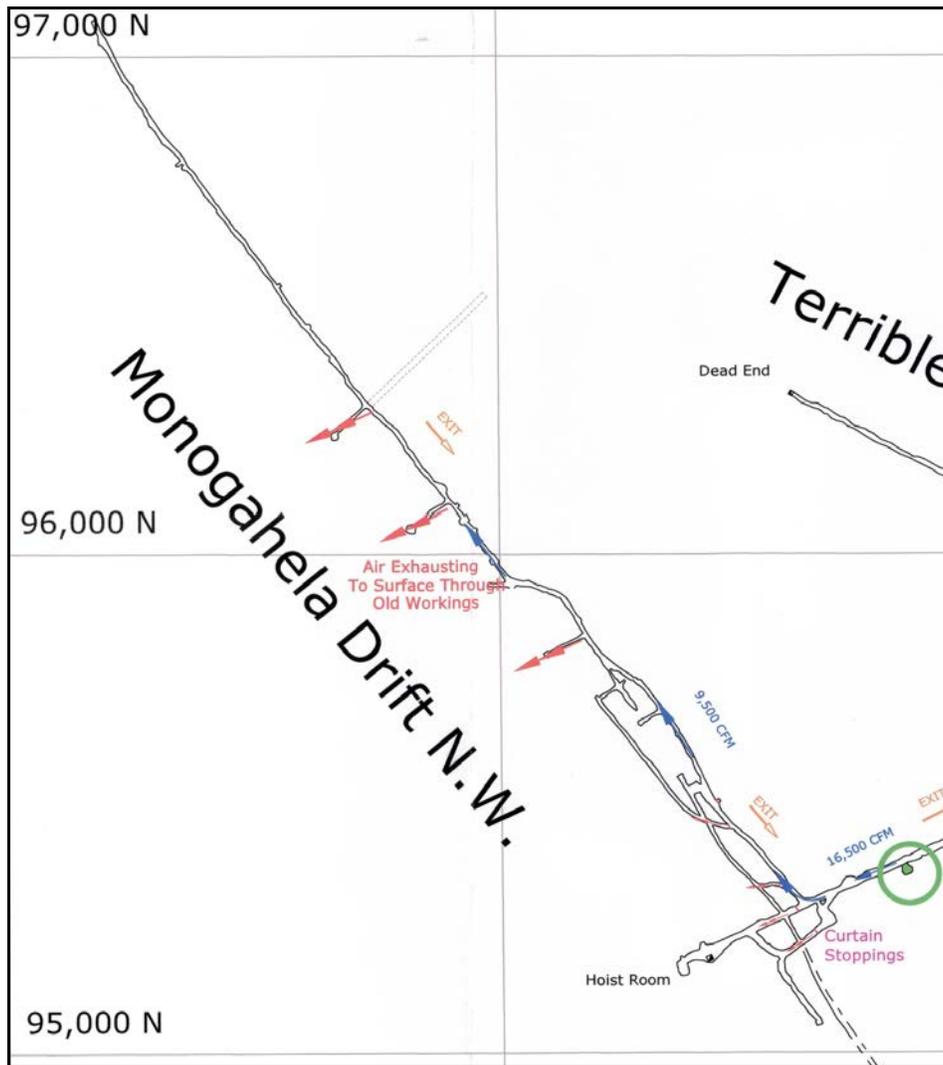
Figure 7 – Portion of the January 23, 2013 Ventilation Plan Map

According to the plan map, airflow in the Revenue tunnel exited the mine through the Monogahela drift (see Figure 7). It also showed that the Revenue tunnel, in by the Monogahela drift (the track entry to the shaft), and the first two crosscuts off the Monogahela drift were to be closed off with curtain stoppings. This would have caused the main airflow to enter the Monogahela drift before exiting through old workings. During his interview, Chenoweth confirmed that he personally measured 9,500 cfm in the Monogahela drift at the location as designated on the plan map.

The plan map depicts air exiting the Monogahela drift through three drifts (drill stations) to the southwest off of the Monogahela drift; however, the accident investigation team found that the drill stations were dead end drifts and no air could exit. When asked about this map inaccuracy, Chenoweth stated he physically had not been to the drill stations at the time the map was prepared. Chenoweth thought the air exited through the “last open crosscut.” (The last open crosscut is located 600 feet in by the intersection of the Revenue tunnel and the Monogahela drift and just out by the three drill stations.) Chenoweth said that beyond the “last open crosscut,”

there was no ventilation other than compressed air. The compressed air line normally would have been capped on the end and the air drop valves closed. Therefore, unless compressed air was being used by a miner, the remaining 1,700 feet of the Monogahela drift remained unventilated. Chenoweth stated he would have been concerned if someone had been working there; however, in January 2013, the closest active working area was located about 7,000 feet outby in the Yellow Rose drift.

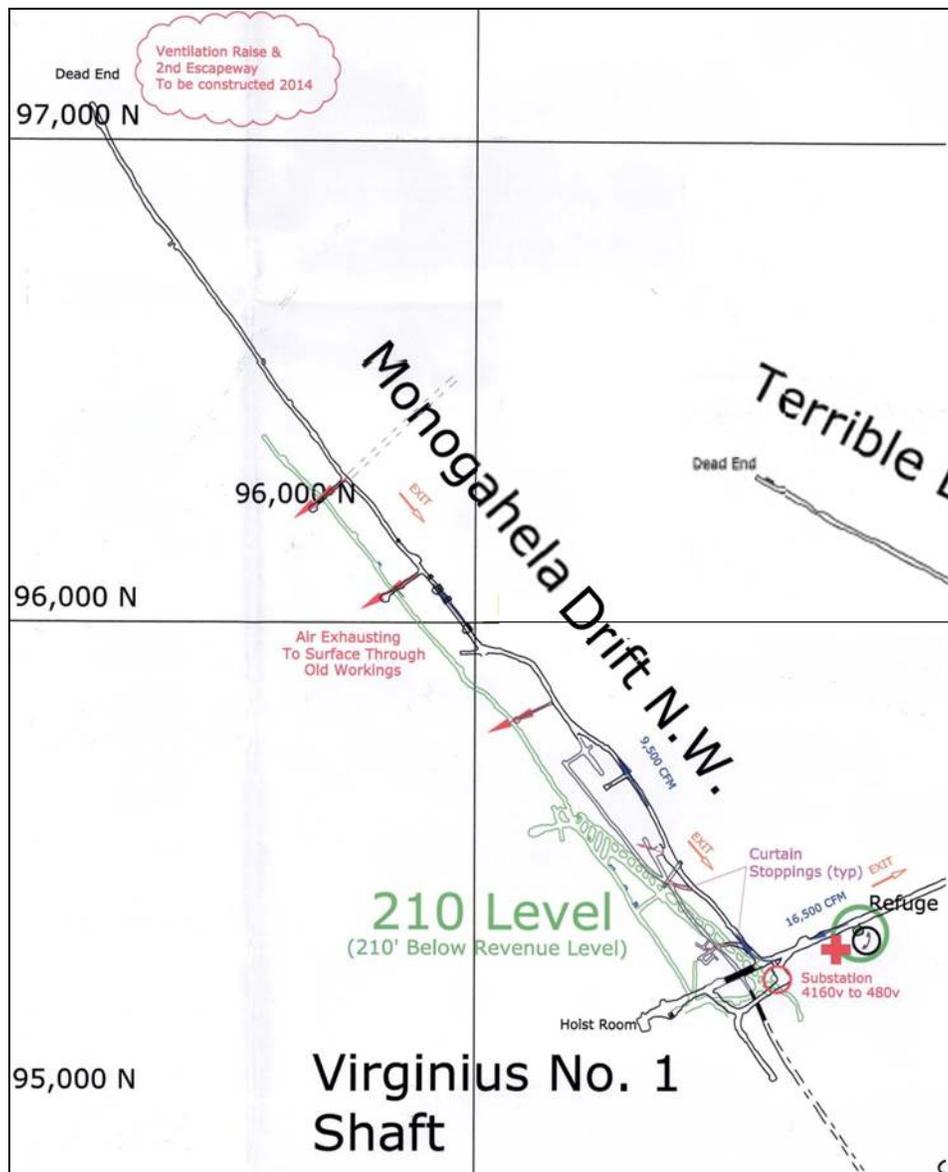
Figure 8 – Portion of the September 27, 2013 Ventilation Plan Map

Items 1 and 2 identified in MSHA's September 10, 2013, letter were directly related to the accident. With respect to Item 1, if the operator took air quantity measurements, as requested, it would have found that the drill stations off the Monogahela drift were dead end drifts. Either the operator did not take measurements or it intentionally submitted the map using false information.

These curtain stoppings also were not present during the accident investigation and the accident investigation team found that the airflow was traveling outby in the Monogahela drift as previously described. Consequently, the accident investigation team determined that the 9,500 cfm shown on the map was inaccurate.

The map also depicted the mine air exiting the Monogahela drift through the drill stations to the southwest and exhausting to the surface through old workings. As previously discussed, this was not possible because they were dead end drifts.

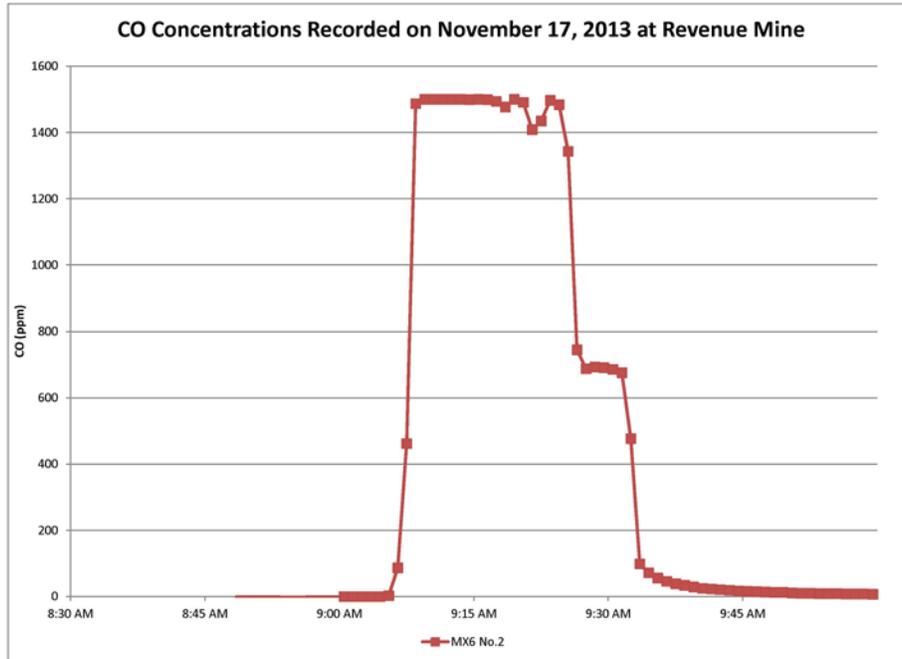
Figure 9 – MX6 No. 2

The data from the day of the accident for CO concentrations is shown on Figures 9 and 10. The data indicates MX6 No. 2 was used during the rescue attempt by Ronald Williams, who entered the gas inundated area at 9:06 a.m. The recorded CO concentrations reached the sensor maximum value of 1,500 ppm within three minutes. It is not possible to determine the actual concentration beyond the sensor maximum. The indicated concentrations began to decline at

9:25 a.m. to a level of approximately 690 ppm CO where it remained for six minutes. After 9:31 a.m., the data indicates the instrument was no longer in the area contaminated by the blast. This coincides with the approximate time that Ronald Williams left the Monogahela drift and traveled to the refuge chamber.

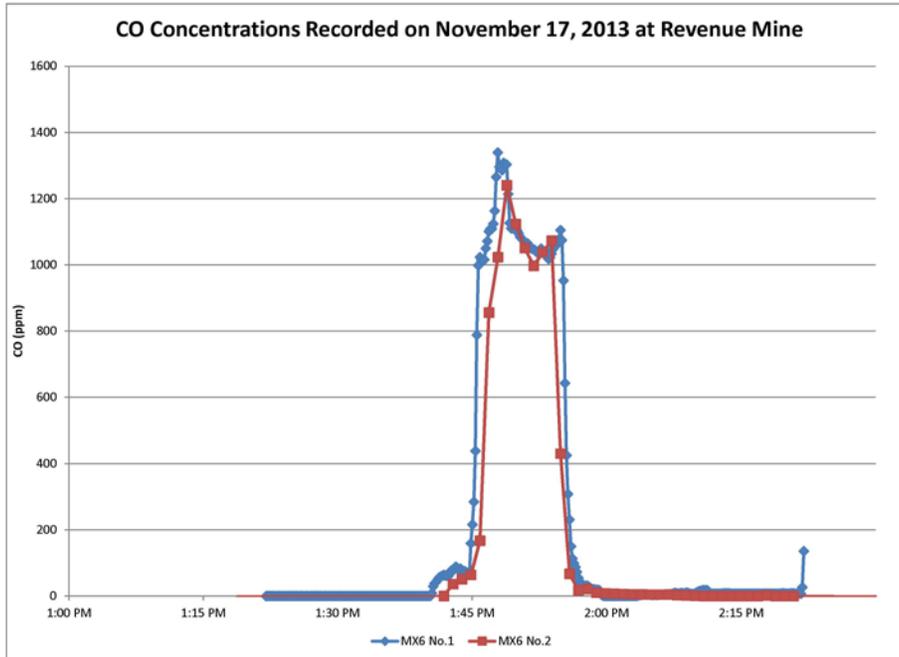
Figure 10 – MX6 No. 1 and MX6 No. 2

Data was retrieved from both MX6's indicating they were used during the recovery of the victims. During that time, CO concentrations still exceeded 1,000 ppm in the Monogahela drift (see Figure 10).

The peaks shown on the instruments during the initial rescue attempts show that the victims and injured miners were exposed to CO concentrations exceeding 1,500 ppm. The momentary plateau (at approximately 9:30 a.m.) shown in Figure 9 coincides with the time during which Ronald Williams had retreated to the compressed air line in the Monogahela drift after his low-air alarm sounded. The response of the gas detectors during the rescue attempts shows that, if the instruments had been used to conduct a post-blast examination, they would have alerted persons to the deadly atmosphere in the Monogahela drift..

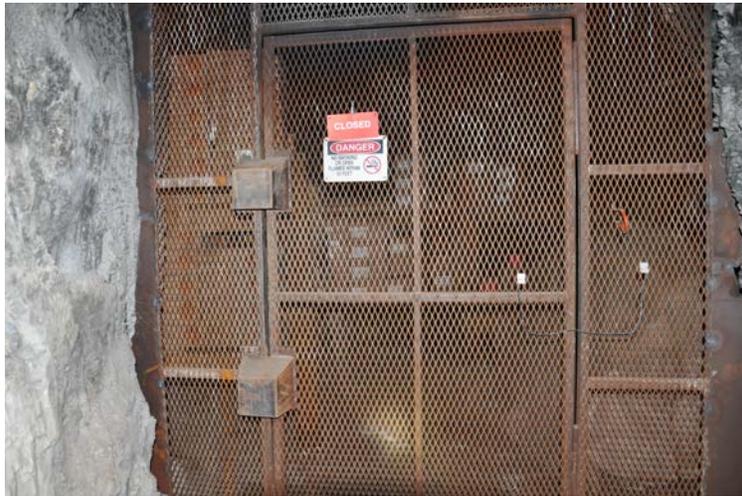
Figure 12 – Entrance to Powder Storage Facility

The front of each storage facility had an expanded metal security gate in place and the roofs were bolted with chain link wire to secure the top (see Figure 12). Although an insulating material had been applied to the interior of the facilities, there were several areas found in each facility with exposed bare metal.

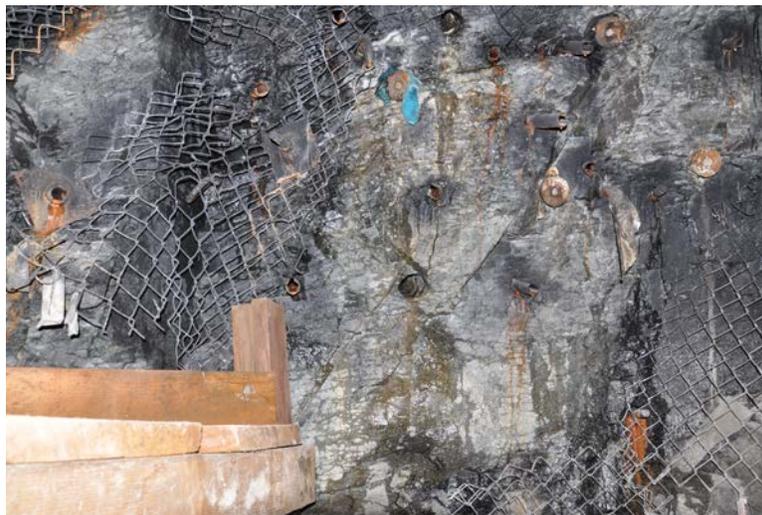
Figure 13 – Inside of Powder Storage Facility

The back was not grouted or coated with shotcrete inside the powder storage facility; therefore, water constantly dripped onto the explosives (see Figure 13). The wet conditions damaged and deteriorated the explosives inside the facility. Water infiltration was not evident in the cap storage facility.

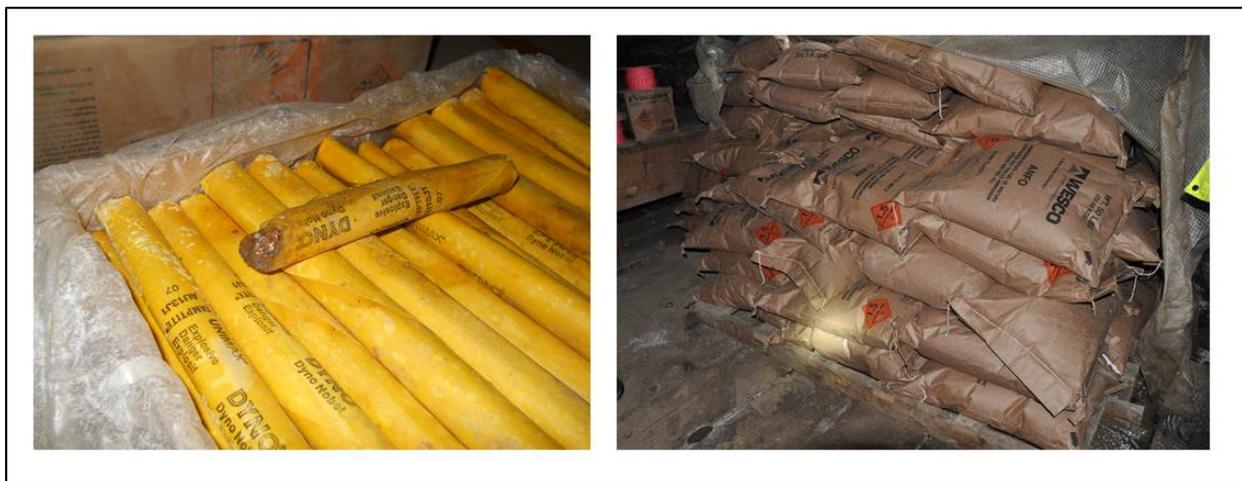
Figure 14 – Explosives in the Powder Storage Facility

The explosives were stored inside the powder storage facility on wooden shelving built along each rib. The shelves were located approximately 30 inches and 60 inches above the floor level. Explosives were stored in the original cardboard containers, but were not stacked to facilitate the use of the oldest product first. Some stacks had three or four different manufacturer's date coded boxes stored together. Approximately 3,750 pounds of blasting agent in the form of bagged ammonium nitrate / fuel oil mixture (ANFO) was stored on wooden pallets on the floor. Exposed metal nails protruding from the pallets presented an additional hazard to the bagged

The accident investigation team conducted a physical inventory in each storage facility. The results showed that the operator, and specifically the responsible shift bosses, did not keep either facility's inventory current; i.e., the inventories did not reflect the actual amount of explosives in the storage facilities. Approximately 2,400 separate units of explosives were missing based on the total amount of each explosive type.
