United States
Department of Labor
Mine Safety and Health Administration
Office of the Administrator
Coal Mine Safety and Health

REPORT OF INVESTIGATION
DECEMBER 7, 1992
UNDERGROUND COAL MINE EXPLOSION
#3 MINE - ID. NO. 44-06594
SOUTHMOUNTAIN COAL CO., INC.
NORTON, WISE COUNTY, VIRGINIA

Release Date: May 6, 1993

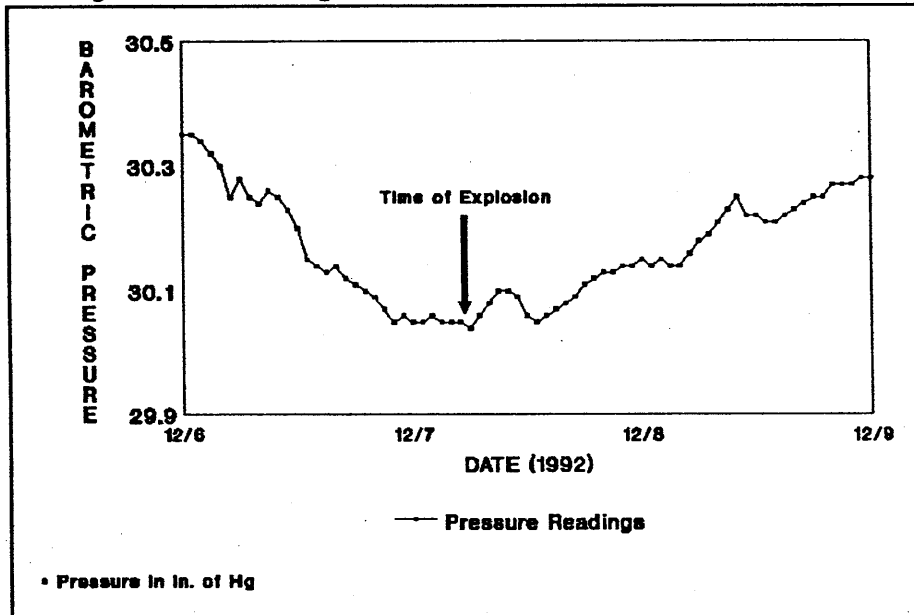
Figure 1 - Graph of the Barometric Pressure

The barometric pressure was recorded by the National Weather Service at nearby Bristol, Tennessee. Figure 1 is a graph of the barometric pressure from December 6 through December 8, 1992.

Figure 1 indicates that a significant drop in the barometric pressure occurred in the hours prior to the explosion. This increases the likelihood of methane migrating from the 1 Left pillared areas.
