FINAL REPORT OF MINE EXPLOSION  
THREE POINT MINE  
THREE POINT COAL CORPORATION  
THREE POINT, HARLAND COUNTY, KENTUCKY

September 16, 1943

Charles M. Keenan  
Coal Mine Inspector

UNITED STATES  
DEPARTMENT OF INTERIOR  
BUREAU OF MINES

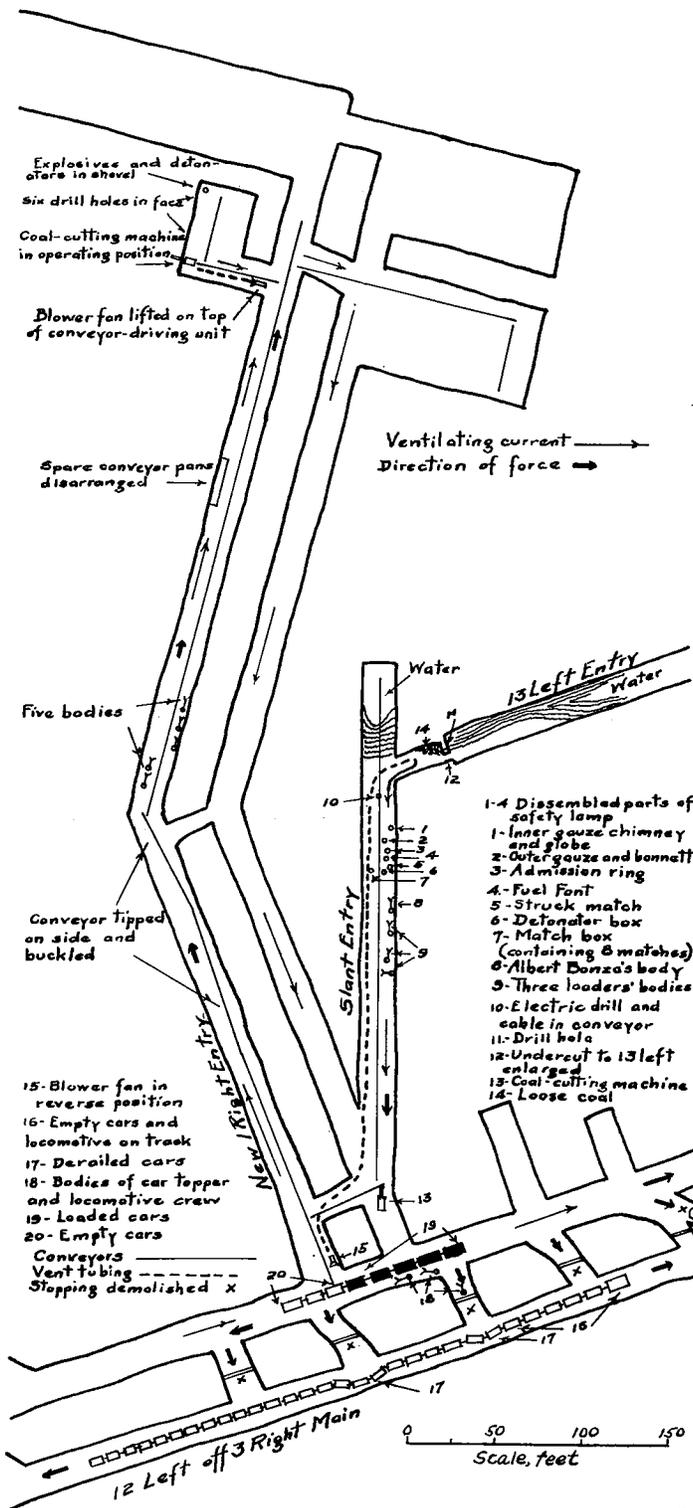
DETAIL MAP OF EXPLOSION AREA  
 NEW RIGHT ENTRY OFF 12 LEFT 3 NORTH  
 THREE POINT MINE

The dissembled nonpermissible flame safety lamp and the matches found near the body of the assistant foreman prove, almost conclusively, that gas was ignited when a match was struck to relight the flame safety lamp.

Since only small percentages of methane were found at any place in the affected area with an electric methane tester, it can be assumed that gas, which had accumulated in the face of the idle 13 left entry, had seeped into the slant entry through either the drill hole or the undercut connection that had been made between the face of the crosscut from the slant entry and the face of 13 left entry. It is highly probable that the flame safety lamp had been extinguished by the mixture of methane and air in the vicinity of the crosscut, and, from the location of the bodies, the official had taken the men with him to a point about 50 feet outby the crosscut to relight the safety lamp. Other sources of ignition were not discernible.
