REPORT OF INVESTIGATION

**Fatal Underground Mine Explosion
April 5, 2010**

**Upper Big Branch Mine-South, Performance Coal Company
Montcoal, Raleigh County, West Virginia, ID No. 46-08436**

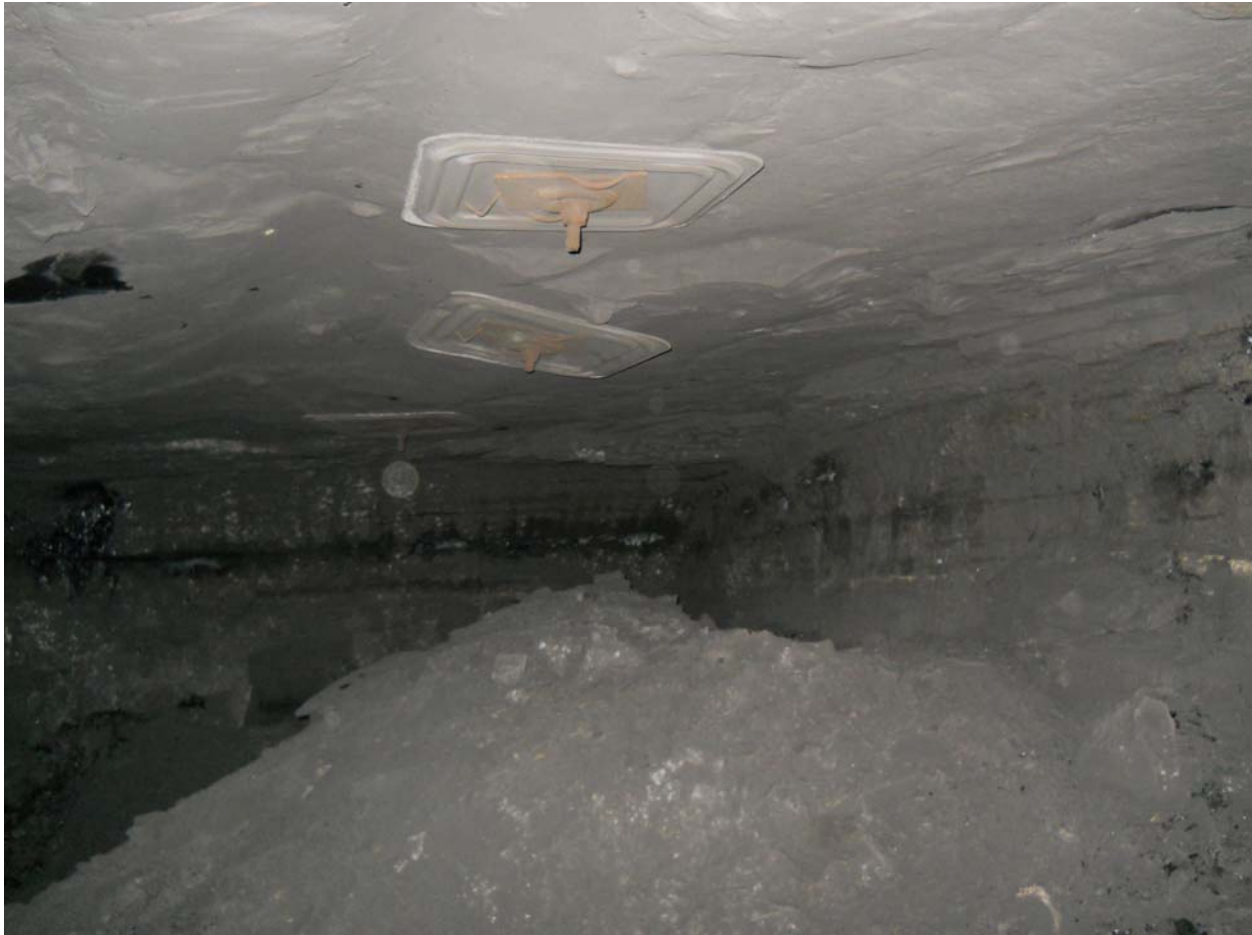
Figure 3. Accumulations of loose coal, coal dust, and float coal dust were measured up to 7 feet wide by 12 feet long by up to 4 feet in depth. These were found consistently along every single air course.

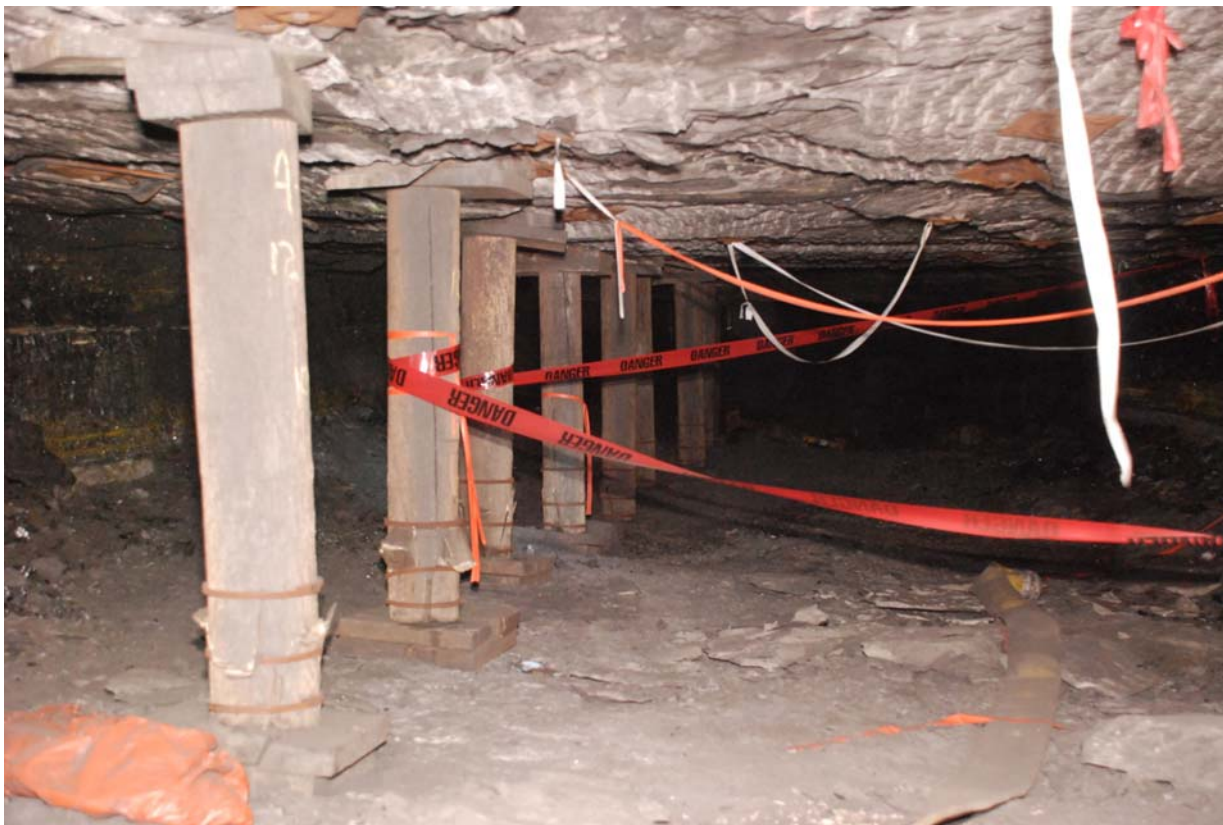
PCC's roof control plan required two rows of posts or two 8' cable bolts in the No. 7 entry in the longwall tailgate as supplemental support. This requirement was intended to maintain adequate roof support in that entry. PCC only installed one row of posts in the entry as shown in Figure 4. Both the single row of posts and the resulting roof control issues were obvious; examiners testified that they did not like to travel in that entry due to the bad top. PCC never recorded the hazard in any of its examination books. Poor roof conditions led to a roof fall in the No. 7 entry, which likely restricted air flow coming off the longwall face, and allowed methane to accumulate prior to the explosion. The investigation indicated that this fall was present prior to the explosion; blackened dust from the explosion was present on the fall and could only have occurred after the explosion.

Figure 4. Photograph of Tailgate 1 North No. 7 entry showing only one row of posts installed. The approved roof control plan required two rows of 8' cable bolts or posts.

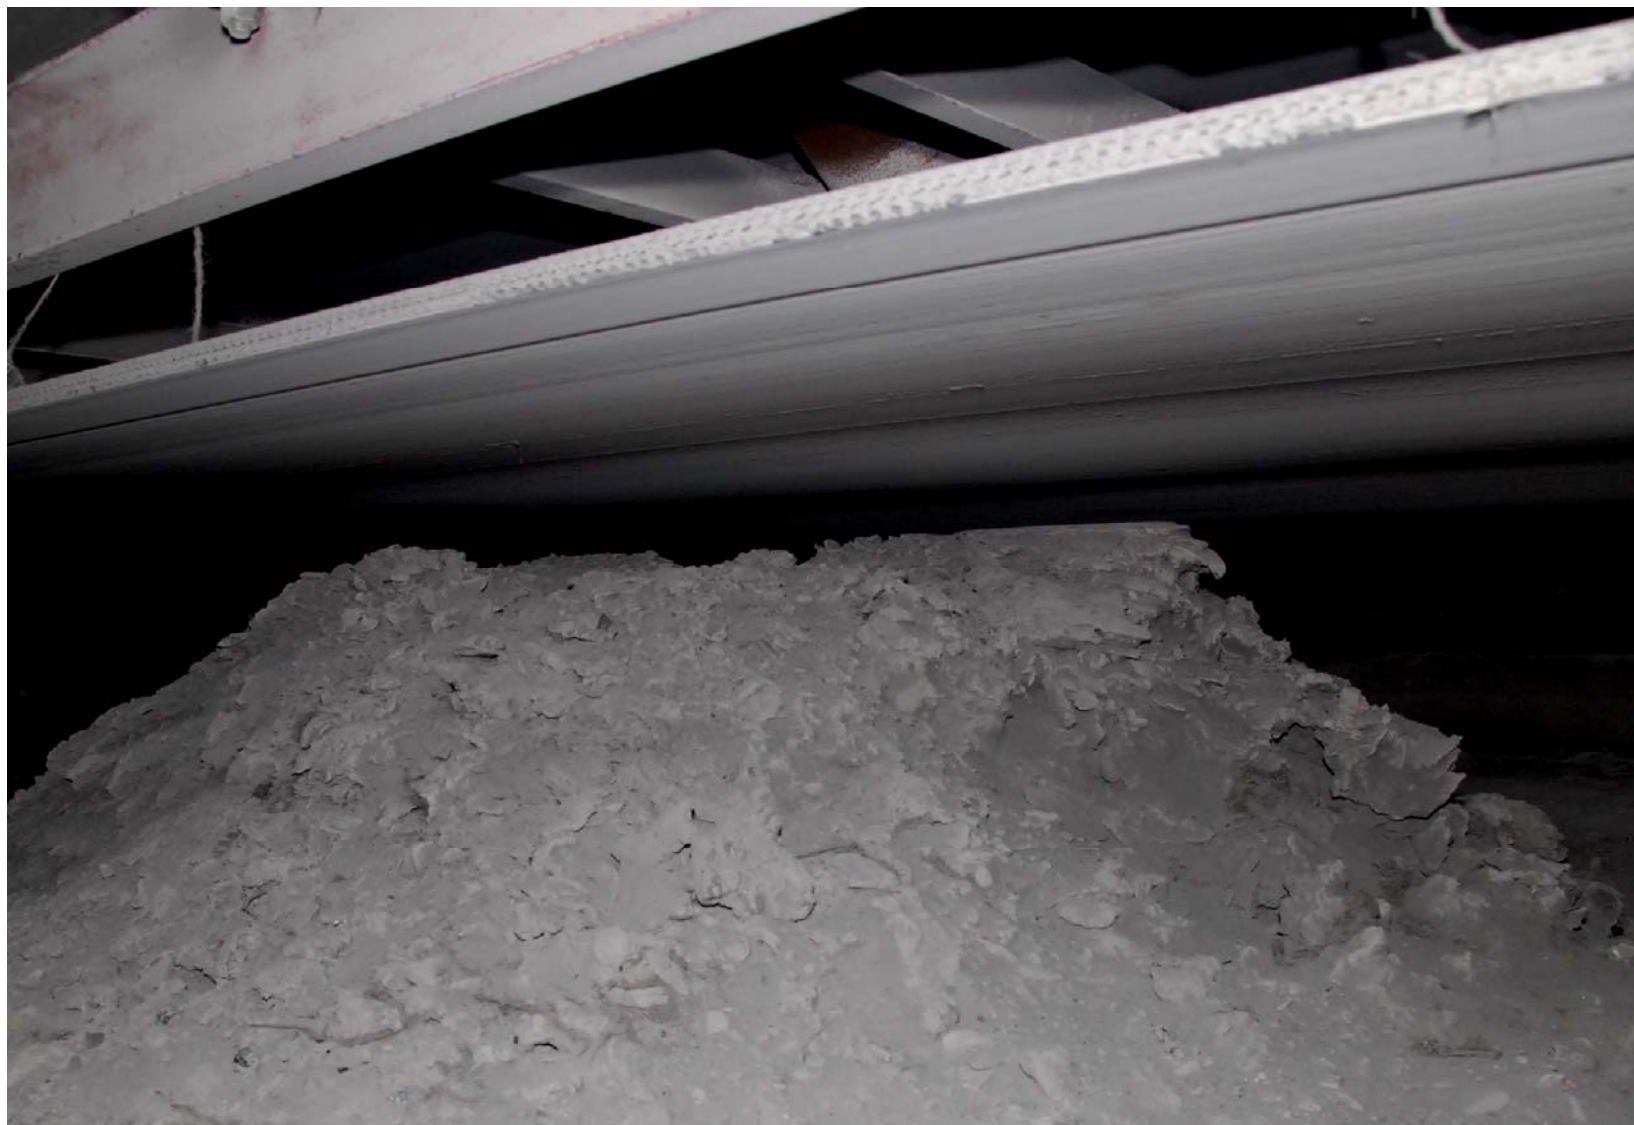
During the underground investigation, MSHA identified accumulations in over 50 locations along the conveyor belts. These accumulations were allowed to pile up below and around the belt and belt structure, and along portions of ribs that were not cleaned up during initial development. Examples of this are shown in Figures 8 and 9. The size and number of these accumulations demonstrate that the hazards existed for a long period of time.

Figure 8. Accumulations of loose coal with the top of the pile flattened due to rubbing the moving belt.

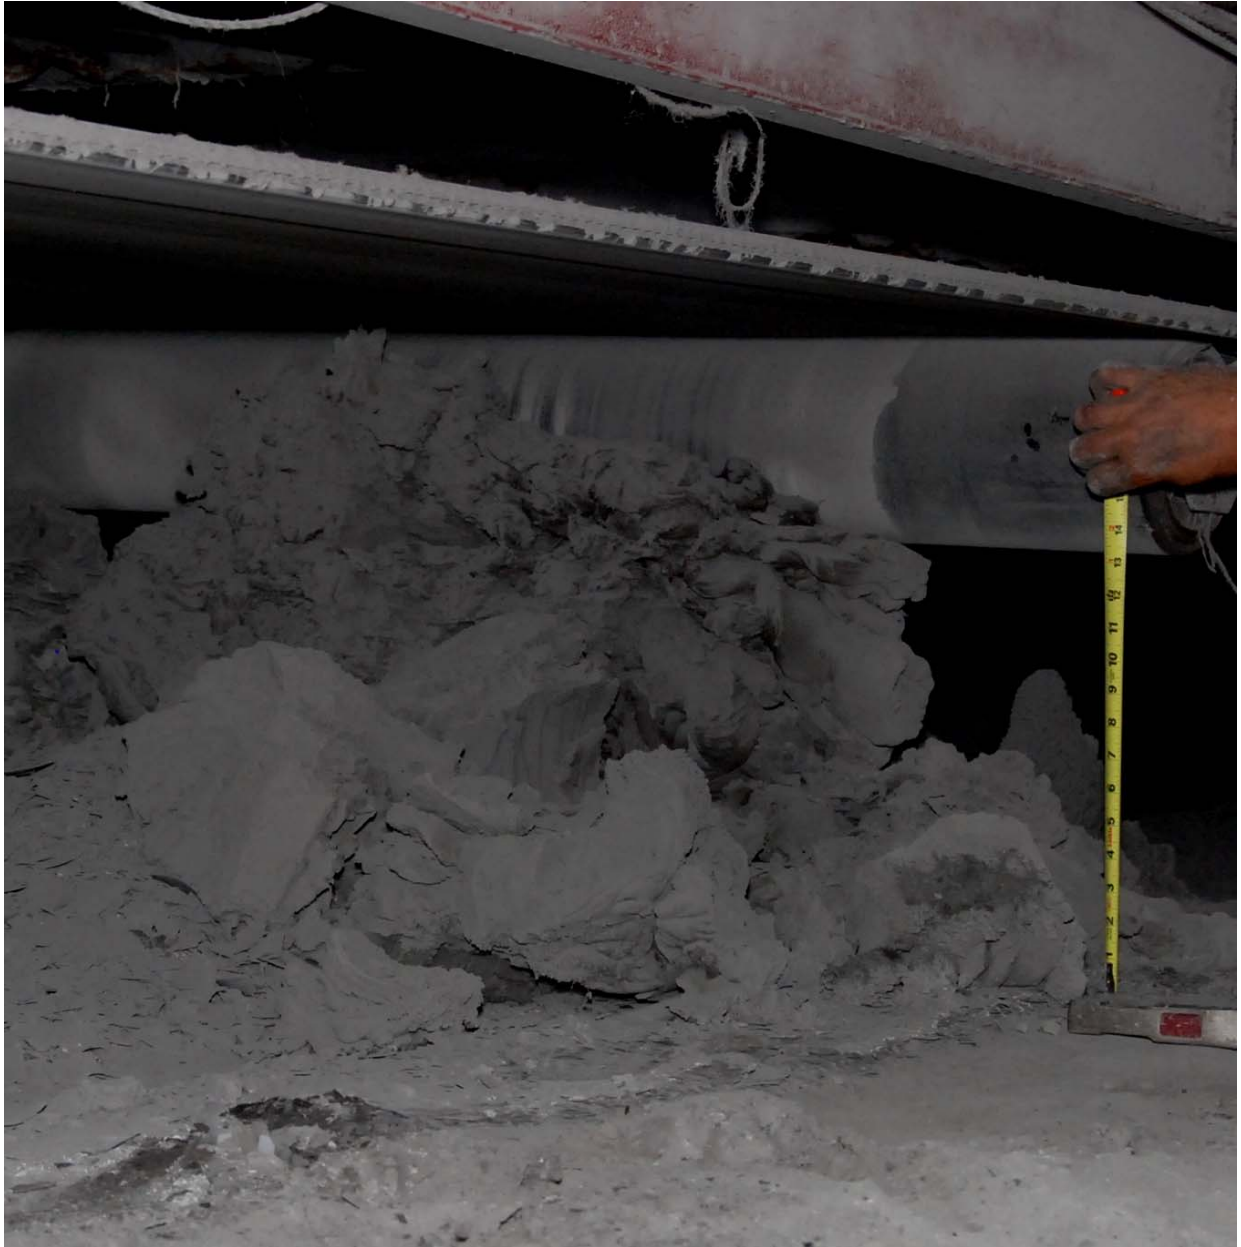
Figure 9. Accumulations of loose coal built up to the point that the belt roller is turning in the accumulations.

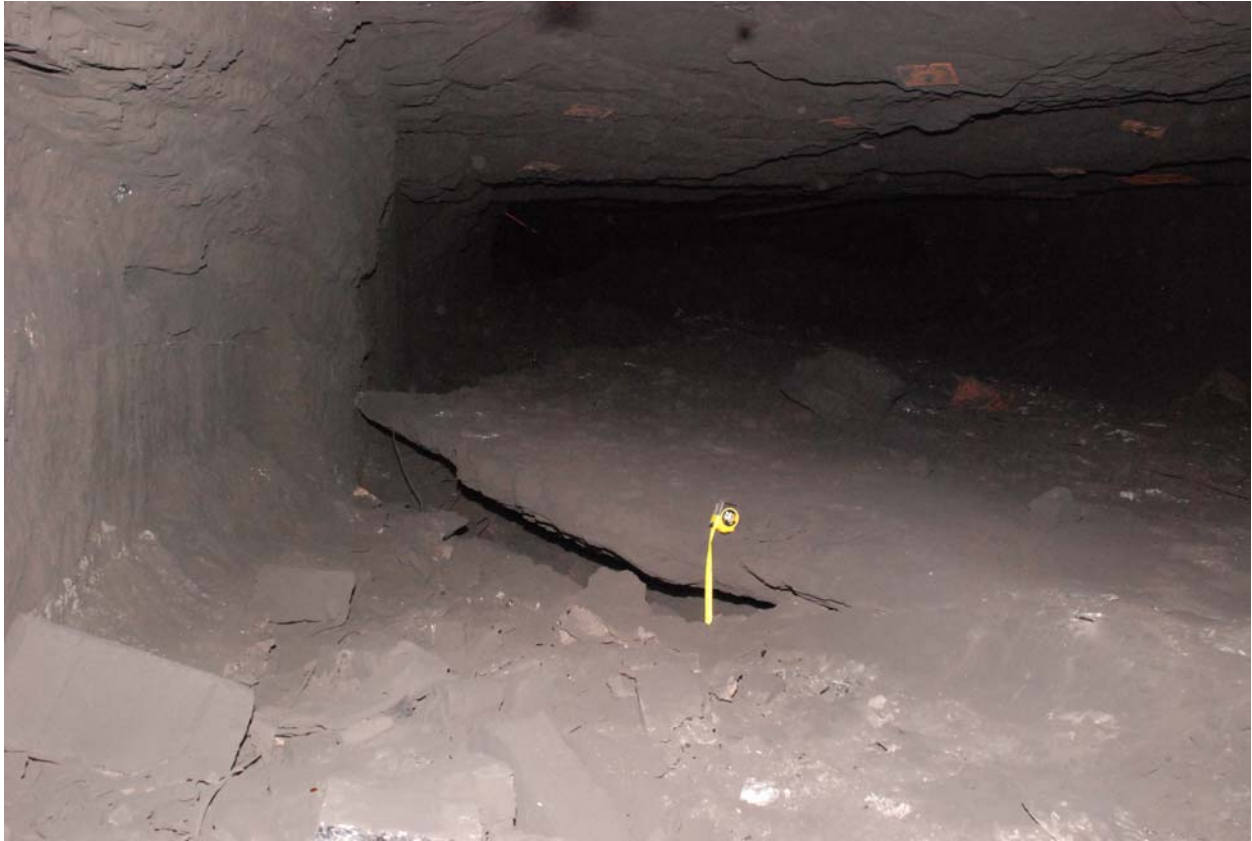
Figure 13. Cantilevered slab of floor sandstone forms broken brow with rootless, open aperture fracture. This style of floor heave is typical throughout Tailgate 1 North, the Panel 1 crossover and adjacent rooms, TG 22, and HG 22.

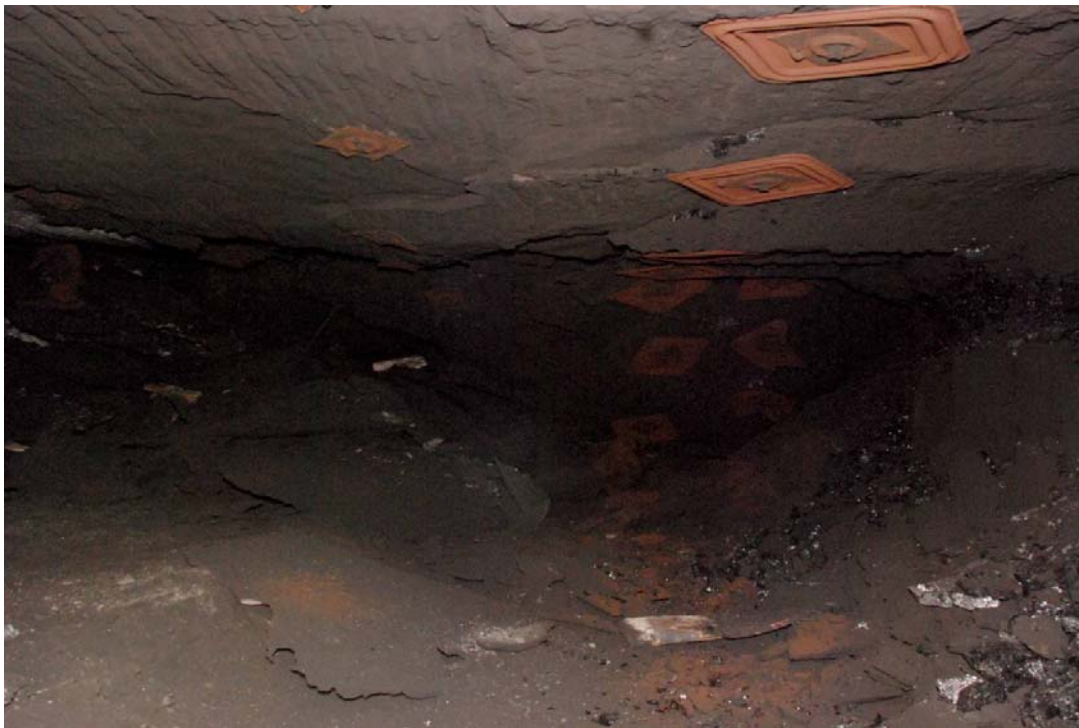
The failure to install appropriate tailgate support is significant because observations indicate that crosscut 49, the next crosscut inby the face, had already caved-in prior to the face reaching crosscut 48 and before the explosion based on debris on the fall rubble (Figure 23). PCC's failure to install either two rows of posts or two rows of eight foot cable bolts for support restricted the airflow in the tailgate entry inby the longwall face and contributed to the inability to adequately ventilate the tailgate area, which is discussed in the next section.

Figure 23. Caved roof in tailgate entry, as viewed in crosscut 49, which represents the next crosscut inby the face. Coatings of soot on the fallen rubble, juxtaposed against small pieces of freshly fallen, white sandstone, indicate that the intersection had caved prior to the explosion.

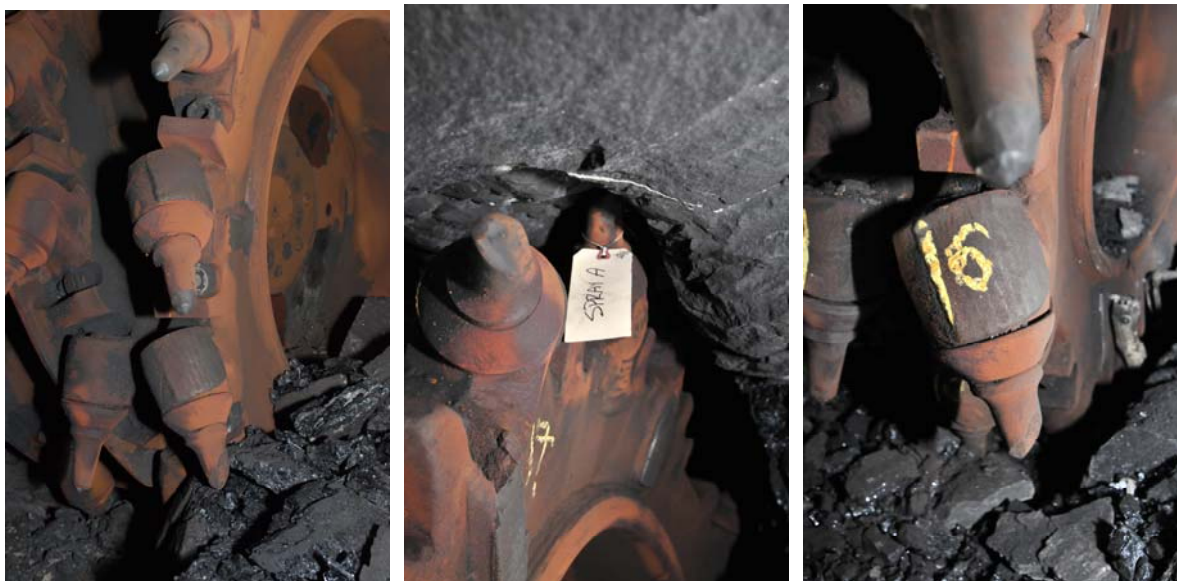
Figure 30. 1 North Panel tailgate drum, showing configuration of water sprays used in the pick-point flushing system. Note that sprays are directed toward the front of the bits, one missing water spray, and two bits exhibiting extreme wear.

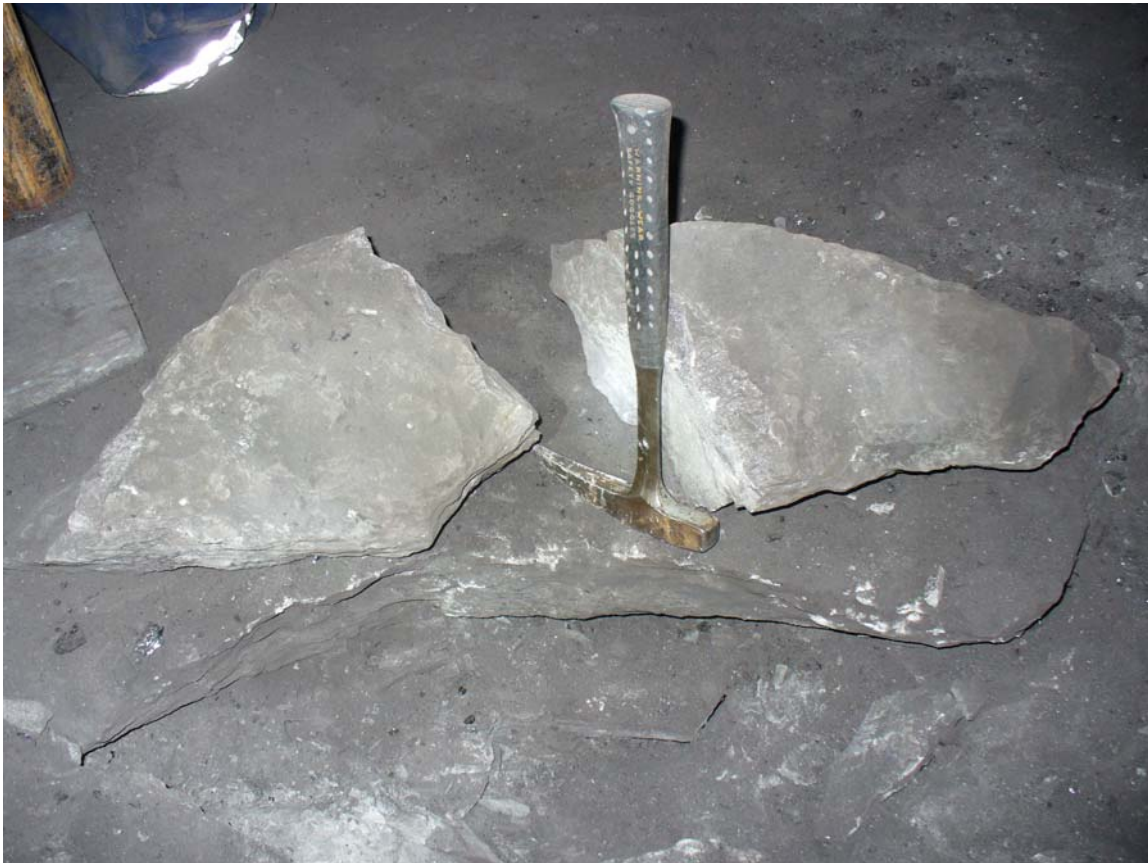
Figure Q-5. Sample of sandstone was collected from floor heave brow beneath survey station 22582 in 1 North Panel longwall tailgate, 36 feet outby the face. Brow of heaved sandstone slab reveals rootless crack.

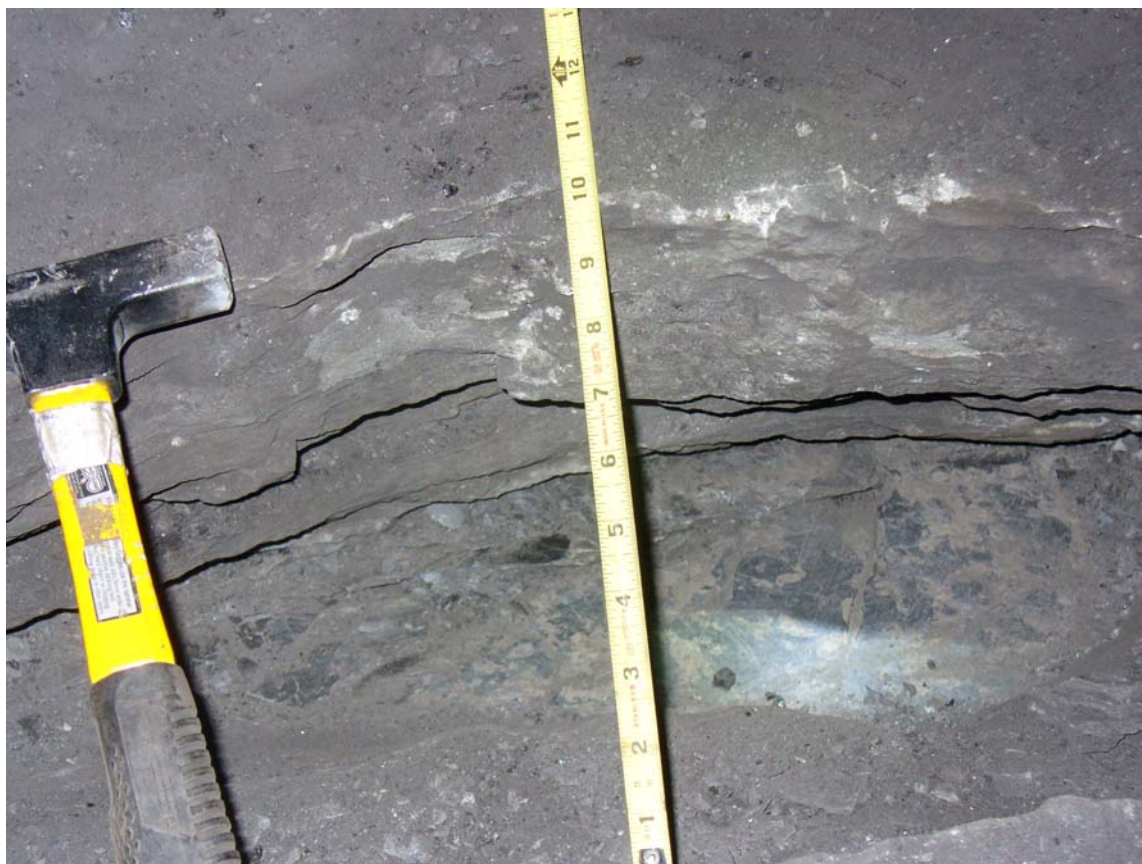
Figure Q-6. View of exposed floor heave crack looking straight down, with hammer and tape measure for scale. The crack is rootless and dies out approximately 12 inches into the floor at a layer of shale.

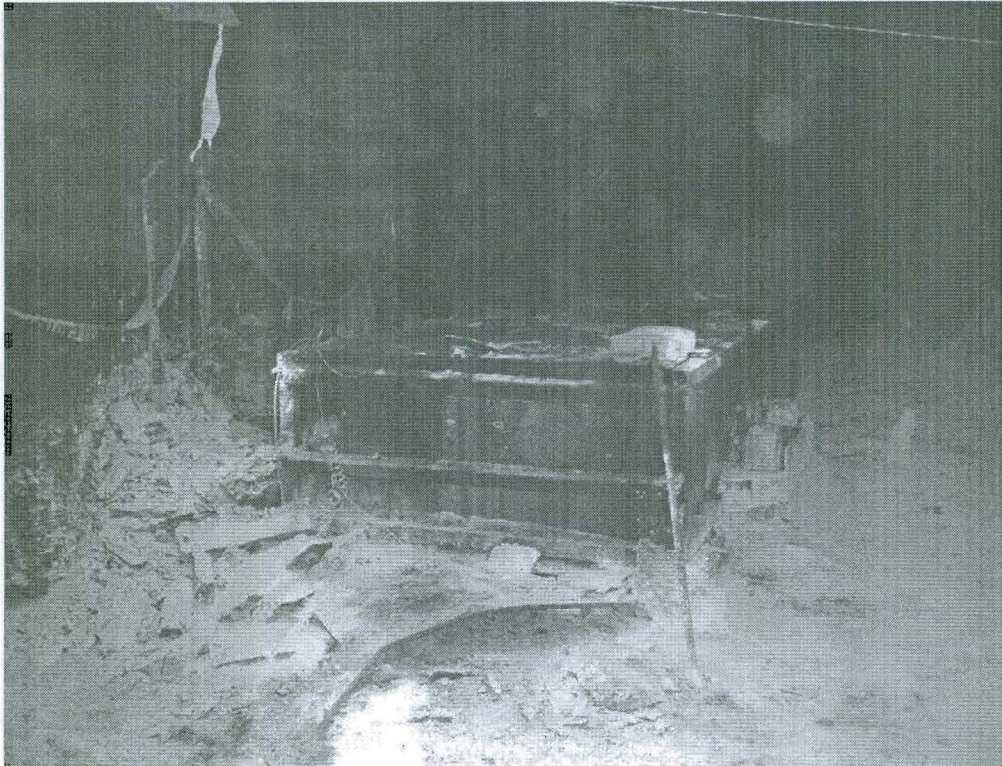
- The unit appeared to have been under up to 20 inches of water. The water reportedly built up following the explosion and while the mine's pumps were not operated. The water was eventually pumped and the area was dry during the inspection.
- Side access door showed no visible damage and there was no evidence of moisture.
- There was evidence of heating on a plastic bag containing the hand-held gas detector stored in this compartment.
- Solaris™ gas detector was located in this compartment. It could not be determined if the detector would operate from the affects of the flash fire and heating due to the battery status. The detector had remained in place and had not been charged since the explosion. There was no visible evidence of damage or heat effects to the detector.

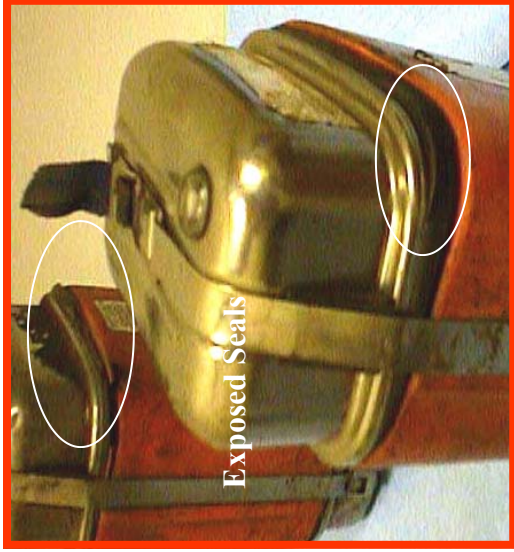
Seals are protruding and security band out of alignment. Such conditions result from forceful impacts.

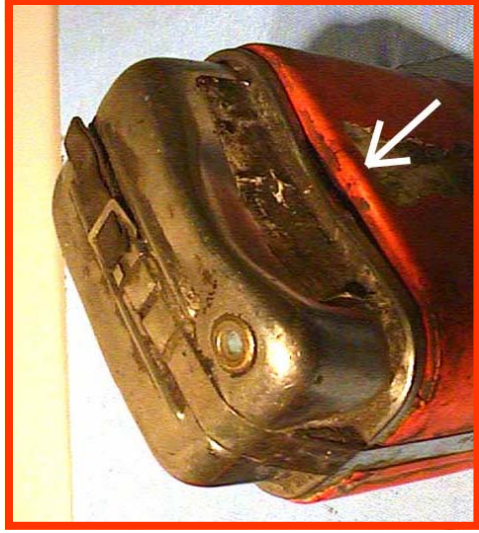
This unit has received a severe impact to its top cover. As a result, the top cover has a significant dent and the seal ring has been displaced.
