UNITED STATES  
DEPARTMENT OF THE INTERIOR  
BUREAU OF MINES  
DIVISION OF COAL MINE INSPECTION

FINAL REPORT OF MULTIPLE FATAL MAN-TRIP ACCIDENT  
VALLEY CAMP NO. 3 MINE  
THE VALLEY CAMP COAL COMPANY  
TRIADELPHIA, OHIO COUNTY, WEST VIRGINIA

September 9, 1966

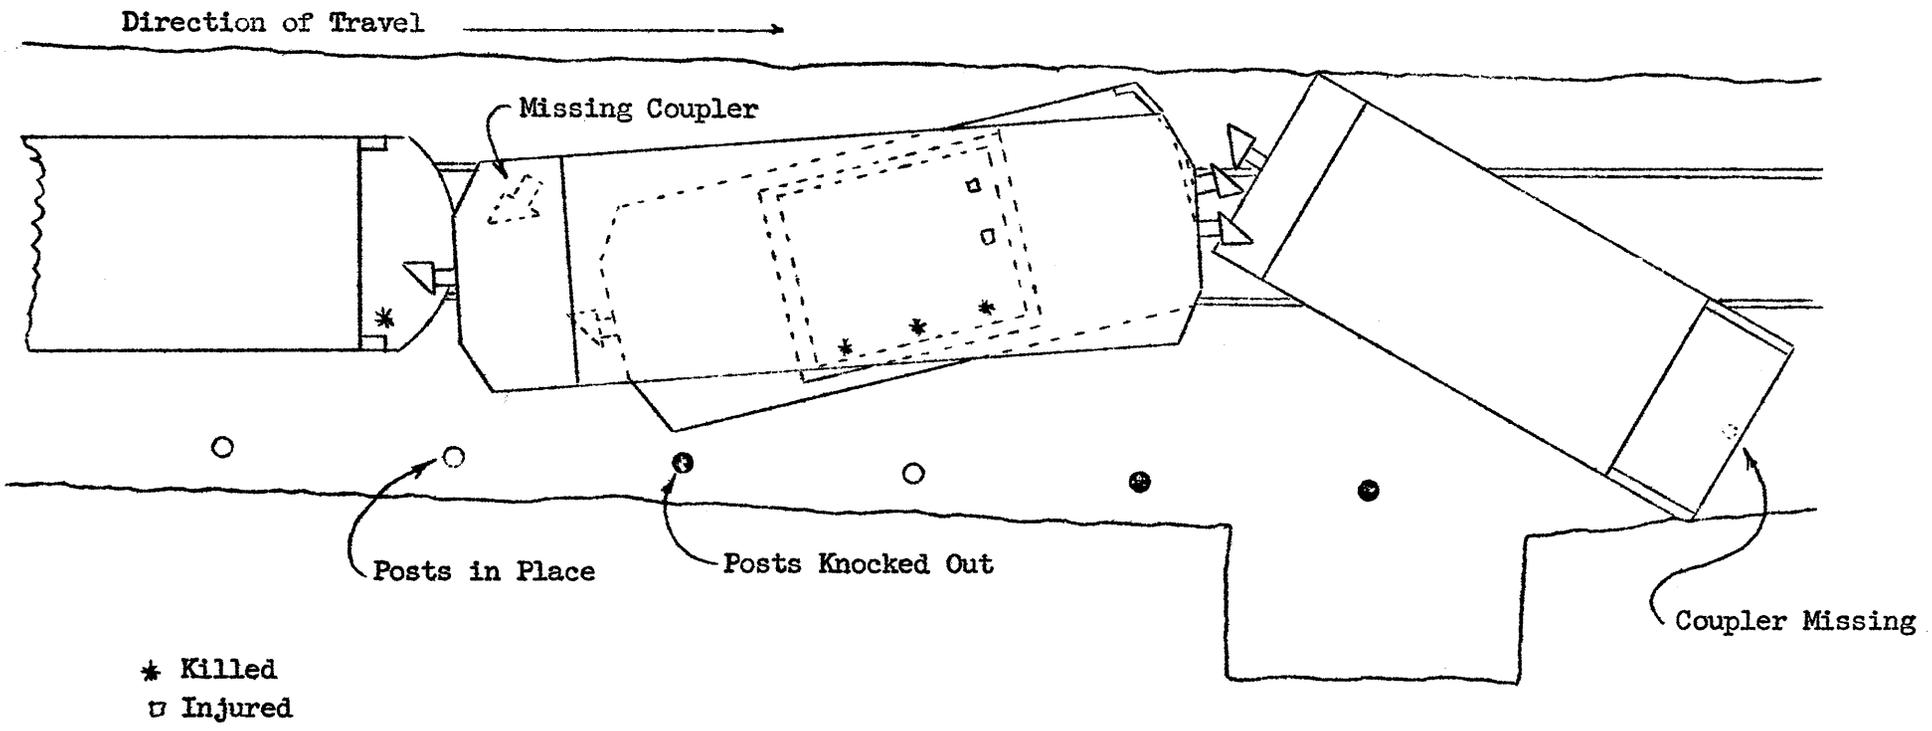
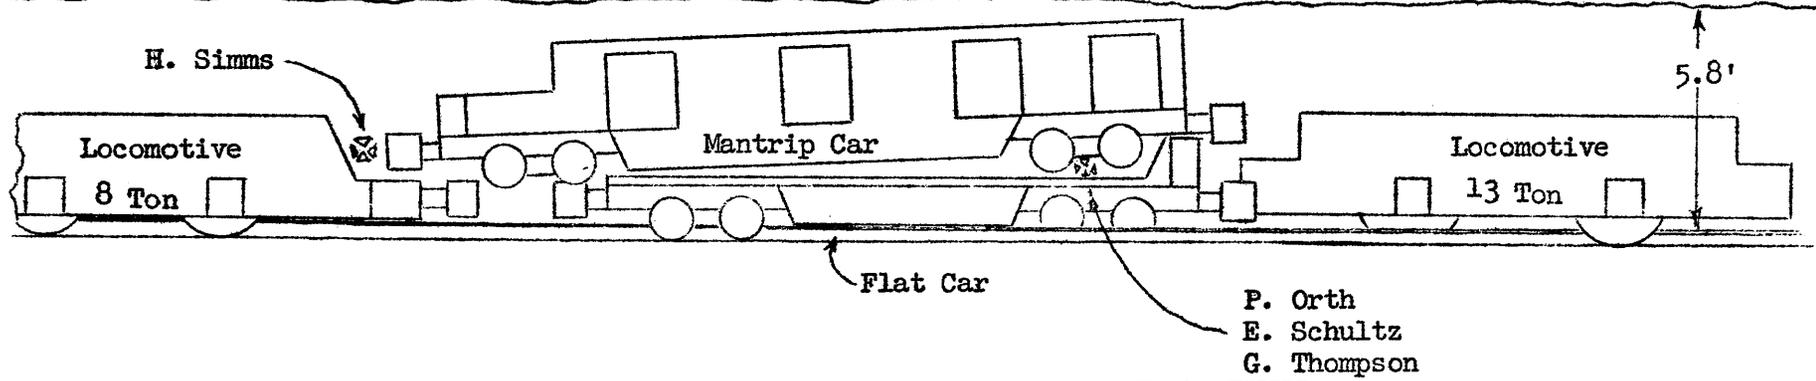
SKETCH OF MULTIPLE FATAL MANTRIP ACCIDENT  
 VALLEY CAMP NO. 3 MINE  
 THE VALLEY CAMP COAL COMPANY  
 TRIADELPHIA, OHIO COUNTY, WEST VIRGINIA  
 September 9, 1966

Point of Origin: The investigation disclosed that the automatic coupler had fallen from the front bumper of the lead locomotive to the roadbed between the rails. The coupler caught the bottom of the rear traction motor of the front locomotive as it passed over it, and it was derailed with the rear wheels to the wire side. The open car was next to pass over the coupler, and the front end of this car was derailed toward the wire side while the rear wheels went off the track on the clearance side. About the time that the full length of the open car had passed over the coupler, the front locomotive lodged cross-wise in the entry and brought the trip to an abrupt stop. This forced the covered man-trip car over the top of the open car, causing it to come to rest on the open car after the bumper struck the front locomotive. The rear locomotive came to rest against the coupling of the man-trip car which overrode the bumper and seat of the locomotive, the area in which one of the victims was seated. The rear wheels of this locomotive were also off the track. The impact caused the cover plates of the front locomotive to be thrown off onto the floor on the wire side.

Cause of Accident: The accident was caused when the automatic coupling, which apparently was not secured with a coupling pin, fell from the front bumper of the locomotive which was pulling the man trip from the 13 east section and derailed the locomotive and the first car of the trip.

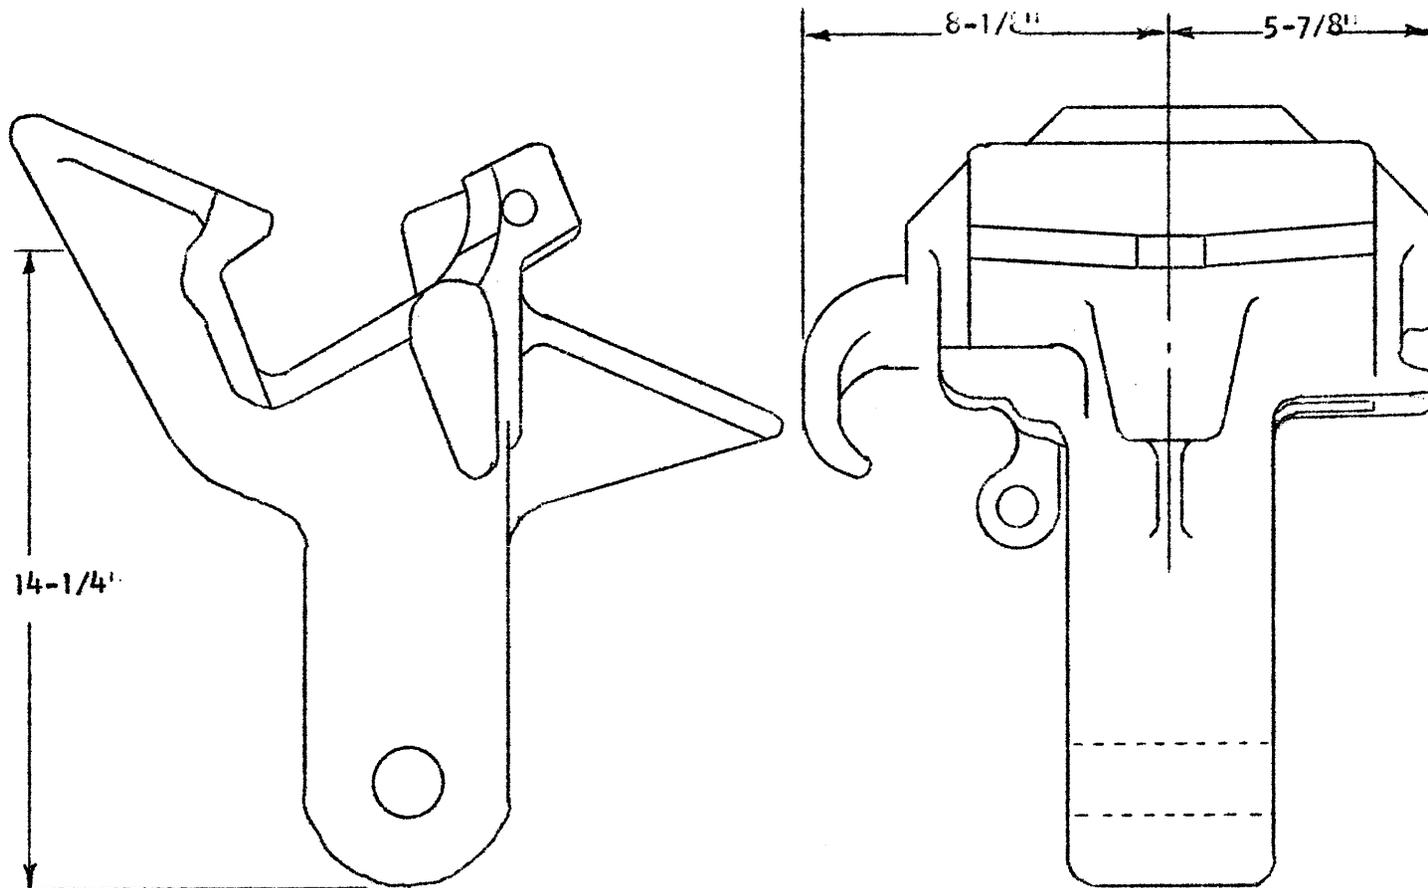
SKETCH SHOWING DIMENSIONS OF COUPLER  
MULTIPLE FATAL MANTRIP ACCIDENT  
VALLEY CAMP NO. 3 MINE  
TRIADELPHIA, OHIO COUNTY, WEST VIRGINIA  
September 9, 1966

1. The coupling pin for the automatic coupler on the front end of the lead locomotive was missing, allowing this coupling to slip out of the bumper pocket and fall to the roadbed. The reason why the coupling pin was missing could not be ascertained definitely. However, information obtained during the investigation disclosed that a loose coupling pin was found on the rear seat of the front locomotive before the departure of the man trip.
2. Heavy materials were being hauled in the same car in which men were being transported.
3. Men were riding in an open car and on the two locomotives when, apparently, there was available seating space in the covered man-trip car.

1. Positive means should be provided to hold the coupling pins securely in place. Motormen should be certain that the pins are in place and locked securely before haulage operations begin and at frequent intervals throughout the shift.
2. Materials or tools should not be transported in the same car with men on any man trip, except in special compartments in such cars.
3. Men should not be transported on flat open-type cars when followed by other track equipment coupled in train.
