UNITED STATES  
DEPARTMENT OF THE INTERIOR  
BUREAU OF MINES

FINAL REPORT OF MAJOR MINE-EXPLOSION DISASTER  
VIKING MINE  
VIKING COAL CORPORATION  
TERRE HAUTE, VIGO COUNTY, INDIANA

March 2, 1961

F. J. Smith  
District Supervisor

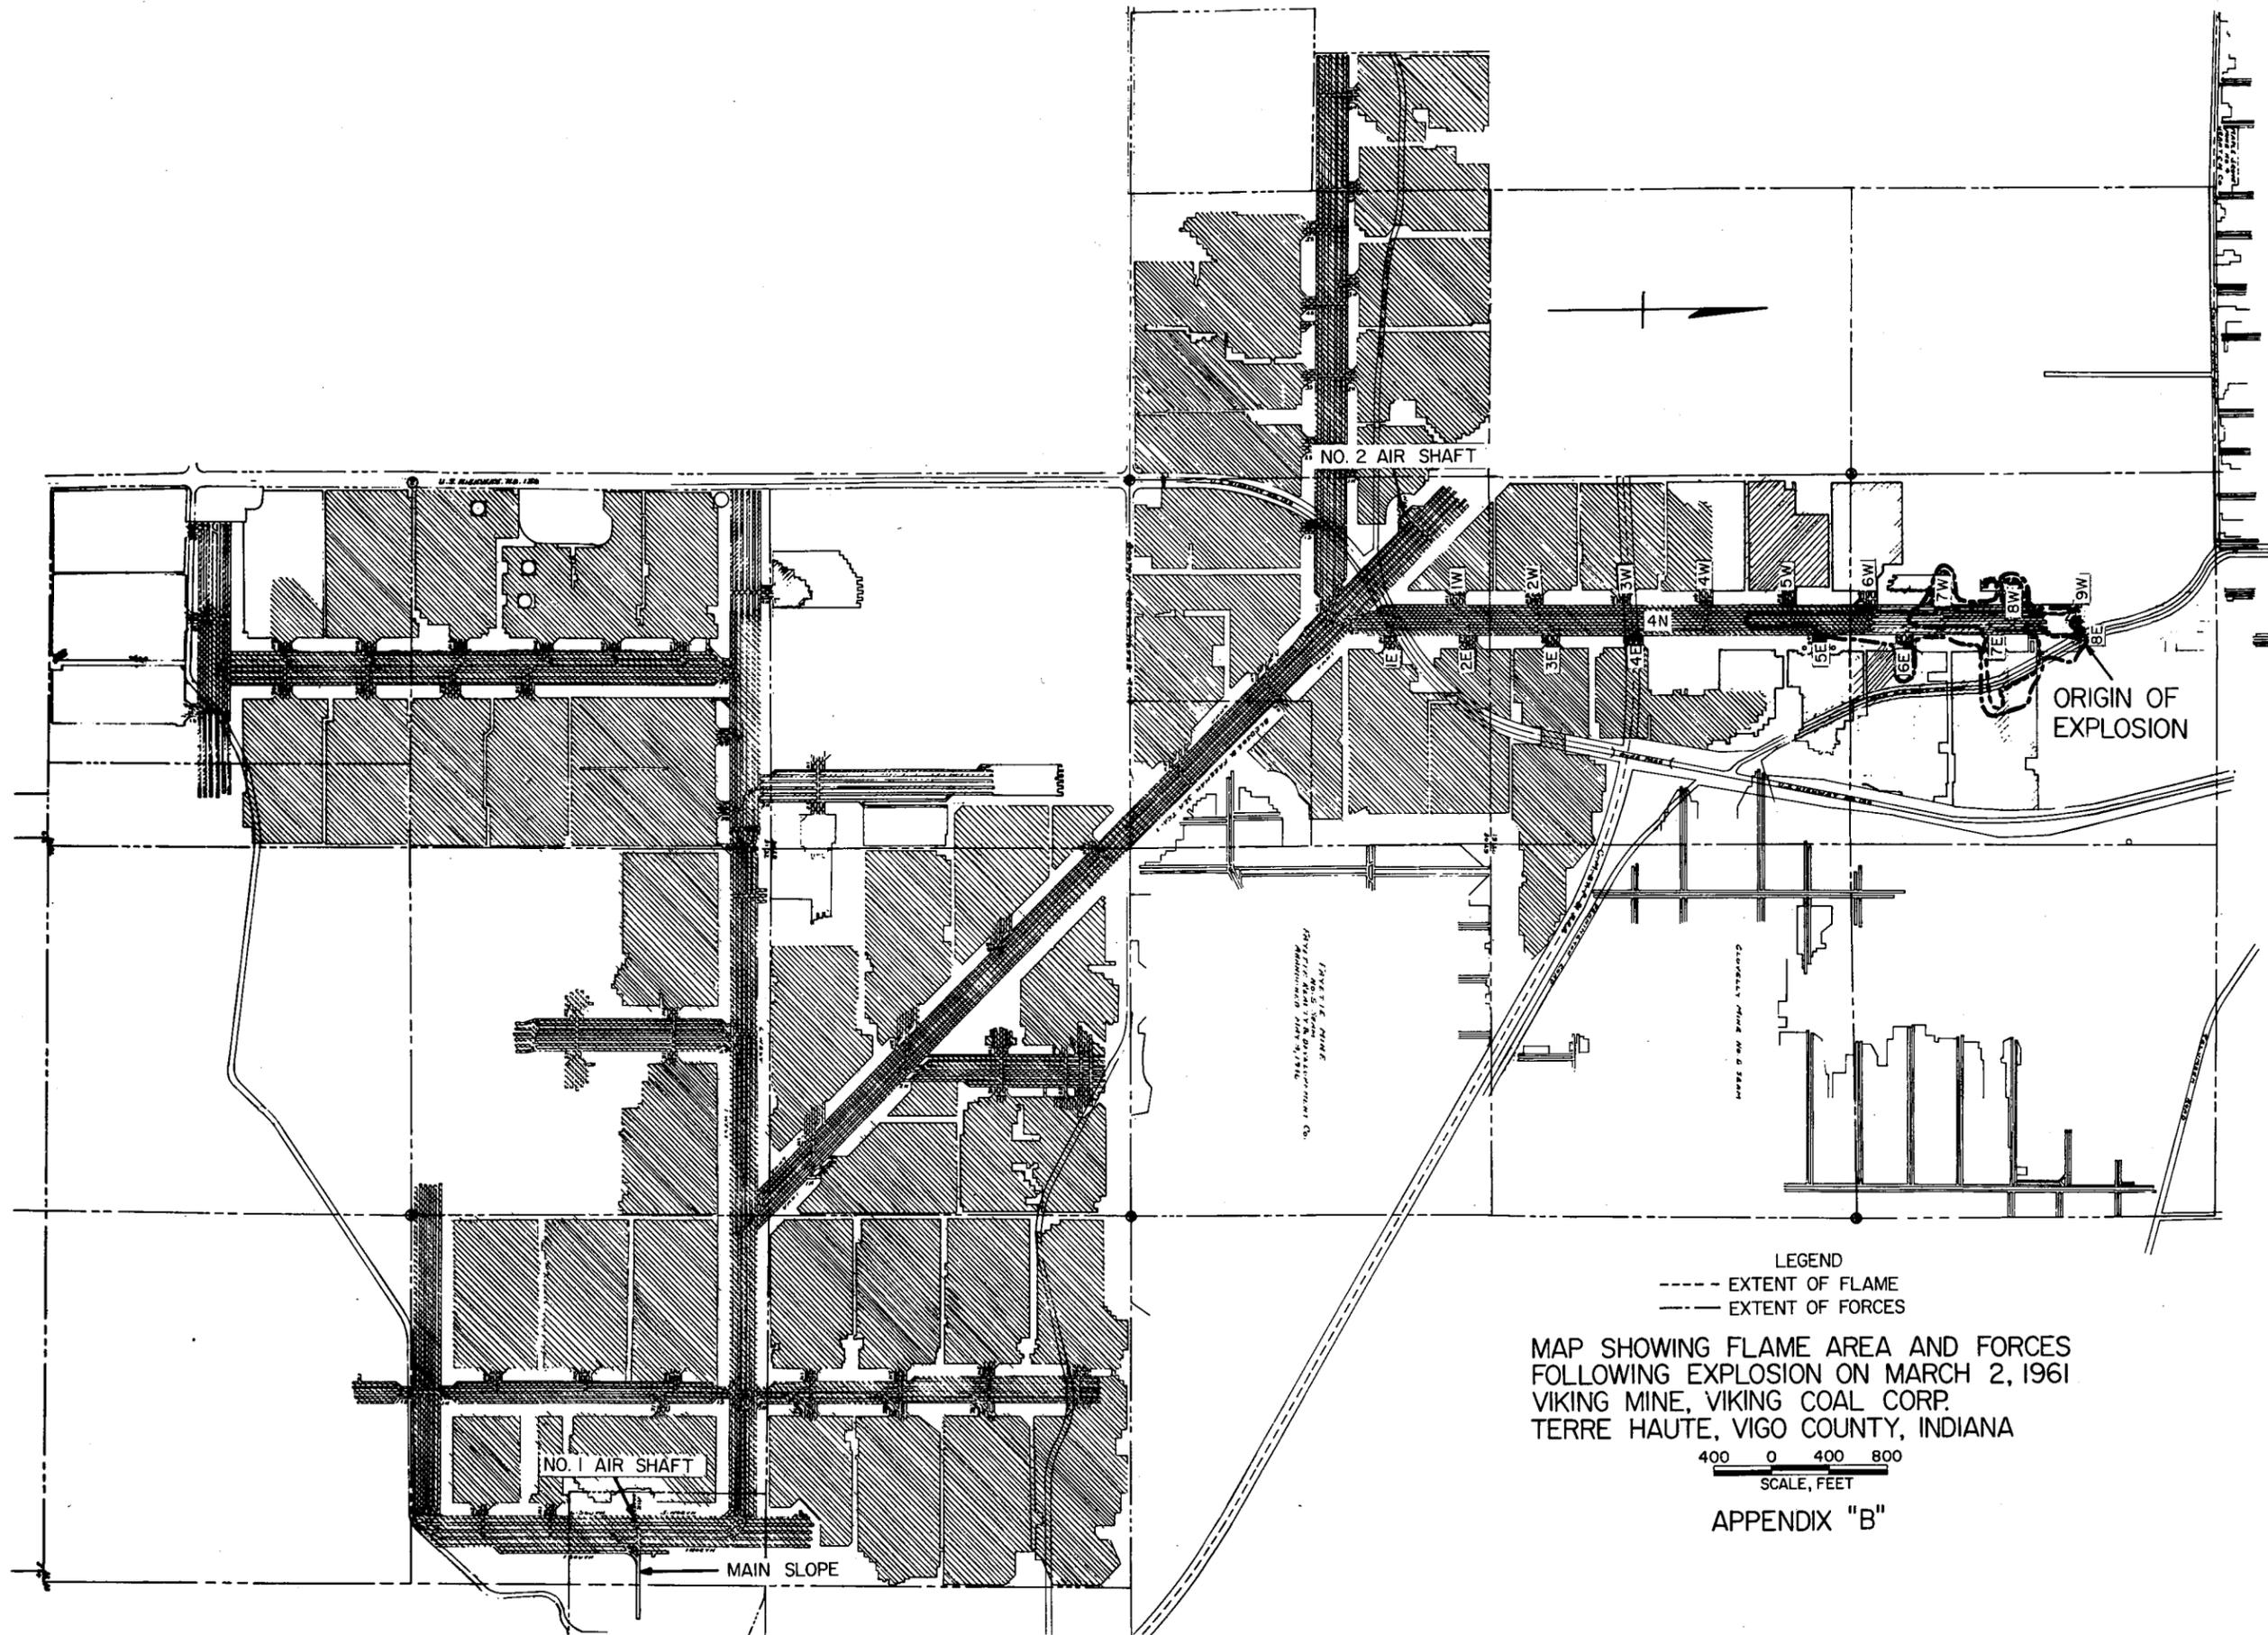
APPENDIX "B"

Bureau of Mines investigators believe that the explosion originated at or near the intersection of the 4 north Right "B", and 8 east Right "A" entries in the 4 north section off the north-west angles when an explosive mixture of methane-air was ignited by an electric arc or

Forces of the explosion radiated from the junction of the 4 north Right "B" entry, and 8 east Right "A" entry and spread left and right into the worked-out 7 and 6 east sections, the active 7 west section and the temporarily idle 8 west section and extended to about 250 feet outby the 5 east section in the 4 north entries off the north-west angles.

ORIGIN OF EXPLOSION

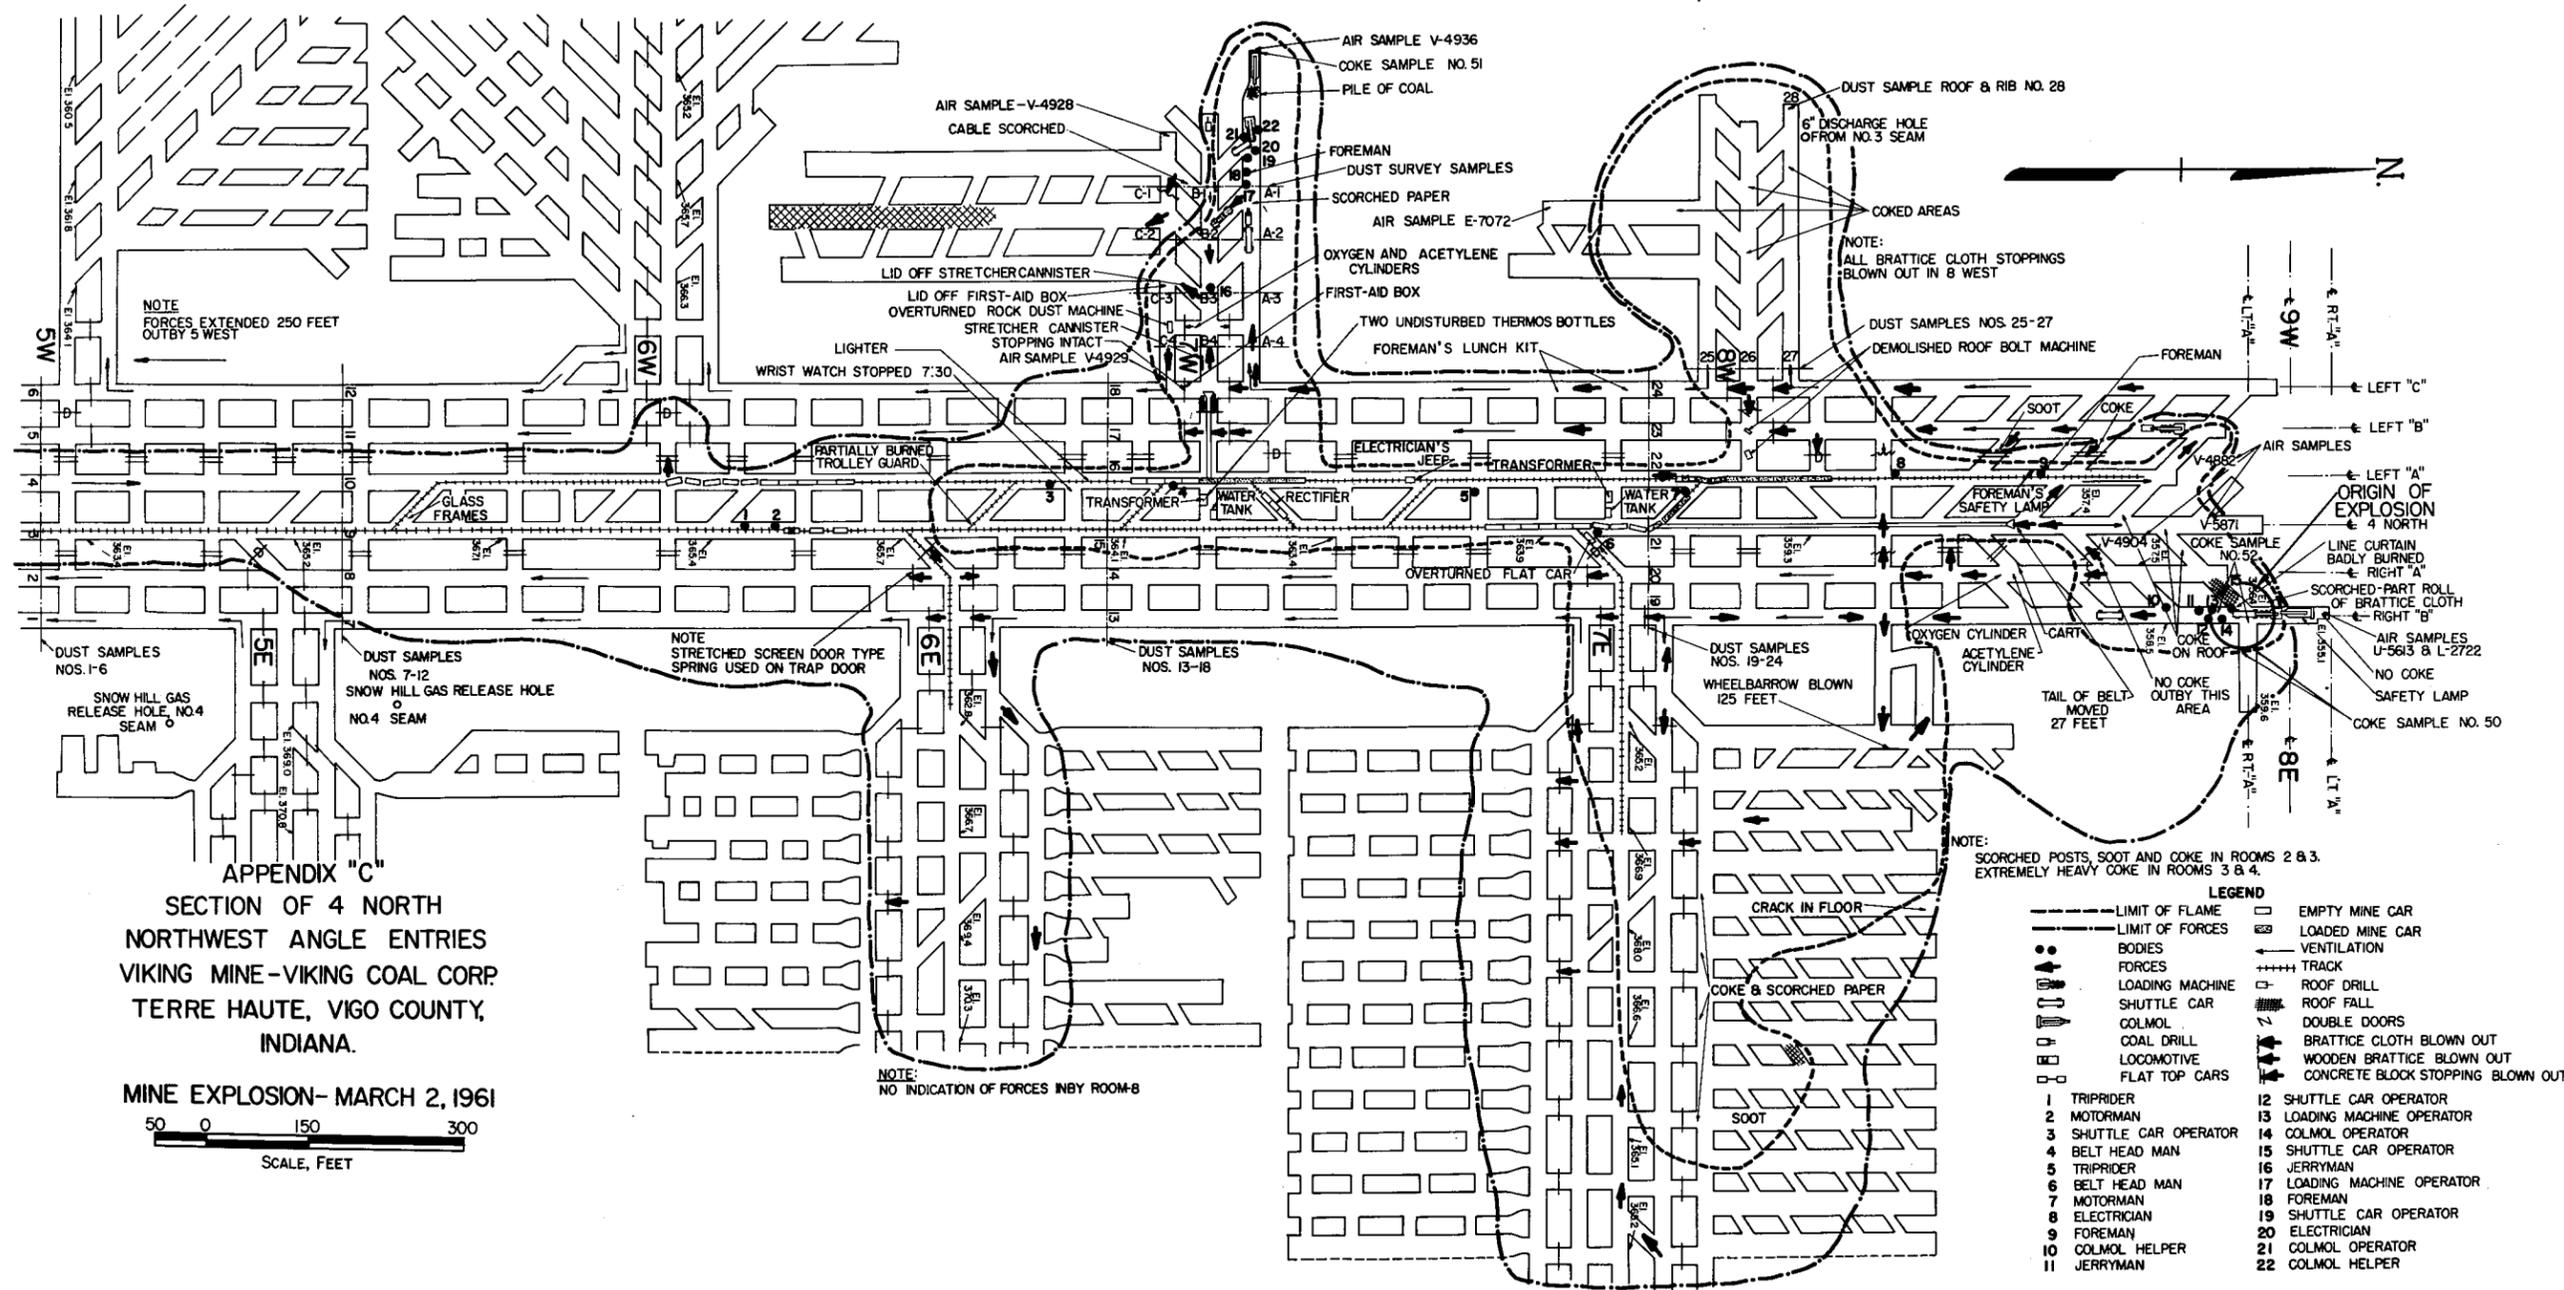
APPENDIX "C"  
SECTION OF 4 NORTH  
NORTHWEST ANGLE ENTRIES  
VIKING MINE-VIKING COAL CORP.  
TERRE HAUTE, VIGO COUNTY,  
INDIANA.

empty shuttle car had back switched or was in the act of back switching into the 4 north Right "B" entry. This shuttle car was forced or moved a short distance down the entry. All the controls of the face equipment were in the "off" position. The bodies of all the victims were found lying face down and all were headed in the same direction, away from the face area. The continuous-miner operator and his helper were the only victims that were not burned seriously and both died from lack of oxygen or from inhaling hot gases. The section foreman was apparently eating his lunch in the 4 north Left "A" entry and the electrician was found about 140 feet outby the section foreman in the same entry. There was coal on the 4 north belt conveyor and 10 cars were loaded with coal; eight were in the 4 north Left "A" entry and two were in the slant crosscut between the 4 north and 4 north Left "A" entries. A 13-ton locomotive was in front of the 8 loaded cars. Ten-car trips were usually hauled to the bottom from this working section, and since the required number of cars were loaded, the trip was about to be assembled and hauled to the bottom. The motorman was found about 10 feet from his locomotive in the slant crosscut between the locomotive and the belt head, and the trip rider was found in the third crosscut, about 200 feet outby the motorman. The belt-head operator was located about 60 feet outby the belt head. (Appendix C)

The six men in the 7 west Right "A" entry were found within a few feet of one another between the last two open crosscuts. Apparently they had been moving away from the face area and were lying on their stomachs with hands trying to protect their faces. The jerryman was found in the 7 west entry about 60 feet outby the loaded shuttle car he was operating as relief driver during the regular driver's lunch period. The belt-head operator and the recently relieved shuttle-car operator were located 40 and 150 feet, respectively, outby the 7 west belt head on the 4 north Left "A" entry. (Appendix C)
