REPORT OF INVESTIGATION
UNDERGROUND MINE COAL DUST EXPLOSION

No. 11 Mine (ID No. 15-02290)
Adkins Coal Company
Kite, Knott County, Kentucky

December 7, 1981

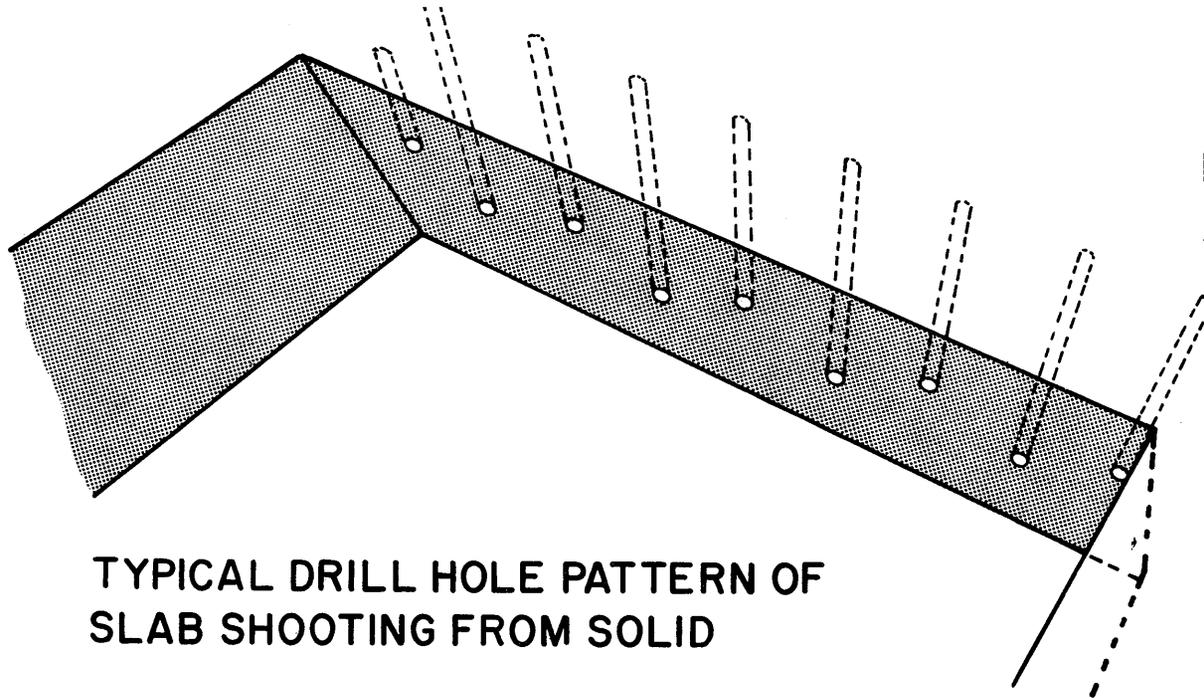
TYPICAL DRILL HOLE PATTERN OF
SLAB SHOOTING FROM SOLID

Coal was blasted from the solid face by certified shot firers using a method commonly called "slab shooting." When using this method, the breaker hole is drilled at an angle of about 45 degrees toward the rib from a point along the face to a depth that would cause the shot to pull the coal to develop a straight rib and a second free-face. The remaining holes are then drilled across the face while continually lessening the angle until the rib hole on the other side of the entry is drilled straight into the face so that a straight rib will be formed that will be flush with the existing rib. In preparing the places to be blasted, there were 7 to 9 blast holes drilled about 30 inches apart, ranging in depth from 4 to 10 feet in both the entries and crosscuts. See Appendix E for a typical sketch for hole placement for slab shooting off the solid.

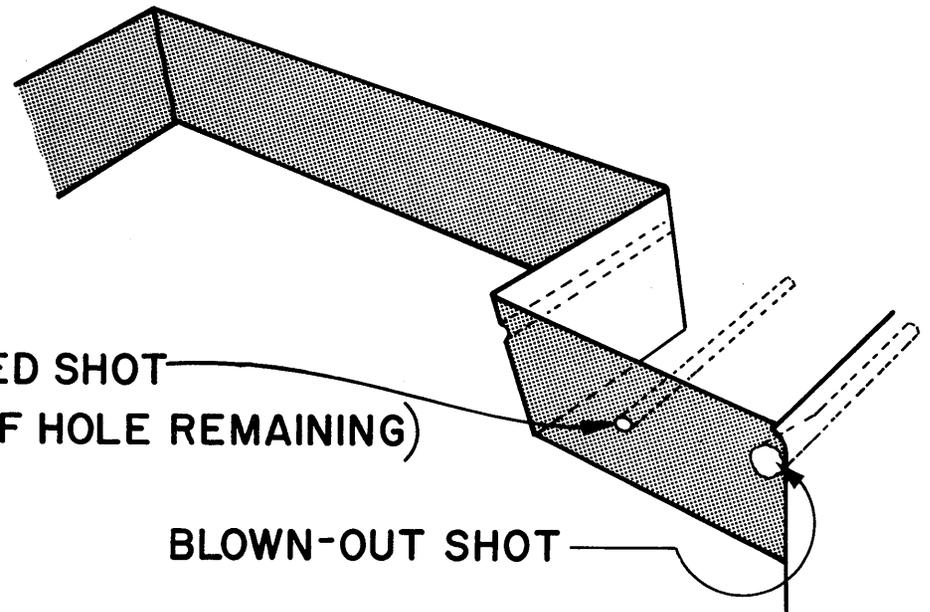
11. The misfired blast hole in the face of the No. 1 entry was 74 inches in depth and contained a continuous train of undetonated explosives. This blast hole contained at least 6 cartridges of explosives which weighed approximately 5 pounds. This was in excess of the 3-pound per hole limitation. The investigators found no evidence of stemming or a blasting cap in this hole.

FAILED SHOT
(74" OF HOLE REMAINING)

BLOWN-OUT SHOT
