UNITED STATES
DEPARTMENT OF THE INTERIOR
BUREAU OF MINES
DISTRICT C

REPORT OF MULTIPLE FATAL COAL MINE ROOF-FALL ACCIDENT
NO. 22 MINE
BETH-ELKHORN CORPORATION
ELKHORN DIVISION
DEANE, LETCHER COUNTY, KENTUCKY

May 23, 1967

Jack E. Tisdale
Technical Assistant

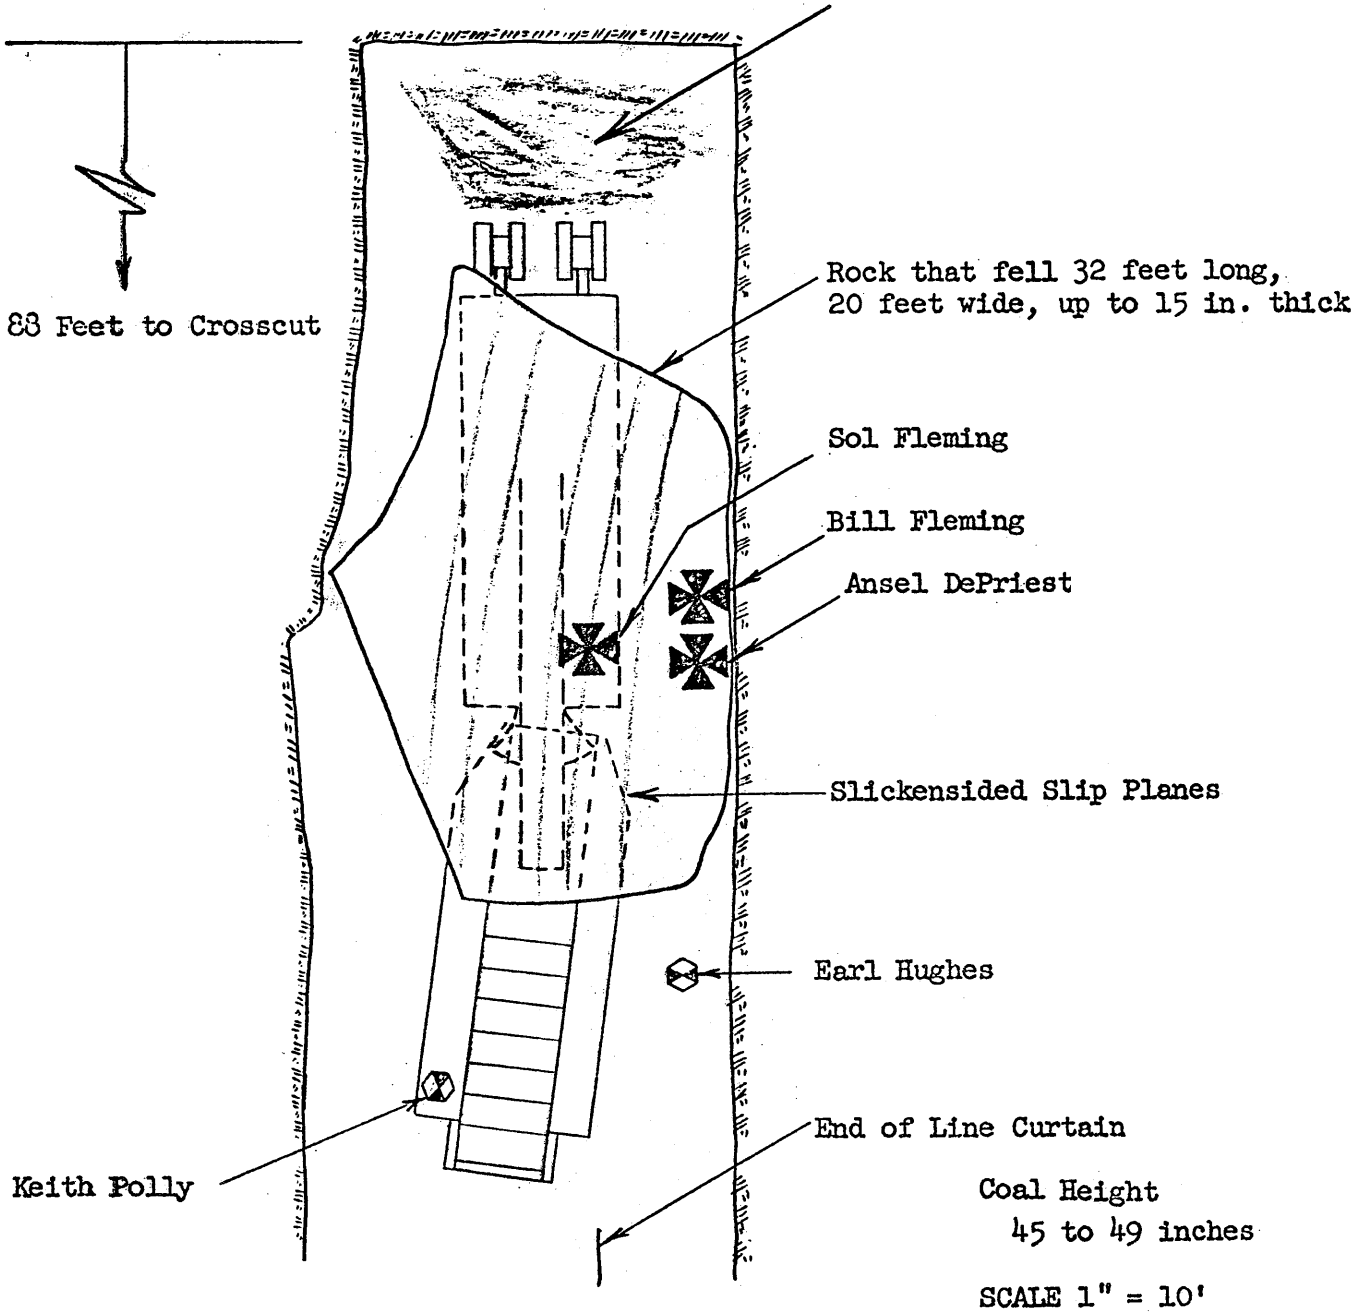
No. 3 Entry

Loose Coal 4 to 10 inches Thick

The roof in No. 3 entry had been sandstone, but where the accident occurred a shale lens was present under an upward roll of the sandstone. The line of separation where the roof changed was not easily seen, and the roof remained even and flat across the shale lens. The shale lens was 32 feet long, 20 feet wide, and varied from 7 to 15 inches thick across the entry from right to left. The entire lens fell, except for some overhand on the left rib, and it broke into several long pieces conforming to the slip planes present.
