UNITED STATES
DEPARTMENT OF LABOR
MINE SAFETY AND HEALTH ADMINISTRATION

FINAL REPORT OF MULTIPLE FATAL ROPE FALL ACCIDENT

FINAL REPORT OF MULTIPLE FATAL ROOF FALL ACCIDENT

BERGER NO. 2 MINE (ID NO. 15-13202)
BON TRUCKING COMPANY, INC.
EVARTS, HARLAN COUNTY, KENTUCKY

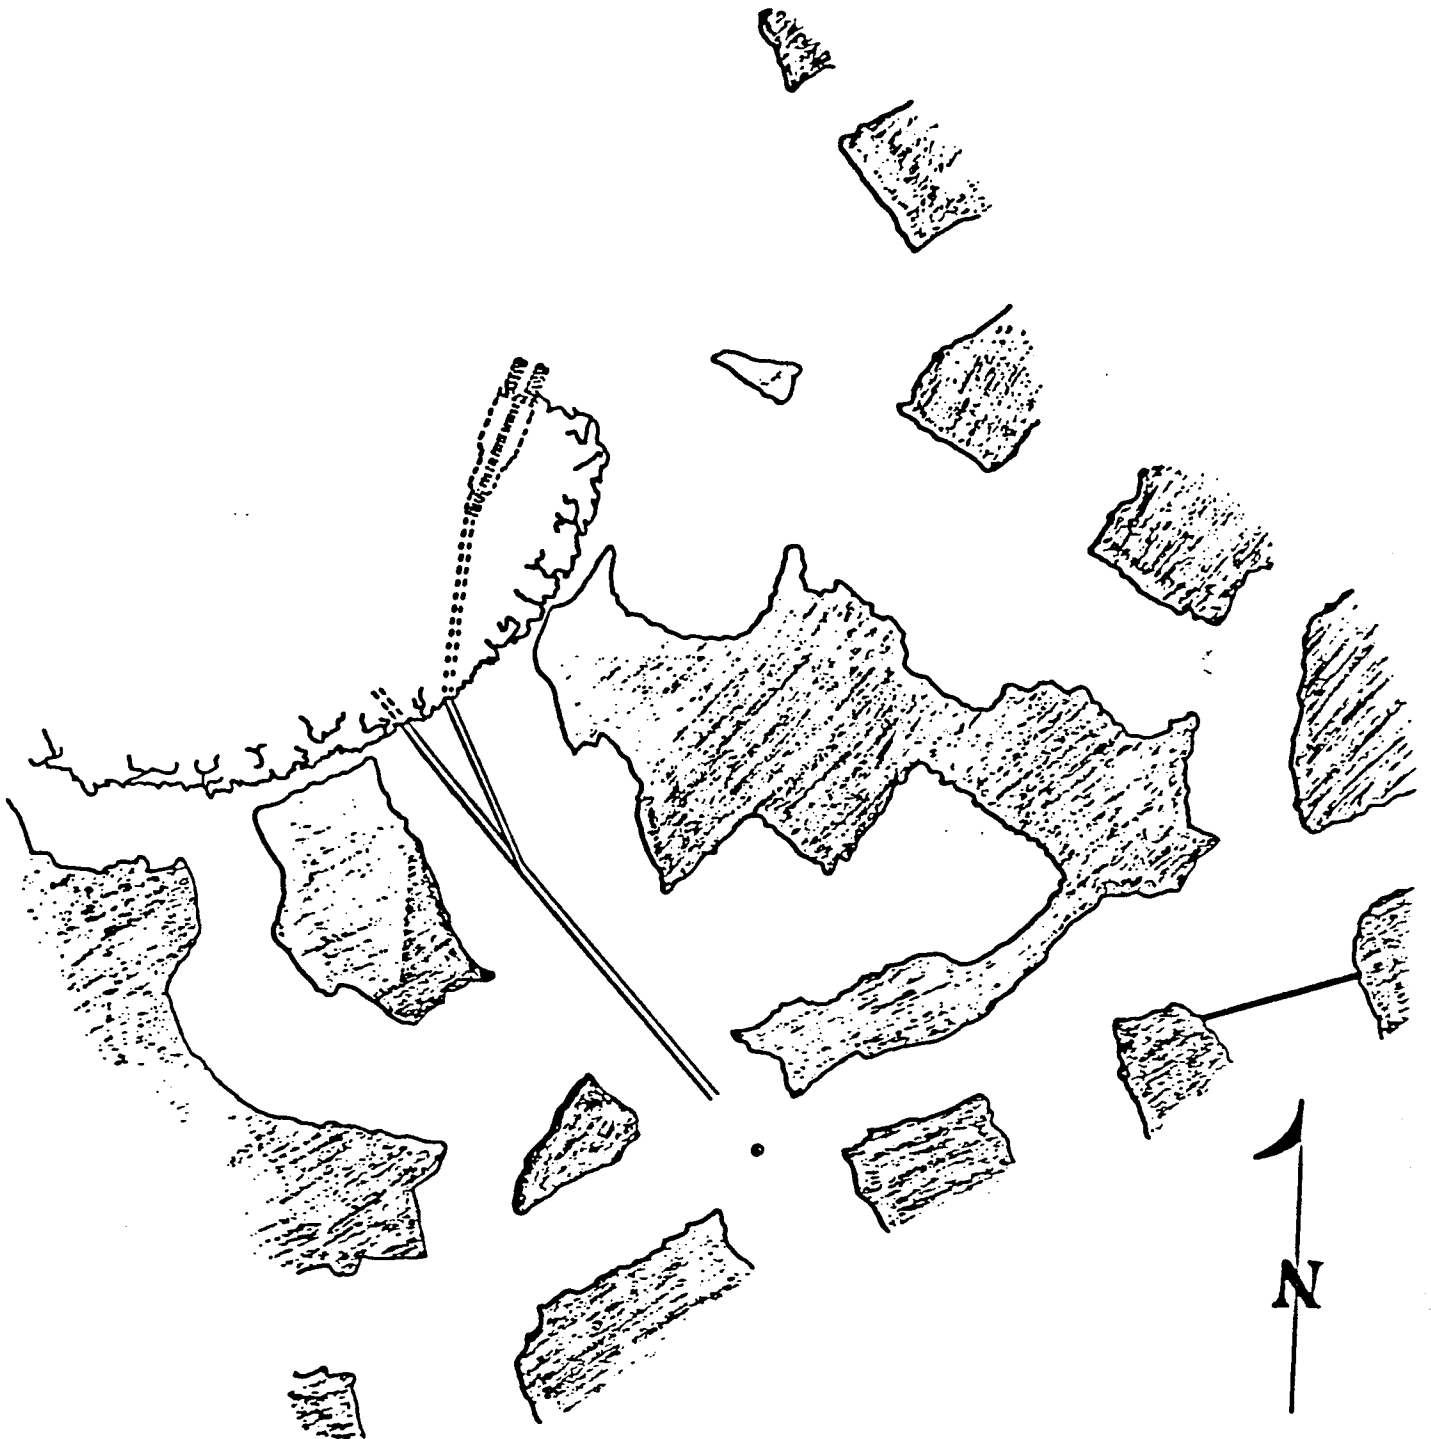
REDUCED SCALE COPY OF EXHIBIT NO. 8
Berger No. 2 Mine (ID No. 15-13202)
Bon Trucking Company, Inc.
Evarts, Harlan County, Kentucky
September 12, 1984

Exhibit Number 8 is a one-inch equals ten-foot sketch of the immediate accident scene showing the approximate location of the continuous mining machine, bridge conveyor, belt haulage conveyor, and the roof fall. This sketch was drawn from measurements taken during the underground investigation on September 19 to 21, 1984. See Appendix H.

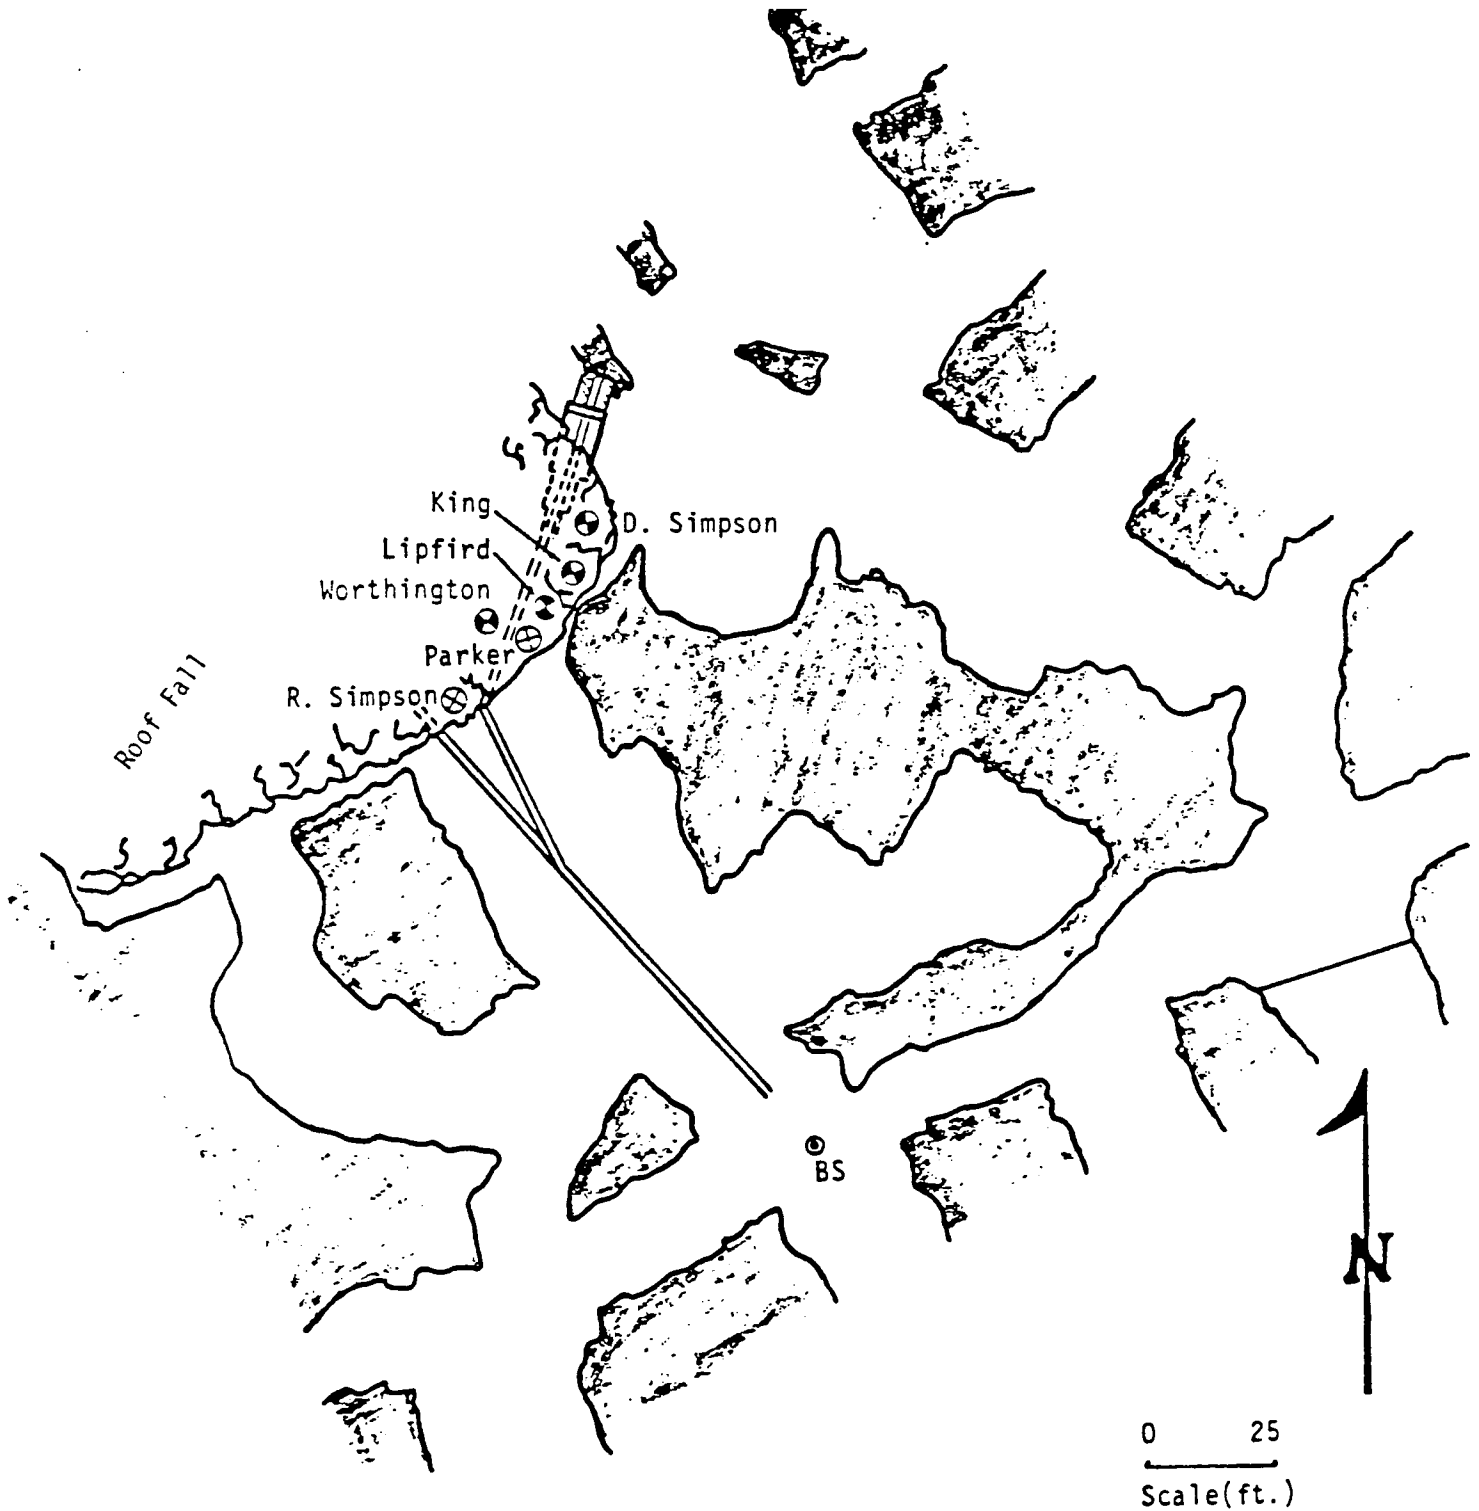
SKETCH OF MULTIPLE FATAL ROOF FALL ACCIDENT
Berger No. 2 Mine (ID No. 15-13202)
Bon Trucking Company, Inc.
Evarts, Harlan County, Kentucky
September 12, 1984

The accident occurred with little or no warning while repairs to a bridge conveyor, used with an auger-type continuous mining machine, were being made. A large portion of the roof, about 100 feet long, 30 feet or more wide, and 10 feet to a featheredge in thickness, fell and covered one bridge conveyor and part of the mining machine.
