FINAL REPORT OF MAJOR MINE-EXPLOSION DISASTER  
NO. 2 MINE  
CARBON FUEL COMPANY  
HELPER, CARBON COUNTY, UTAH

December 16, 1963

Lester D. Knill  
Subdistrict Supervisor

Joseph Freeman  
Coal Mine Inspector

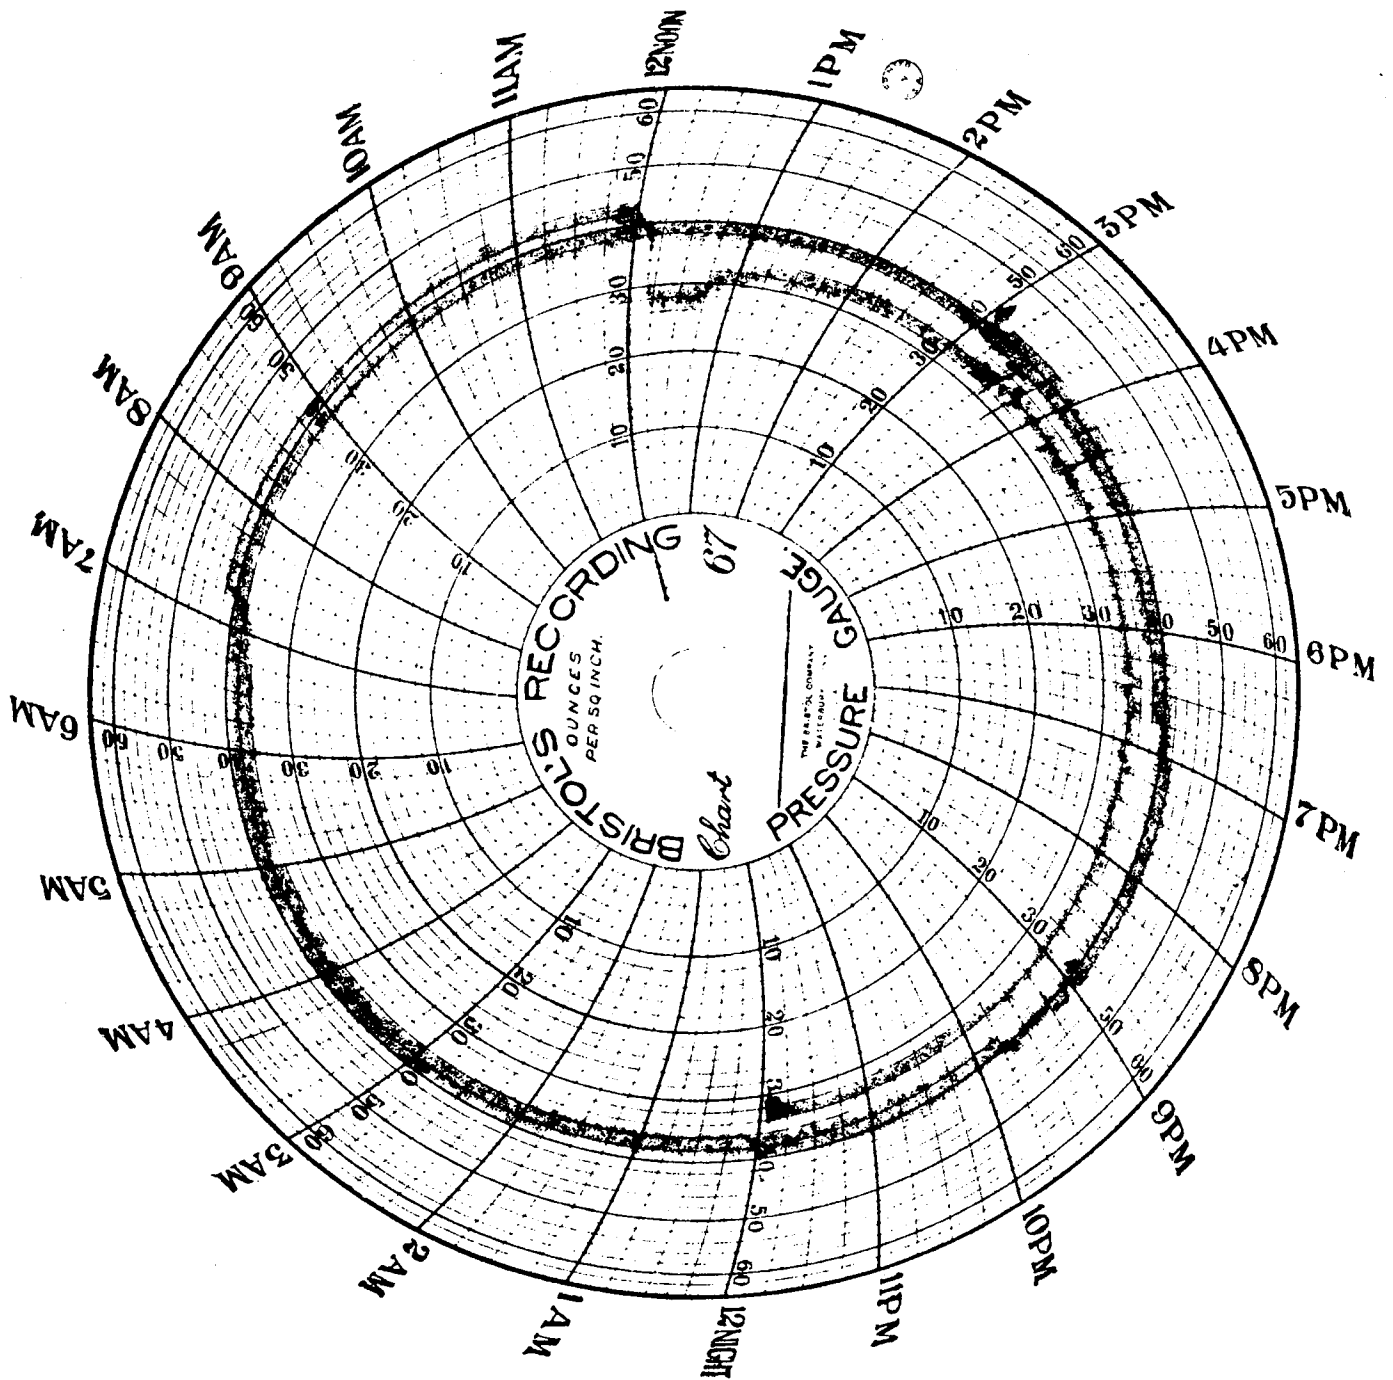
FAN CHART - DECEMBER 16, 1963

1. The explosion involving methane and coal dust occurred about 12 m. Monday, December 16, 1963. The time of occurrence was arrived at by the fan chart and statements from men in other areas of the mine. (Refer to appendix D.)
2. The victims died in a relatively short time from carbon monoxide poison and burns. All received first to third degree burns, one a fractured right skull and compound fracture of the left hand, one a severe concussion, and one a possible skull fracture.
3. Methane was being liberated in the face areas, and had been found infrequently with a flame safety lamp in the fifth west dip section. Methane was detected in the disaster area about 1:15 p.m. the day of the explosion and an air sample collected at the face of No. 4 dip entry after ventilation had been reestablished contained 0.26 percent methane.
