FINAL REPORT, EXPLOSION, CARSWELL MINE,  
KOPPERS COAL COMPANY, KIMBALL,  
McDOWELL COUNTY, WEST VIRGINIA,  
JANUARY 22, 1941

W. J. Fene  
Mining Engineer

F. E. Griffith  
Assistant Mining Engineer

UNITED STATES  
DEPARTMENT OF THE INTERIOR  
BUREAU OF MINES

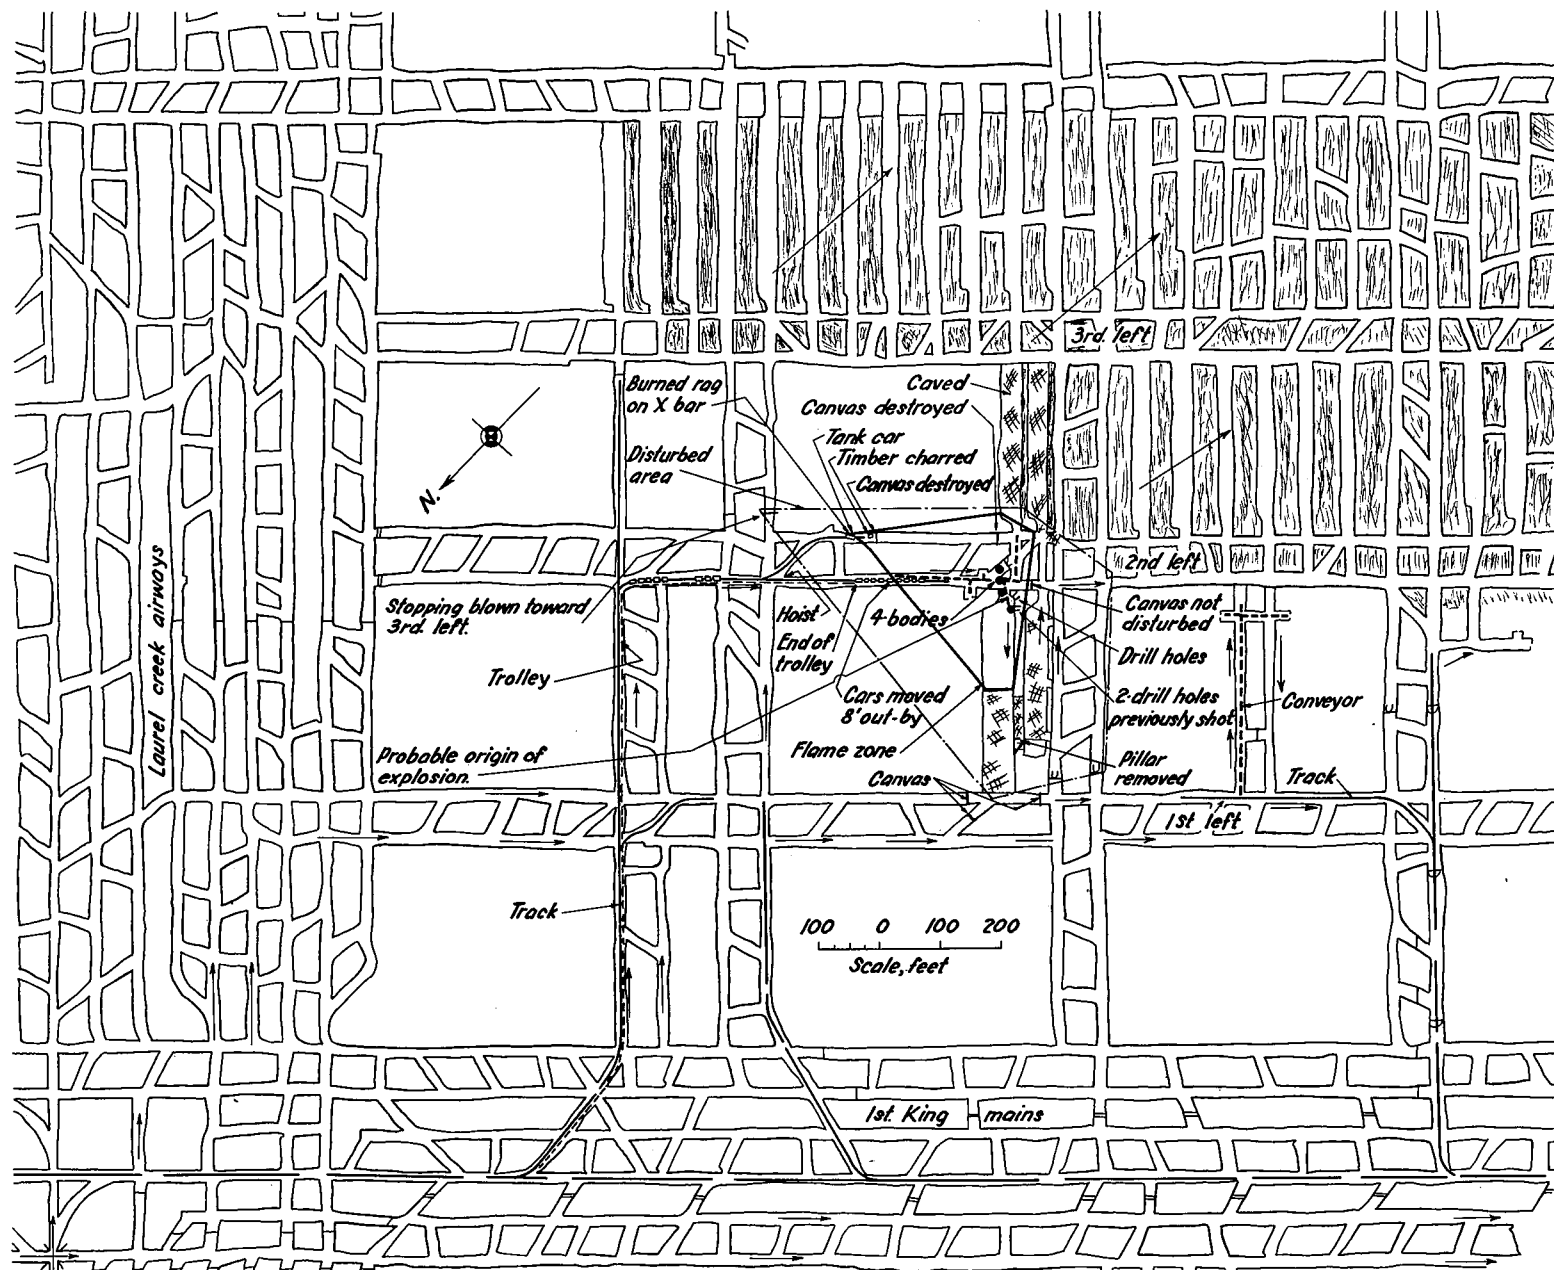
EXPLOSION AREA AND WORKINGS IN 2ND. LEFT OFF 1ST. KING MAINS - CARSWELL MINE - KOPPERS COAL CO. JAN. 22, 1941.

From evidence found following the explosion and from statements of survivors it appears that the explosion had its origin at the mouth of room 36 when gas issuing from this room was ignited by an arc from the nips of a mining machine cable which were attached to the power cable at this point.

The explosion was confined to the 2nd left conveyor section. A canvas check curtain and a post had been set afire on 2 left entry 160 feet in by 41 room. This fire was extinguished by the party making the first exploration of the section. Relatively little property damage was done with the exception of disrupted and torn-down cables, damaged electric junction box, conveyor pans moved about, and a cave at the intersection of 36 room with 2 left air course.

The inspectors of the West Virginia Department of Mines who investigated the explosion and the Bureau of Mines investigators were in agreement that the cause of the explosion was the ignition of gas by an electric arc at the intersection of 36 room with 2 left air course.
