REPORT OF UNDERGROUND COAL MINE INVESTIGATION
MULTIPLE FATAL FALLING OBJECT (ELEVATOR) ACCIDENT

CHETOPA MINE (I.D. NO. 01-00323)
ALABAMA BY-PRODUCTS CORPORATION
GRAYSVILLE, JEFFERSON COUNTY, ALABAMA

July 24, 1977

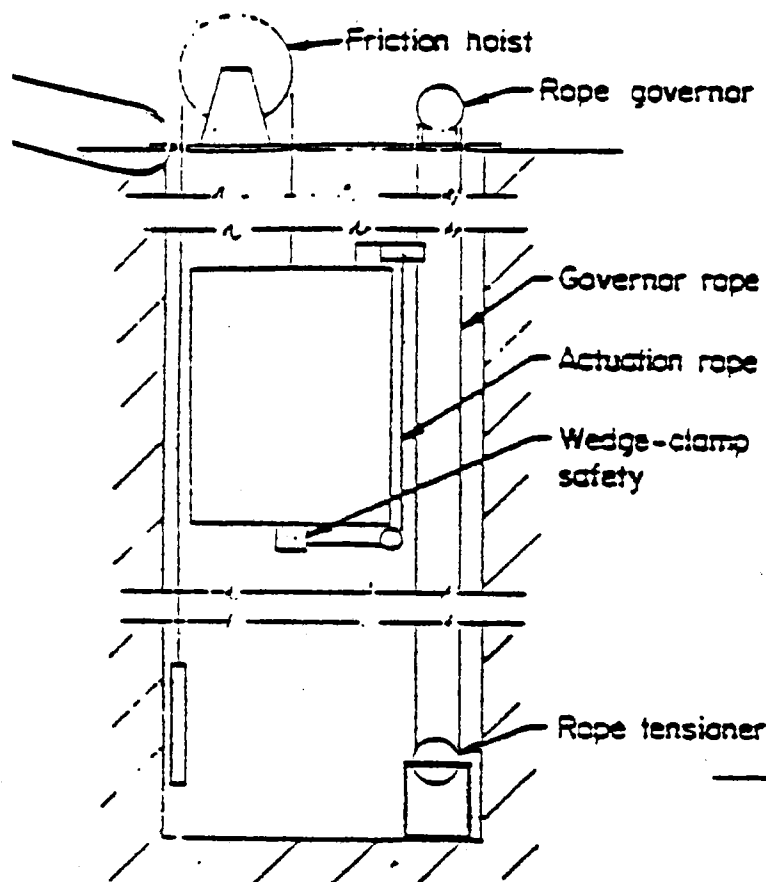
Elevator Schematic

13. The traction ropes broke because they were worn and corroded to the point where they could no longer sustain the load. The use of Fullers Earth and dripping water probably hastened the wear and corrosion of the traction ropes.

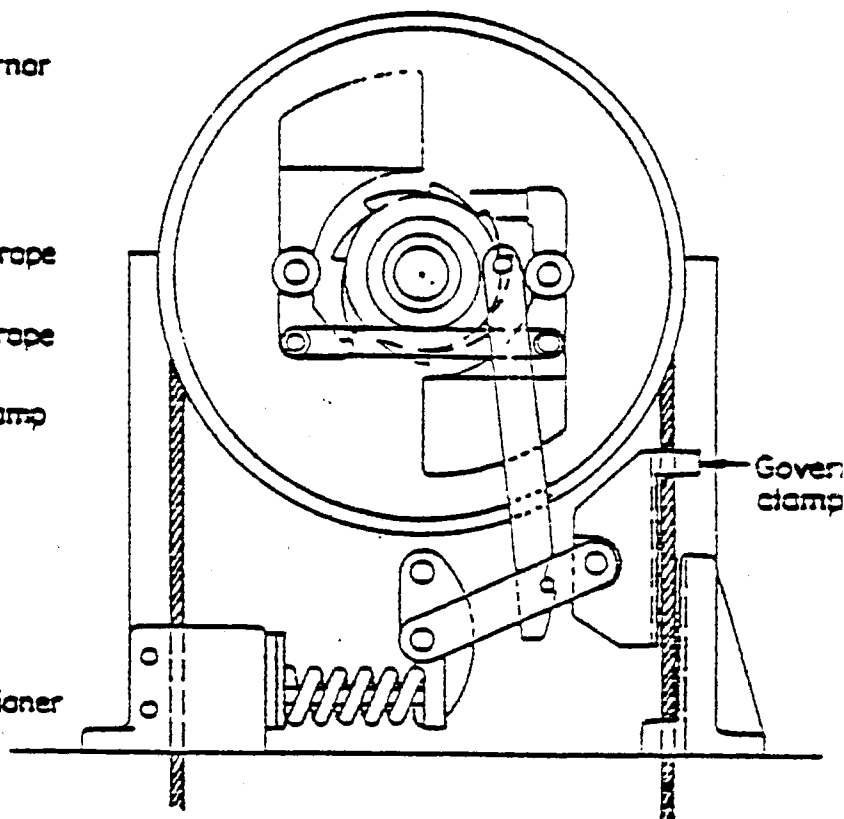
Rope Governor

6. The shaft was 18 feet in diameter, 409 feet deep, unlined and dripping water was present.
7. The position of the governor-rope release carrier in the shaft was approximately 205 feet from the floor of the machinery room, which indicates the governor rope gripping jaws functioned on overspeed and gripped the governor rope which pulled the safety rope from the releasing carrier.

10. The governor rope was of stainless steel type; however, the manufacturer of the governor specified that traction steel type be used.

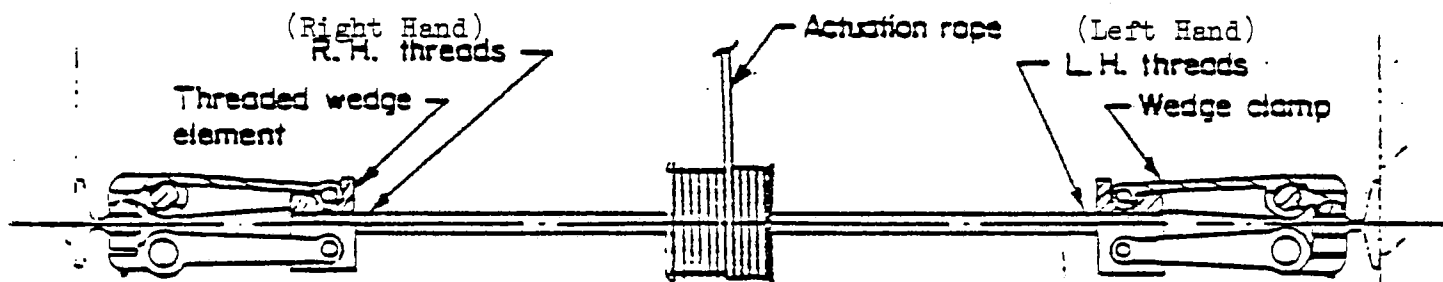
Type B (Wedge-Clamp) Safety
Plan View

8. Approximately 38 feet of the safety actuation rope was attached to the governor-rope releasing carrier socket, indicating that the safety rope pulled out of the safety rope drum. Details of the conveyance were not available to determine the original recommended length of the safety rope. The safety rope was attached to the drum by means of two 3/8 inch Allen Head screws (original design).

9. The end of the actuation rope that pulled from the drum had about 1 1/2 inches of two strands missing, indicating the Allen Head screws had cut the two strands.

11. The safety jaw gibs were badly worn, thickness of gibs ranged from 0.931 to 0.711 which would require more revolutions of the safety drum to cause the safety jaws to grip the guide rails which is a probable reason for the actuation rope pulling from the safety drum. When the safetys are fully set, there should be three full turns of rope remaining on the drum. Examination of the safety rope drum indicated that there were no more than 7 turns of safety rope stored on the drum prior to the accident. The safety rope drum was designed to hold 11 turns of rope. Photographs clearly show that 12 threads of the thread bar were beyond the safety wedge. Threads on the thread bar were 4 per inch, which indicated that 1 revolution of the rope drum would move the safety wedge 1/4 inch. It would take approximately 20 inches of rope being pulled from the drum to move the safety drum one complete revolution. Elevator safety standards (ANSI A 17.1) require that the actuation rope move no more than 30 inches before the safety jaws begin to exert pressure against the guide rails. Approximately 140 inches of rope had been pulled from the safety drum.
