FINAL REPORT ON COAL OUTBURST  
NO. 2 MINE  
CLINCHFIELD COAL CORPORATION  
DANTE, RUSSELL COUNTY, VIRGINIA  
May 20, 1948

Edward Thomas  
Mining Engineer

William R. Park  
Coal-Mine Inspector

Originating Office - Bureau of Mines  
Norton, Virginia  
W. H. Tomlinson, Engineer-in-Charge

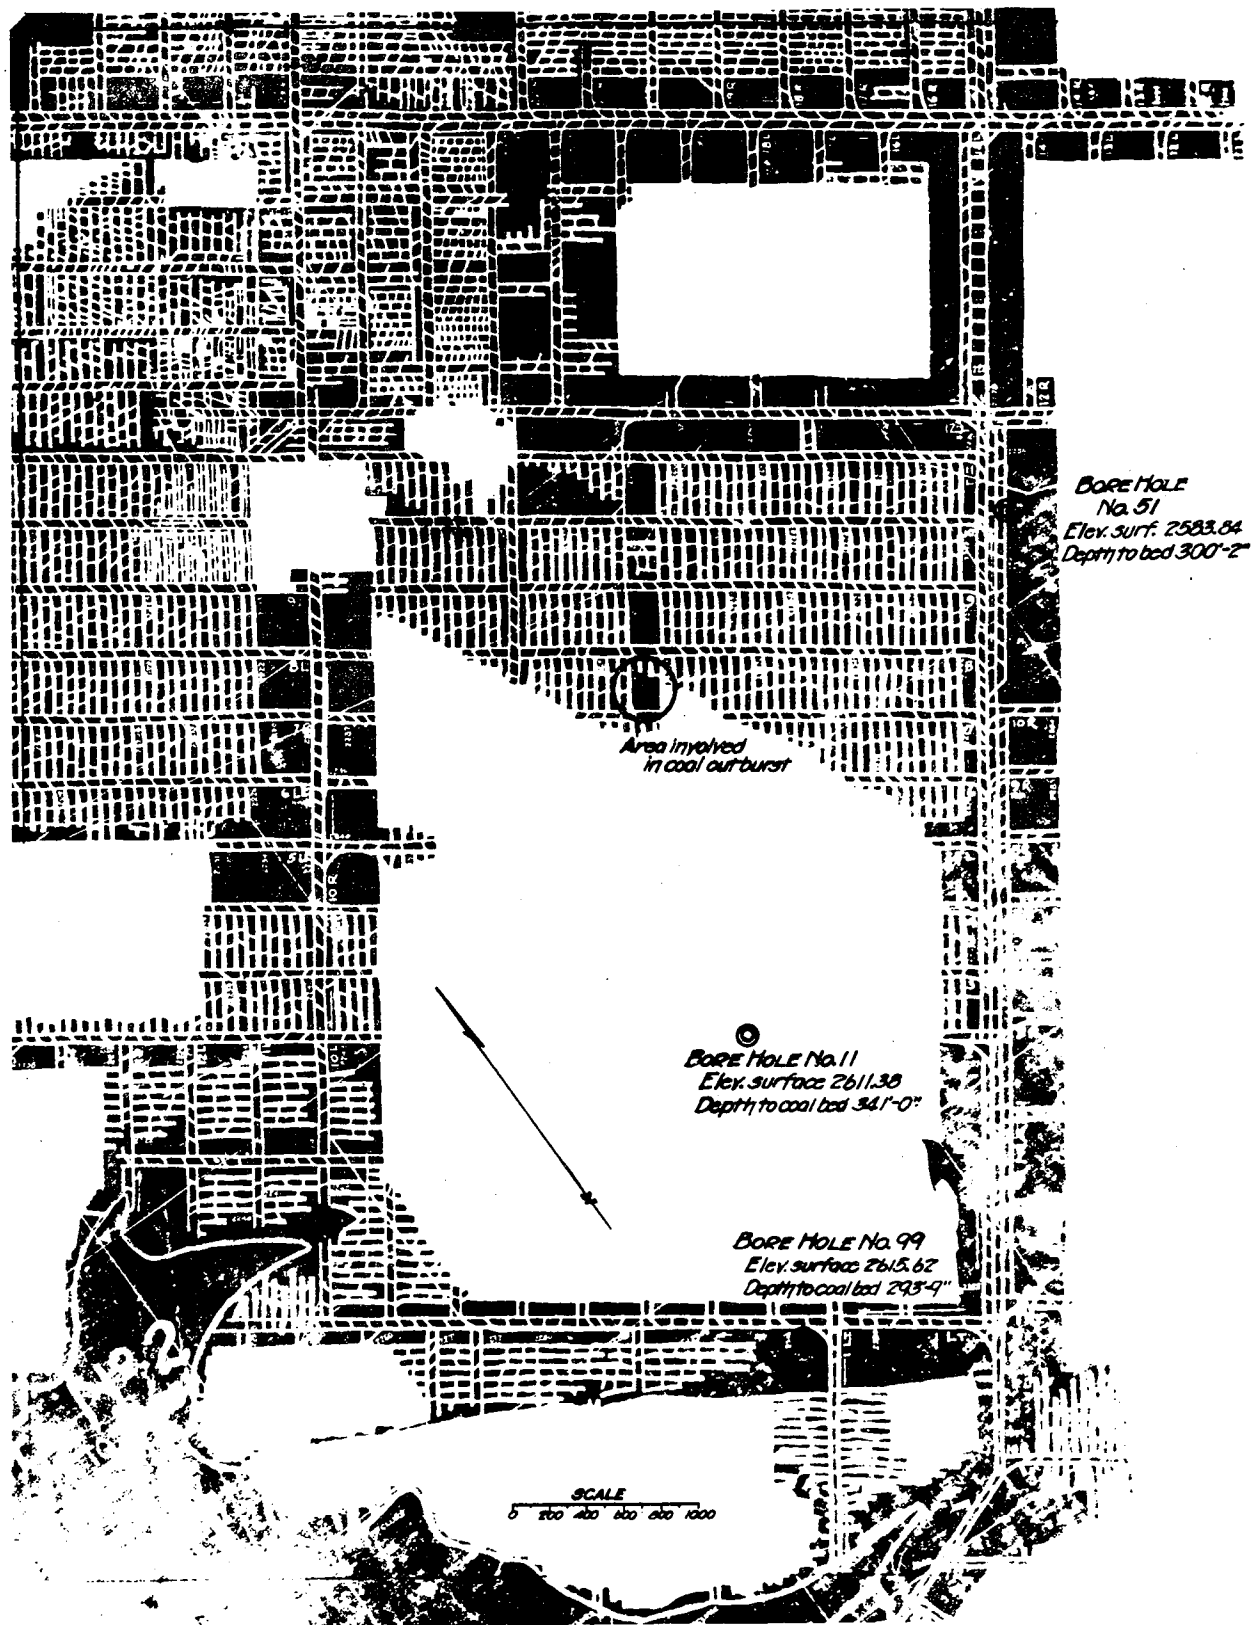
The overlying strata, as taken from logs of two boreholes drilled by the company about 2,000 feet from the affected area, are as follows: (The location of these boreholes with respect to the site of the outburst is shown in fig. 1.)

The two pillar lines shown in Figure 1 had been started during the press for production during the first world war, and in 1926, when the post-war market was more competitive, both pillar lines were abandoned. The barrier pillar had been left to prevent a squeeze which might develop on one pillar line from riding over to the other. At the time of reopening the area 22 years later, it was decided to abandon the pillars to the right of the barrier, because the roof had caved in many places, and to reestablish the pillar line to the left of the barrier.

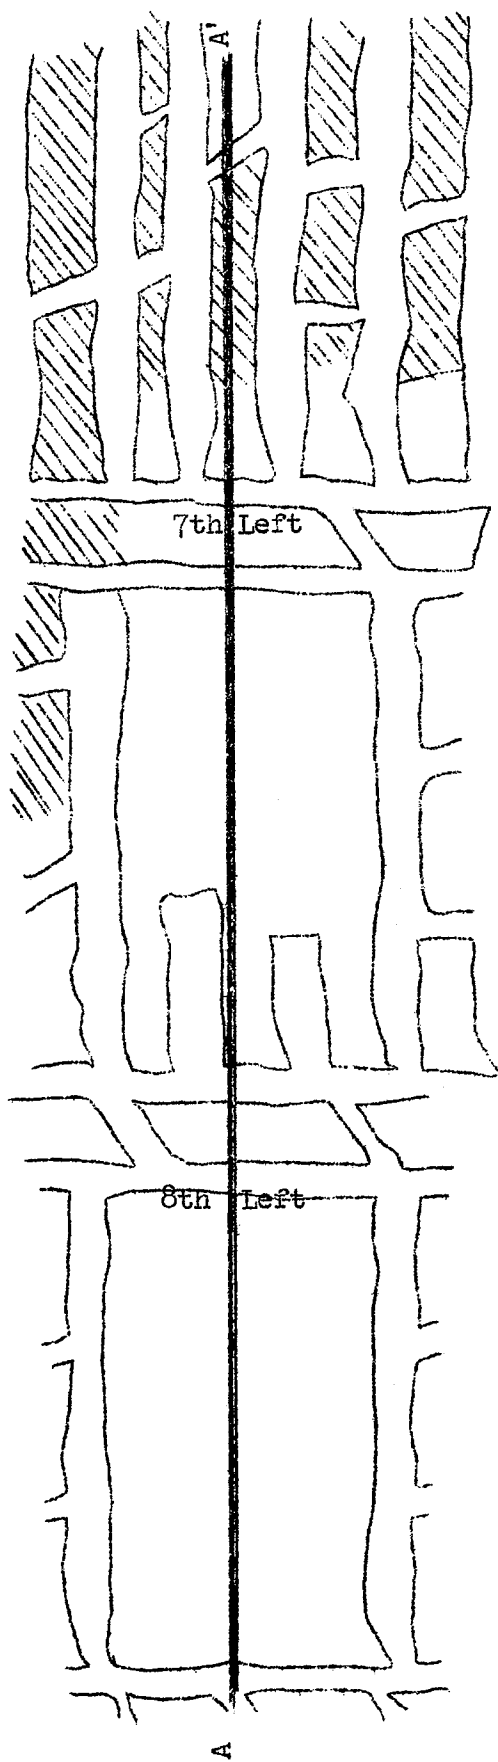
Section on line A-A' showing condition before  
barrier pillar was mined

5. Under no circumstances should openings be driven toward the goaf in solid coal within the abutment area. (See figure 3.)

Examination of the face area to the left of the barrier pillar (19 left off 12 left) in which the outburst occurred, revealed evidence that substantial caves had not been made on the main pillar line before it was abandoned in 1926. Inasmuch as this was the only substantial pillar in the area and, together with pillar remnants on 7 left, projected well out into the goaf, it is reasonable to suppose that there was an impingement of stresses on this, the only solid block of coal in the area which was able to bear a great amount of stress without undue crushing. Thus a condition illustrated by figure 3 was present. That is, after the pillar line was abandoned, the weight of the cantilevered strata over the goaf crushed the 7 left pillar remnants and the near end of the large pillar (a) until the restraining action of the failed coal prevented lateral expansion. The convergence of the floor and roof ceased when the core of the pillar resisted further deformation through compression. Thus an equilibrium of stresses was reached at some point within the abutment area and

(b) an enormous amount of elastic energy was stored. When the pillar was being split by driving two openings toward the goaf, one or more coal outbursts were inevitable as soon as the faces reached the critical point in the abutment area where the resistance of the solid coal was insufficient to withstand the pressure being exerted outward from the core of the pillar. As shown in figure 4, the pillar virtually exploded when the restraining material was removed. The forces were outward rather than toward the goaf because the fulcrum of the lever, causing the pressure, was in the goaf and the action was similar so that of a pumpkin seed when squeezed between the thumb and forefinger.
