UNITED STATES
DEPARTMENT OF LABOR
MINE SAFETY AND HEALTH ADMINISTRATION
COAL MINE SAFETY AND HEALTH

REPORT OF INVESTIGATION
Fatal Underground Coal Mine Explosion
May 20, 2006

Darby Mine No. 1
Kentucky Darby LLC
Holmes Mill, Harlan County, Kentucky
ID No. 15-18185

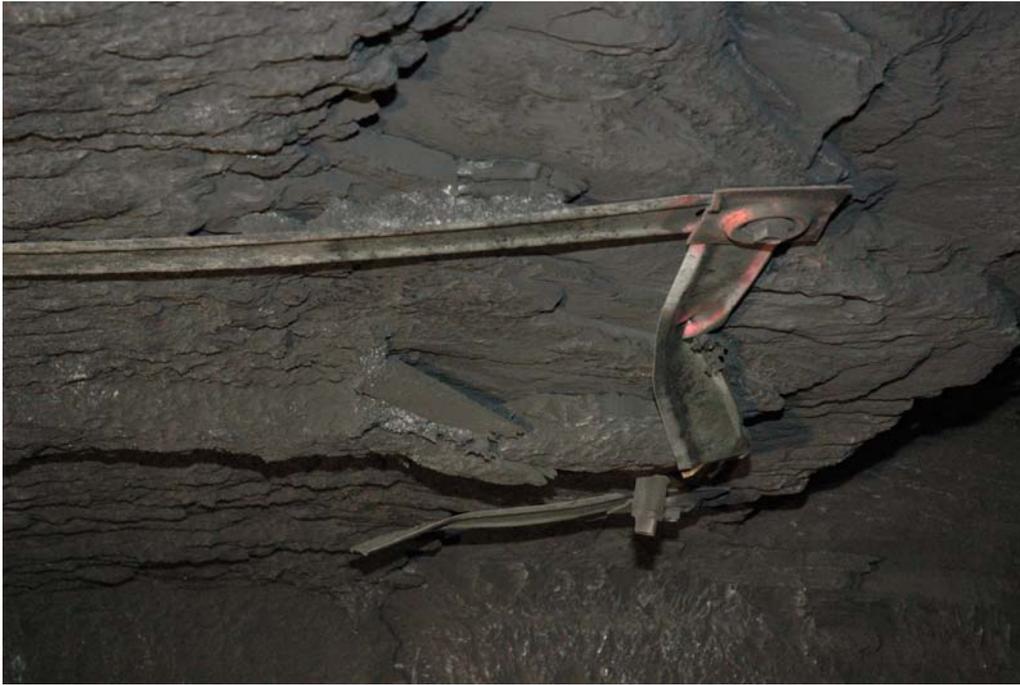
Figure 2 - Roof Straps at the No. 3 Seal Location for A Left

The physical evidence suggests that Brock and Lee arrived at the area of the return seals and commenced to cut metal roof straps (see Figure 2) that had been placed in the area as roof support but which had not been removed when the seals had been built. The acetylene cylinder and cutting torch were found in the area as was a piece of roof strap that gave indications that it had been cut with a torch. Brock had a methane detector with him but it is clear that it was not being used to check continuously for methane given that it was found in his pocket after the explosion. The detector was functional since it was giving off an alarm when the body was found. There is no indication that any test for methane was made behind the seals before the cutting commenced. There was no means available to sample the atmosphere behind the No. 3 Seal. Therefore, a cutting torch should not have been used in the vicinity of the seals.

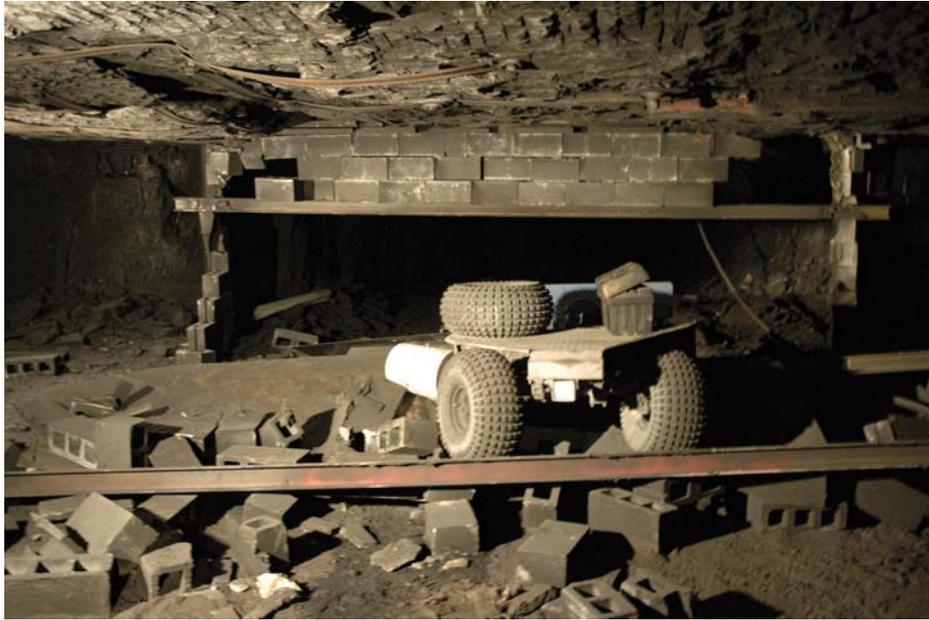
Figure 3 - Personnel Carrier Lodged on Overcast Debris

After traveling approximately 300 feet, the personnel carrier became lodged on debris from an overcast that had been extensively damaged by the force of the explosion (see Figure 3). The crew got off of the vehicle and proceeded on foot until they reached the power center located one crosscut inby the No. 4 Belt Drive. Somewhere near this point, Ledford and Middleton removed their SCSR mouthpieces and discussed how they should exit the mine. Ledford informed Middleton that he had located the high-voltage power cable and that he intended

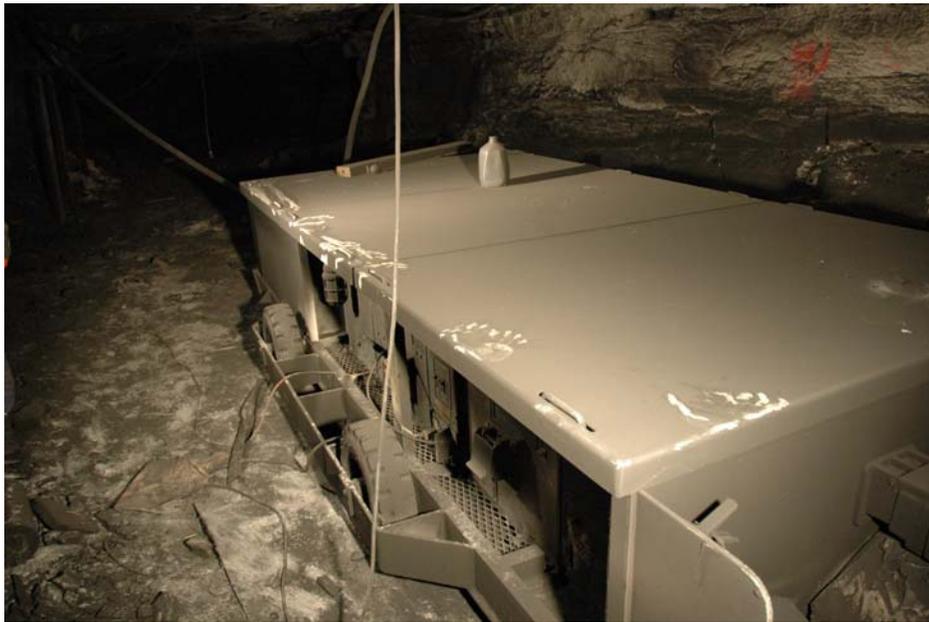
Figure 4 - Power Center at No. 4 Belt Drive

to follow it to the surface. Middleton told Ledford that he was going back to find the power center (see Figure 4). After another short discussion, Ledford began walking outby in the No. 5 Entry, using the high-voltage power cable as a guide. Ledford had no further contact with the other miners.

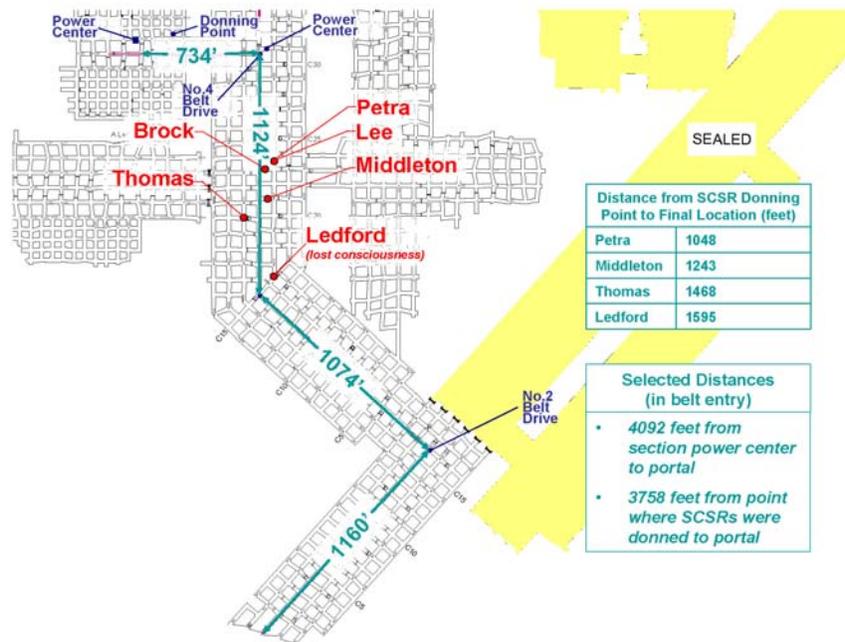
Figure 5 - Distances from SCSR Donning Points to Final Location of Miners

Petra, Middleton, and Thomas attempted to escape but eventually succumbed to carbon monoxide poisoning at different locations in the mine. Petra was found in the No. 5 Entry approximately 500 feet outby the No. 4 Belt Drive power center. Middleton was found approximately 700 feet outby the No. 4 Belt Drive power center in the left crosscut off of the No. 5 Entry. Thomas was found 800 feet outby the No. 4 Belt Drive power center in the crosscut between the No. 2 Entry and No. 3 Entry in the return air course. Figure 5 shows the distances from where the SCSRs were donned to the location where the miners were found.

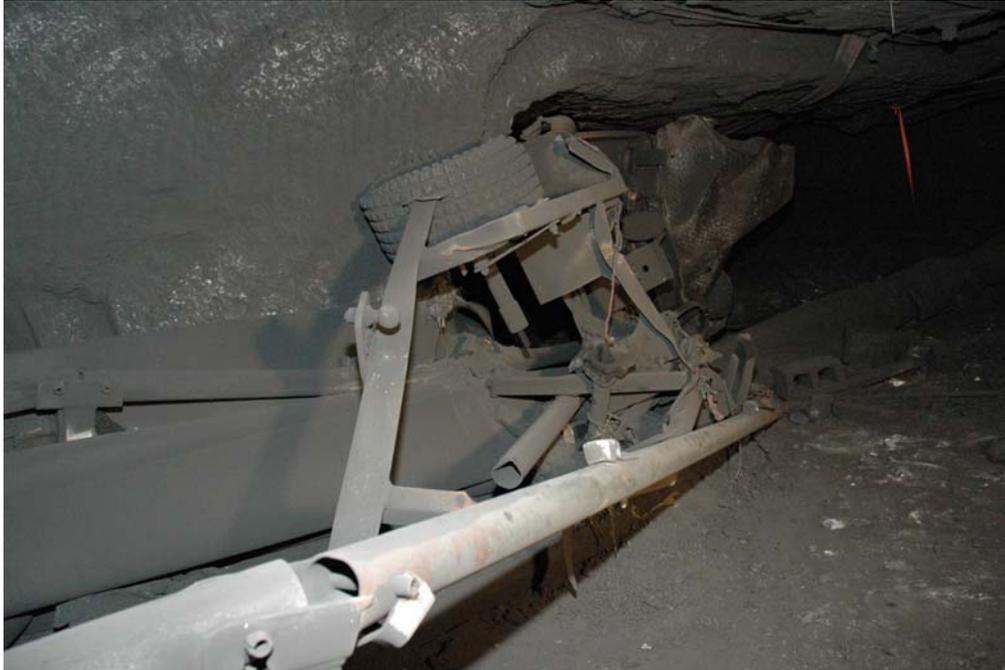
Figure 6 - Damaged Personnel Carrier on top of Conveyor Belt Debris

was found on top of the debris from the destroyed intake overcast. A search was made around the personnel carrier and no persons were found. End caps from two SCSRs were found on the personnel carrier. Footprints indicated someone may have traveled inby in the Mains toward the old works.

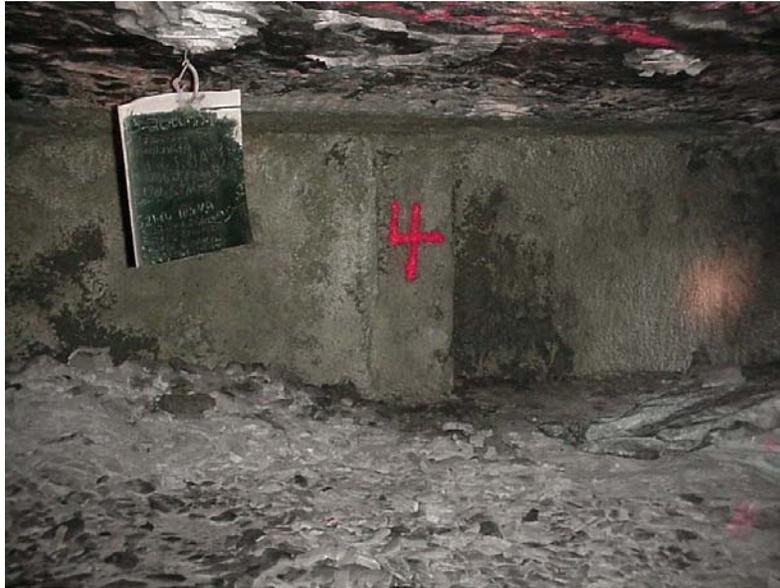
Figure 9 - No. 4 Intake Seal

After the explosion, seven solid concrete block seals were constructed which complied with 75.335(a)(1) to replace the Omega seals at the intake seals. The plan approved by the District Manager for the construction of the new seals required that the existing No. 4 Seal (Omega) be breached prior to completing the solid concrete block seal that would replace it. Figure 9 is a picture of the No. 4 Intake Seal prior to being breached.

On June 7, 2006, team members of the MSHA's Mine Emergency Unit, while under apparatus, breached this seal. The team observed the following deficiencies:

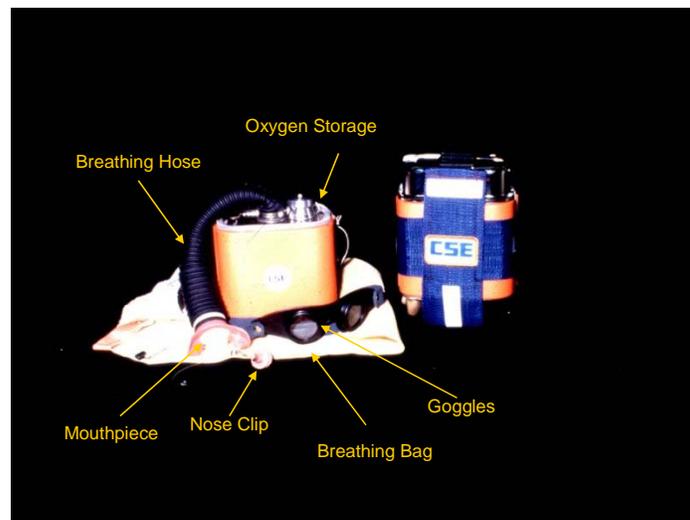
Figure 10 - SCSR Deployed

Of the four miners who donned SCSRs, only one miner survived. Accident survivor Paul Ledford donned CSE SR-100 serial number 93609. Accident victims Roy Middleton, Paris Thomas and Bill Petra, donned CSE SR-100 serial numbers 84784, 89692, and 105936, respectively.

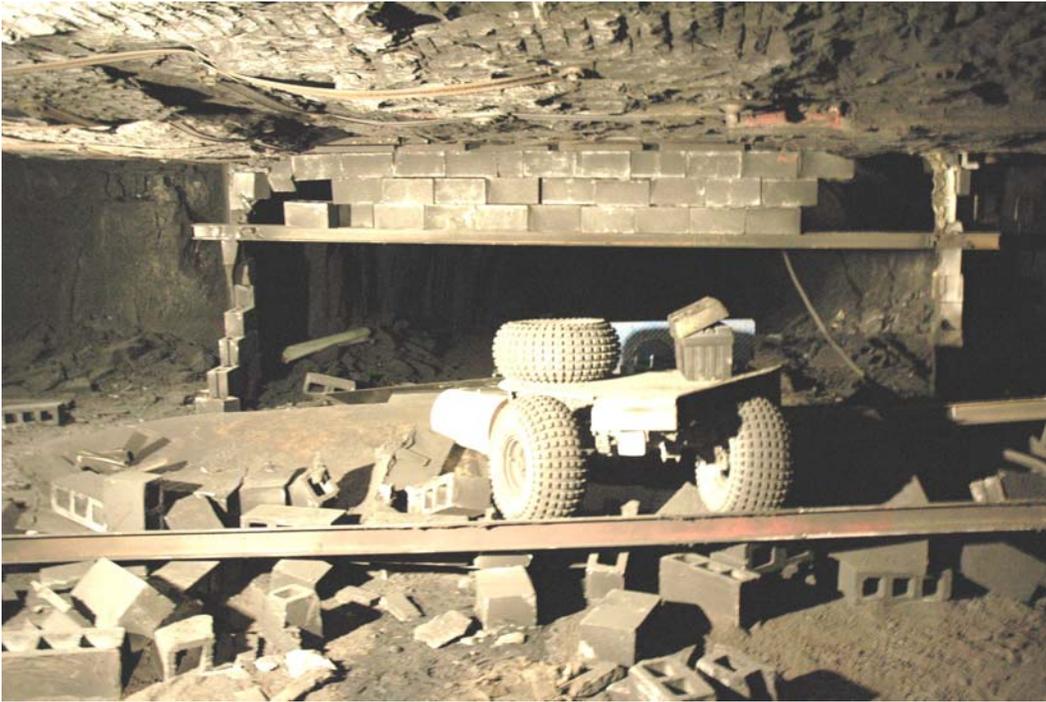
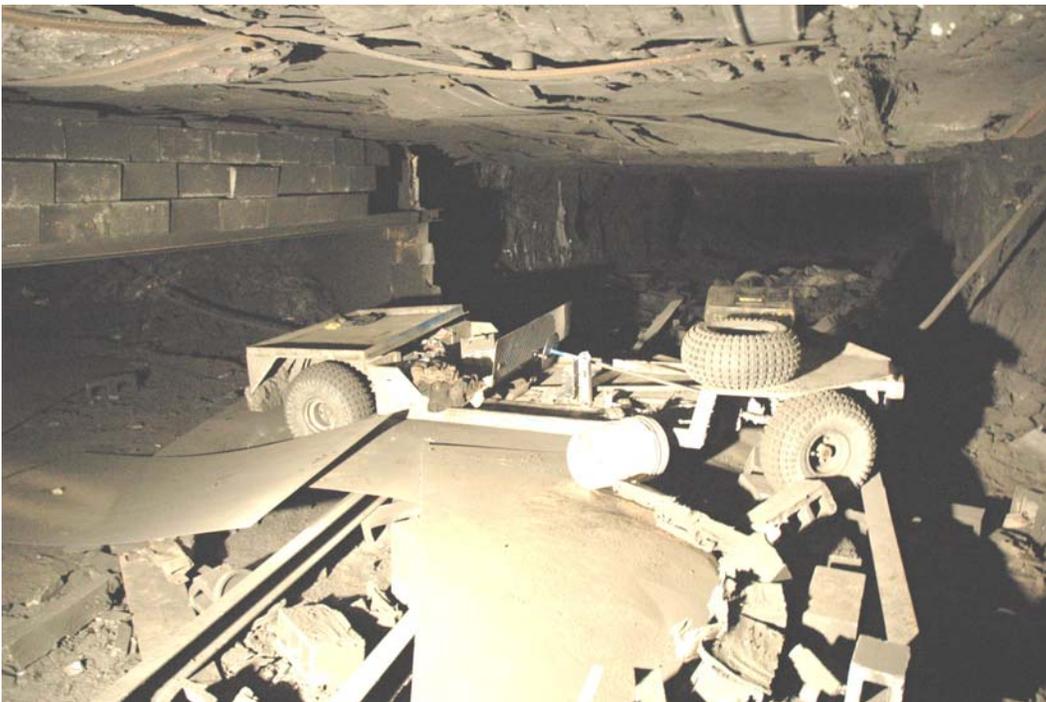
Photograph 1 - No.1 personnel carrier on damaged overcast

Photograph 2 - No.1 personnel carrier on damaged overcast

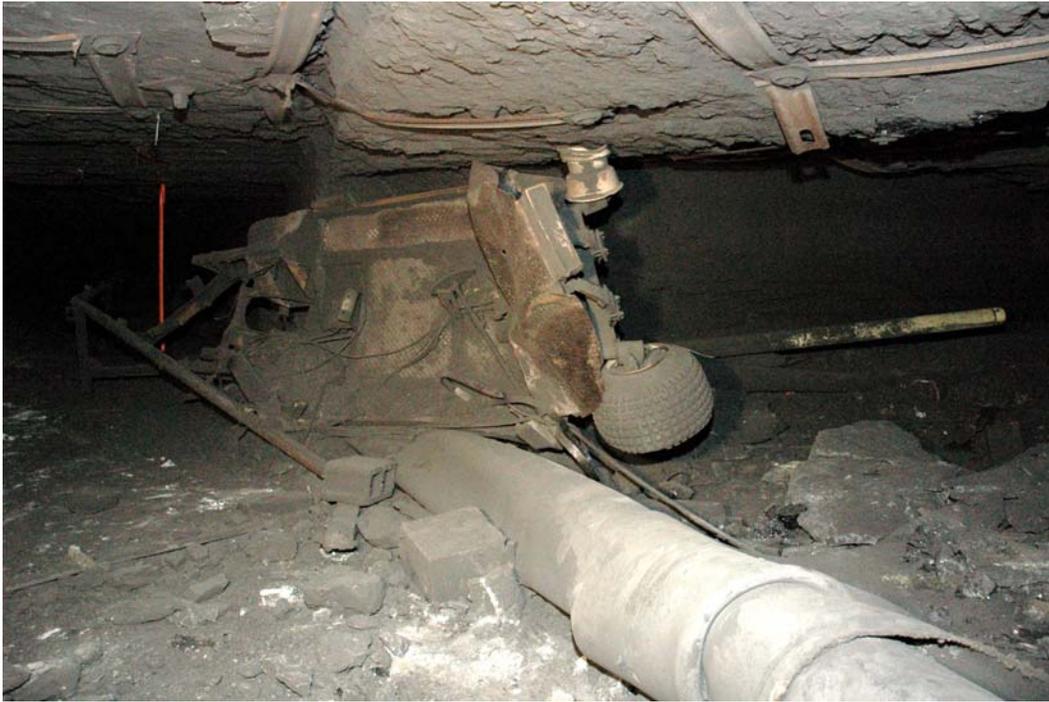
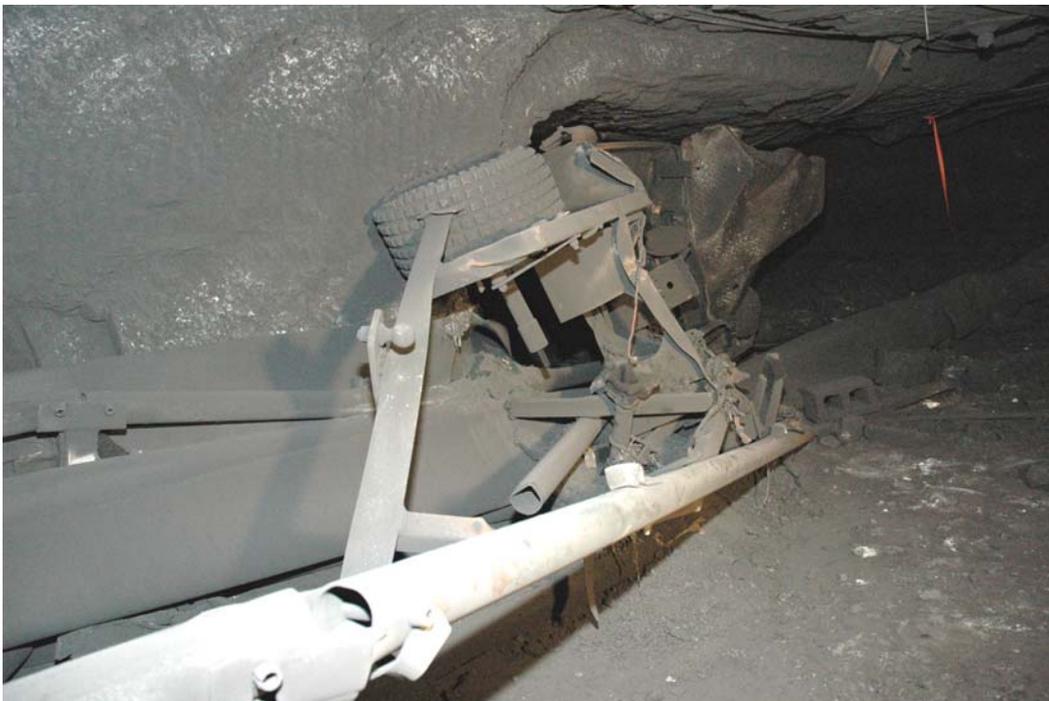
Photograph 3 - No. 3 personnel carrier in the No. 4 Entry

Photograph 4 - No. 3 personnel carrier in the No. 4 Entry

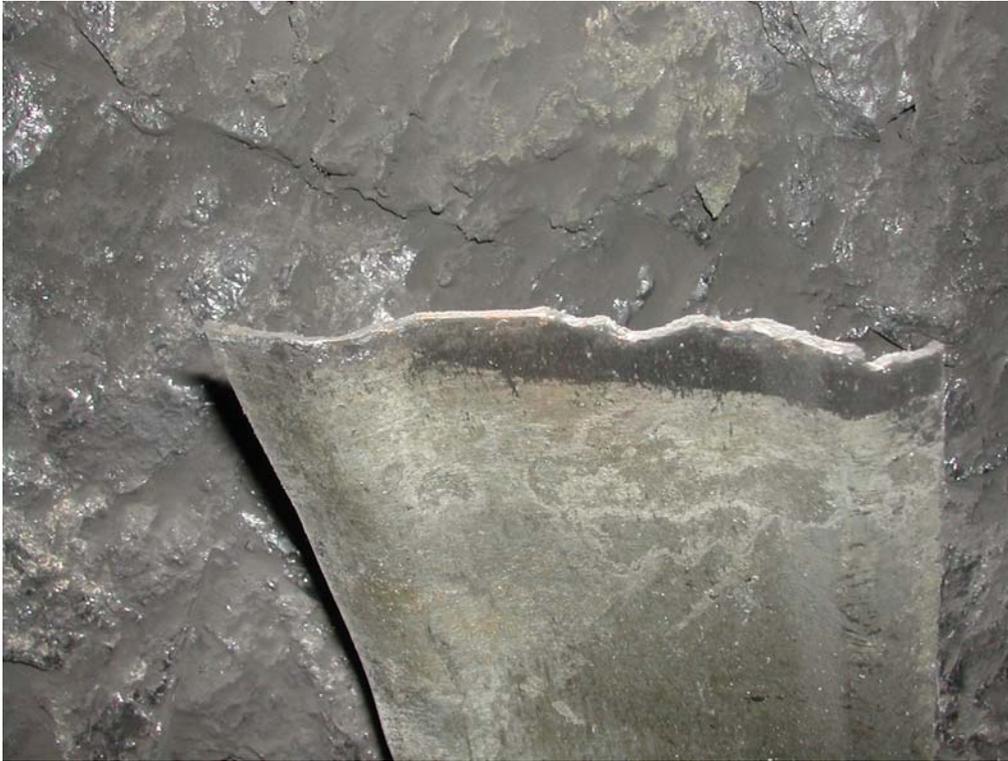
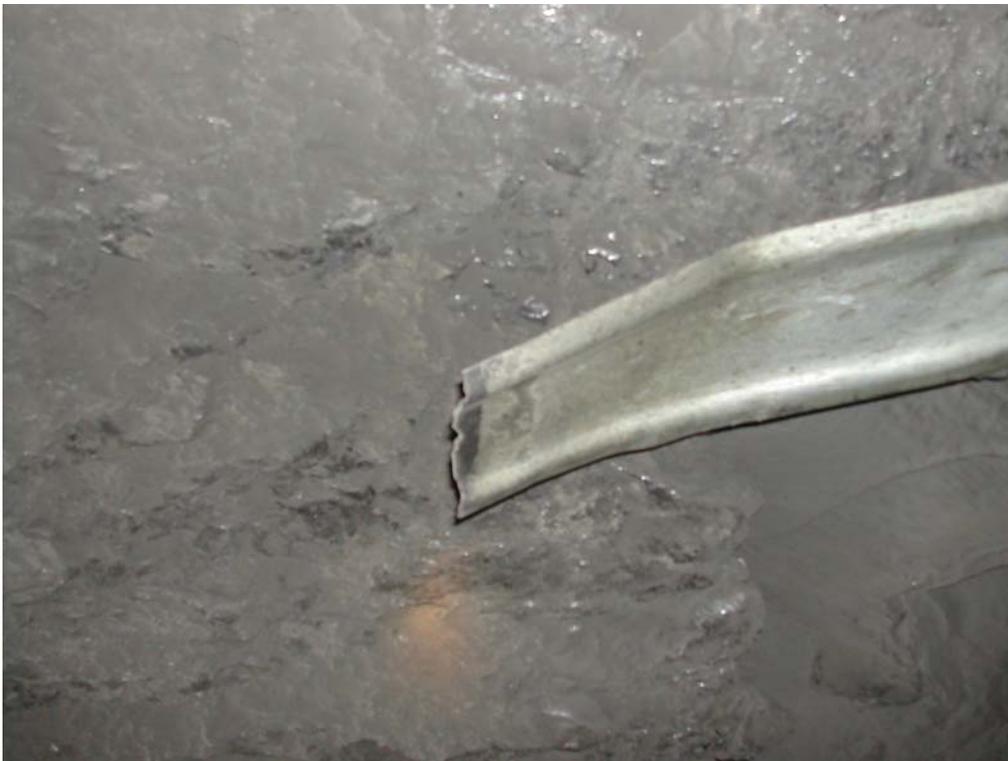
Photograph 5 - Inby segment of roof strap at A Left No. 3 Seal

Photograph 6 - Inby segment of roof strap at A Left No. 3 Seal

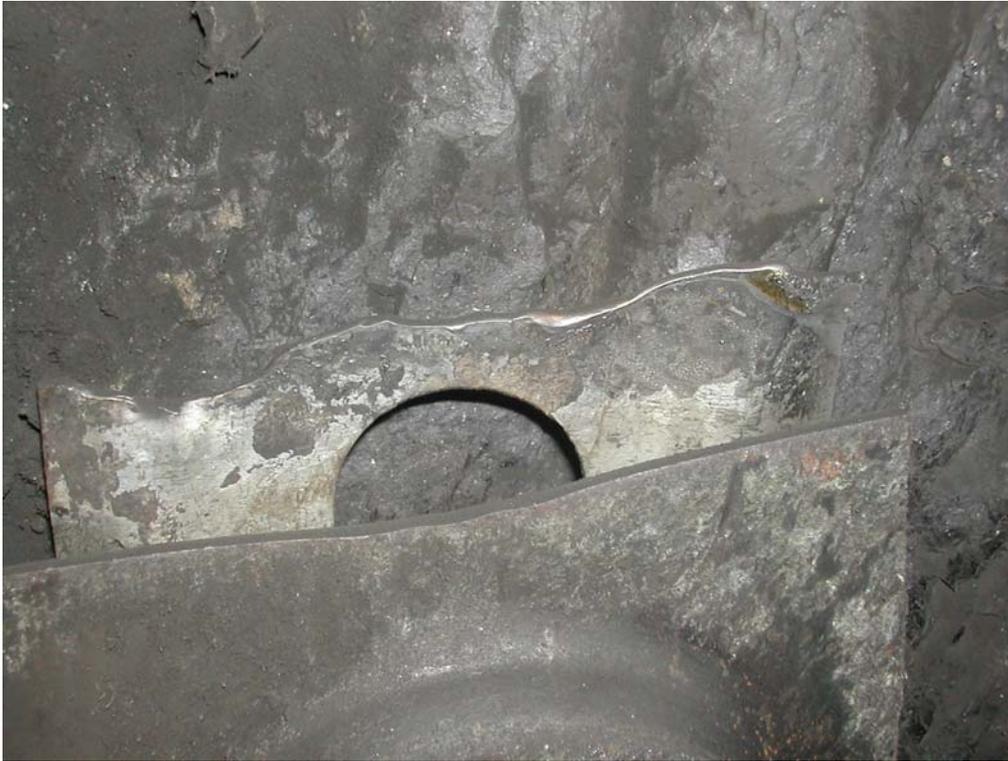
Photograph 7 - Outby segment of roof strap at A Left No. 3 Seal

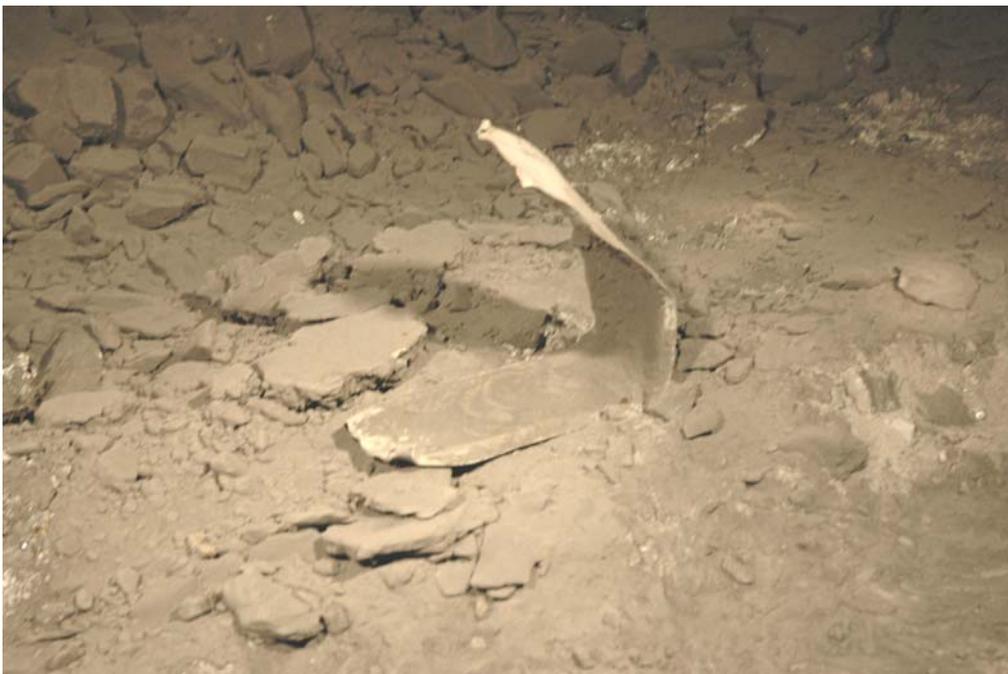
Photograph 8 - Middle segment of roof strap found in No. 5 Entry

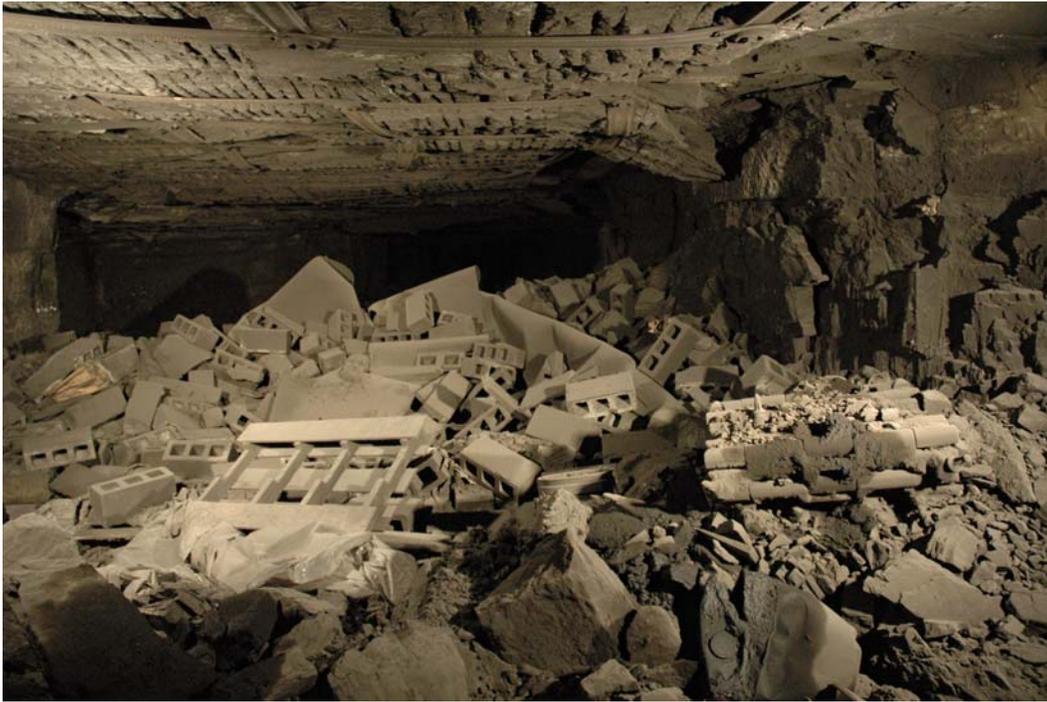
Photograph 11 - Debris from stopping near B Left Section

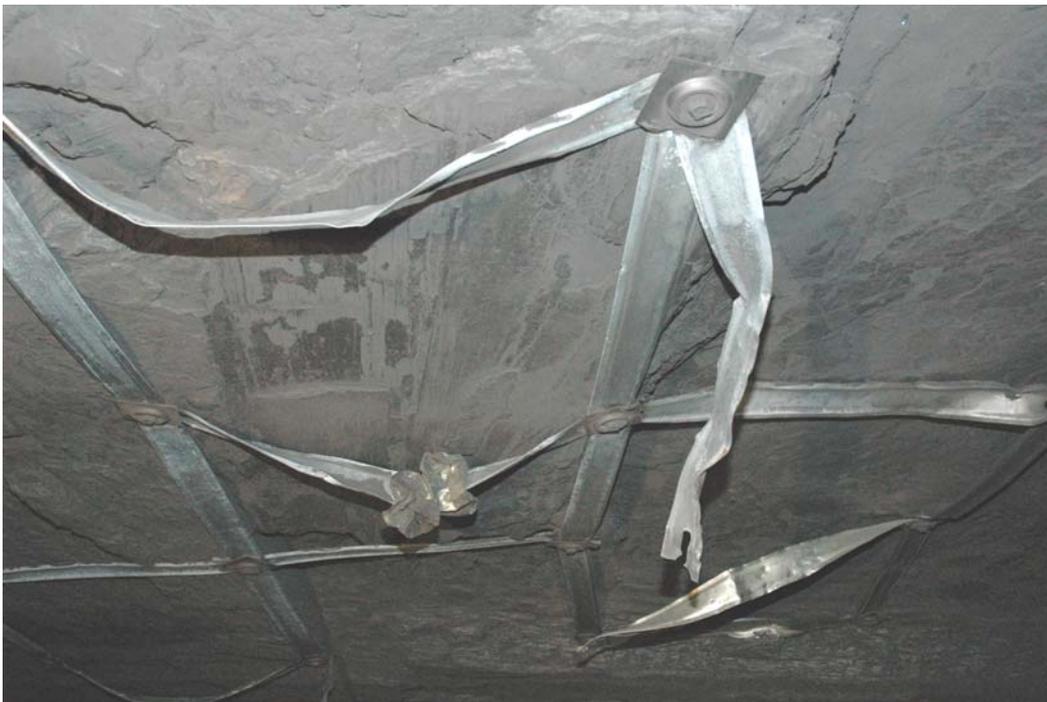
Photograph 12 - Damaged roof straps near A Left No. 3 Seal
