**REPORT OF EXPLOSION
DERBY #3 MINE, STONEGA COKE & COAL COMPANY
DERBY, VIRGINIA**

**Joseph F. Davies
District Engineer**

DEPARTMENT OF THE INTERIOR

BUREAU OF MINES

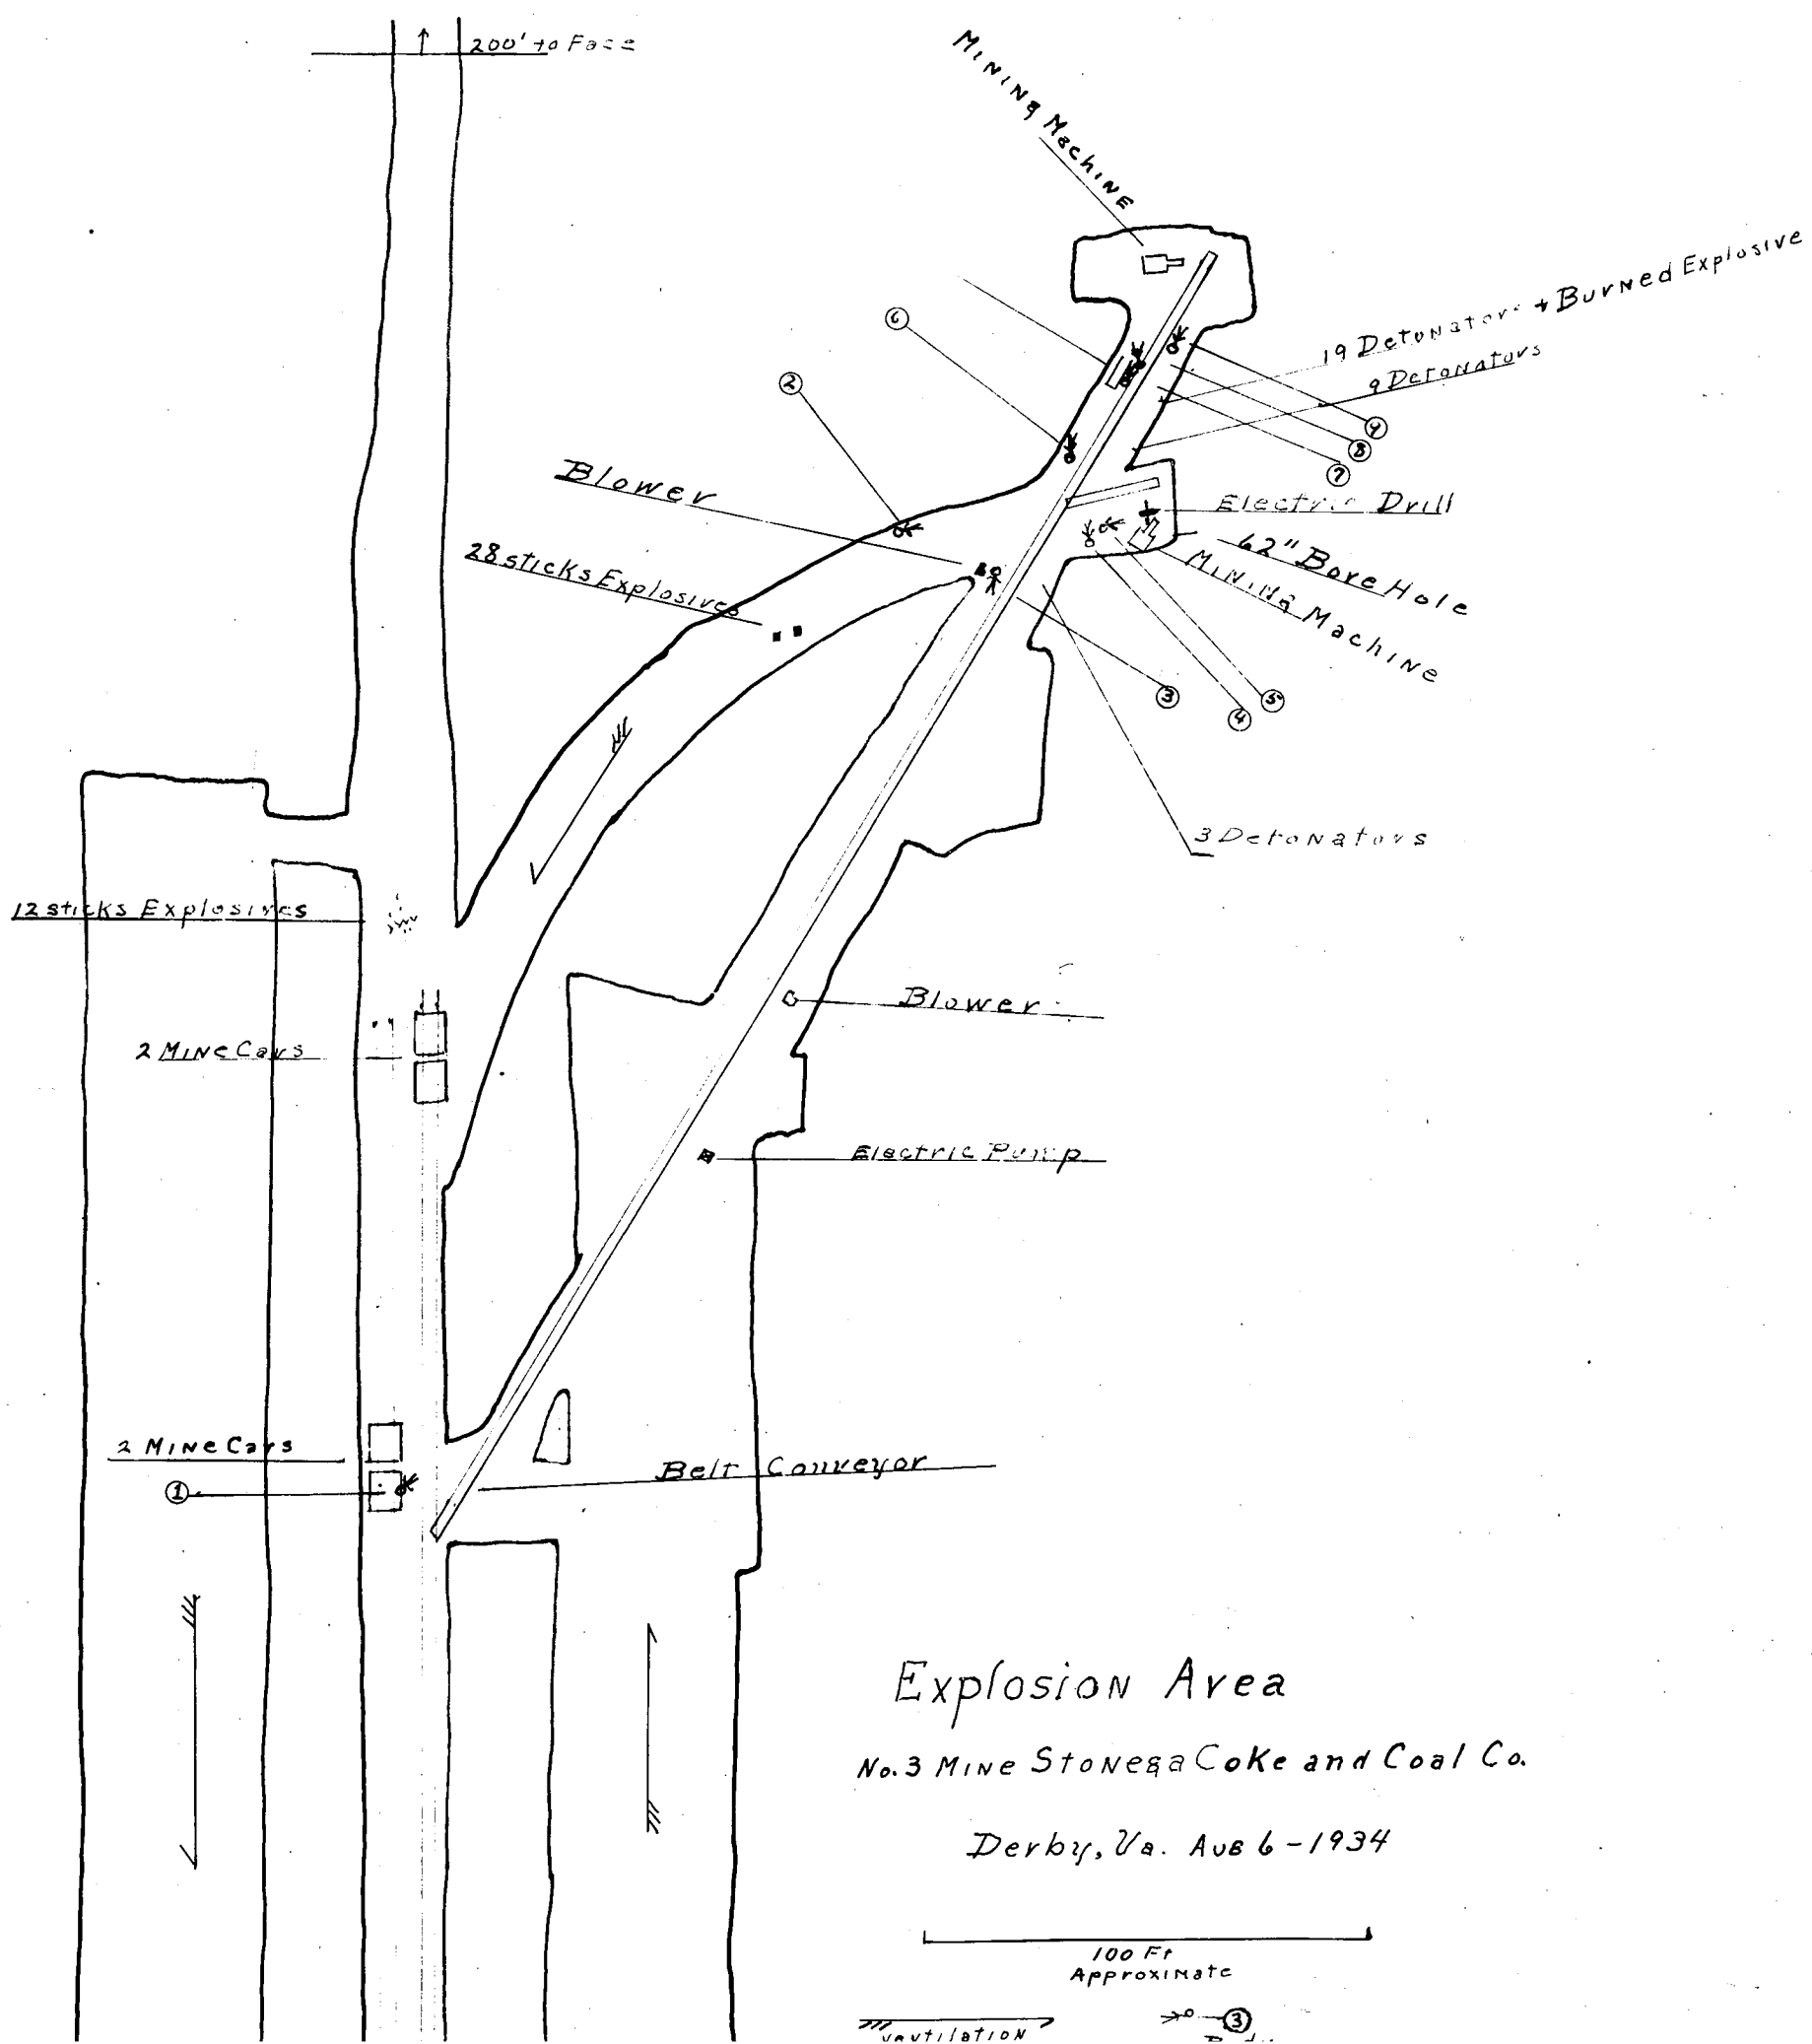
Explosion Area

evident, increasing very materially until just inby the intersection of the three face left entries and the Main West butt headings. Evidently the forces were very materially reduced due to relief of pressures through the three face left entries, and again the pressures were evidently very materially reduced further at the intersection of the Main West entries with the two face left or main haulageways. Comparatively light forces passed out through the portals to the outside. It will be noted by examining the accompanying maps that the direction of forces from point of origin to the portals was almost in effect a straight line. This relief of pressures no doubt prevented violence from extending any farther into the mine. The extent of forces is indicated on the photostat copies of the map of the explosion area.
