UNITED STATES  
DEPARTMENT OF THE INTERIOR  
BUREAU OF MINES

FINAL REPORT OF MAJOR MINE-EXPLOSION DISASTER  
DUTCH CREEK MINE  
MID-CONTINENT COAL AND COKE COMPANY  
REDSTONE, PITKIN COUNTY, COLORADO

December 28, 1965

Joseph Freeman  
Federal Coal-Mine Inspector

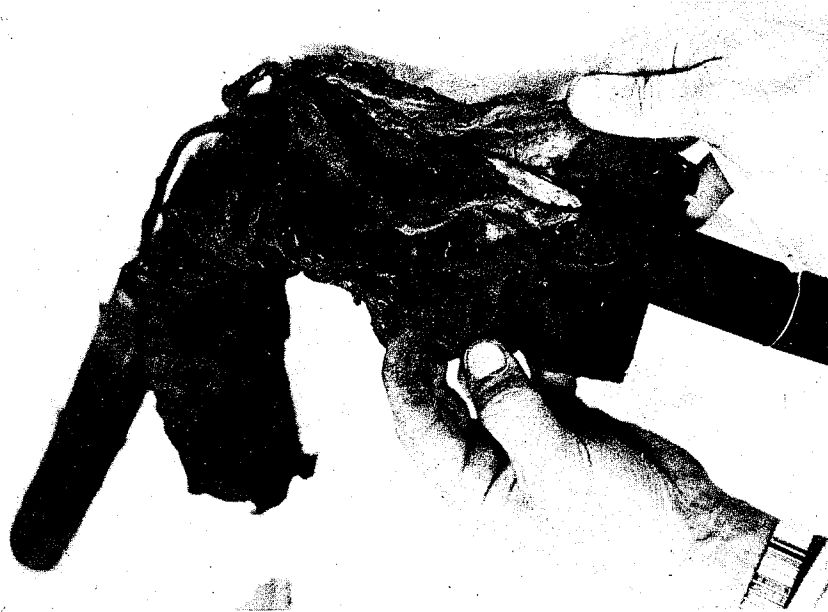
Figure 1

The permissible Joy loading machine, type 14 BU 10-11 DH, had one lock washer missing from a bolt in the controller compartment but no openings in explosion-proof compartments were found. This machine used an extension cable to connect the trailing cable to the power center. Five temporary splices were found in the trailing cable and three in the extension cable of this machine. One of the temporary splices in the trailing cable, located 31 feet from the cable anchor at the machine, indicated a short between the power conductors and had blown out. Examination of this splice indicated that considerable heavy arcing had occurred between the power conductors at the time of a phase-to-phase fault (see photographs, appendix G). In making up this splice, the connectors on the power conductors were not staggered properly to minimize damage to the insulation. The three grounding conductors had been grouped and placed on one side of the splice, and this did not provide proper ground-fault tripping when the short occurred in the splice.

Cause of explosion: The disaster was caused by the ignition of an accumulation of methane by an electrical arc or spark when a temporary splice in the trailing cable of the loading machine shorted out, or by an arc or spark when a bare power conductor in a splice in the trailing cable of the shuttle car came in contact with the frame of the shuttle car. Methane was being liberated from the face, ribs, and a large feeder in the floor in No. 3 crosscut off room 6. The gas accumulated because face ventilation was restricted by a pile of coal behind the continuous miner. Coal dust from the coal pile, from the face equipment, and from the shuttle-car roadway entered into the propagation of the explosion.

Blown-out temporary splice in loading machine trailing cable, showing grounding conductors (fig. 1), and burned power conductors (fig. 2). The outside tape has been cut open to show inside of splice.

12. Care should be used to protect all trailing cables from avoidable mechanical damage; trailing cables of continuous miners and loading machines should be suspended, where possible, to prevent them from being run over.
