**United States
Department of Labor
Mine Safety and Health Administration
Office of the Administrator
Coal Mine Safety and Health**

**Report of Investigation
Underground Coal Mine Explosion
Dutch Creek No. 1 Mine – I.D. No. 05-00301
Mid-Continent Resources, Inc.
Redstone, Pitkin County, Colorado
April 15, 1981**

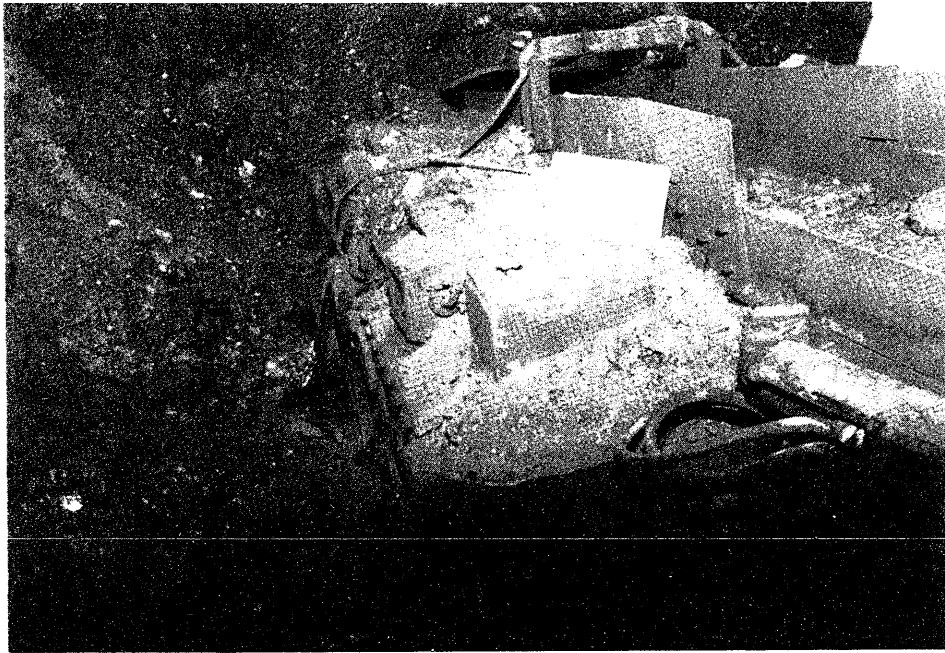
MSHA investigators concluded that the explosion originated in the face area of the No. 1 entry in the 102 Section, when a methane-air mixture within an explosion-proof compartment on a continuous mining machine was ignited by an electric arc. The compartment, containing electrical components of the mining machine, had not been maintained in a permissible condition. Flame and major forces of the explosion propagated from the face area of the 102 Section, and split in the main slope entries at the mouth of the 102 Section. Flame and forces traveled inby in the Nos. 7, 6 and 5 entries of the slopes to the Slope Section, and then moved outby in the slope entries. The flame extended as far as the No. 56 crosscut, and the major forces traveled further outby to the No. 48 crosscut.

FIGURE 1. - Lighting system box on left side of Joy 12 CM continuous mining machine in face of No. 1 entry 102 section.

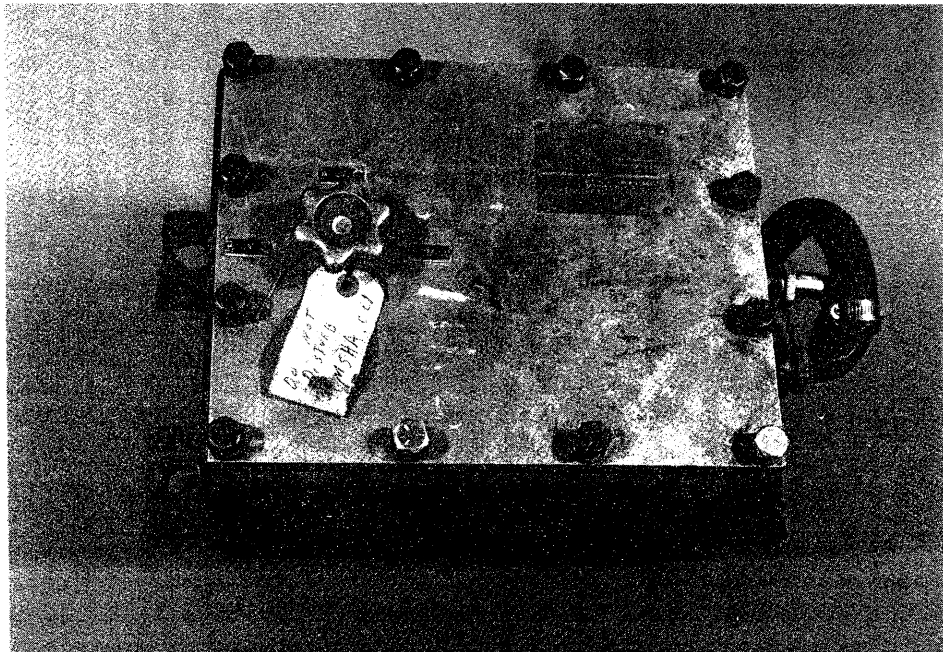
FIGURE 2. - McJunkin Corp. lighting system box.

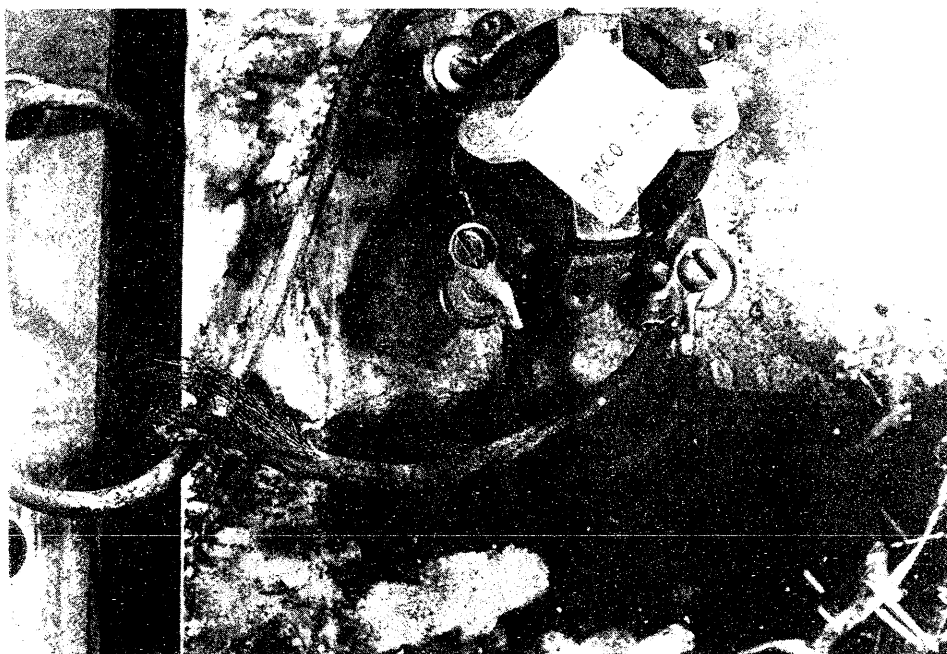
FIGURE 3. - Light switch and No. 14 wire inside McJunkin Corp. lighting system box.

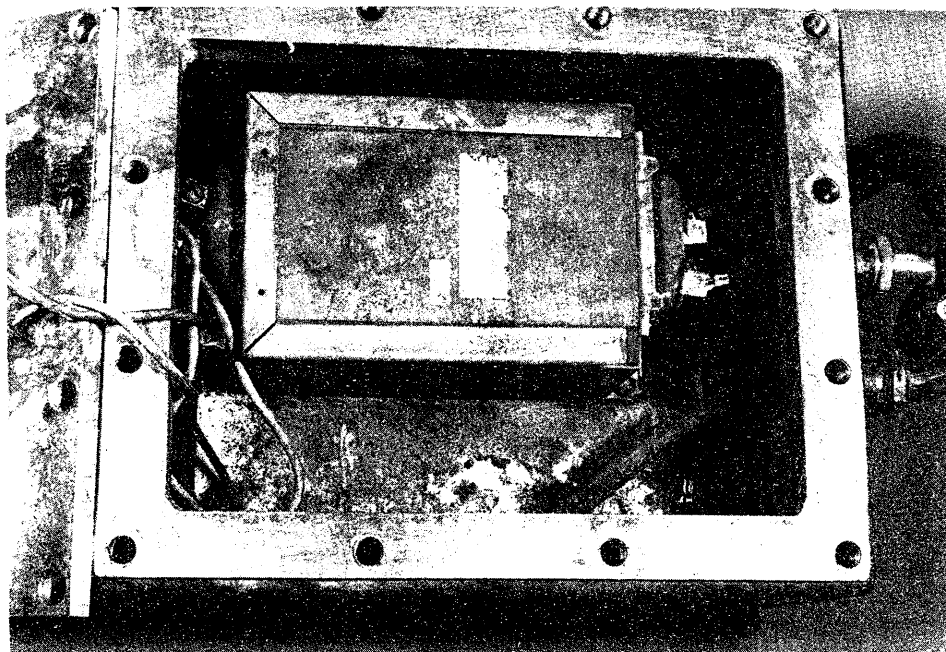
FIGURE 4. - Transformer inside the McJunkin Corp. lighting system box.

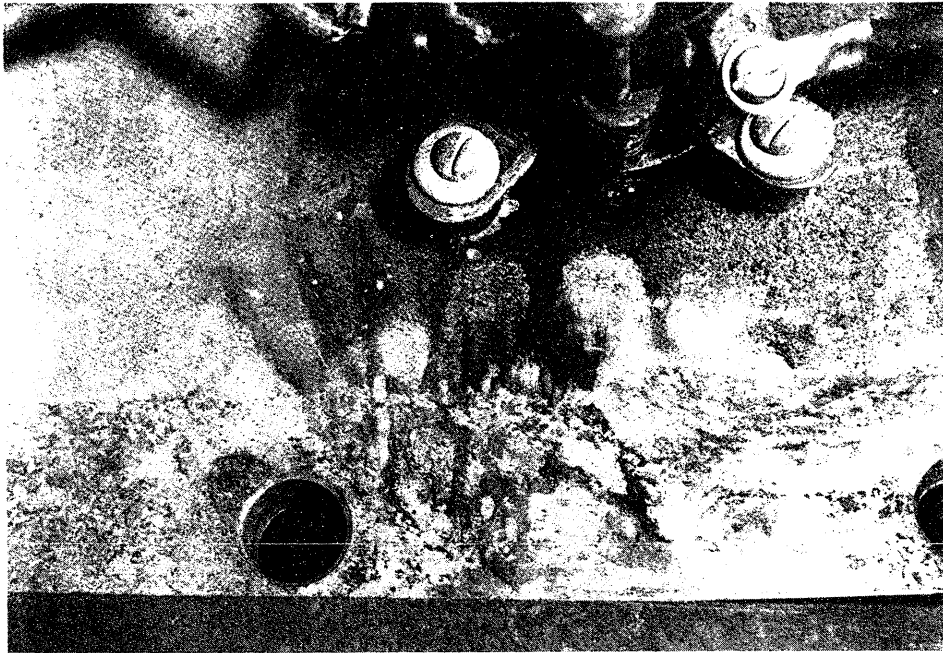
FIGURE 5. - Dust inside the McJunkin Corp. lighting system box.

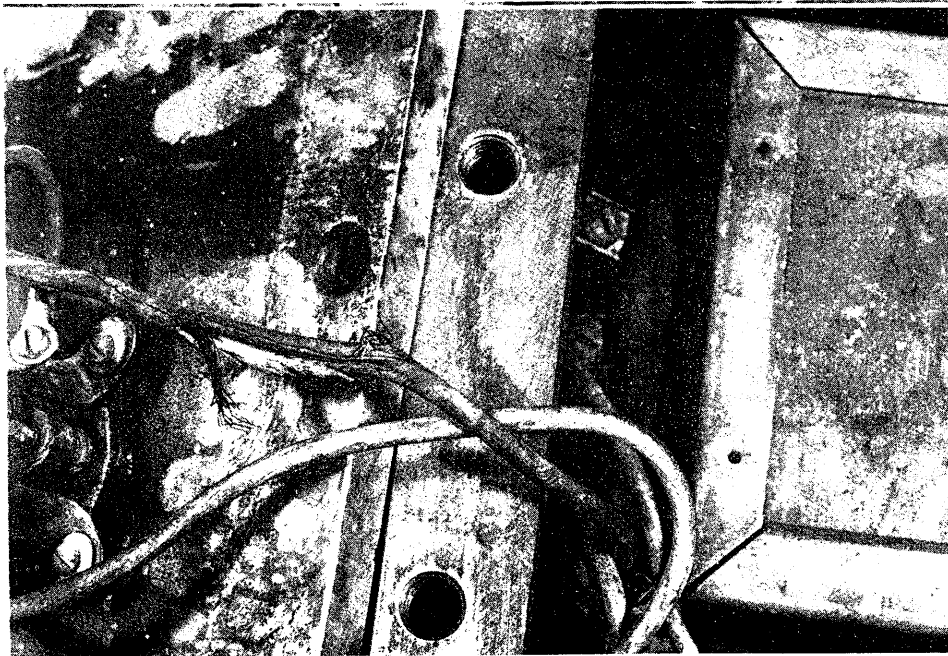
FIGURE 6. - No. 14 wire inside the McJunkin Corp. lighting system box.

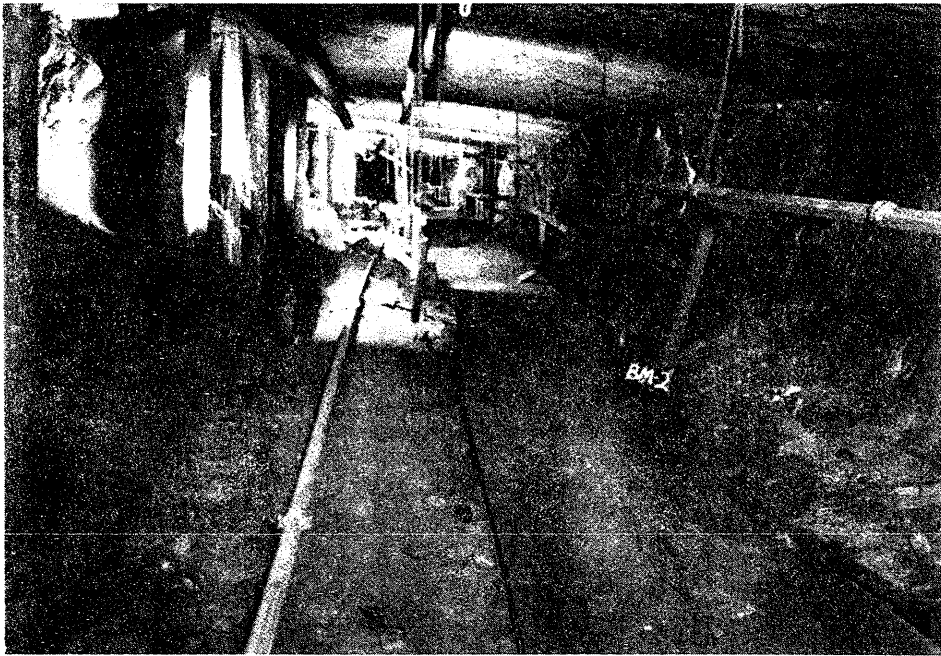
torn apart. Cap lamps and self-rescuers were torn away from the victims. Posts were dislodged and scattered, and the shuttle car canopy was lifted off the car parked at the belt feeder, and moved 50 feet outby in the No. 1 conveyor belt entry. The conveyor belt was blown completely out of the belt tailpiece, and the conveyor belt and belt structure and pipelines were extensively damaged and blown into a pile along the rib. A section of the conveyor belt and belt structure starting 650 feet from the belt tailpiece and running 275 feet outby remained intact. Three prefabricated metal overcasts at the mouth of the 102 Section were dislodged and destroyed. Figures 7-11 in Appendix L are photographs of this damage.

FIGURE 7. - Belt destruction 102 section.

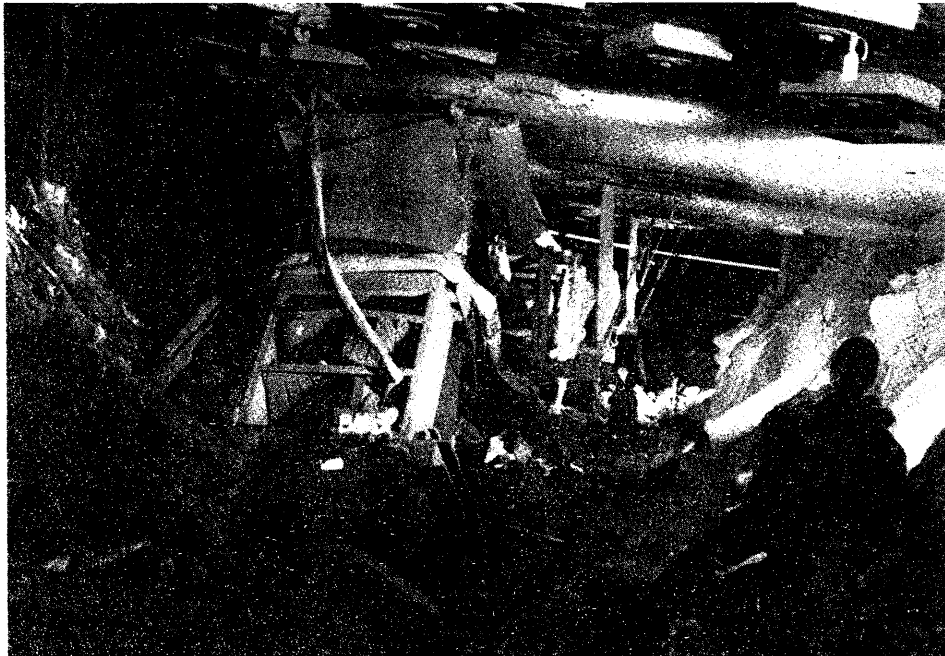
FIGURE 8. - Belt air lock 63rd x cut No. 7 slope.

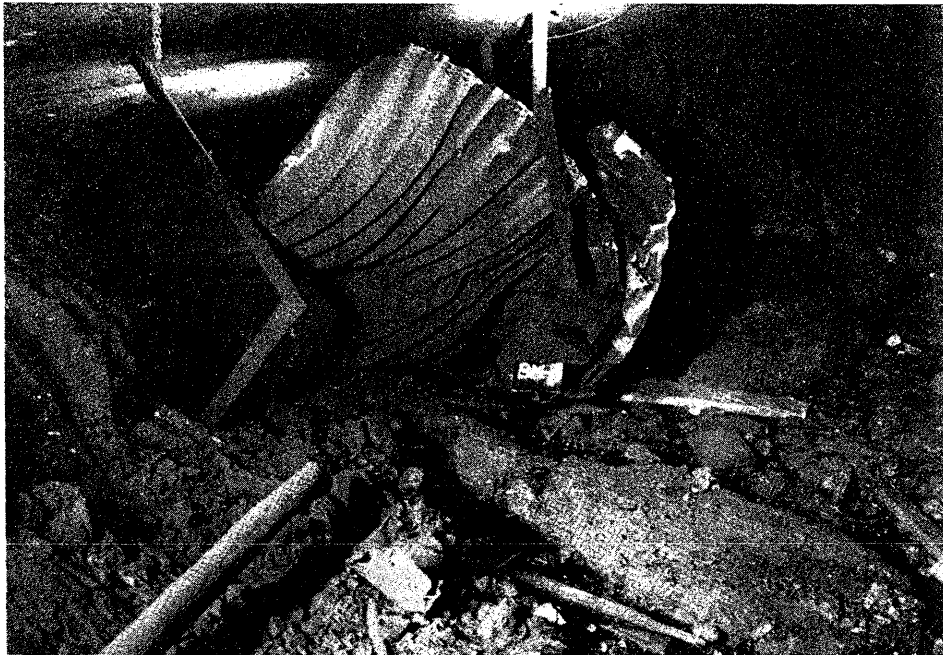
FIGURE 11. - Overcast destruction No. 64 x cut No. 7 slope.

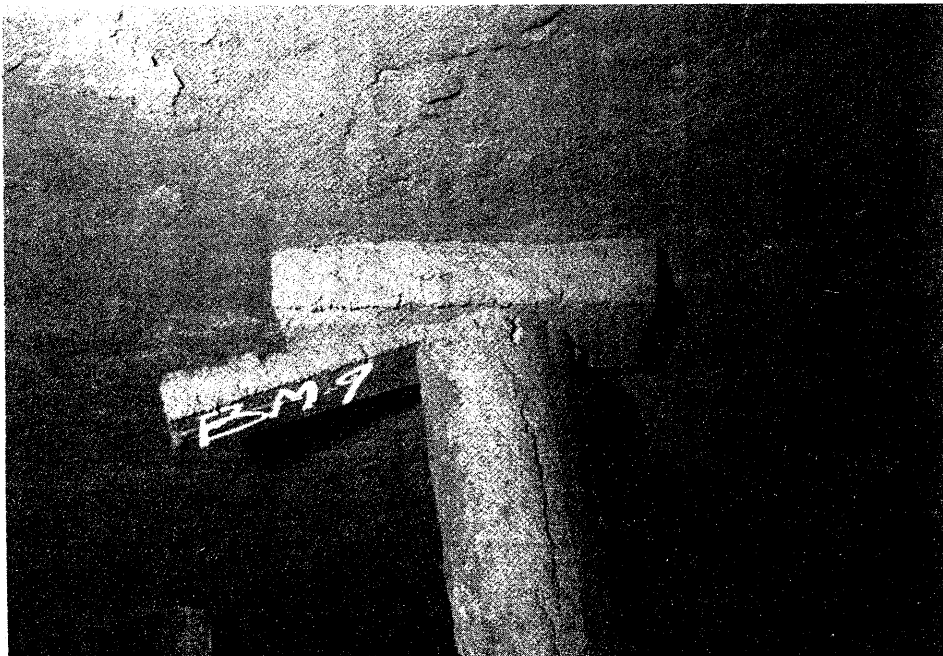
FIGURE 12. - Heavy coke on post about 20 ft outby last open x cut No. 2 entry 102 section.

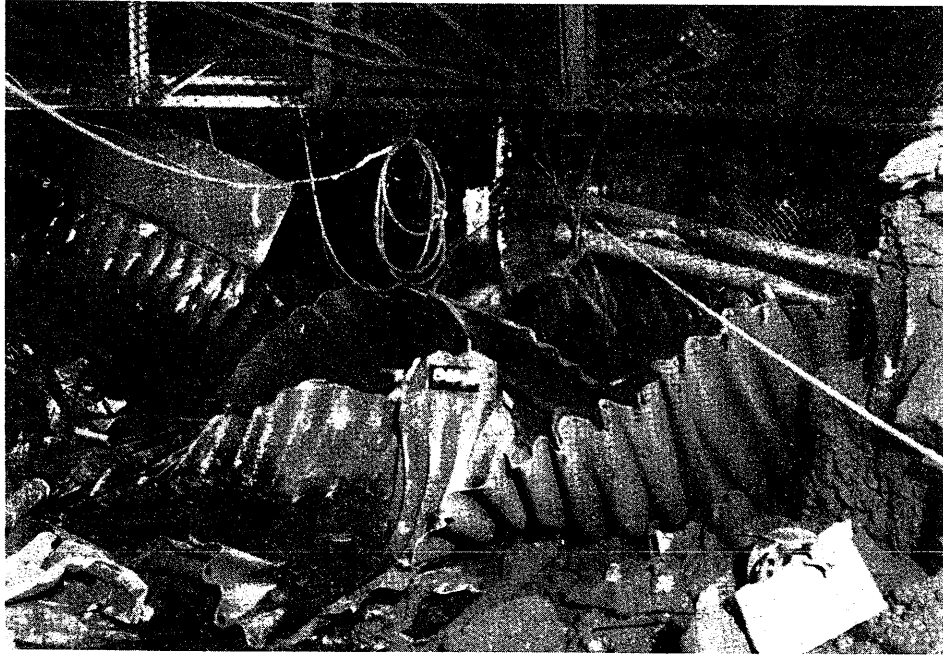
FIGURE 9. - Overcast destruction No. 6 slope 63 x cut.

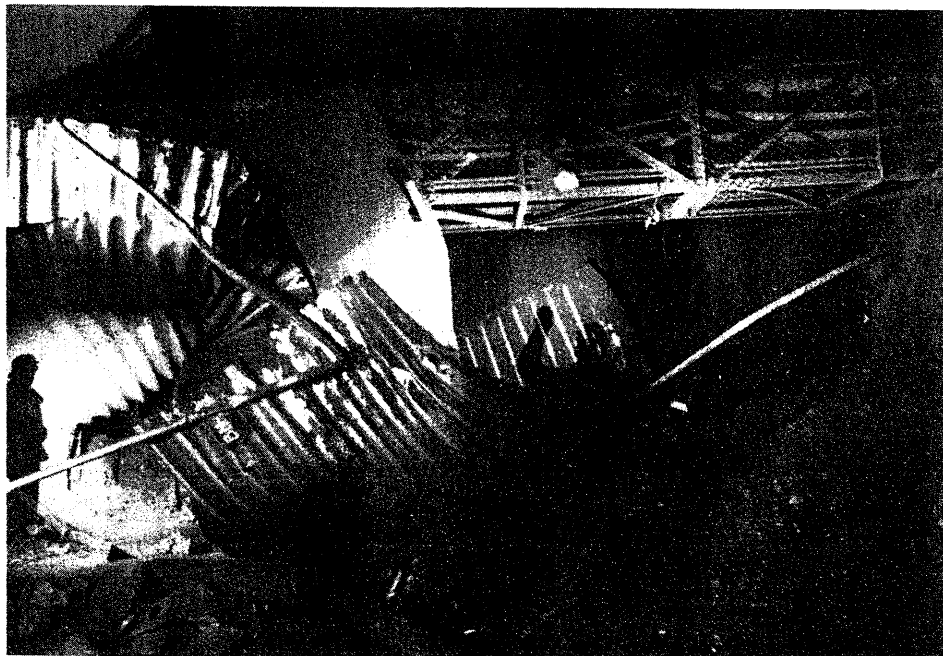
FIGURE 10. - Overcast destruction No. 5 slope No. 63 x cut.

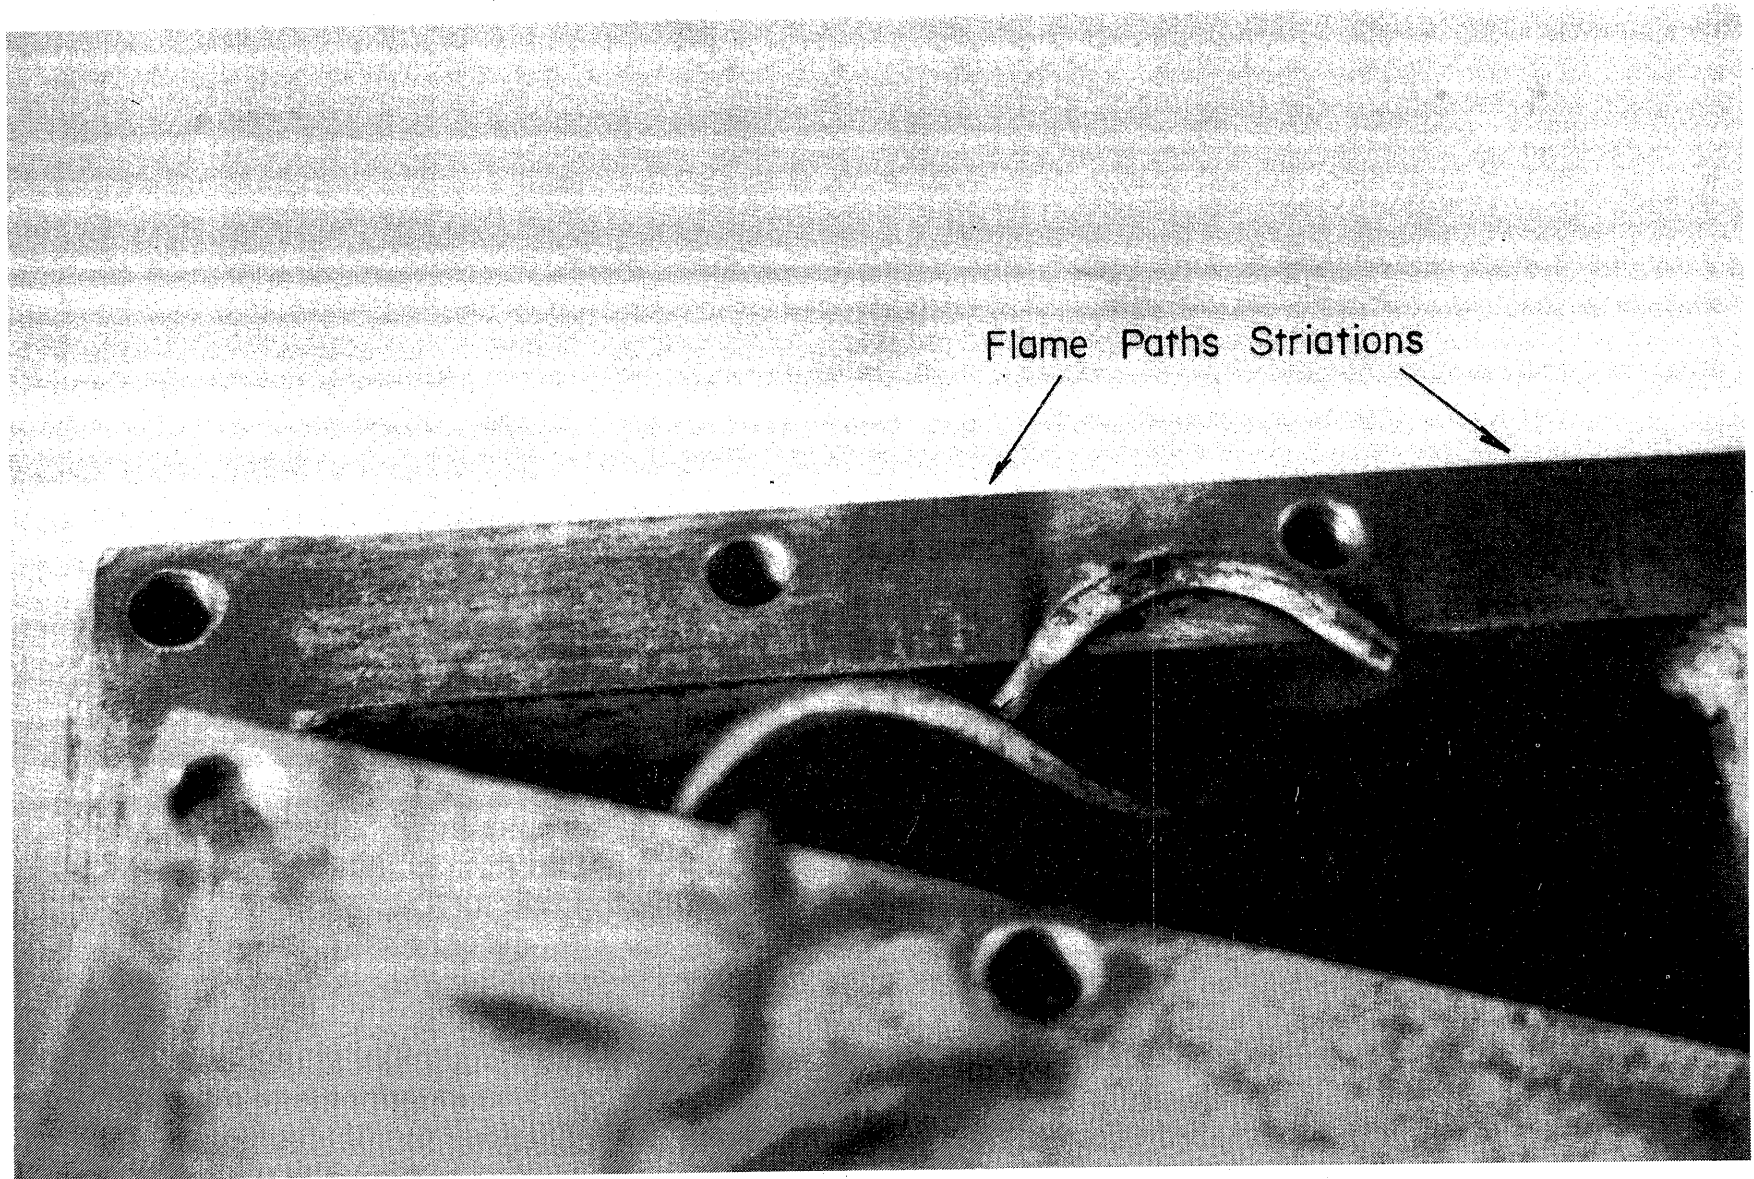
FIGURE 2 - Original Box showing fingers in dust on both sides of pinched wire.
