The following men were injured fatally about 7:15 a.m., January 5, 1971, when the cage they were riding plunged about 600 feet to the bottom of the shaft, El Dorado Mine, El Dorado Limestone Company, Shingle Springs, El Dorado County, California:

Subject: Report of Multiple Fatal Hoisting Accident, El Dorado Mine  
and Mill, El Dorado Limestone Company, Shingle Springs,  
El Dorado County, California, January 5, 1971, by Charles H.  
Schultz.

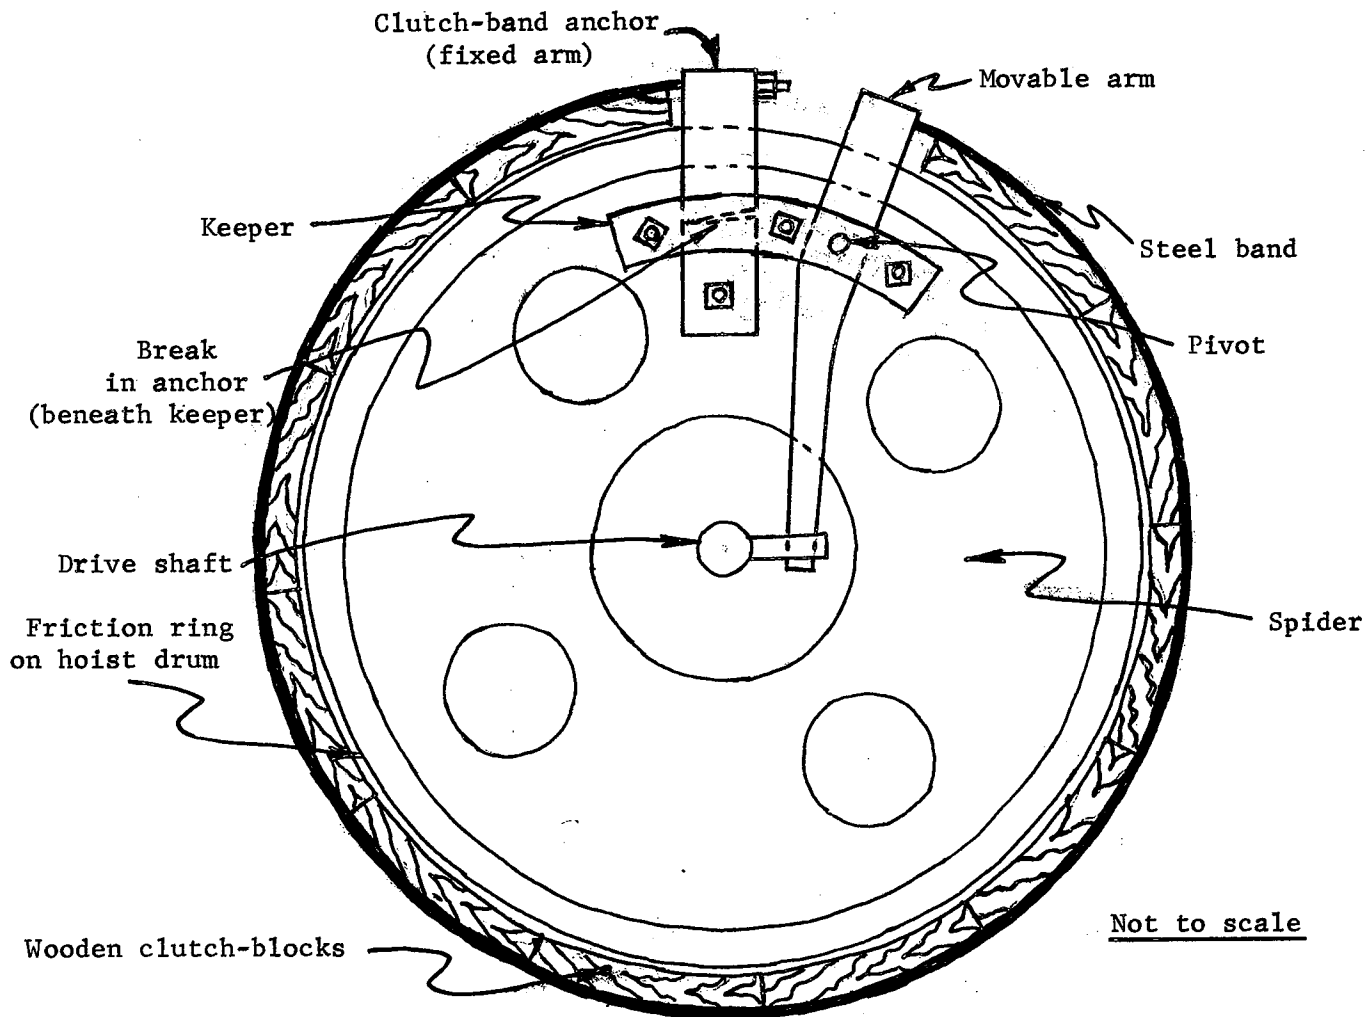
LANE BAND FRICTION CLUTCH

NOTE: - The cast-iron spider is keyed to the drum drive shaft. The movable arm moves about the pivot point when the clutch is engaged, thus tightening the steel band and wooden clutch-blocks against the friction ring on hoist drum. For details see Mining Engineers' Handbook, Vol. I, p. 12-16.

Clutch became disengaged when clutch-band anchor broke, thus permitting drum to rotate and cage to fall.

The direct cause of this accident was the breaking of the clutch-band anchor on the south drum, which disengaged the clutch and permitted the

hoisting cable to unwind. Contributing to the seriousness of the accident was the lack of an automatic overspeed device on the drum.

An imminent danger closure order was issued January 12, 1971, stating: "Broken clutch-band anchor on south hoist drum shall be replaced with an unbroken anchor." The order debarred persons from man-hoisting operations in the south compartment except those persons described in Sec. 8 (a)(1) and (b)(1) of Public Law 89-577, the Federal Metal and Non-metallic Mine Safety Act. A copy of this order is appended to the report of a mine health and safety inspection made in conjunction with this investigation. The order was annulled January 17, 1971, following the installation of a new clutch-band anchor and a new movable arm on the south hoisting drum, and a thorough testing of the hoisting facilities.

A notice was issued requiring that an overspeed device be installed on the hoist. Another notice was issued requiring the clutch of each drum to be mechanically or electrically interlocked with the brake of each drum to prevent accidental withdrawal of the clutch. These notices were listed in the aforementioned inspection report. Also, recommendations were made in the inspection report concerning other aspects of the hoisting operation.

57.19-7            Man hoists shall be provided with devices to prevent overspeed.
