UNITED STATES  
DEPARTMENT OF THE INTERIOR  
BUREAU OF MINES  
REGION VIII

FINAL REPORT OF MINOR FIRE DISASTER  
NO. 3 ELKHORN MINE  
POND CREEK POCAHONTAS COMPANY  
EVANSTON, BREATHTT COUNTY, KENTUCKY

December 13, 1952

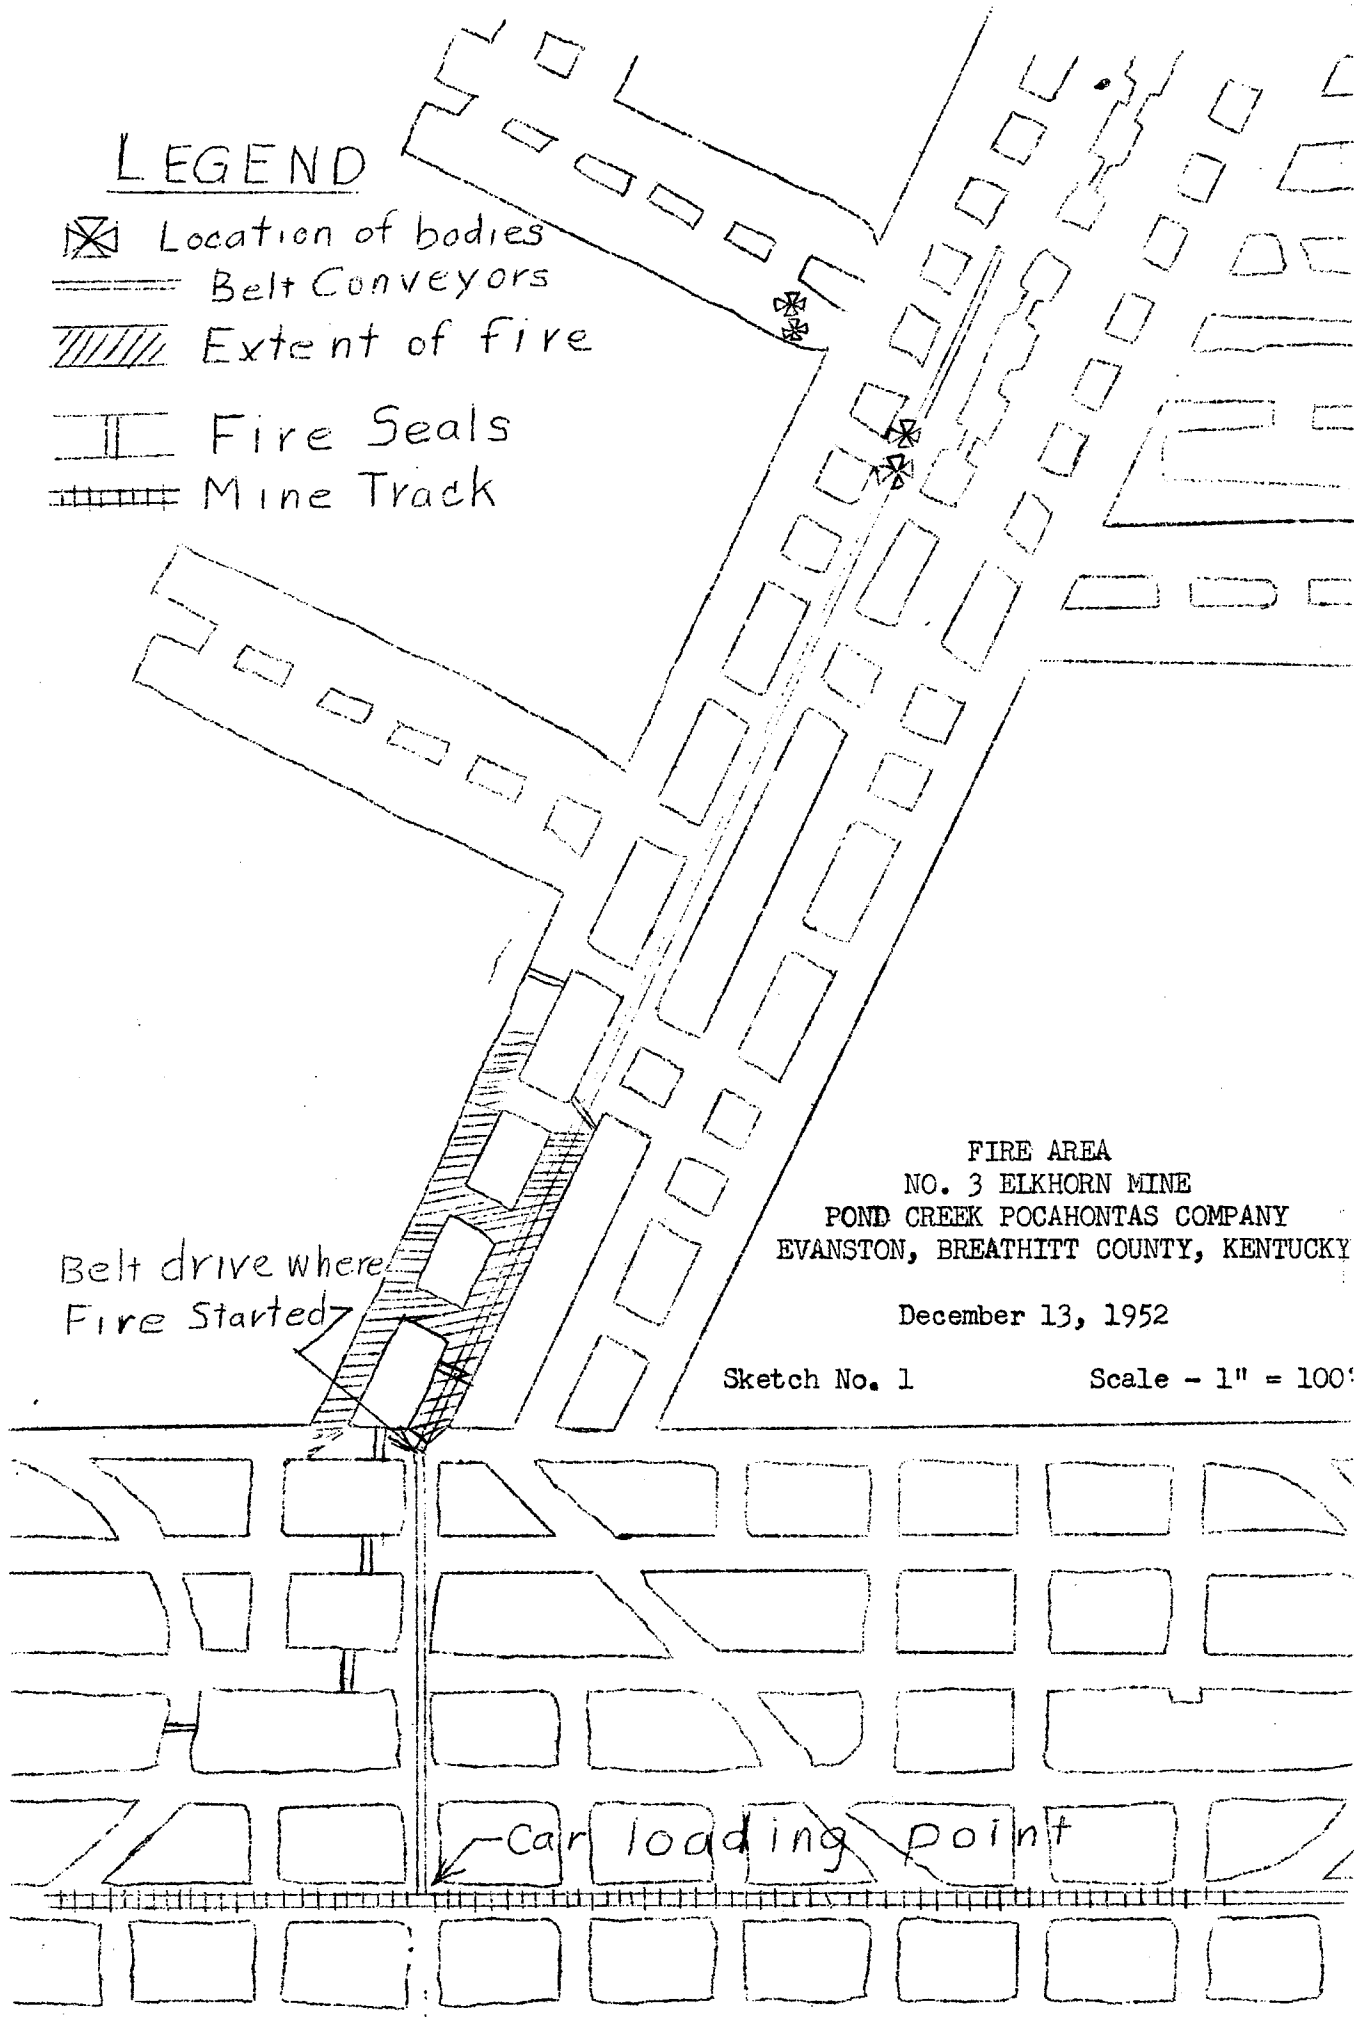
Sketch No. 1

Probable Point of Origin. It is apparent that the fire originated at the drive head of the main belt conveyor in No. 2 entry of 3 butt entries. One of the men who was riding on the "pony" belt into 3 butt entries and who was first to discover the fire said he saw flame near the bottom of the main belt drive.

FIRE AREA  
NO. 3 ELKHORN MINE  
POND CREEK POCAHONTAS COMPANY  
EVANSTON, BREATHITT COUNTY, KENTUCKY

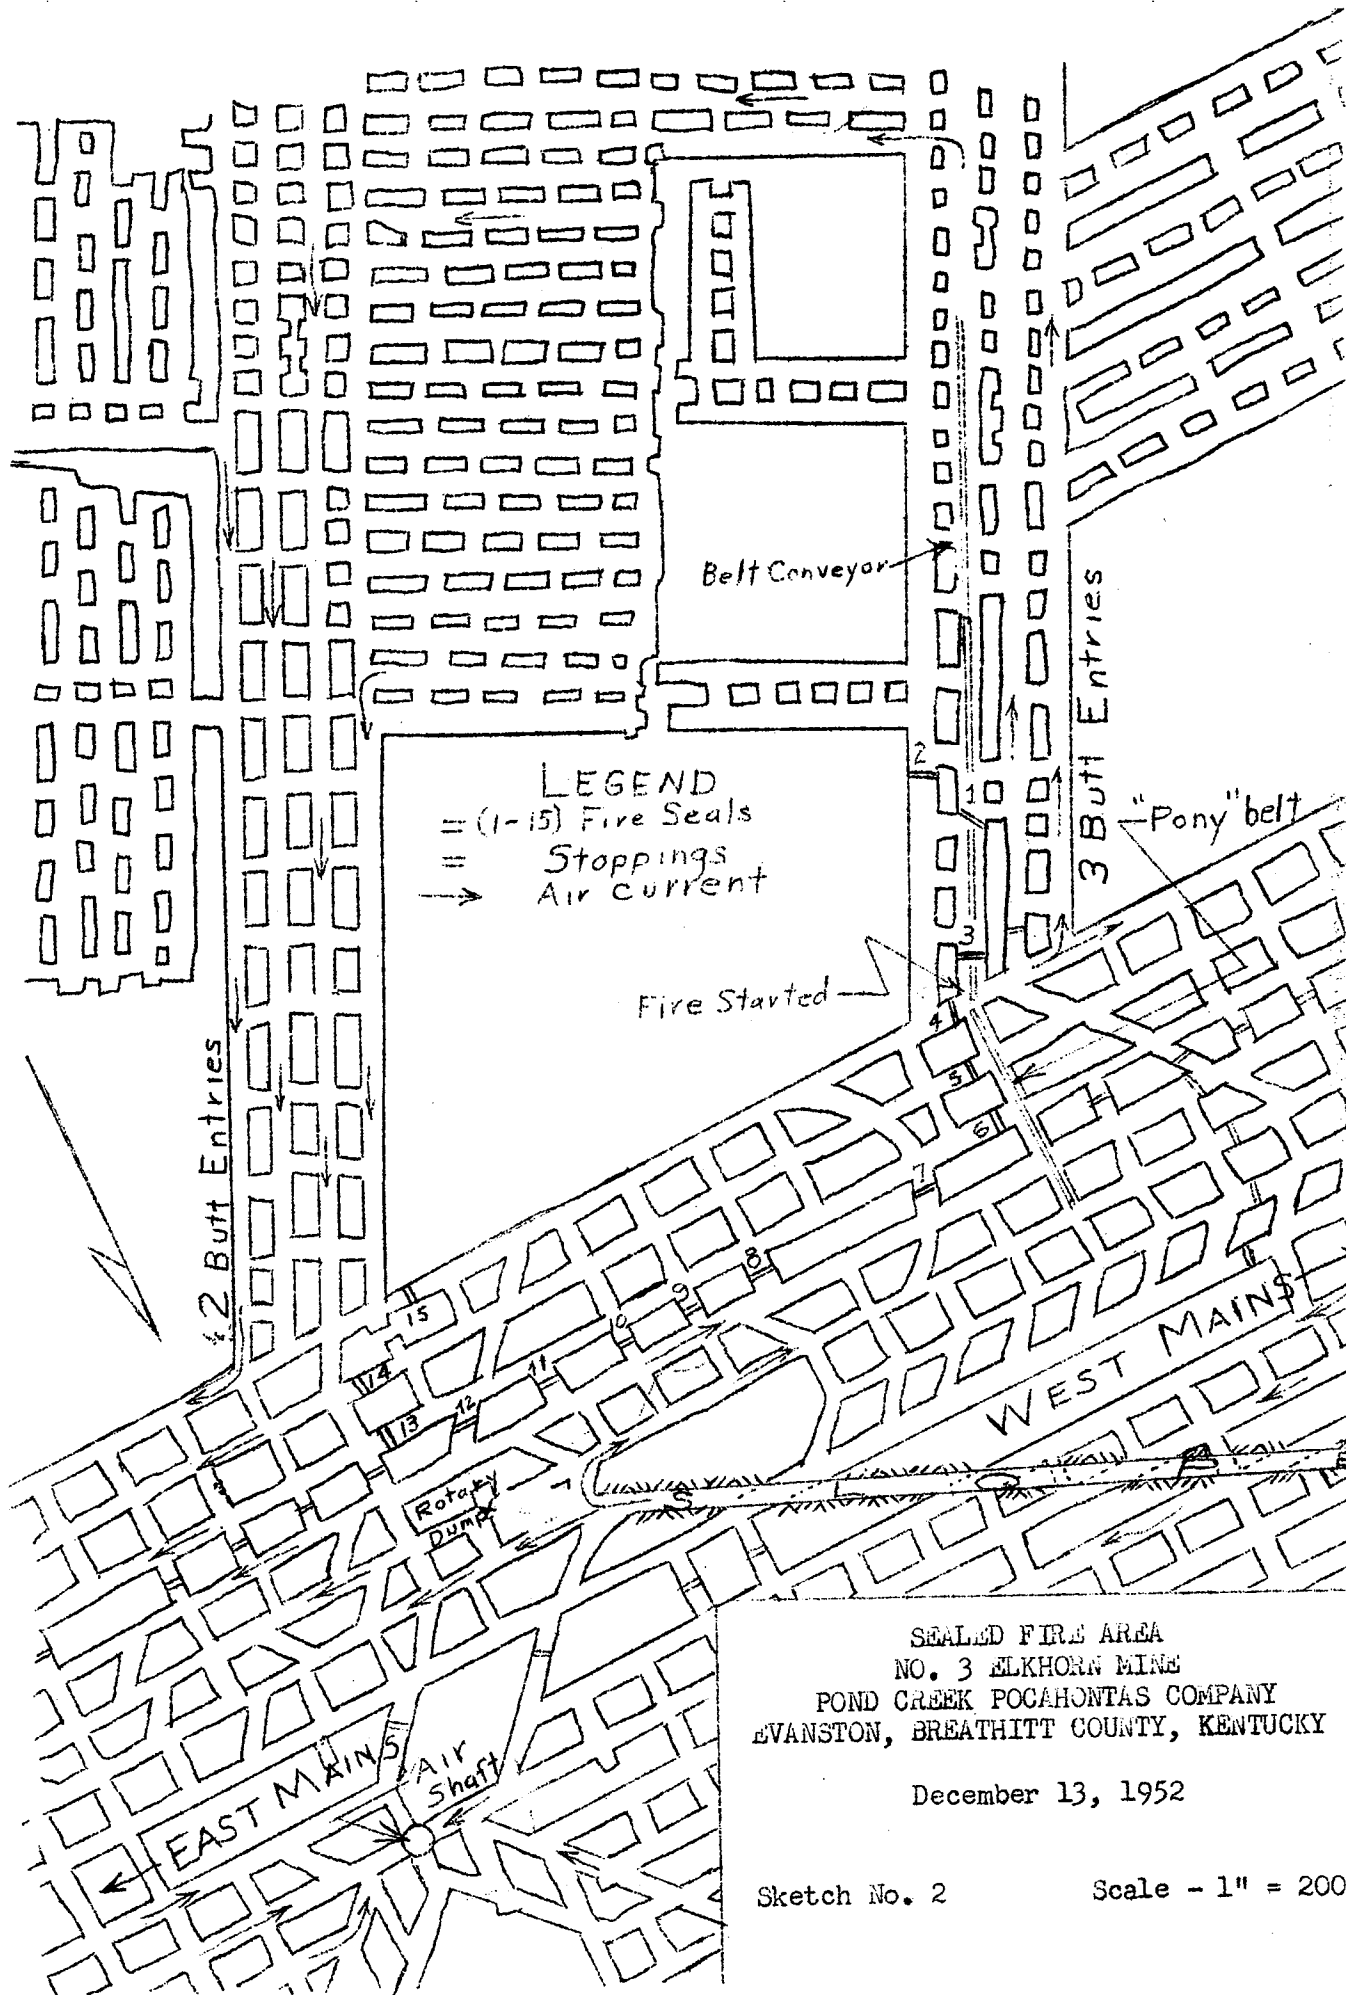
Sketch No. 2

Loading of the burning materials was discontinued, and preparations were made to start erecting the fire seals at 11:20 a.m., December 19. The fire was enclosed completely by means of 15 concrete block seals at 10:45 p.m., and all persons were out of the mine at 11:00 p.m., December 19.

SEALED FIRE AREA  
 NO. 3 ELKHORN MINE  
 POND CREEK POCAHONTAS COMPANY  
 EVANSTON, BREATHITT COUNTY, KENTUCKY
