Report of Mine Explosion,

FARMVILLE MINE, CAROLINA COAL COMPANY,

Coal Glen, North Carolina,

May 27, 1925.

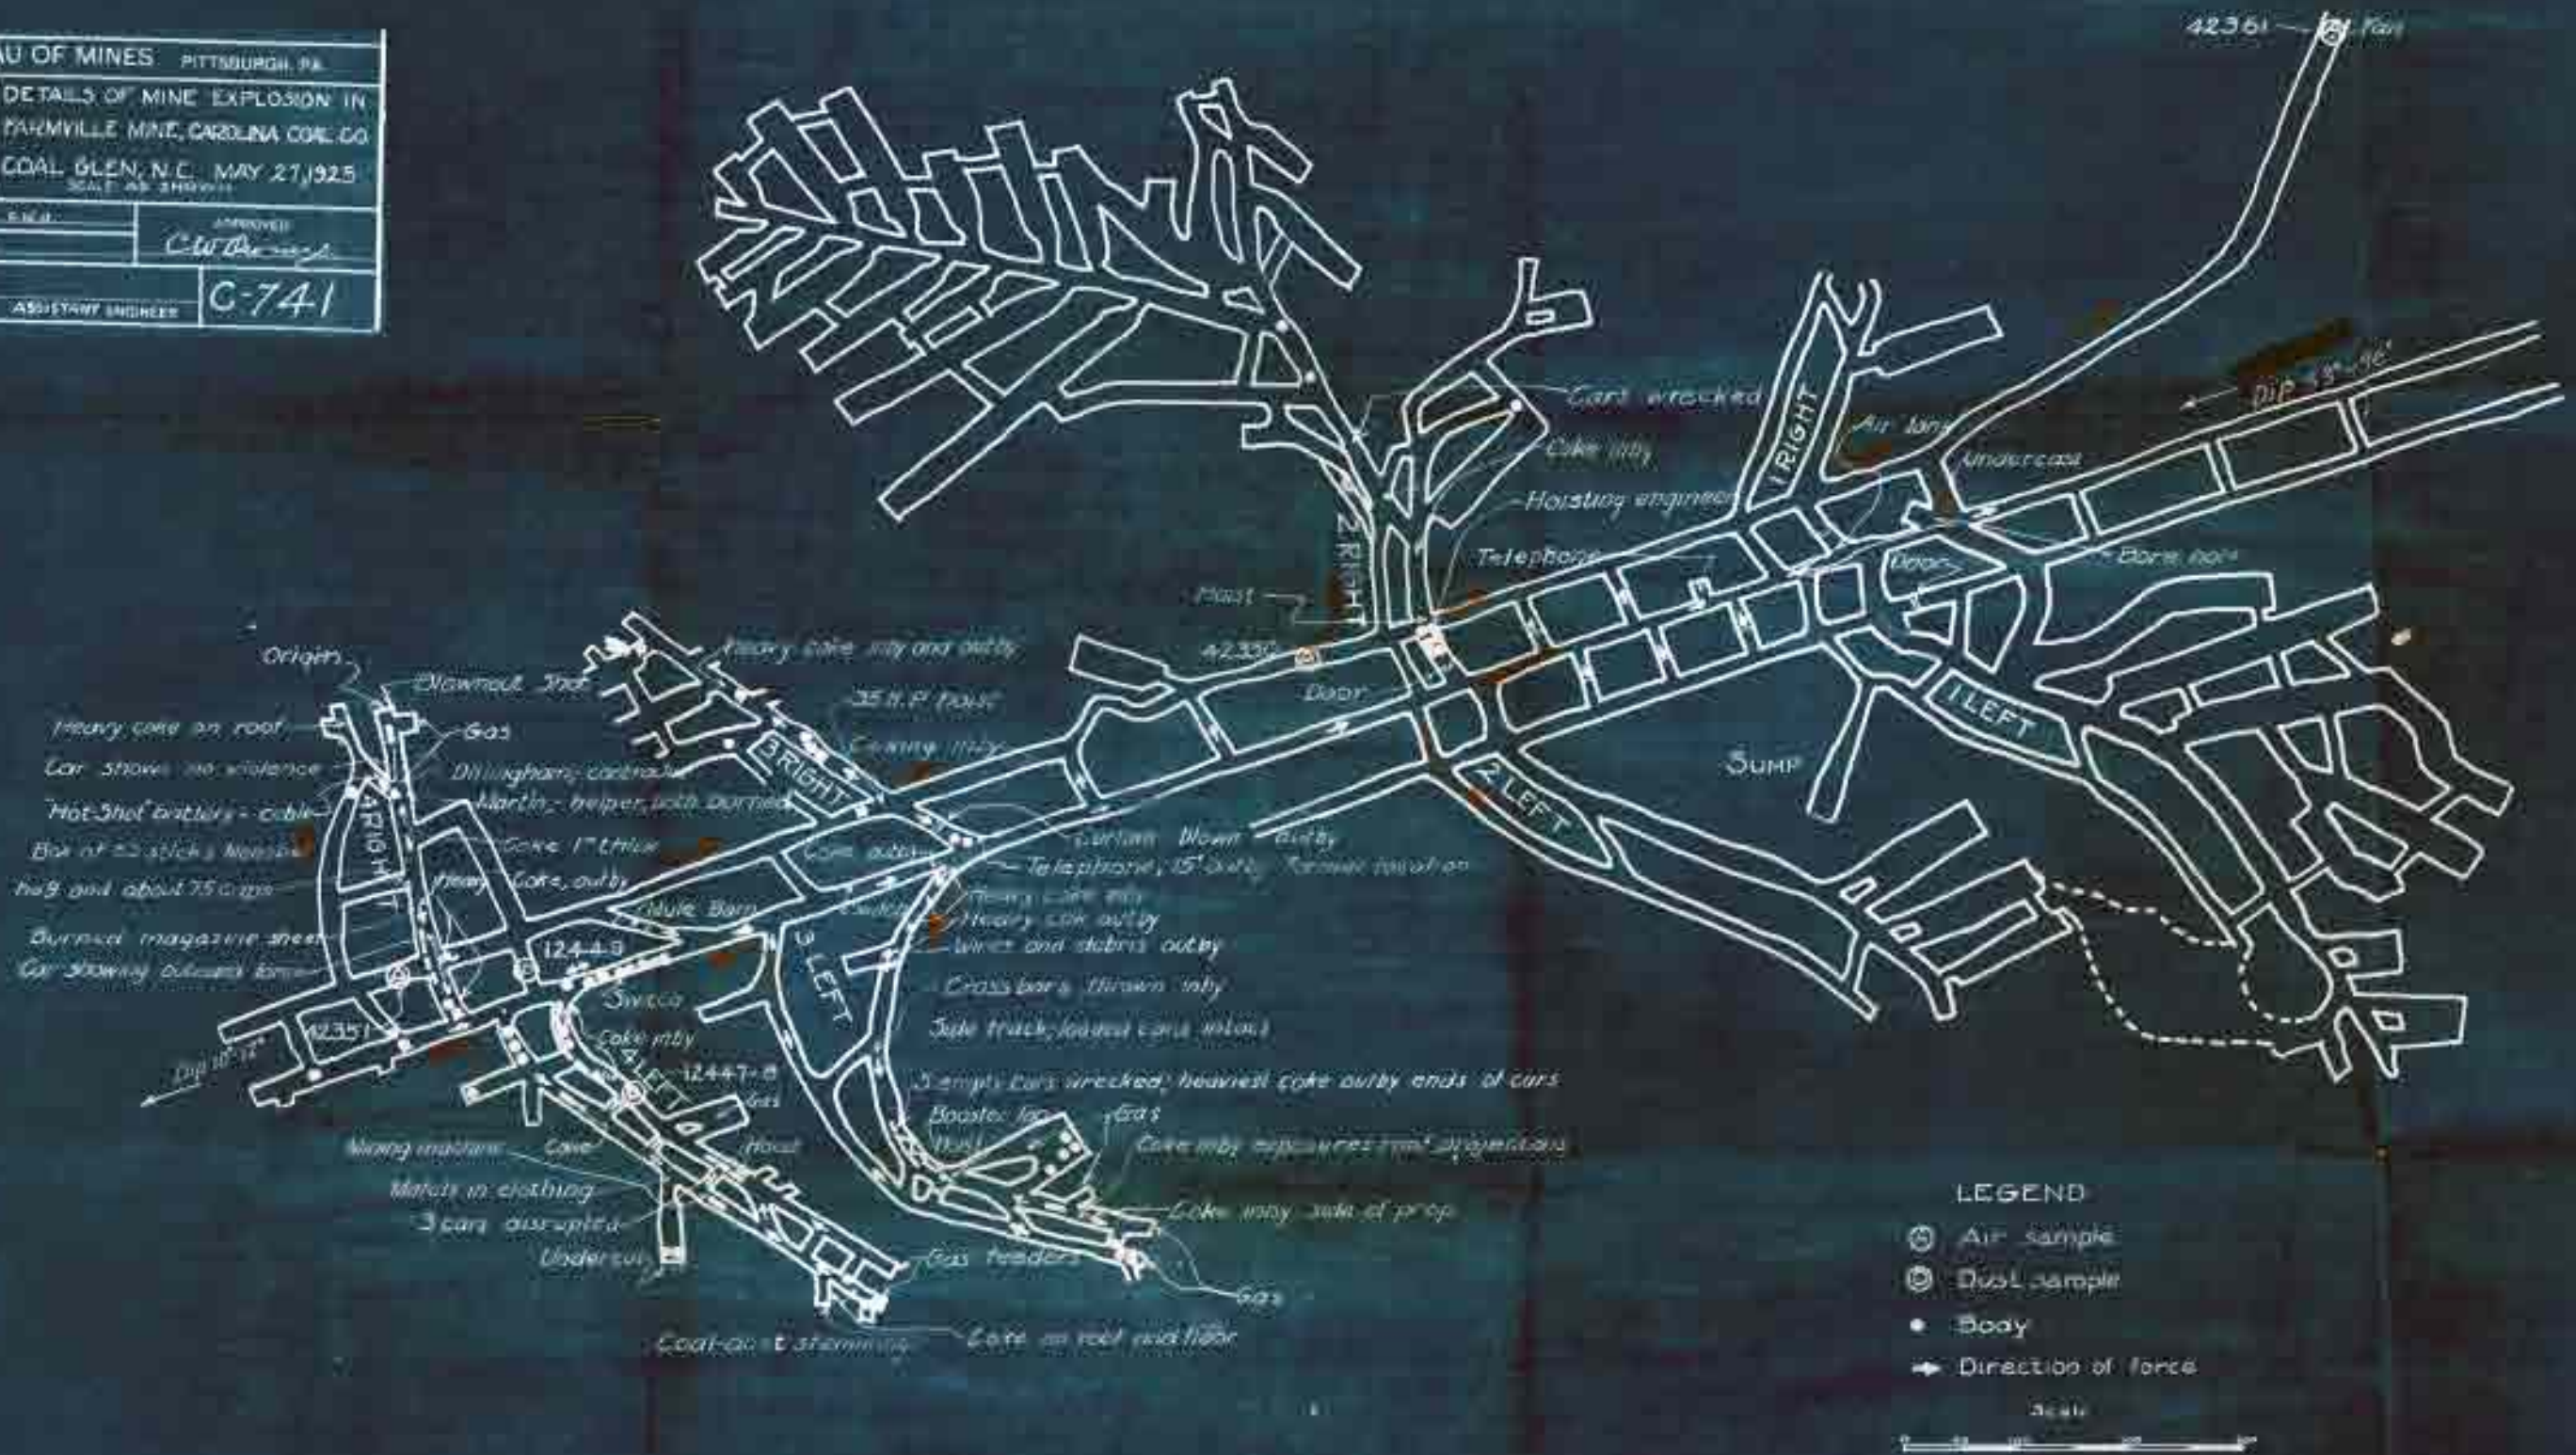
BUREAU OF MINES PITTSBURGH, PA.	
DATE 7/2/25	DETAILS OF MINE EXPLOSION IN FAIRMILE MINE, CAROLINA COAL CO. COAL GLEN, N.E. MAY 27, 1925
DRAWN BY E. H. M.	APPROVED C. W. Brown
CHECKED BY	
ASSISTANT ENGINEER C-741

second right aircourse to the foot of the slope, as indicated by burned insulation on power cable and by caked and coked dust on the timbers. Coke was found in second right evidencing flame and force into this entry. Similar evidence establishes the fact that flame and slight force went into the third and fourth left and fourth right entries, but the greater movement was out of these entries. In fourth right heading there was extremely heavy coking and slight violence near the face. The bodies of 3 men found near the last crosscut were badly burned. A blown out shot was found at the face of this entry and additional evidence indicates the origin to have been at this point.

The first timber was fallen indicating outward force. Six loaded cars were on the side tracks with one empty thrown against second loaded car, indicating outward force. An empty car, 5 feet inby left slope aircourse, had its outby bumper wedged against inby side of a sheave wheel, showing outward force. A gob stopping in the second crosscut was blown toward the heading. Opposite the third crosscut was found a partly damaged hoist showing outward force and 3 cars were badly broken, frames twisted and showing great outward force. The middle car showed evidence of explosives having been detonated. The drawbar was bent downward, the iron frames were bowed outward; the side boards badly splintered and blown from the frames; pieces of paper, evidently cartridge wrappings, were found on the inside of car; the end gate was found 20 feet outby. The inby end of the first car was bent inward, indicating an outward force. The force was into the breakthrough, toward the air course, whereas in all the other breakthroughs up to this point the force had been from the aircourse toward the heading. Violence at this point was greater than at any point in the mine.

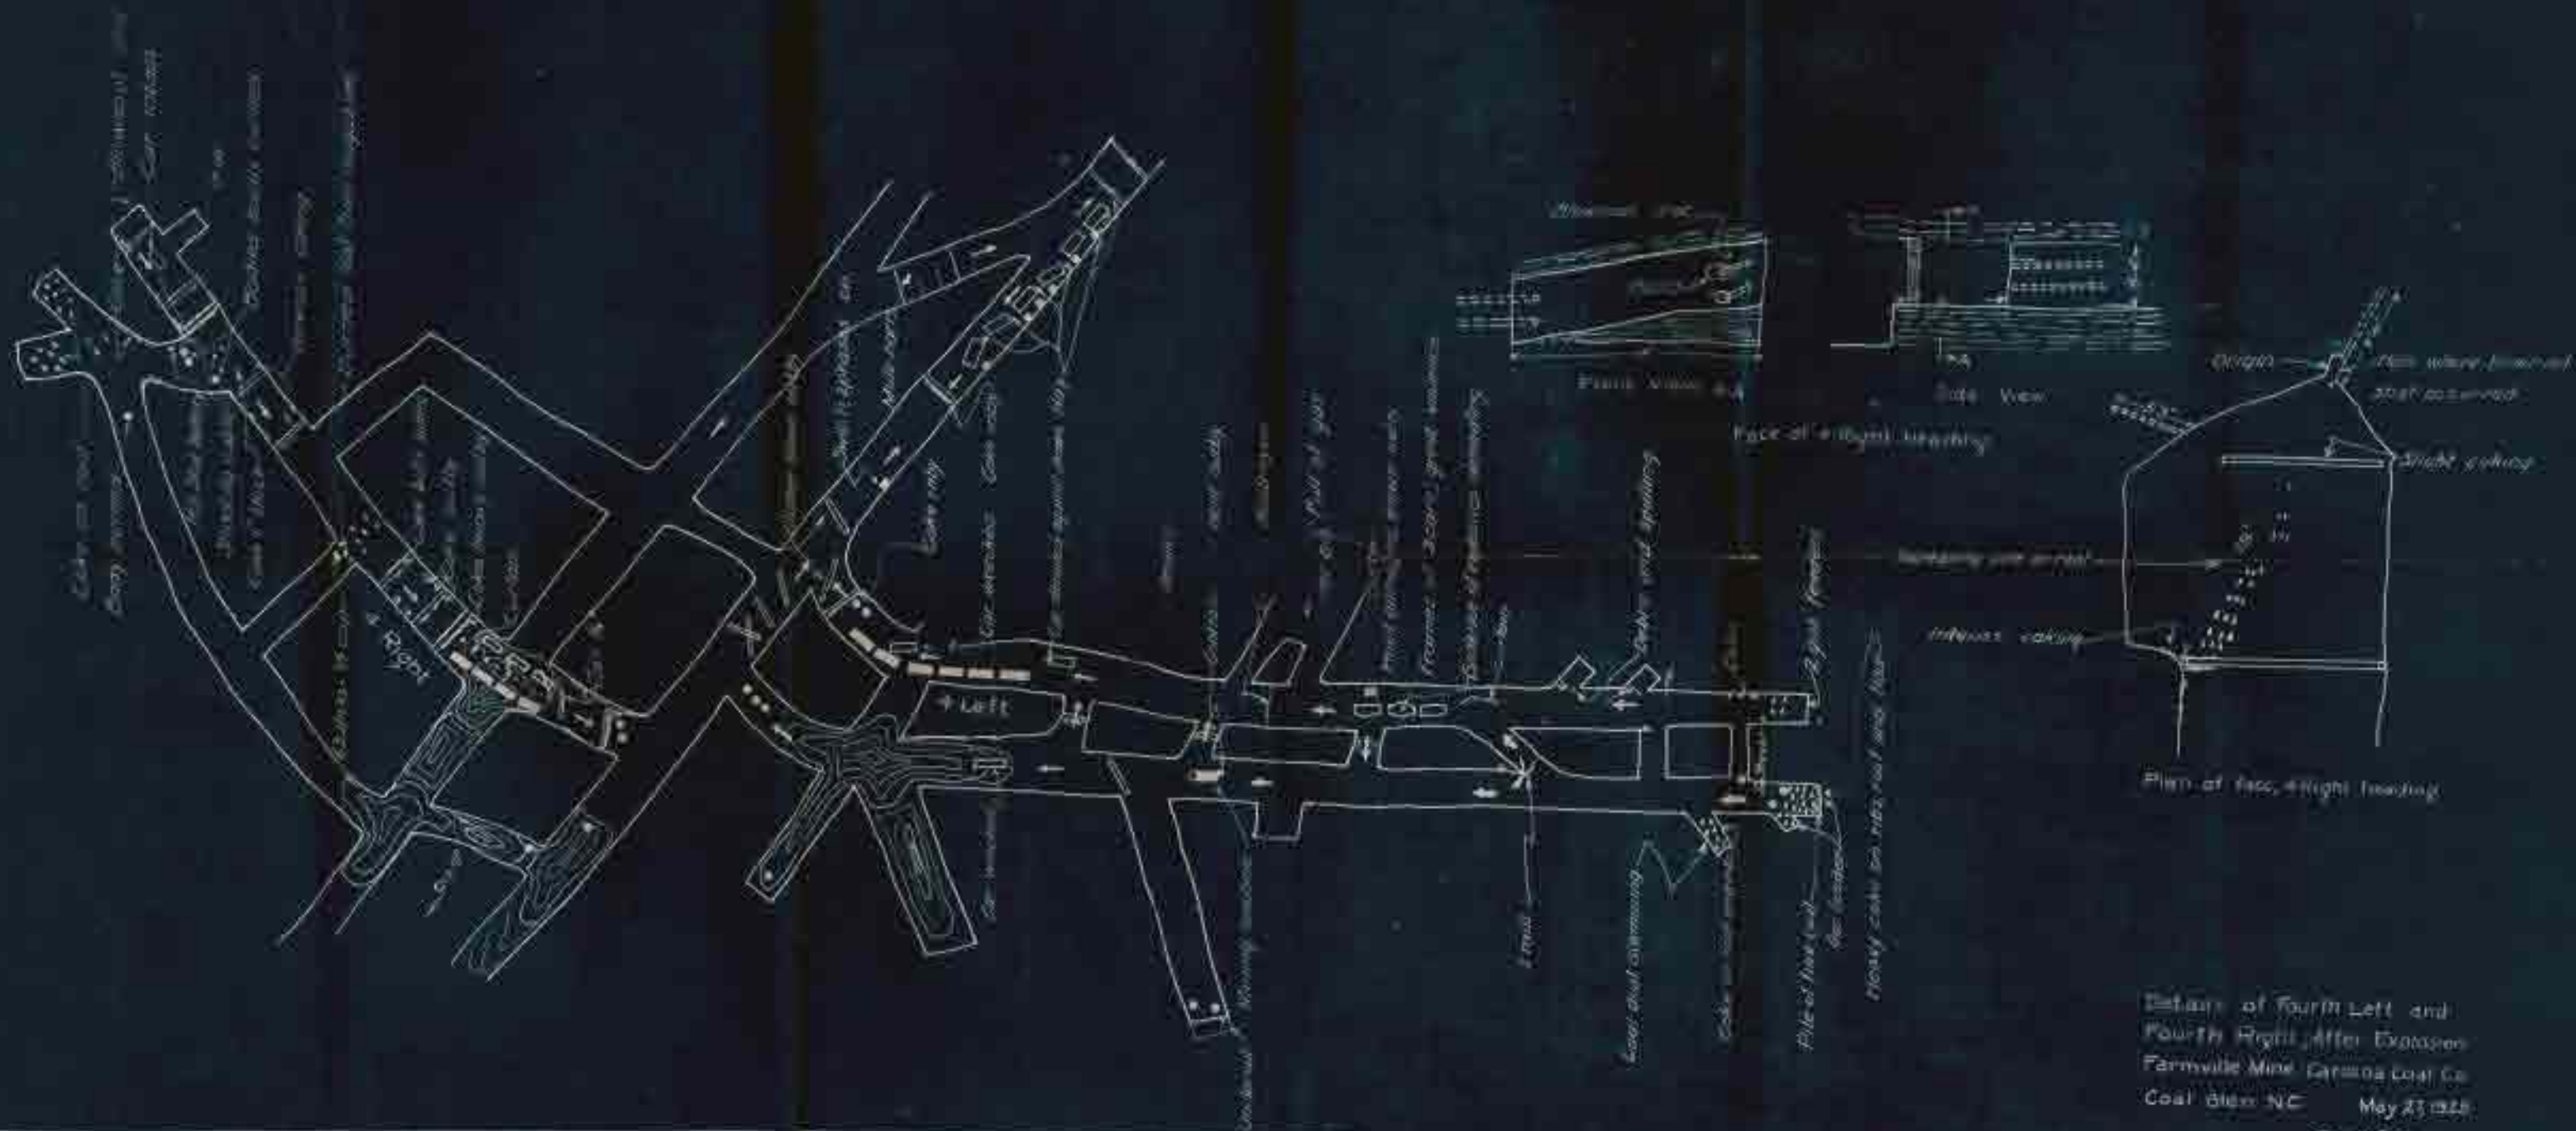
Details of Fourth Left and Fourth Right After Explosion
 Farmville Mine, Carolina Coal Co.
 Coal Blm. NC May 23, 1928.

The curtain in the crossover or slant, was blown into the heading. Debris showing outward force was found from this point to the last crosscut. At the face of the heading were 2 gas feeders. One was also

found at the face of the 4 left aircourse. There were also large quantities of coke on the ribs, roof and floor. A gas feeder was found in the last room. A shovel at the last crosscut showed outward force. The second room from the face contained coke on the floor and roof. A dummy in one of the "guns" from a shot showed that coal dust had been used. At the slant leading to the heading, 2 rails were found blown against the rib indicating outward force.

A Goodman mining machine was found in by the next room (second from the slope) with the controller in an off position, evidently having just finished cutting the room, where 2 men were found, one presumably drilling a hole, (as two holes had already been drilled in the face), the other cleaning up the cuttings. A match was found in the jacket of one of these men. Out by this room 30 feet was found a car wrecked by an outward force. Coke was only on the inby end.
