REPORT OF INVESTIGATION  
(UNDERGROUND COAL MINE)

MULTIPLE FATAL EXPLOSIVES ACCIDENT

No. 1 Mine (ID 15-12590)  
Frank Crawford, Jr., Coal Company  
Woodbine, Whitley County, Kentucky

October 27, 1980

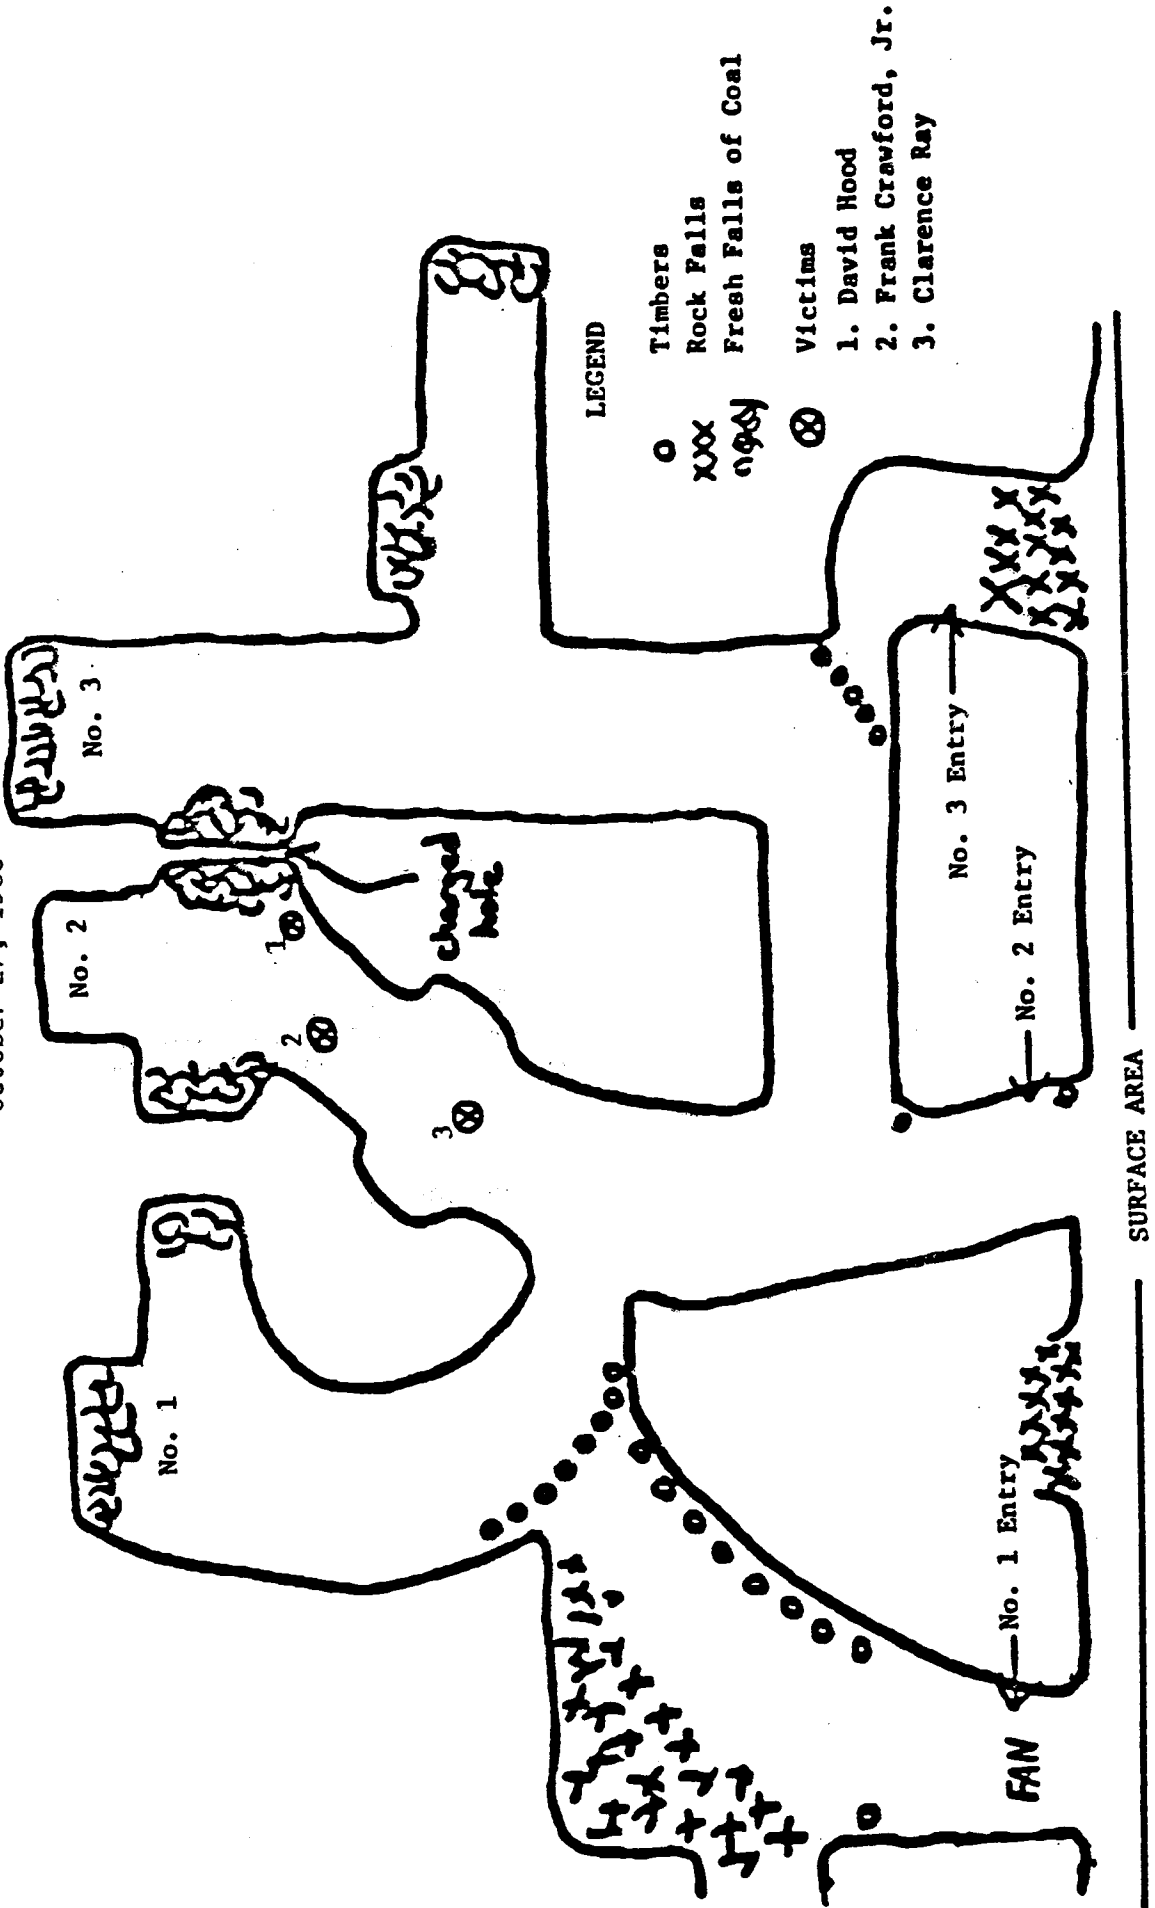
SKETCH OF MULTIPLE FATAL EXPLOSIVES ACCIDENT  
 MINE NO. 1 (ID. 15-12590)  
 FRANK CRAWFORD, JR., COAL COMPANY  
 WOODBINE, WHITELY COUNTY, KENTUCKY

On Monday, October 27, 1980, about 7:45 p.m., a multiple fatal explosives accident occurred in the face area of the No. 2 entry of the No. 1 Mine, Frank Crawford, Jr., Coal Company. The accident resulted in the death of Frank Crawford, Jr., President, David Hood, Scoop Operator, and Clarence G. Ray, Driller. Reportedly, Crawford and Hood had six weeks mining experience and Ray had 20 years. At the time of the accident, Hood was apparently lighting fuses that were the means of detonating blastholes when a previously lit blasthole in the crosscut left in No. 3 entry shot through injuring him. Crawford and Ray attempted to aid Hood, and because of the lack of adequate ventilation, all three were overcome by noxious gases emitted by the detonated explosives.

8. An accurate and up-to-date mine map was not available and there were no means provided (survey stations) for determining the course developing entries were being driven. This contributed to the cause of the accident in that the distance between the No. 2 and No. 3 entries was apparently less than the victims anticipated.
9. There had not been an inspection made at the mine because the local office of MSHA did not know the mine had reopened.
10. An autopsy was performed on the victims and the report stated that the following was the cause of death:
