FINAL REPORT ON MINE EXPLOSION
FRANKLIN COLLIERY, LEHIGH VALLEY COAL COMPANY
WILKES-BARRE, LUZERNE COUNTY, PENNSYLVANIA

DECEMBER 11, 1947

UNITED STATES
DEPARTMENT OF THE INTERIOR
BUREAU OF MINES

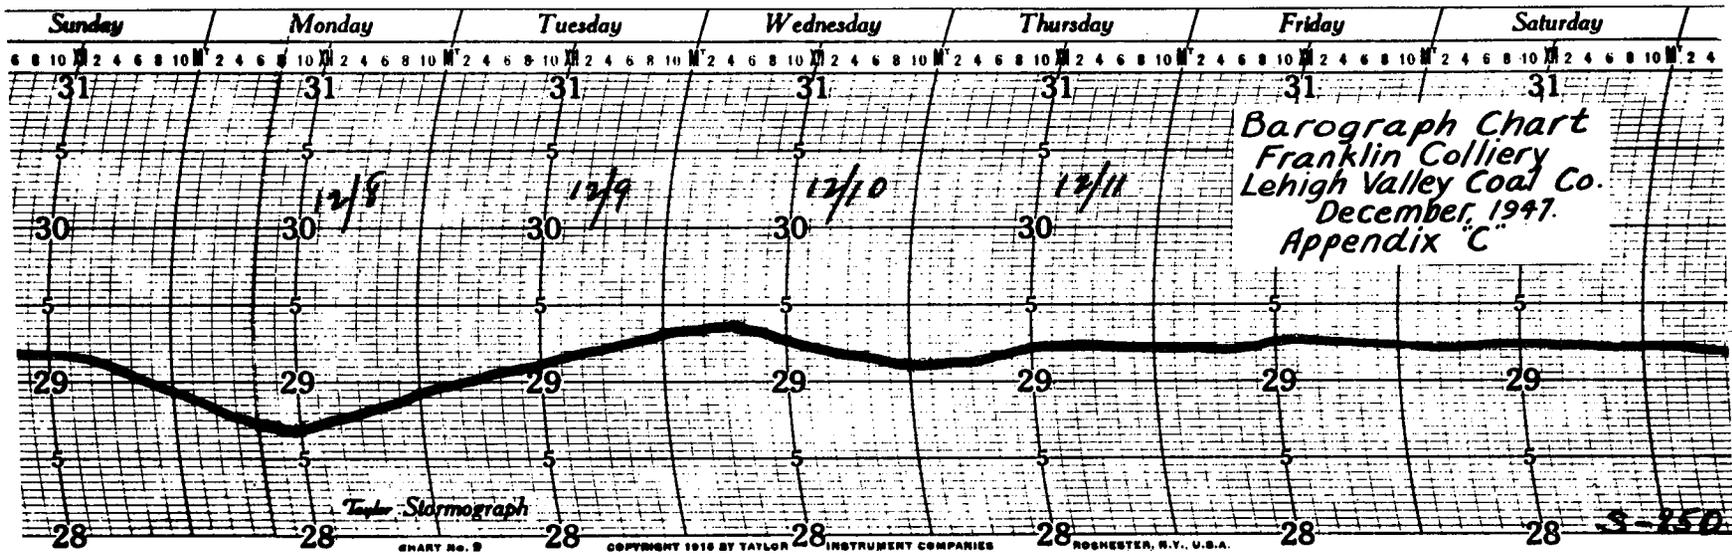
Appendix C

The weekly barograph chart, appendix "C", for the Wilkes-Barre area indicates a gradual increase in the atmospheric pressure from 28.70 inches of mercury at noon on Monday to 29.35 inches at 7 a.m. on Wednesday. From this high point, the curve dips to 29.10 inches at midnight before it starts a rise which reached 29.25 inches at noon on Thursday, December 11, 1947. These changes in barometric pressure probably had no effect on the liberation of gas.
