REPORT OF INVESTIGATION

Fall of Highwall Double Fatality
October 28, 2011

Equality Mine
Armstrong Coal Company Inc.
Centertown, Ohio County, Kentucky
ID No. 15-19344

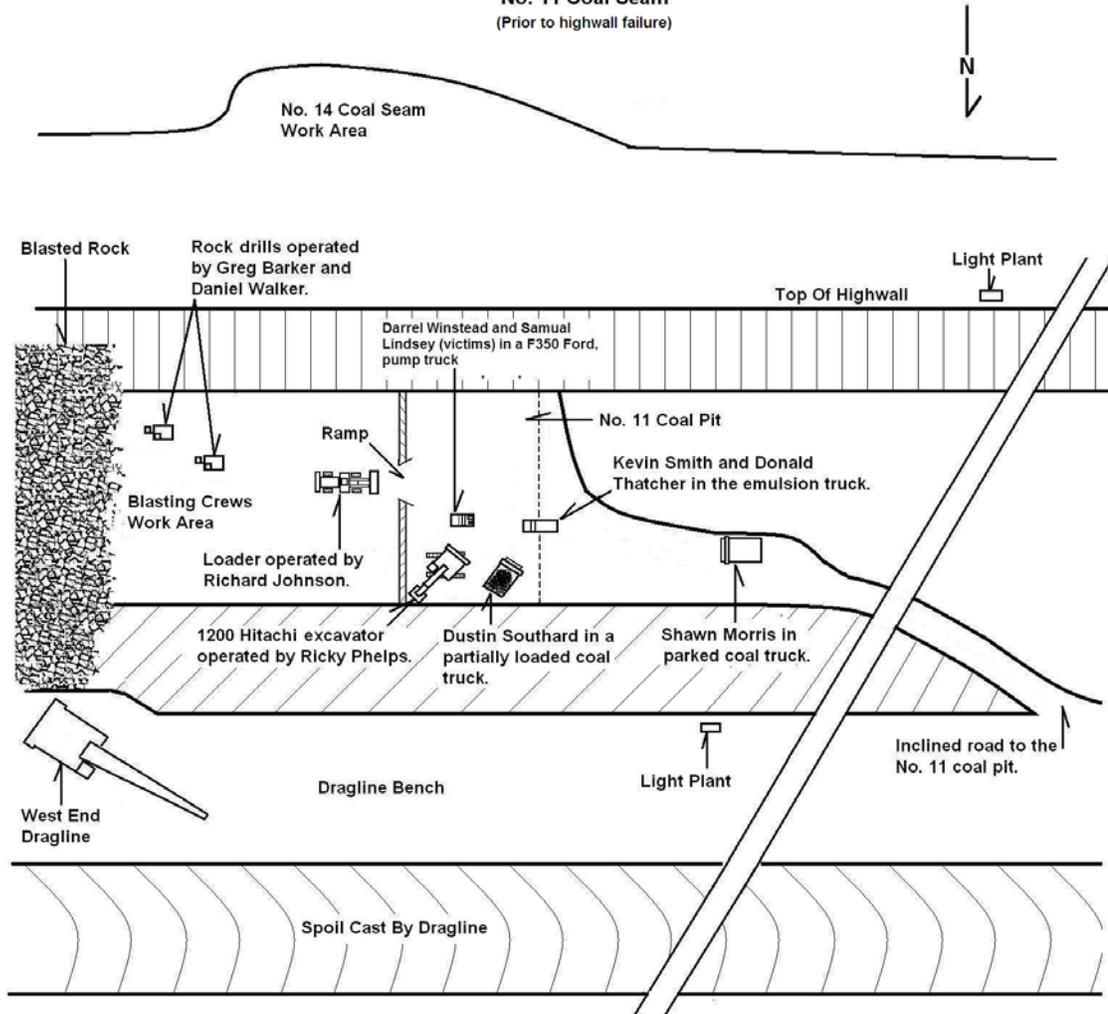
Accident Scene Sketch

The Accident Scene West End Dragline Pit No. 11 Coal Seam (Prior to highwall failure)

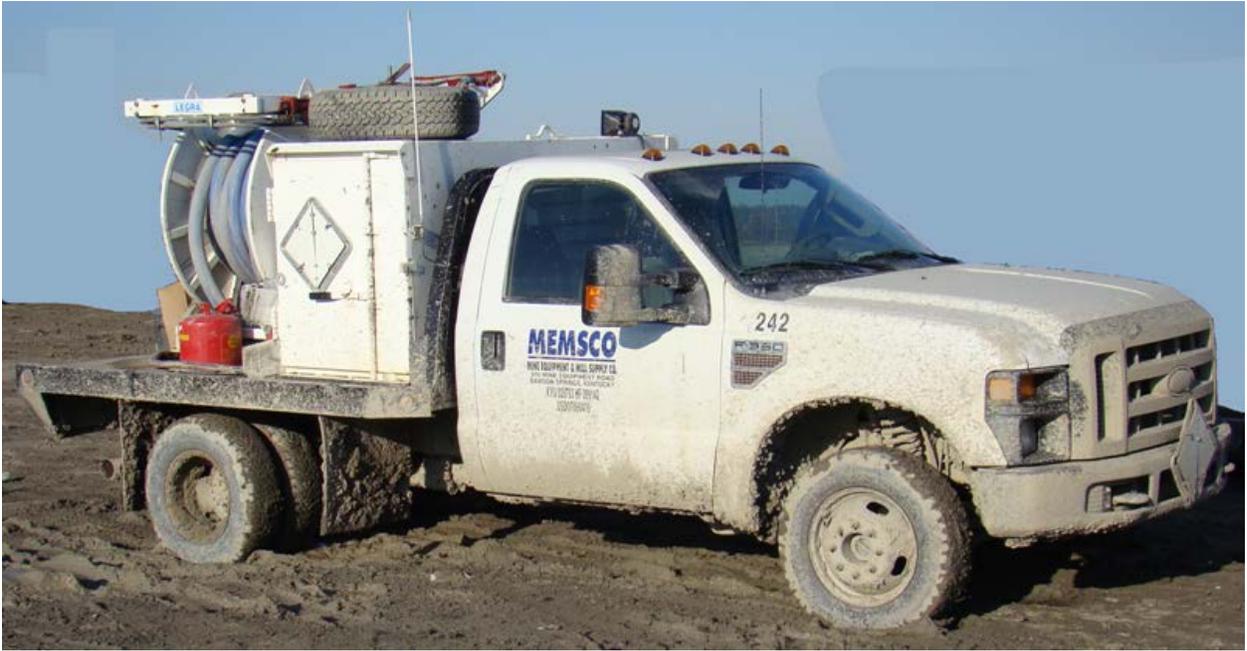
Exhibit 1

Type of vehicle involved in the accident

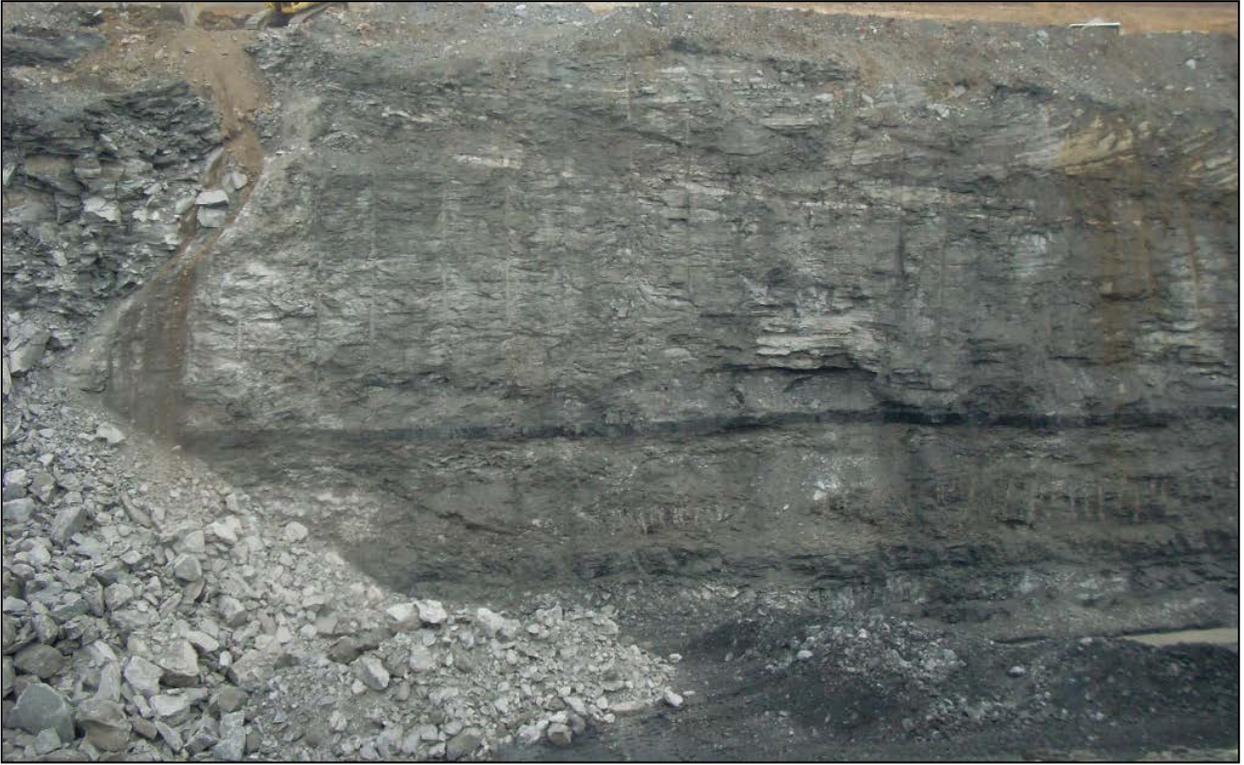
APPENDIX B (cont.)
Exhibit 2

Two geologic features, specifically pinched-out sandstone and undulating strata at the top of the highwall, were also observed in the strata just west of the failure. These features were not observed in the highwall to the east of the failure area. It appeared that the pinched-out sandstone and warped strata coincided with the type of discontinuity (potential slickenside) that defined the western boundary of the failure area. Published literature suggests that the surface that defined the western boundary of the failure area could be a slickenside that was caused by differential compaction of

Highwall adjacent to and immediately to the West of Accident site

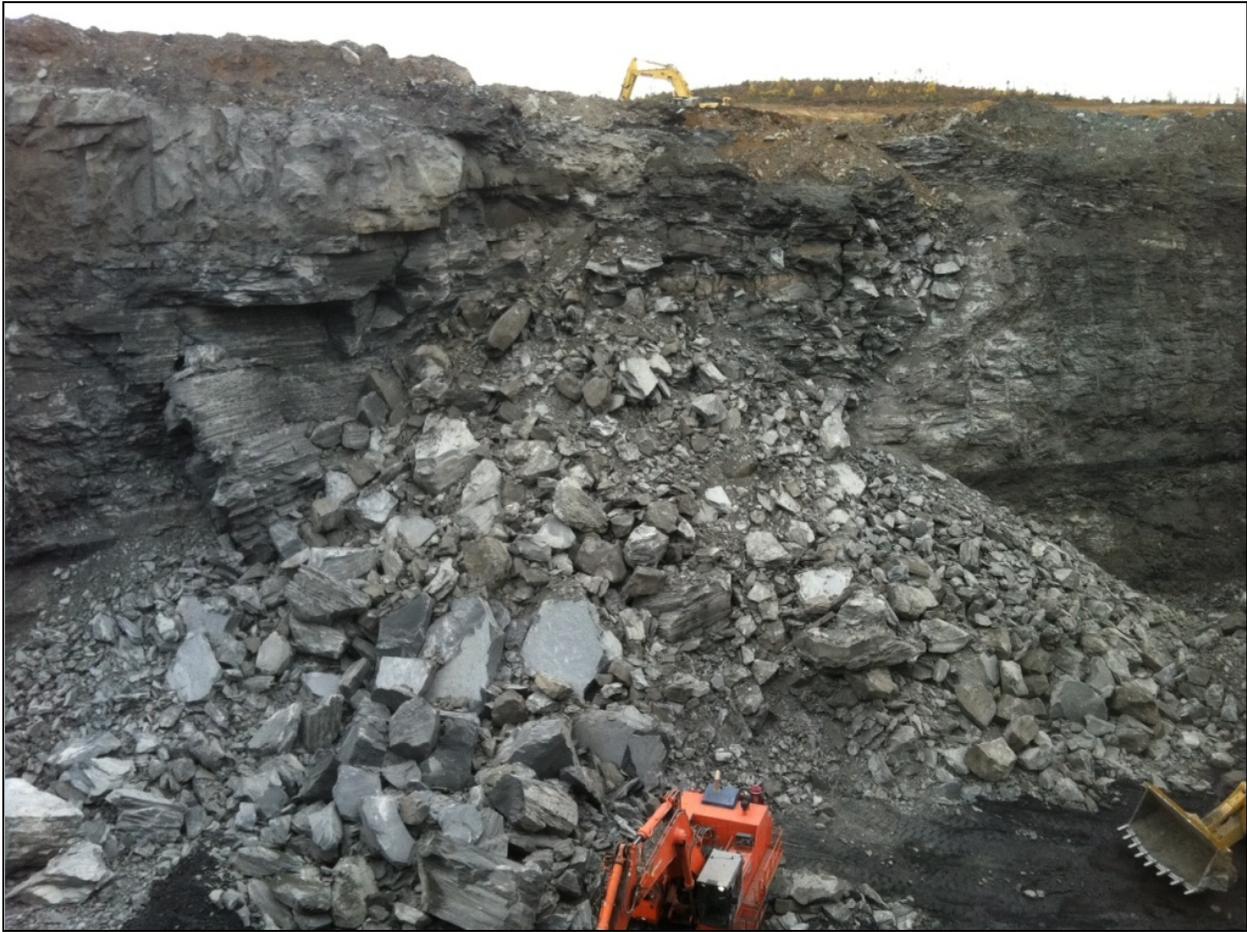
APPENDIX B (cont.)
Exhibit 3

Spoil-side view of accident site

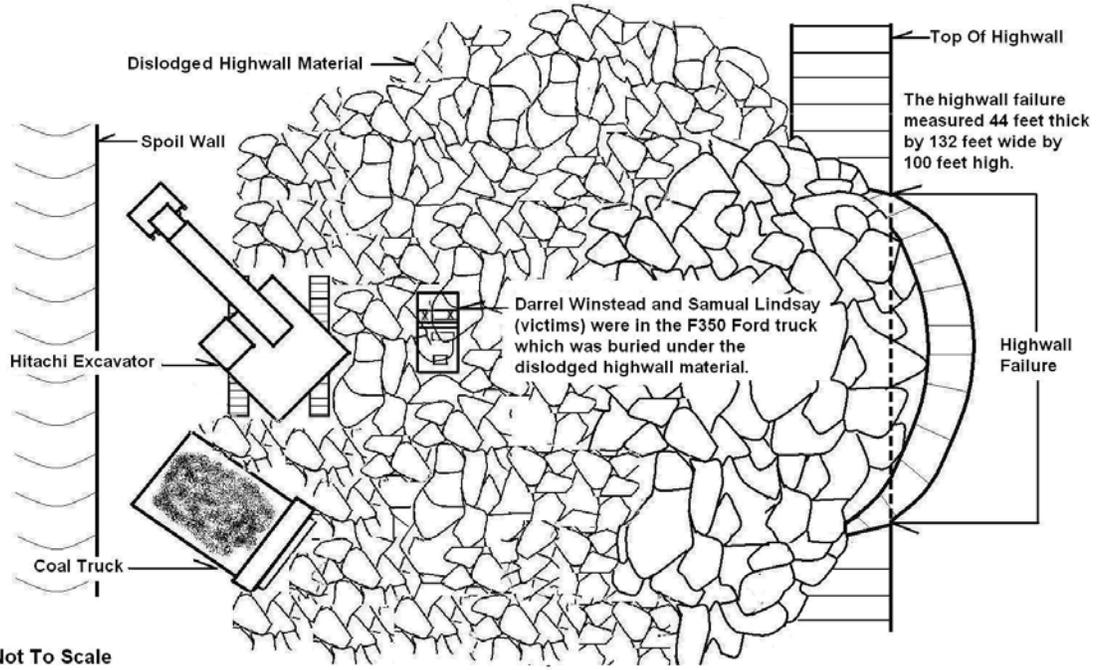
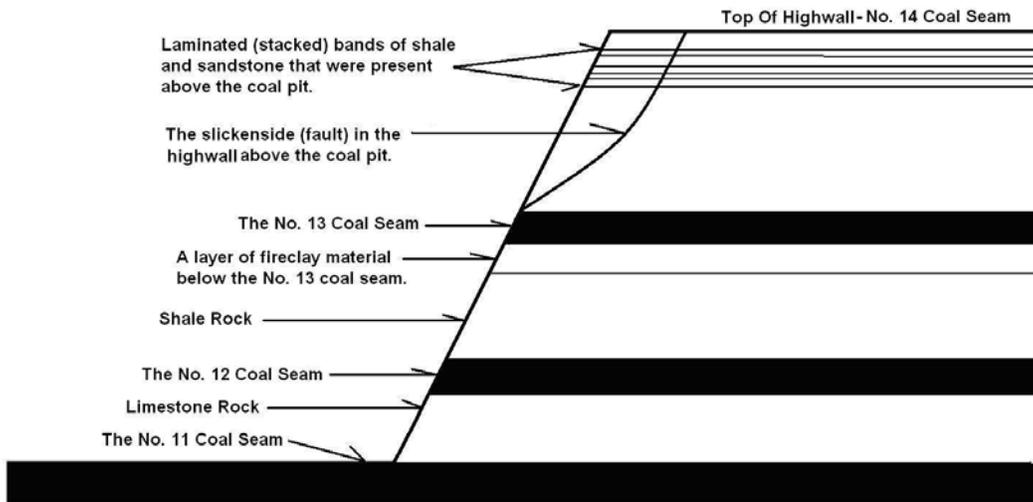
Exhibit 4

The Accident Scene
