UNITED STATES  
DEPARTMENT OF THE INTERIOR  
BUREAU OF MINES

FINAL REPORT OF MAJOR COAL-MINE BUMP DISASTER  
GLEN ROGERS NO. 2 MINE  
RALEIGH WYOMING MINING COMPANY  
GLEN ROGERS, WYOMING COUNTY, WEST VIRGINIA

December 9, 1957

Originating Office - Bureau of Mines  
Mount Hope, West Virginia  
W. R. Park, District Supervisor  
Health and Safety District C

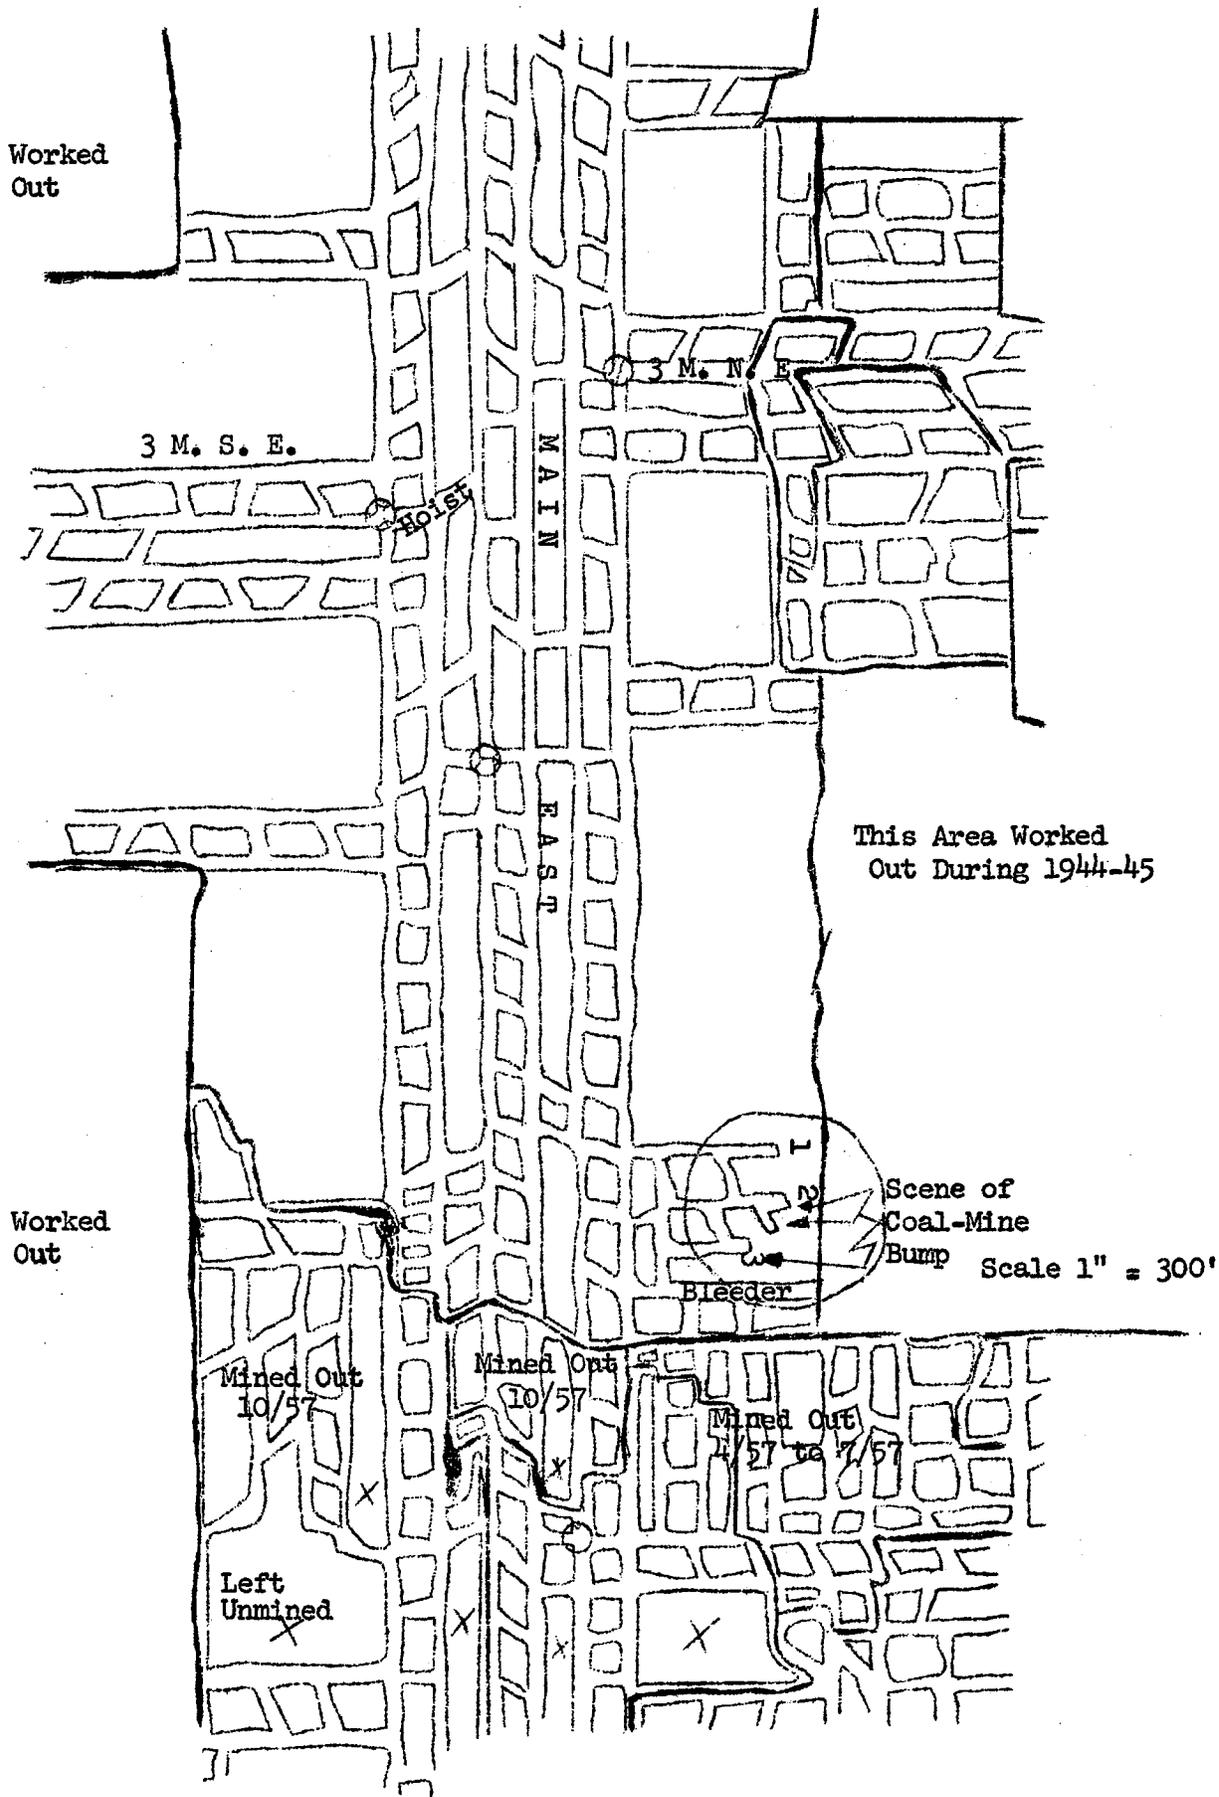
APPENDIX B

From Appendix B, it will be noted that No. 1 room had advanced about 230 feet, the No. 2 room approximately 250 feet, and the No. 3 room about 190 feet into the barrier block. However, in starting these rooms it was decided that, rather than clean up the rock in the No. 6 main east entry, a sub-entry would be driven and the 3 rooms developed as shown in Appendix B. The No. 1 room was started first and the sub-entry was turned to the right off No. 1 room and driven parallel with the No. 6 main east entry until it intersected the first bleeder entry. Subsequently, Nos. 2 and 3 rooms were turned off the sub-entry, but inasmuch as the No. 3 room was the last to be turned, it lagged behind Nos. 1 and 2 rooms.

Investigation revealed that the thick massive sandstone roof inby and outby the large barrier pillar being mined had not caved and, in all probability, it could not cave as desired, because of incomplete extraction inby. It was further noted that the mine floor in the area involved was a hard, dense, sandy shale that resisted heaving. Combination of these factors undoubtedly subjected certain areas of the large barrier block, particularly along the back or gob side, to high stresses that extended for considerable distances within the block. From Appendix B, it will be noted that the 3 rooms were being driven in the manner and

It will be further noted from Appendix B, that the method of development in many instances in main east resulted in the formation of several blocks of coal much larger in dimensions and different in shape than the surrounding coal pillars. Furthermore, the method used in recovery of coal pillars in the main east area had been governed in most instances by conditions or expediency, consequently complete recovery of pillars was not striven for as a requirement. The consequence is that several complete pillars and numerous remnants of coal pillars remain unmined in the gob areas. The large blocks, as in the case of the large barrier pillar involved, were not always developed systematically and sufficiently in advance of the extraction line before becoming part of the active pillaring area. Obviously, this method is not in accordance with best mining practices and often results in bumps, if conditions conducive to such occurrences are present when an attempt is made to mine them.

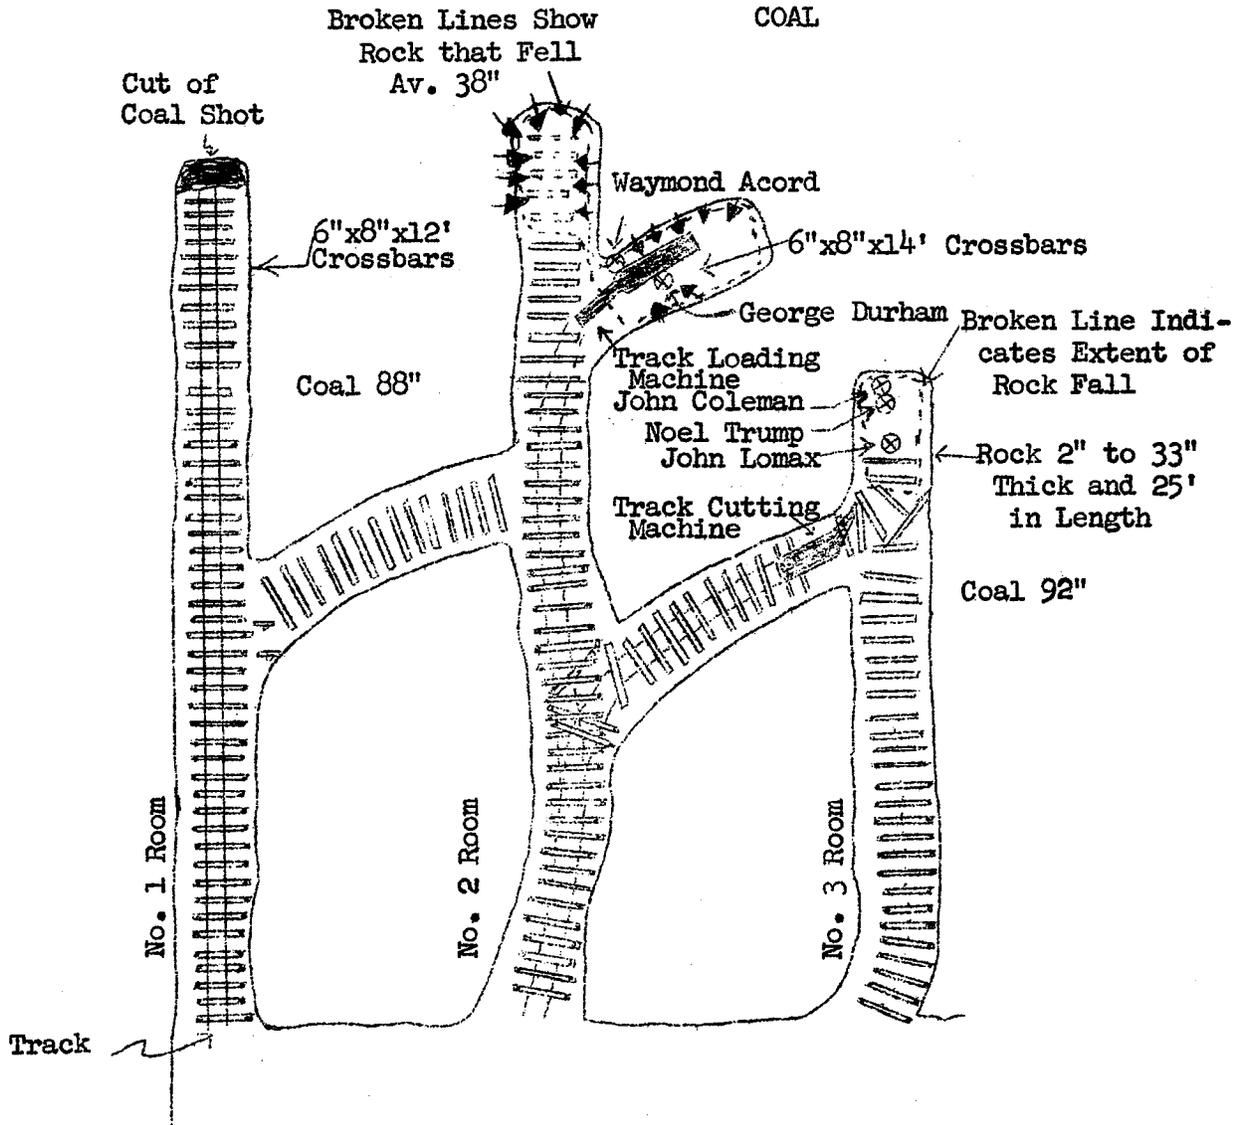
APPENDIX C

direction as indicated on 75-foot centers in the large barrier pillar and this development was being done toward an old gob area within the front abutment or highly stressed area of the block. When the faces of these places reached this highly stressed area, a coal-mine bump occurred with considerable force and mostly in the direction as indicated in Appendix C.

NOTE - Heavy arrows indicate direction of forces.
