REPORT OF INVESTIGATION
(UNDERGROUND COAL MINE)

MULTIPLE FATAL INUNDATION (BLACKDAMP) ACCIDENT

No. 5 Mine (I.D. No. 15-05184)
Grays Knob Coal Company
Grays Knob, Harlan County, Kentucky

June 3, 1981

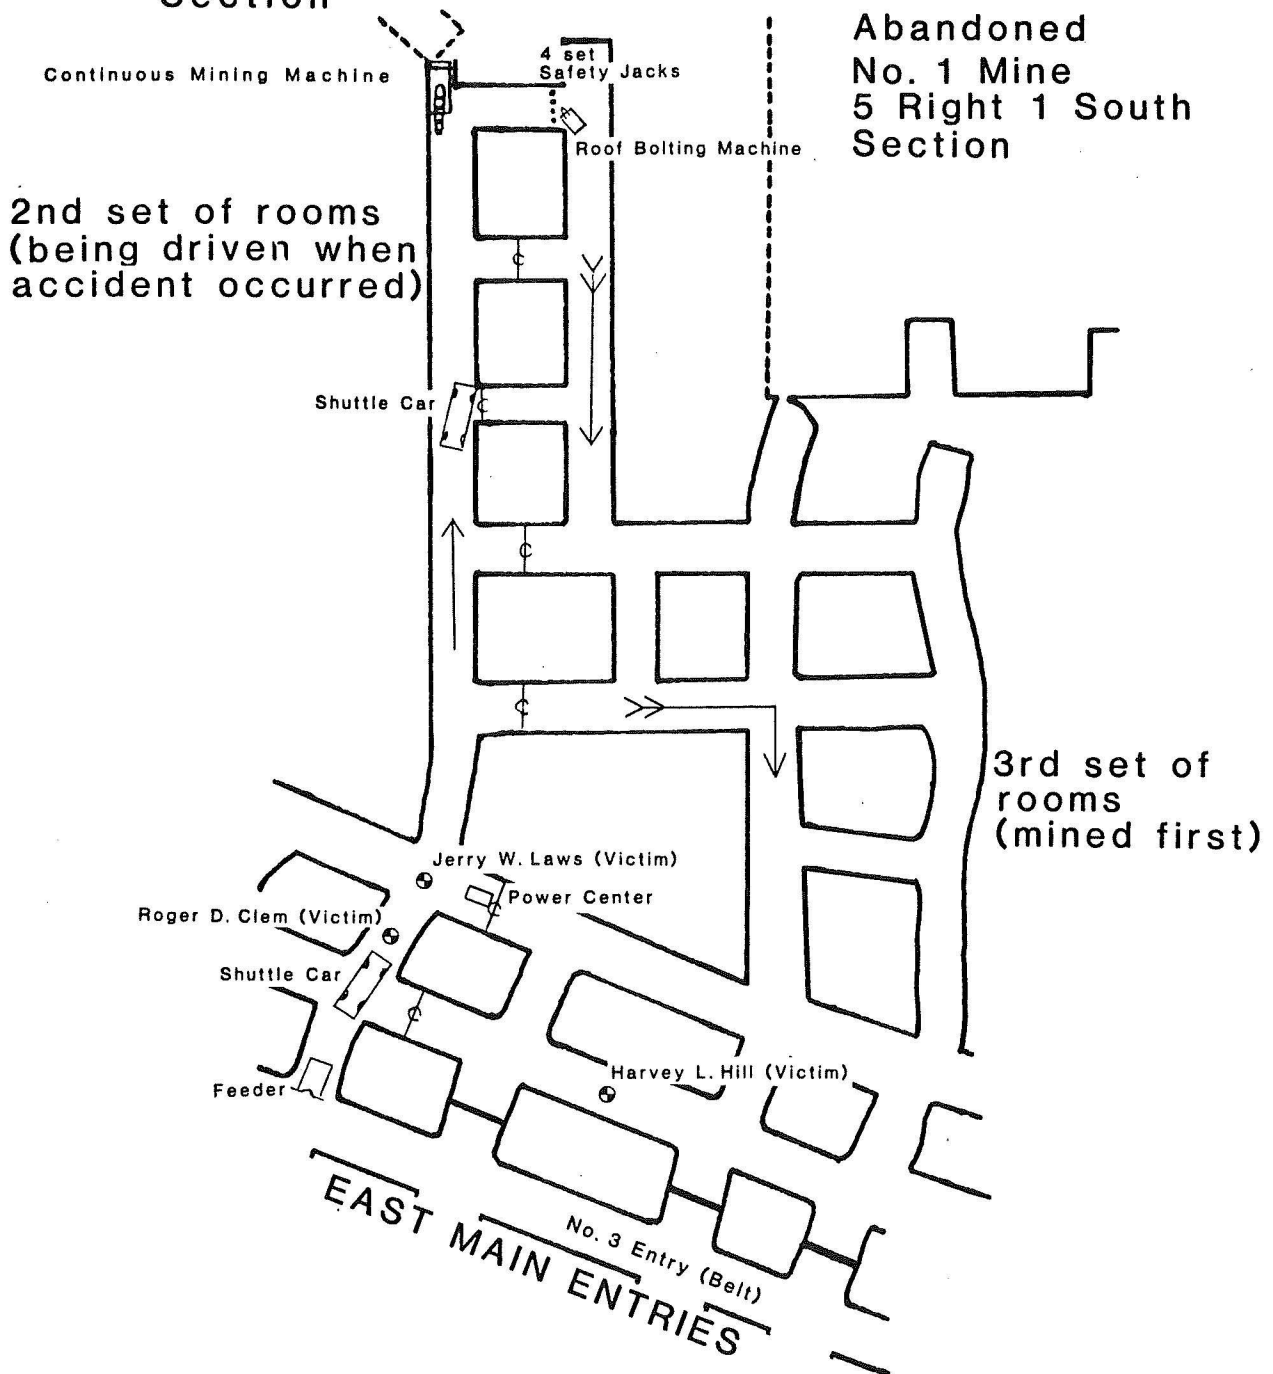
Sketch No. 1

4. The two rooms being developed when the accident occurred were on 60-foot centers with connecting crosscuts every 70 feet. The No. 1 room had been driven approximately 345 feet in by east main when an opening about 30 inches by 30 inches was made in the lower left side of the face into the abandoned No. 1 mine. Test boreholes were not drilled in advance of the working faces during the development of these rooms. Reportedly, test boreholes were drilled in advance of the working faces, in accordance with Section 75.1701, Title 30, Code of Federal Regulations, Part 75, during all other approaches to the No. 1 mine.

5. The mine workings of the No. 1 mine were inaccurately shown on the mine map due to an apparent error which occurred during mine traverses of the 2 south area of the abandoned No. 1 mine. The 4 left 2 south section of the No. 1 mine had been developed approximately 75 feet closer to 5 right 1 south than indicated on the mine map.
