United States
Department of Labor
Mine Safety and Health Administration
Office of the Administrator
Coal Mine Safety and Health

Report of Investigation
Underground Coal Mine Explosion
Greenwich Collieries No. 1 Mine - I.D. No. 36-02405
Greenwich Collieries Division of Pennsylvania Mines Corporation
Green Township, Indiana County, Pennsylvania
February 16, 1984

George M. Fesak
Electrical Engineer

Dale R. Cavanaugh
Mechanical Engineer

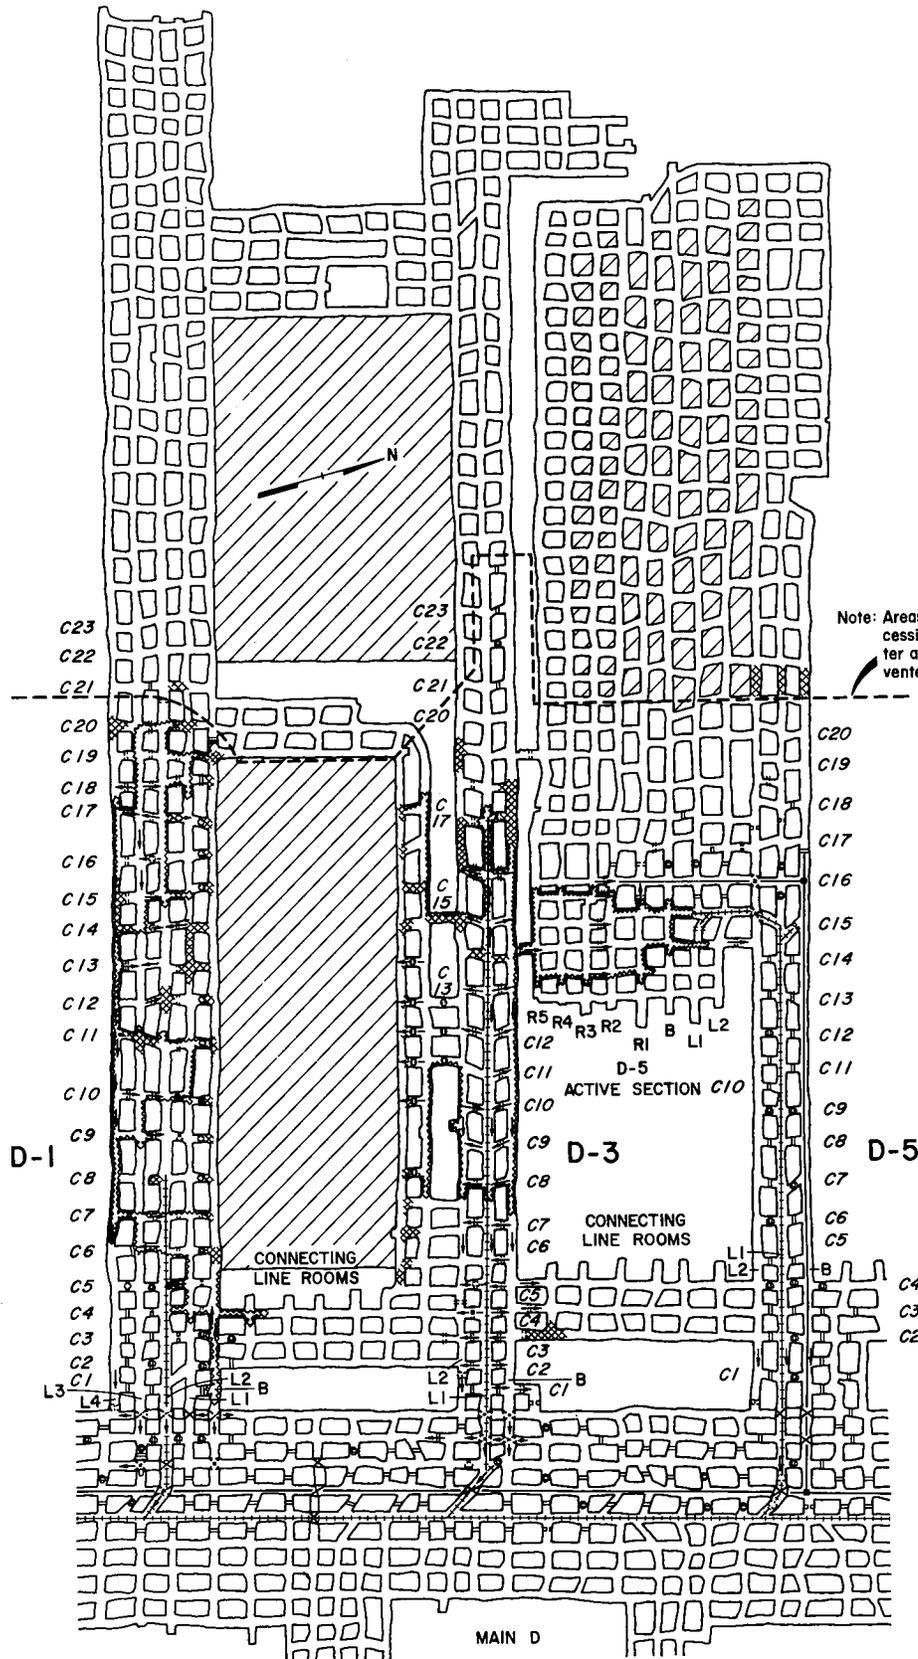
APPENDIX S - MINE MAP (Affected Area)

Note: Areas in by dotted line were inaccessible during investigation. Water accumulations and caves prevented farther exploration.

Direction and extent of forces, extent of flame, and information gathered during the investigation.

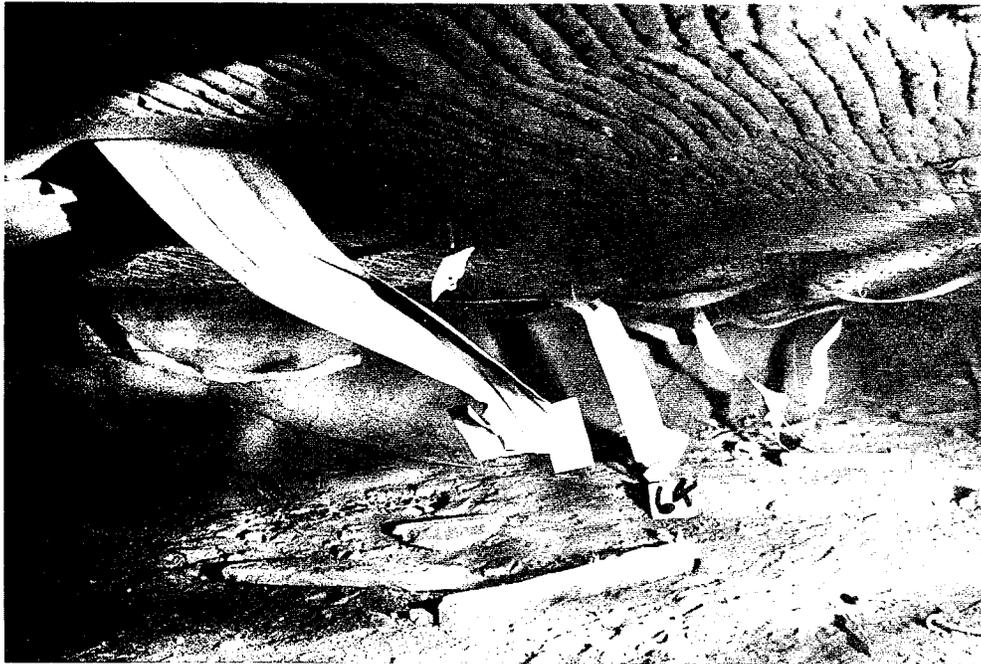
View in outby direction of damaged roof support in the B entry of D-3 at the No. 10 crosscut.

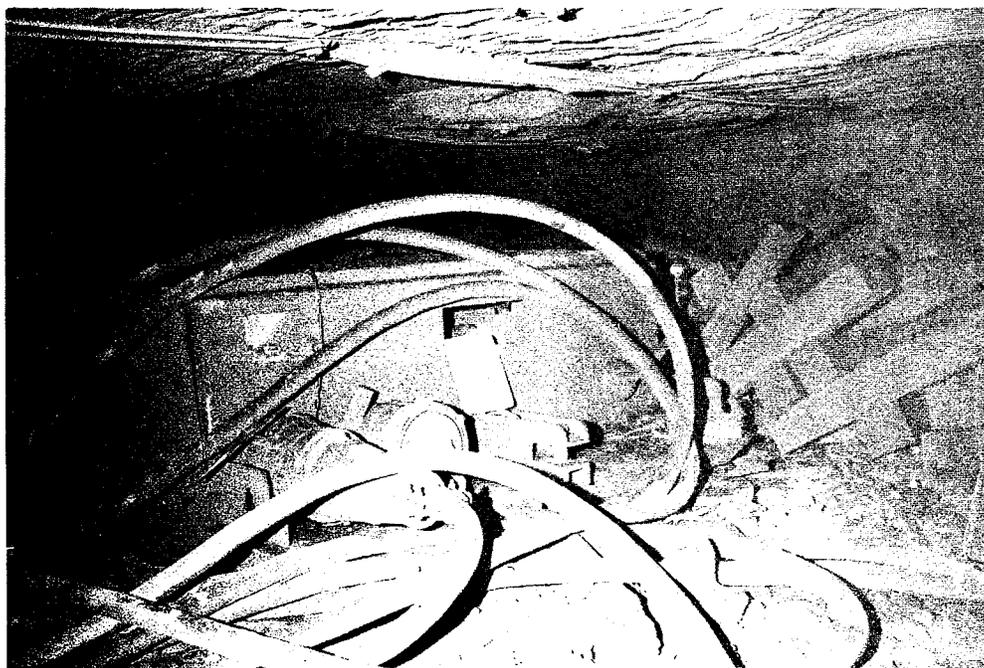
High-voltage end of the portable power center located in the No. 11 crosscut of D-3 between the L1 and B entries.

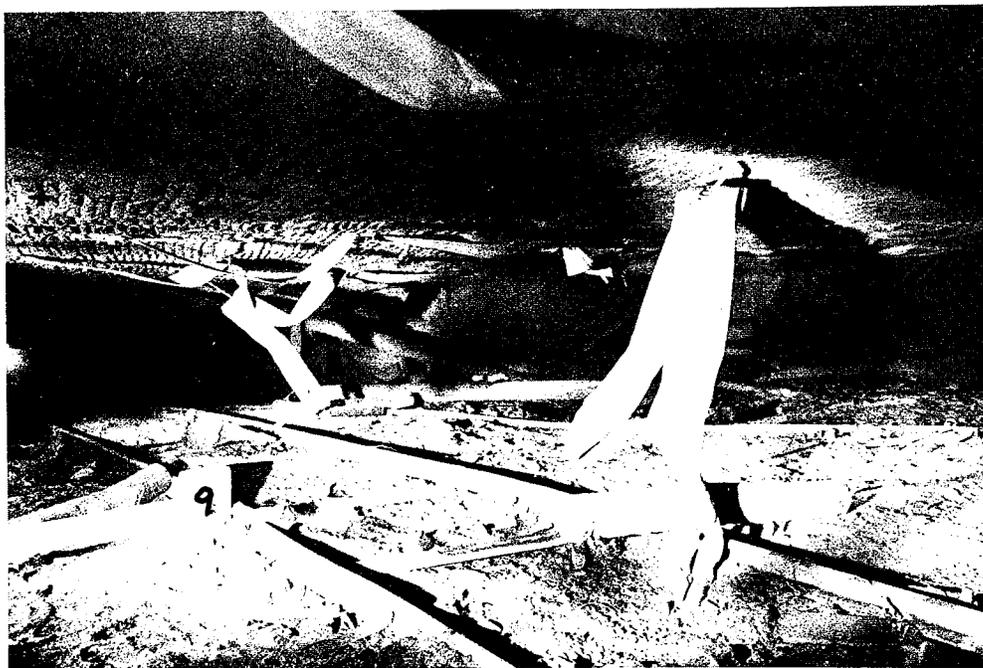
View in the outby direction of damaged roof support in the L1 entry of D-3 at the No. 12 crosscut.

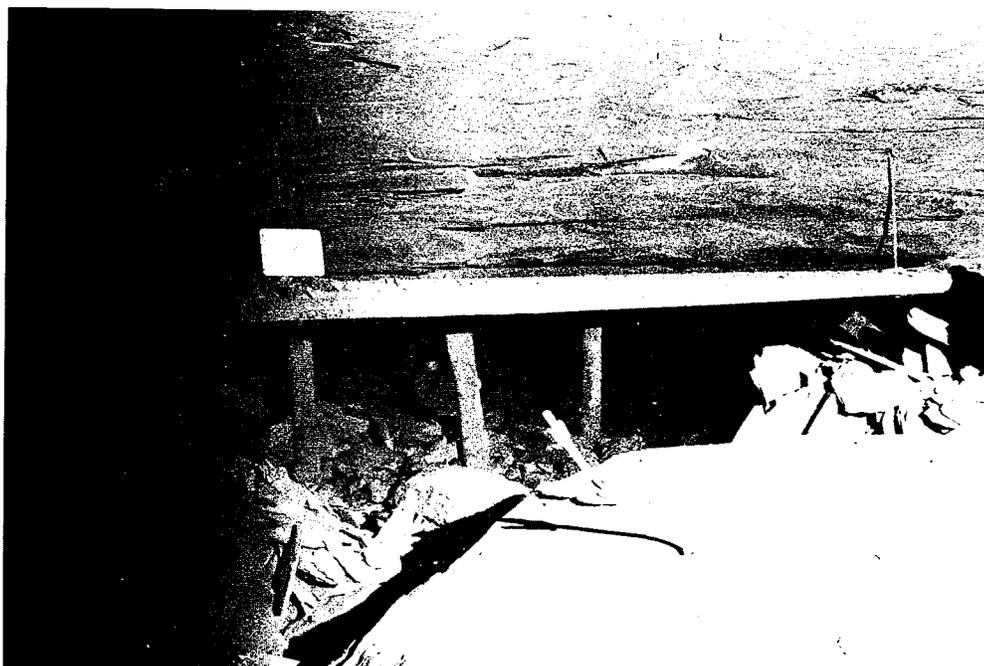
View toward the B entry of the fall and high intersection in the L1 entry of D-3 at the No. 13 crosscut.

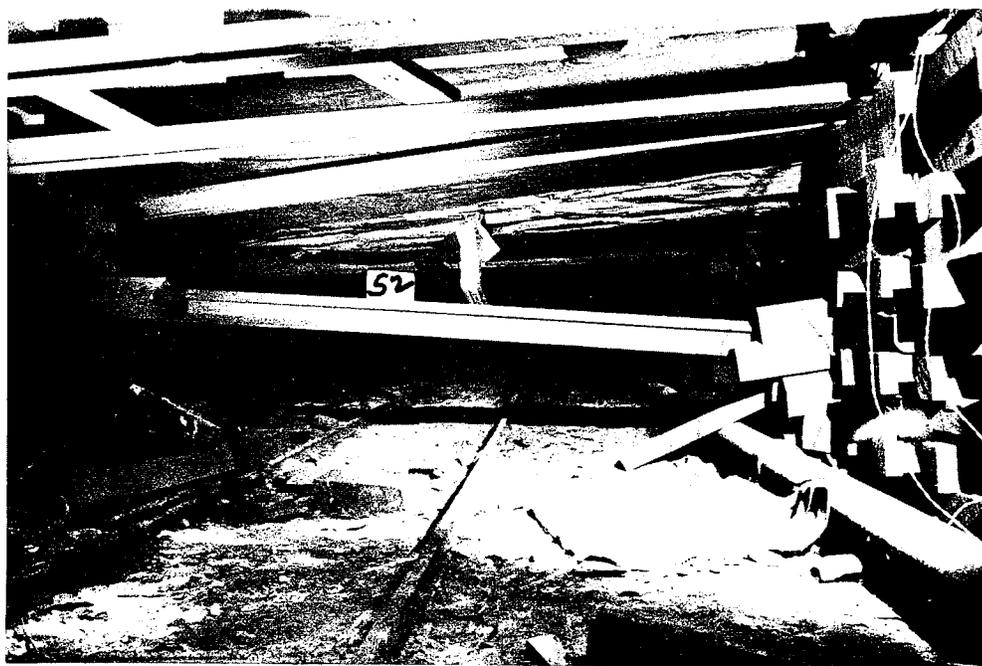
View in the inby direction of high intersection in the L1 entry of D-3 at the No. 14 crosscut.

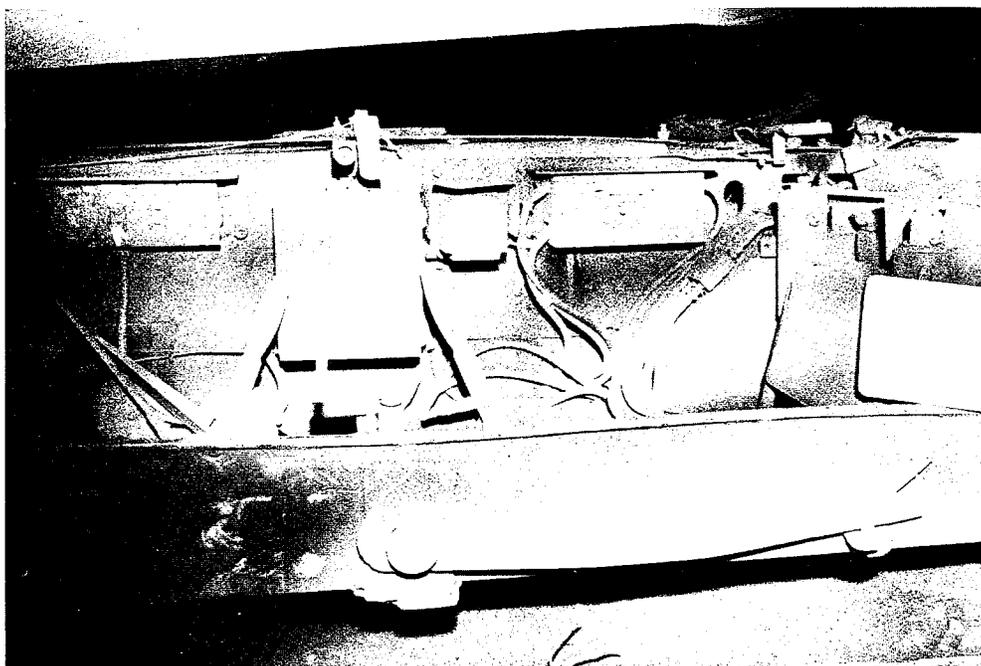
Operator's compartment of the battery-powered locomotive in the L1 entry of D-3 near the No. 15 crosscut.

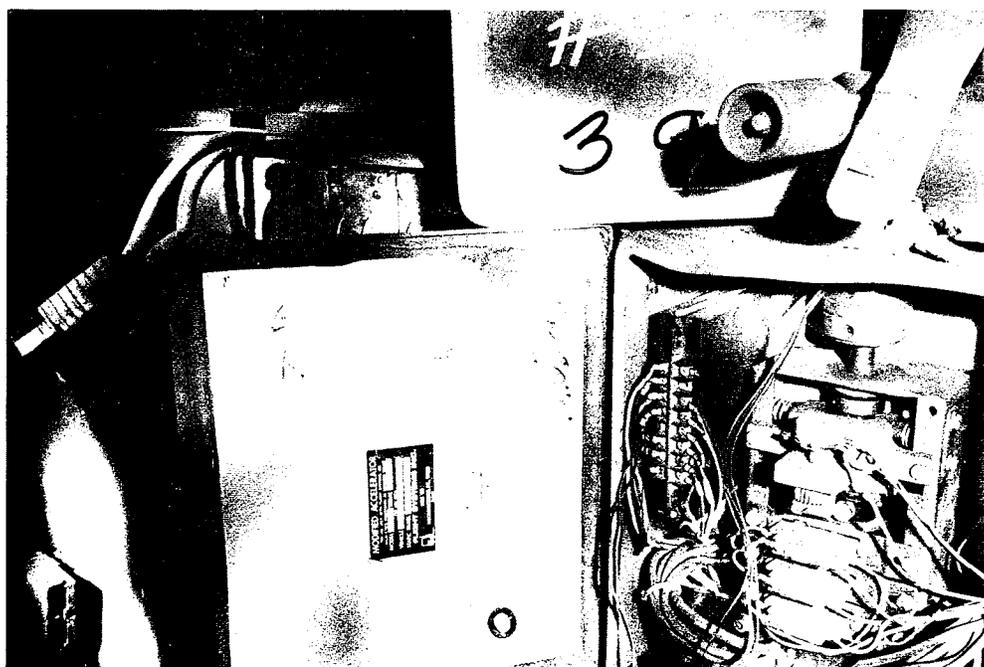
Tram control station on the battery-powered locomotive in the L1 entry of D-3 at the No. 15 crosscut.

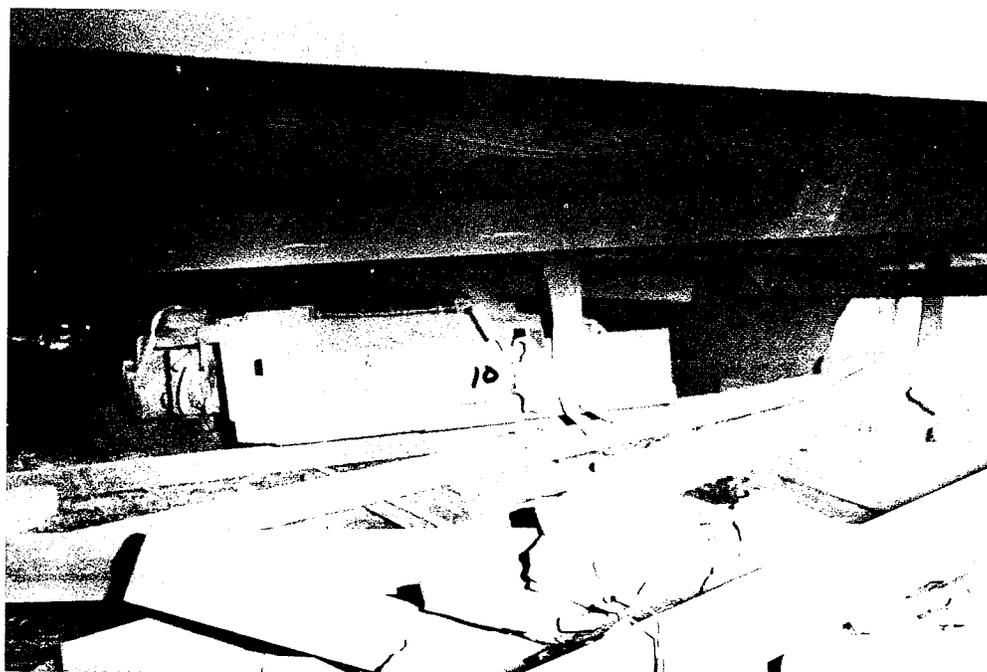
View in the outby direction of damaged roof support and inby end of locomotive in the L1 entry of D-3 at the No. 15 crosscut.

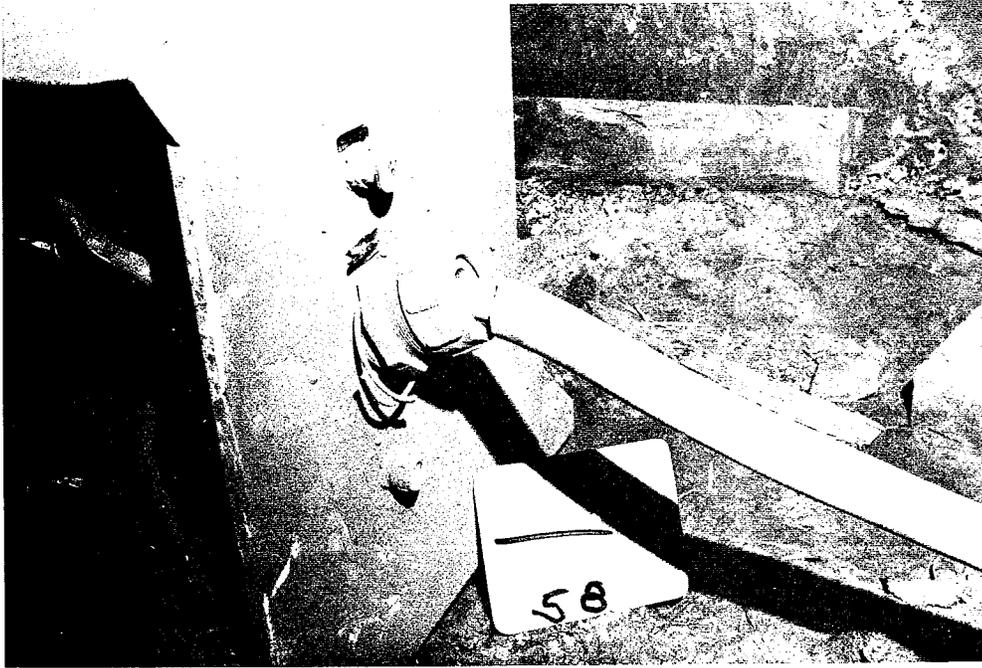
Left end of the five-circuit distribution box located in the L1 entry of D-3 between the Nos. 15 and 16 crosscuts.

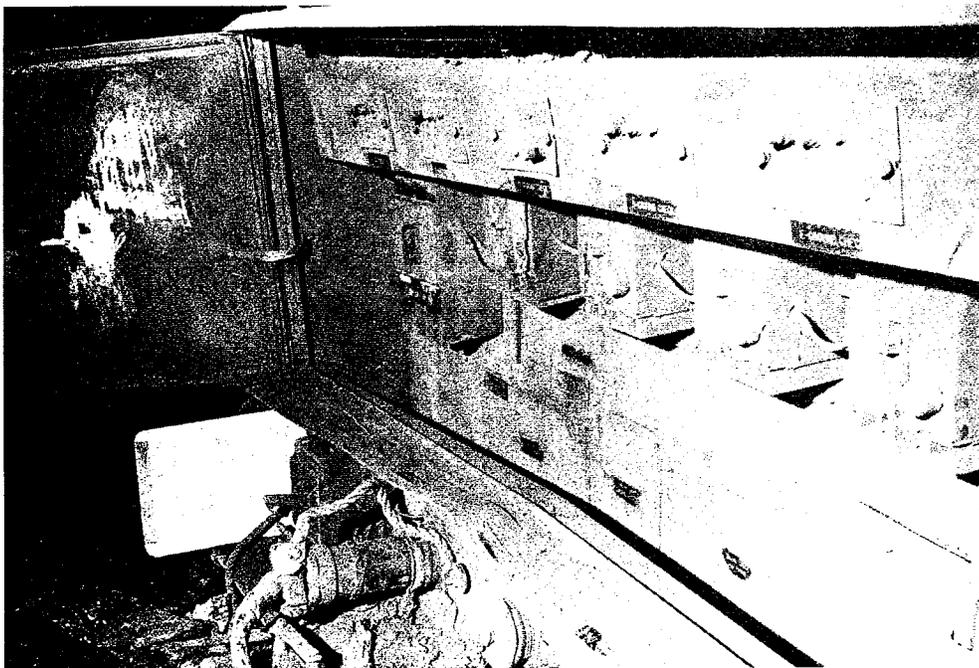
Front of the five-circuit distribution box located in the L1 entry of D-3 between the Nos. 15 and 16 crosscuts.

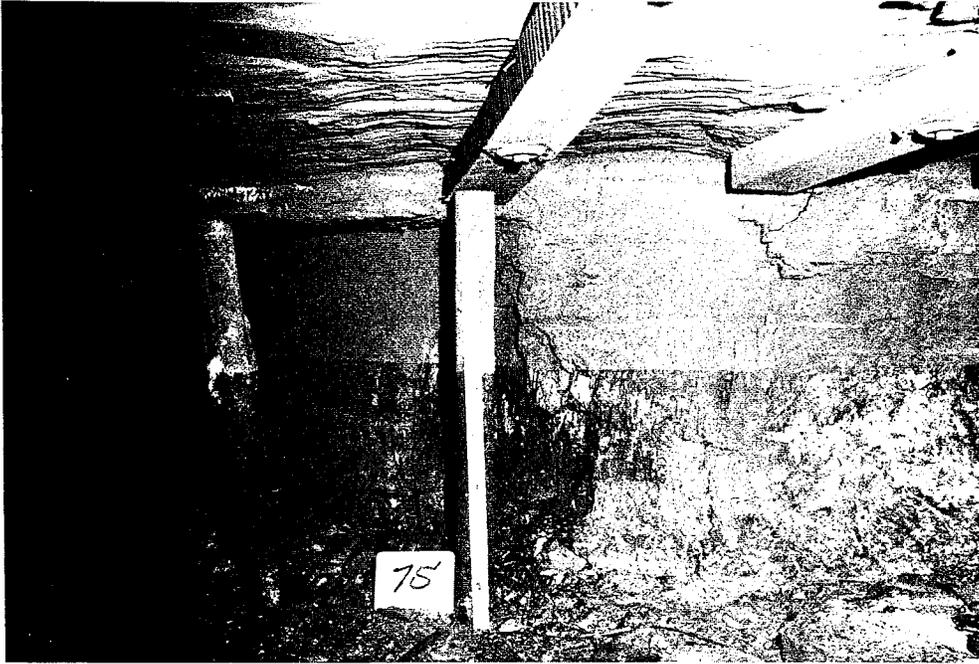
High water level line on rib near the Labour pump in the L1 entry of D-3 at the No. 17 crosscut.

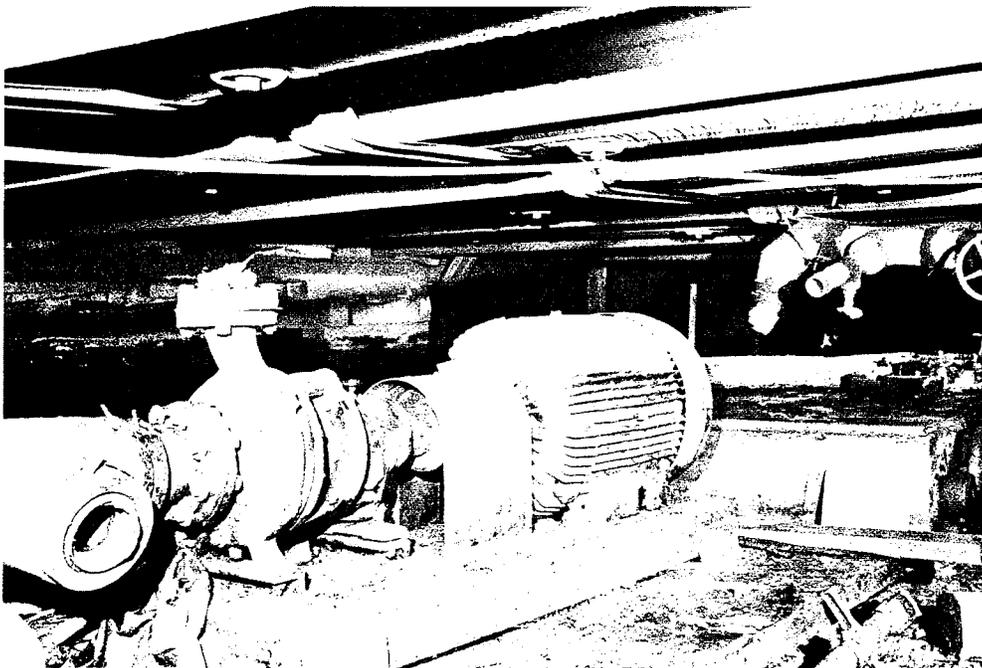
View in outby direction of the flatcar-mounted Labour pump and both ends of broken discharge line in the L1 entry of D-3 at the No. 17 crosscut.

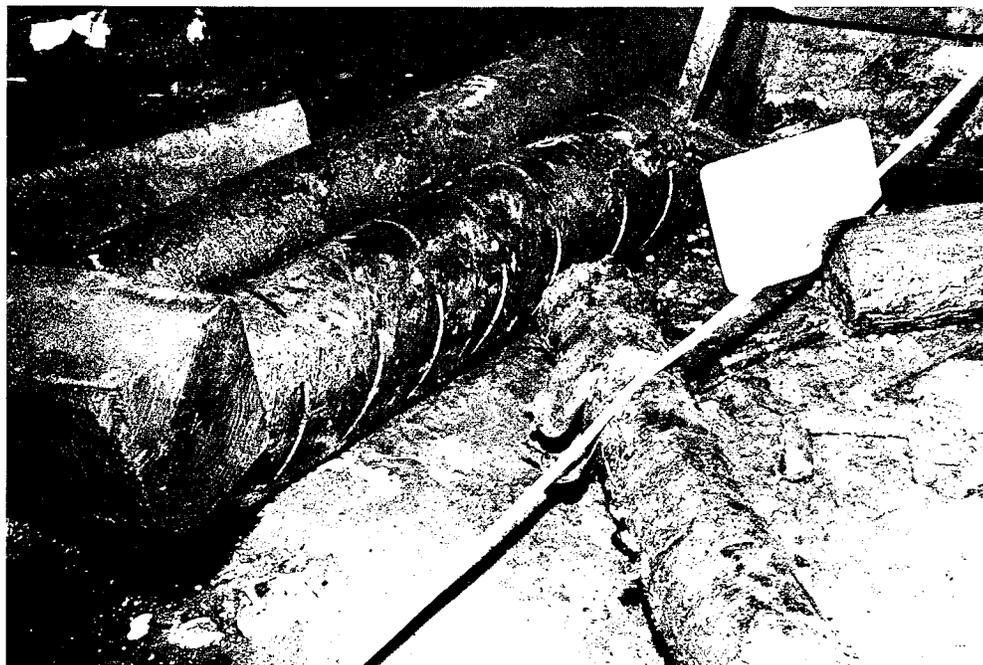
Part of the 10-foot strainer that the three victims removed from the intake line just prior to the explosion, located in the L1 entry of D-3 just inby the No. 17 crosscut.
